AL RAWDAH CASUALTY INVESTIGATION REPORT

Fall and Fatality of Wiper

Port Des Galets, l'île de La Réunion | 30 January 2019

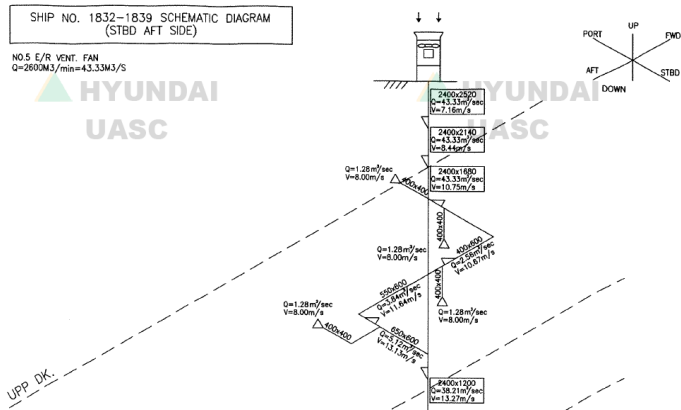
Figure 1: Schematic Diagram for No. 5 Starboard Engine Room vent duct.

- 1. Ship particulars: *see* chart to right.
- 2. In October 2018, damage to the impeller for the No. 5 Starboard Engine Room ventilation fan was observed by the crew of AL RAWDAH. The necessary spare parts that were ordered were delivered on board on 19 December 2018.
- 3. It was determined by the Chief Engineer (C/E) that the replacement of the damaged impeller would be conducted while the ship was in port alongside and conducting cargo operations.
- 4. The impeller is coupled to an electric motor, mounted vertically in the fan duct, which is about 20 m deep (*see Figure 1*). The motor is connected to the duct shell door. The door is mounted with hinges on one side and secured by bolts and nuts on the other three sides. The door provides direct access to the motor and impeller. The fan duct is not fitted with fall protection or anchor points for a safety line.

1. Additional safety training was conducted for AL RAWDAH crewmembers regarding the proper use of PPE.
2. Safety awareness of all crewmembers to be increased by continuous training during shipboard visits by office staff, seminars, and shore based briefing sessions.
3. The promotion and evaluation system for officers was amended to include an increased focus on safety awareness and risk management for senior officers.
4. Grating was installed in the ventilation ducts of AL RAWDAH to prevent another fall into the casing.

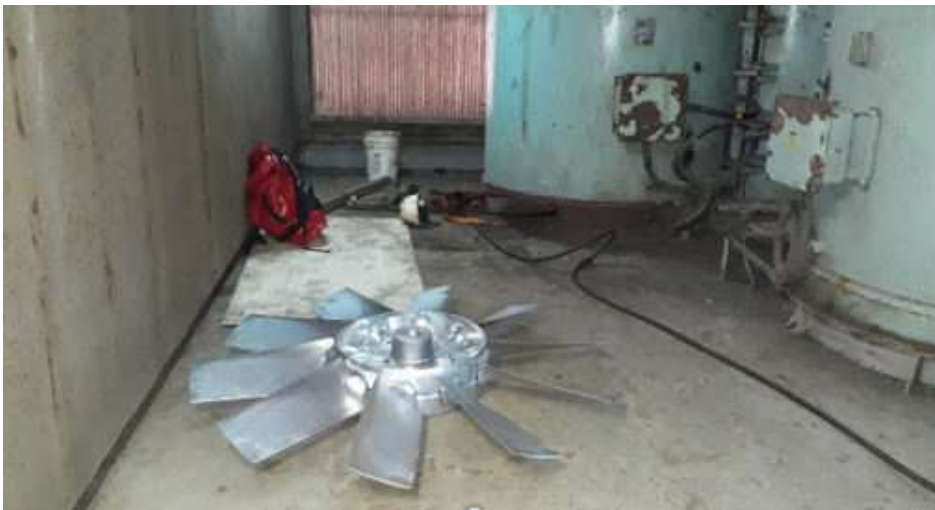
10. Shortly after the Toolbox Talk, the impeller was safely lifted to the Fan Room (*see Figure 2*). All crewmembers assigned to complete this task signed the risk assessment form at the conclusion of the Toolbox Talk.

Figure 2: Fan Room with the No. 5 Starboard Engine Room ventilation fan open and the replacement impeller on the deck after lifting.

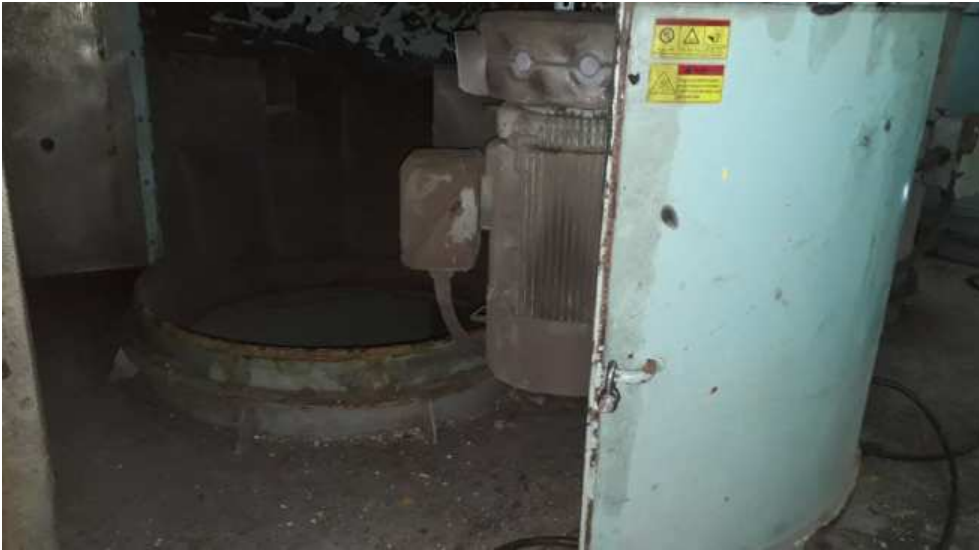
Figure 3: Open duct for the No. 5 Starboard Engine Room ventilation fan. The Wiper was standing between the motor and the opening.

12. At approximately 1330, the Wiper fell into the duct, presumably while pushing the fan duct door open in order to loosen the nuts and bolts holding the damaged impeller to the motor (*see Figure 3*).

The cause of the Wiper's fall into the open fan duct cannot be determined since there were no direct witnesses. However, it is presumed that the Wiper lost his balance while working and fell into the open duct.

The Company's SMS required that safety harnesses be worn whenever there is a risk of falling more than 2 m. Given the depth of the ventilation duct, a safety harness was required to have been worn by any crewmembers working near the opening. In addition, this fall risk would have triggered the requirement for a PTW.

1. It is recommended that the Company:
 - (a) review and revise, as necessary, its senior officer familiarization as related to the SMS safe working practices and conducting risk assessments;
 - (b) verify the onboard implementation of SMS safe work practices and pre-task risk assessments during audits and inspections; and
 - (c) inspect other vessels within their managed fleet for the risk of fall into ventilation ducts during maintenance and implement preventive actions, as appropriate.
