**REPORT INTO THE  
COLLISION BETWEEN  
A TANKER ‘VARKAN EGE’  
AND  
A SAILING VESSEL ‘MEDI MODE’  
23rd AUGUST 2019**

**REPORT NO. MCIB/293  
(No.7 OF 2020)**

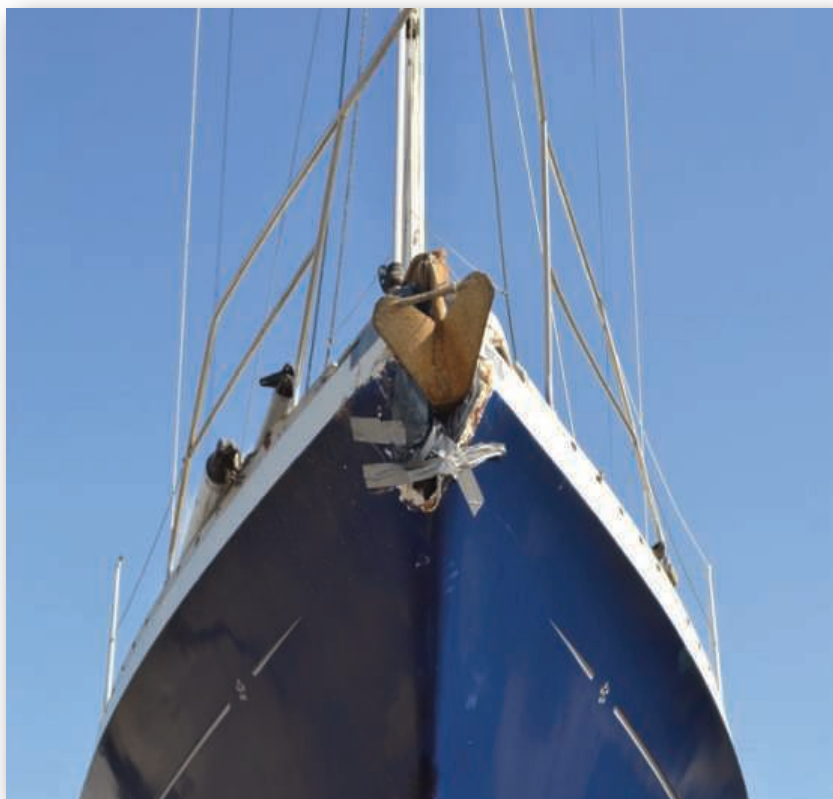
- the stem head fitting was torn away, the pulpit, toe rail and surrounding area was severely deformed;
- the mast was held upright by the baby stay forward;
- rudder control was restricted by damage and was unable to use the full range;
- there was damage to the aft bulkhead and door to the aft cabin; and
- the starboard sheet winch was driven down through the cockpit coaming.

Photograph No.3 - Damage to bow of 'Medi Mode'.

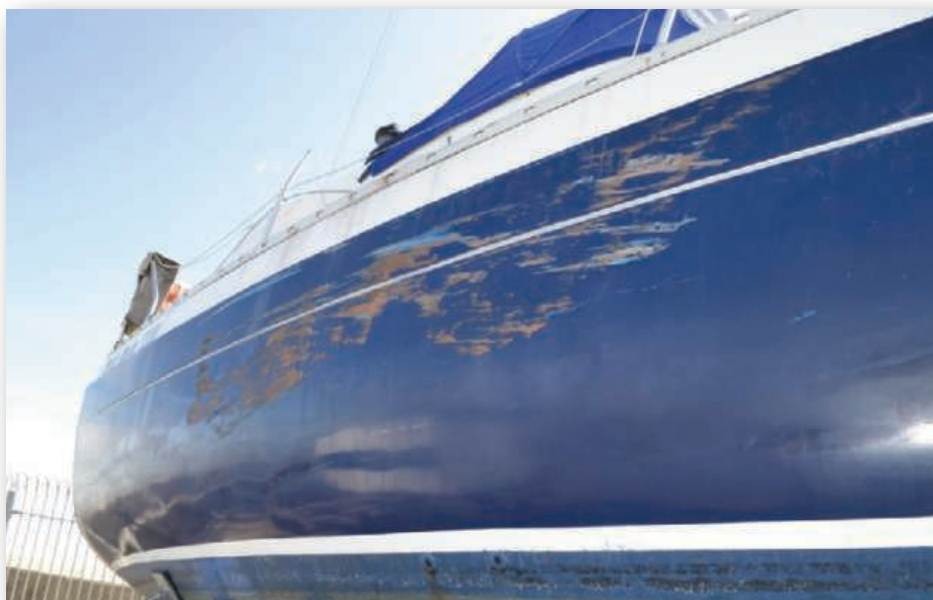
Photograph No.4 - Damage to hull, starboard side.

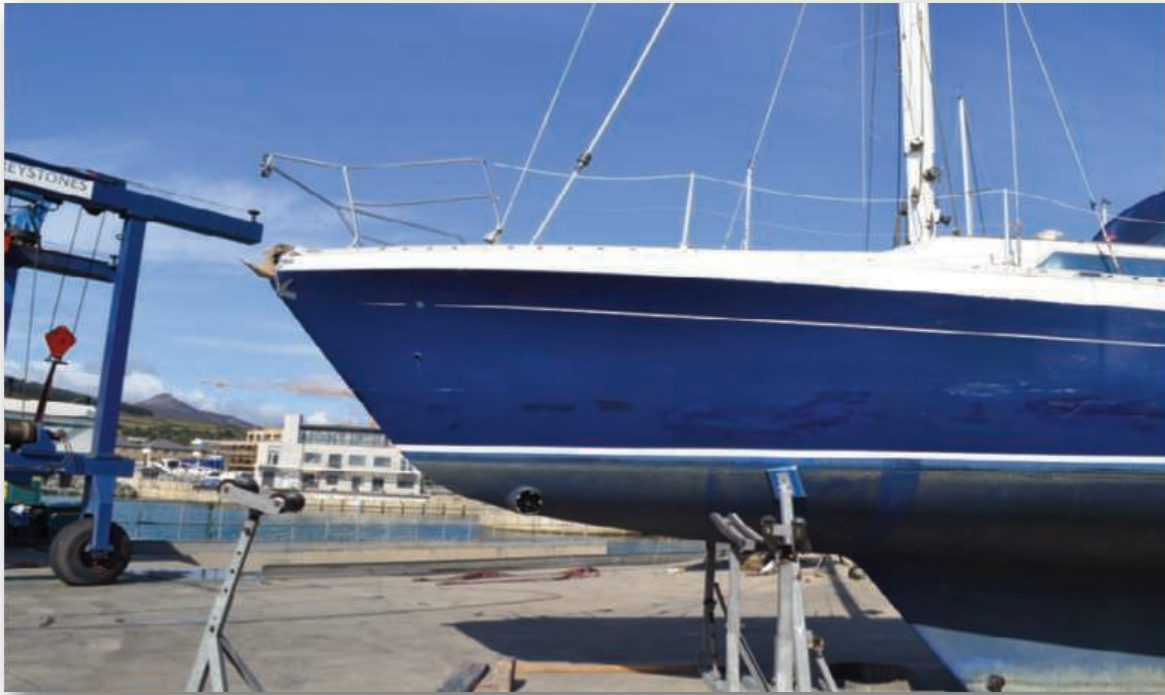
Photograph No.5 - Damage to port bow of 'Medi Mode'.

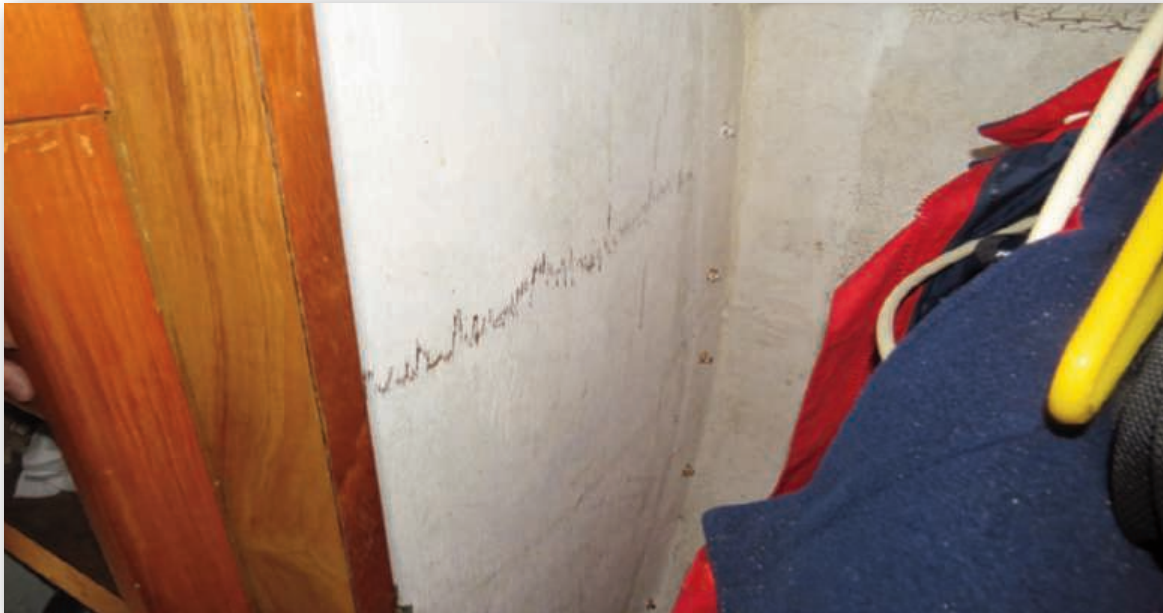
Photograph No.6 - Internal damage to bulhead.

Further damage to aft bulkhead & door to aft cabin.

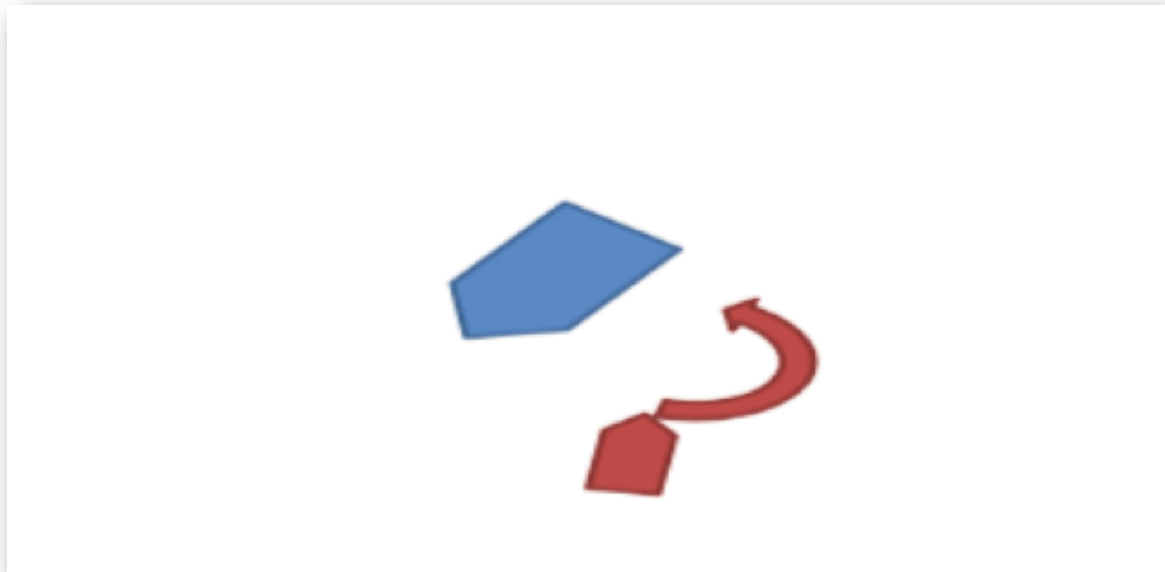
### Appendix 7.5 Demonstration of Incident as Described by 'Varkan Ege'

As 'Varkan Ege' was altered course to Starboard 'Medi Mode' altered to Port.
