STONE I

Marine accident report on loss of control

4 JANUARY 2020

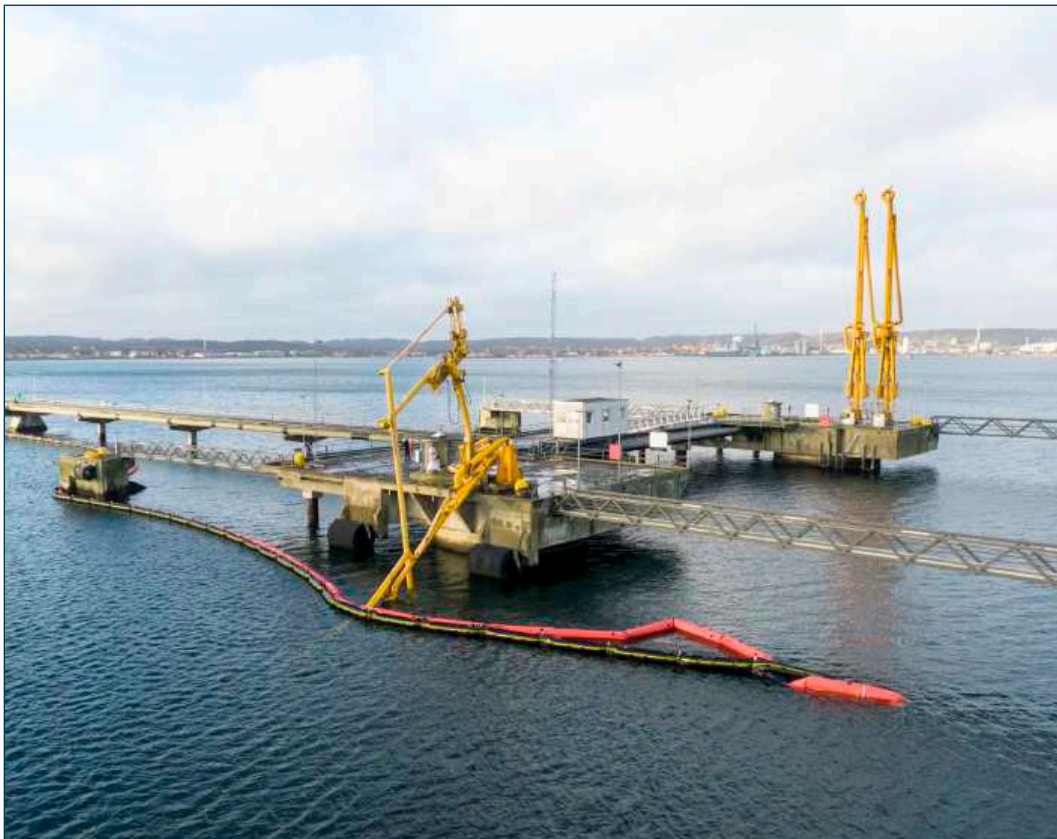
Figure 2: Ensted Oil Terminal after the accident
Source: DMAIB

Shortly after the spill, the authorities deployed the national oil pollution response plan and started containing the oil on the beaches and at sea. It was estimated that 20 m³ gas oil was spilled on to the ship's deck and 3-5 m³ into the sea.

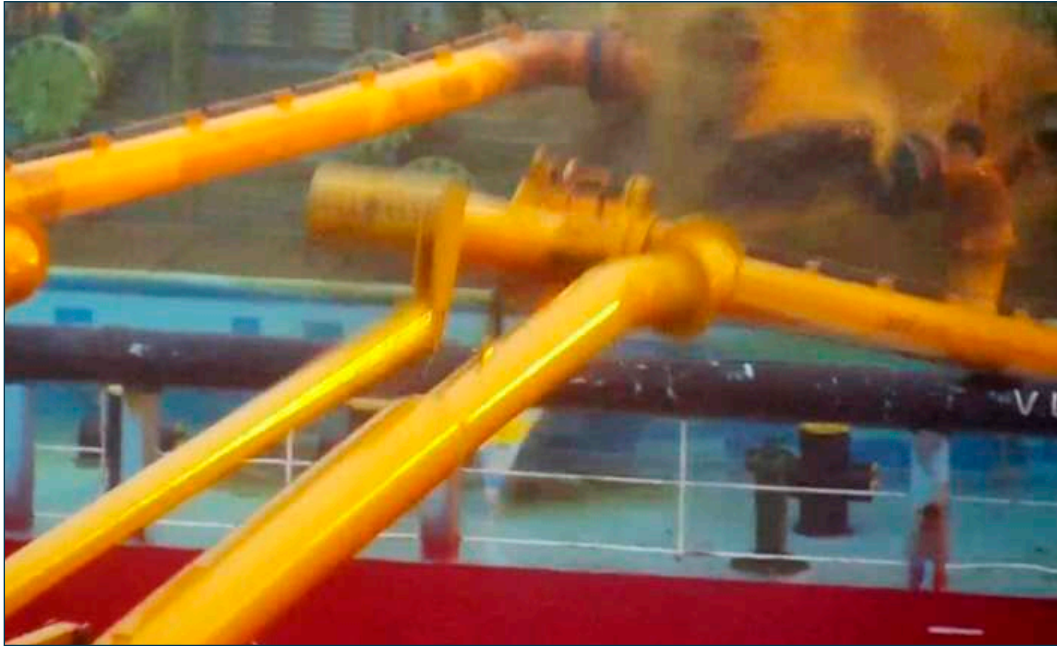
*Figure 3: CCTV footage of loading arms breaking off and oil gushing out.
Source: Inter Terminals Denmark EOT Aps*

Simultaneously, at 0930, the master received information from the deck crew that one of the aft spring lines had parted. An AB who was standby at the manifold rushed to the forward mooring station together with the 2nd officer. Another AB went to the aft mooring station to assess the situation, but he soon realised that he was not able to safely approach the mooring winches, as the mooring ropes payed out uncontrollably, and the brake bands developed heavy smoke. Both loading arms from the jetty broke off the ship's manifold and vacuum gas oil gushed onto the ship and into the water (figure 3 and 4, next page).

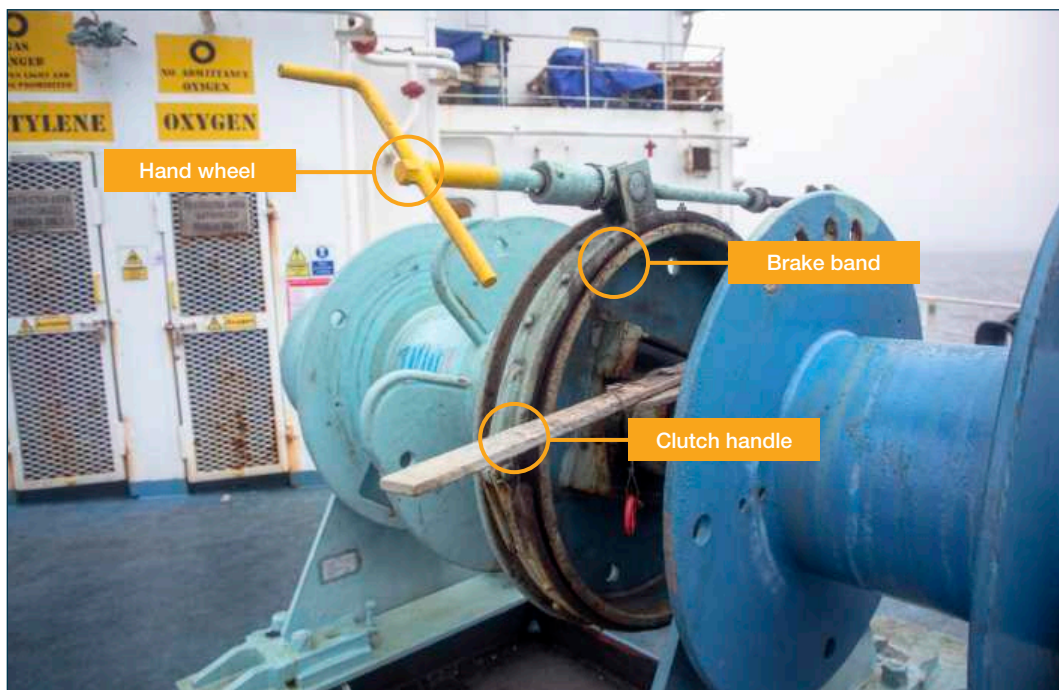
Figure 7: Hand wheel, brand brake and clutch on mooring winch.
Source: DMAIB

Each winch was fitted with a manually operated clutch and band brake with manual setting and release. The brake was tightened by turning the hand wheel (figure 7).

During the investigation on the ship, it was not certain whether the winches had been adjusted during or after the accident. Therefore, it was not possible to determine on site if the winch brakes had been fully applied before the accident. Statements from witnesses affirmed that the brakes on the aft deck winches made a screeching sound and developed smoke, caused by friction between brake band and brake drum, when the ship drifted away from the jetty. This indicated that the brakes were tightened prior to the drifting of the ship; however, it did not verify whether the brakes had been fully or only partially applied.

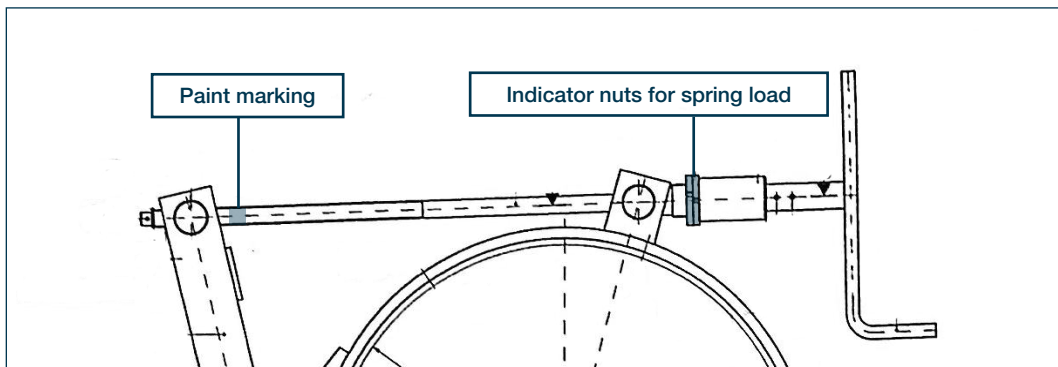
Figure 9: Visual indicators on the winch brake
Source: Zenith Gemi Isletmeciligi AS / DMAIB

As the mooring lines had been pretensioned, and the brakes developed smoke and noise, it could be concluded that the winch brakes were applied. However, it was not possible to determine whether they were fully applied. The visual indicators on the winch brakes' threaded rod left little discretionary space for how much force to apply on the hand wheel. As the brake had been tensioned and the brake tensioning left little possibility for maloperation, DMAIB found it most plausible, that the brakes were fully applied on the winches. However, the possibility of partial brake tension on any of the individual winches cannot be excluded.

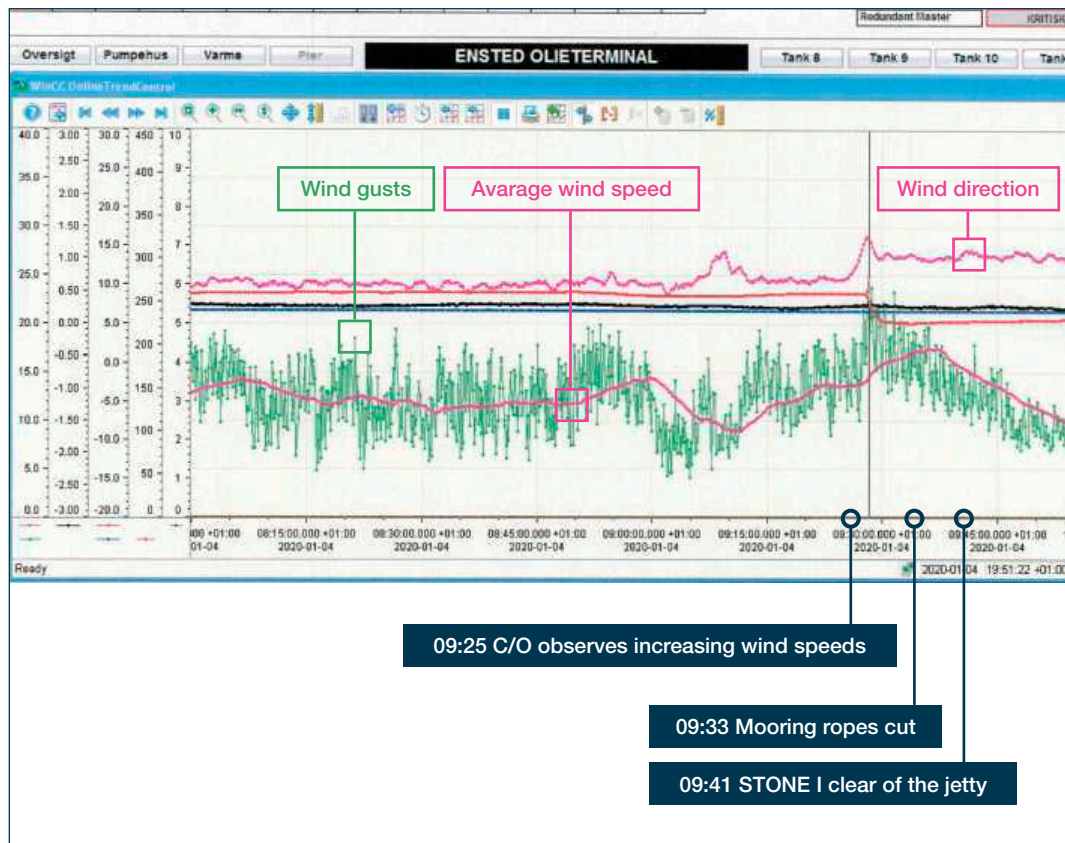
Figure 11: Screenshot from Inter Terminals' trend control panel
Source: Inter Terminals Denmark EOT Aps/DMAIB

On figure 11 next page, a record of wind direction and speed from Ensted Oil Terminal is presented. It shows wind measurements and trend data for the average wind speed for the period 0800-1000 on 4 January 2020. STONE I's mooring winches started to pay out at 0929. In the period of 0927 to 0940, the wind data shows a sudden increase in wind speed up to 25 m/s and a change of wind direction from 270° to 325 °. This wind speed was higher than the forecast predicted. However, the average wind speed did not at any time during the time period exceed the terminal's wind criteria for loading.

- The mean wind did not exceed wind criteria that the terminal and ship had agreed.
- The wind gusts exceeded the forecast received by the ship.
- The wind direction and location of the accommodation exposed the aft part of the ship to a higher lateral force than on the forward.

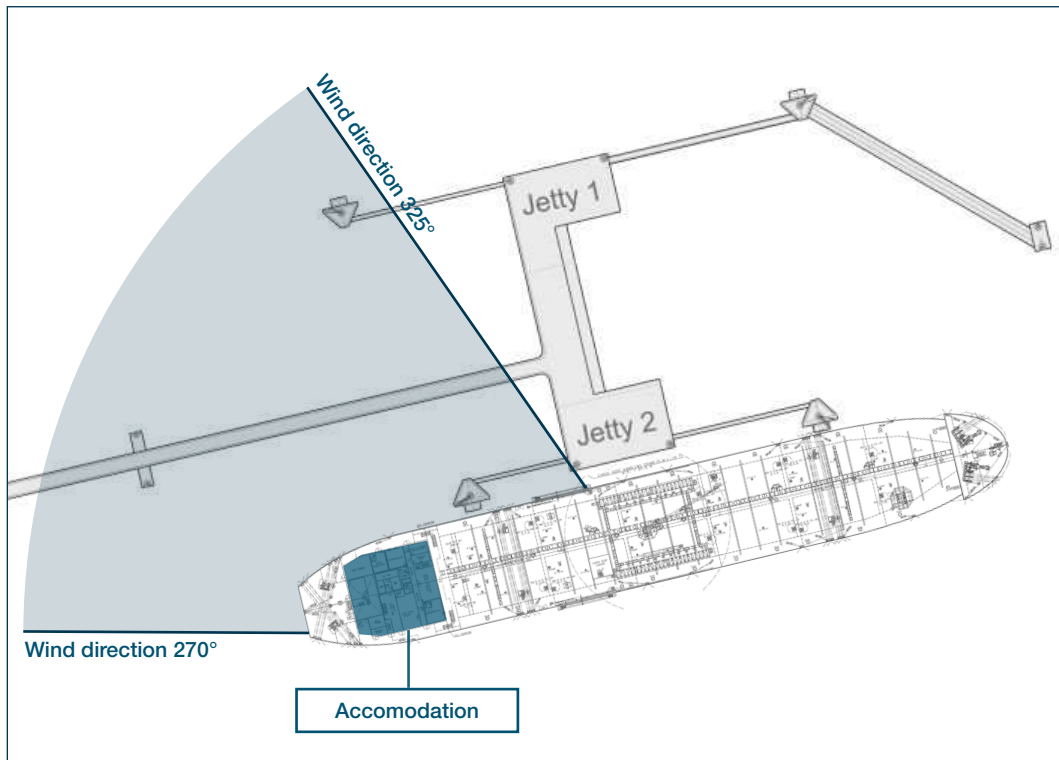
Figure 12: Wind forces acting on the ship during the accident

During the accident STONE I was berthed port side alongside, heading 080°, and the wind came from a WNW direction. The wind hence acted on the ship's aft on port side, where the ship's accommodation was located (figure 12, next page). The wind direction and location of the accommodation exposed the aft part of the ship to a higher lateral force than on the forward, which caused a higher the load on the aft moorings than on the forward.

The owner of the terminal contracted FORCE Technology to calculate at what wind force the winch brakes would release. The report prepared by FORCE concluded that the ship should not suffer from collapse of the winch holding capacity for wind speeds below 31 m/s for any wind direction. This finding implies that the winches had not been correctly applied or malfunctioned. However, the report contained several uncertainties. E.g. the pretension of the moorings and the mooring ropes vertical angles were not included in the calculation. These are significant factors for determining the load on the winches.

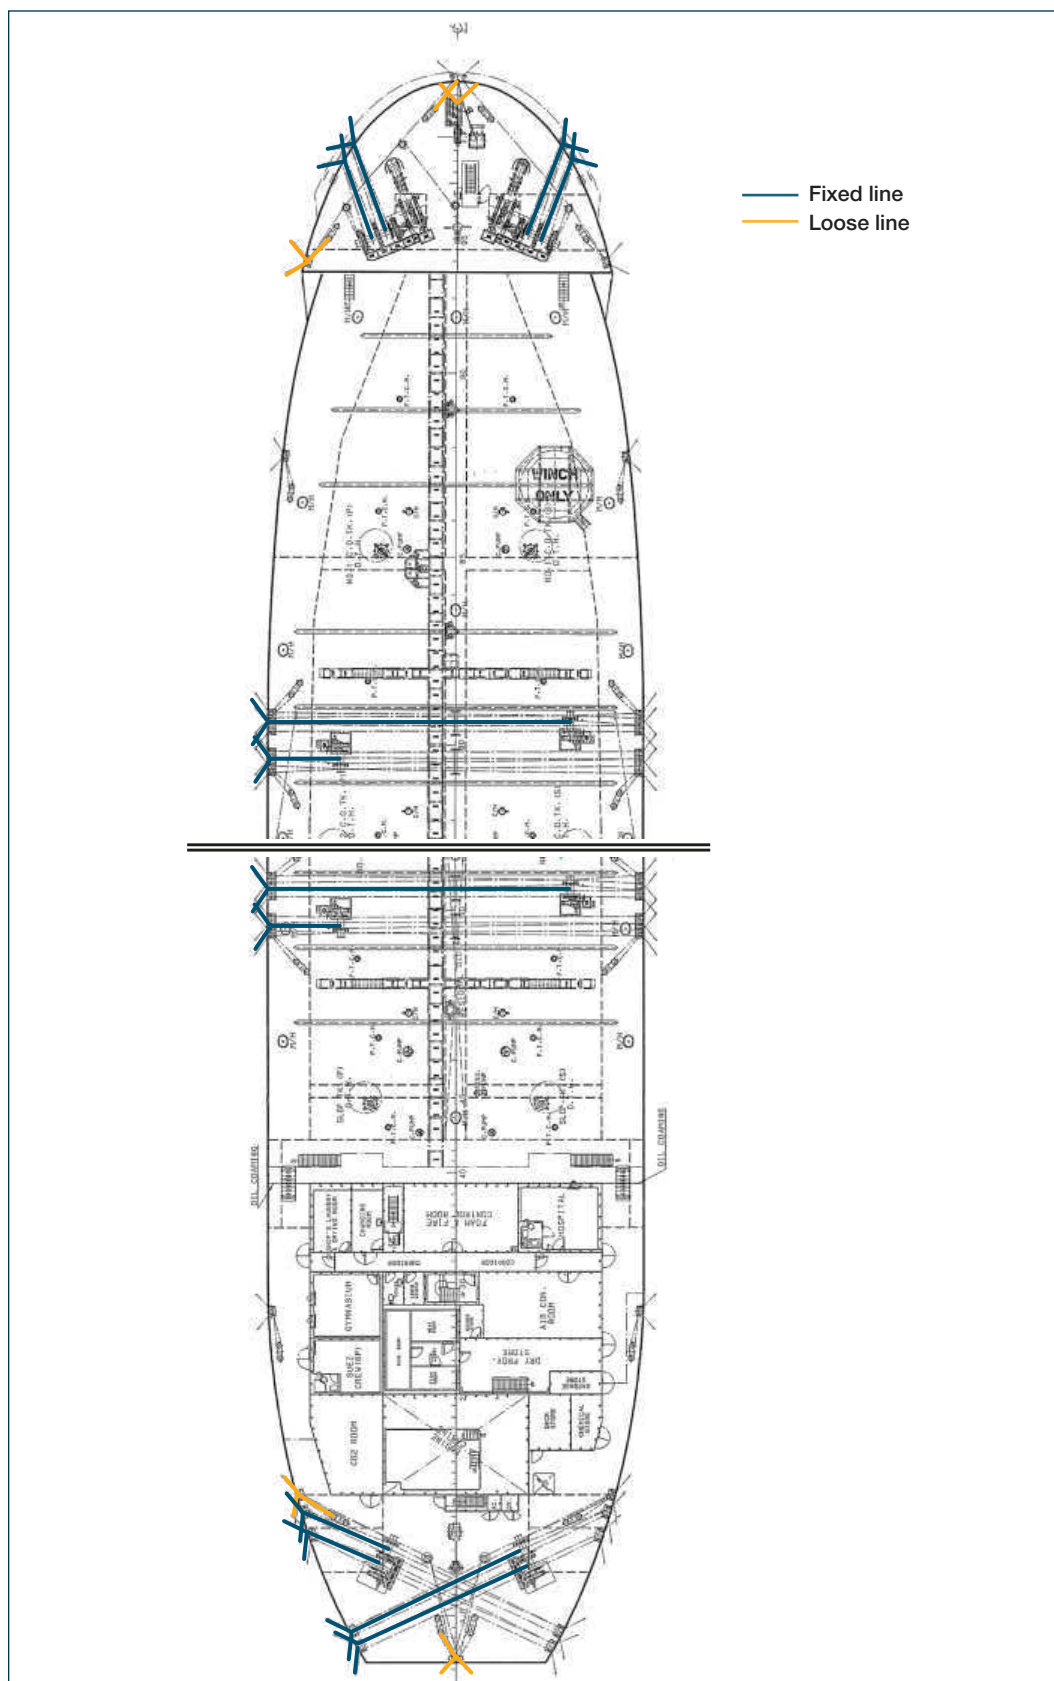
Figure 18: Possible ways of directing mooring lines on STONE I when berthed on port side.
Source: Zenith Gemi Isletmeciligi AS / DMAIB

The illustration below shows the possible ways of directing mooring lines on STONE I, when the ship was portside alongside. It is noted that on the aft mooring station the mooring layout did not allow for mooring lines to be directed from the winches to the berth via the transom (figure 18).

- The aft mooring station did not allow for mooring lines to be directed from the winches to the berth via the transom.
- The mooring management plan recognised that an optimal mooring pattern was not always achievable.
- In the event of deteriorating weather or sea conditions, the mooring management plan stated that the master should not hesitate to put out extra moorings, if he considered this to be necessary.

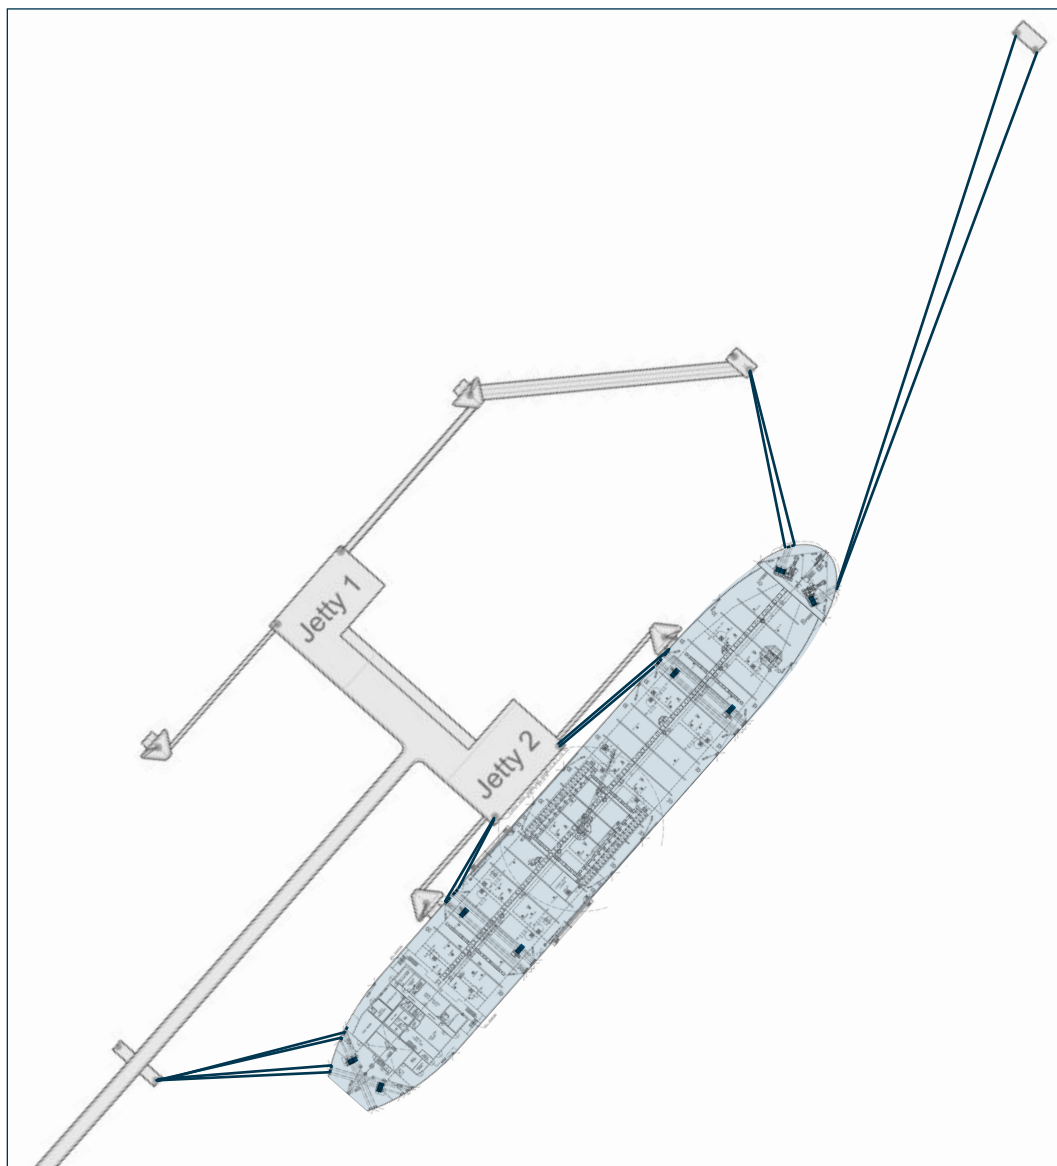
Figure 22: STONE I moored at Ensted Oil Terminal
Source: STONE I

The agreed mooring configuration was similar to the typical mooring pattern in the ship's mooring management plan. However, during berthing, the master was informed that the jetty's bollards and hooks were not aligned to direct the breast lines in an optimal angle. The master assessed the situation and decided to accept the mooring configuration as this seemed to be the only feasible option. STONE I was thus moored with four lines on the forecastle, four lines on the main deck and four lines on the aft (figure 22).

- On the aft part of STONE I, the mooring configuration on the day of the accident differed significantly from the planned.

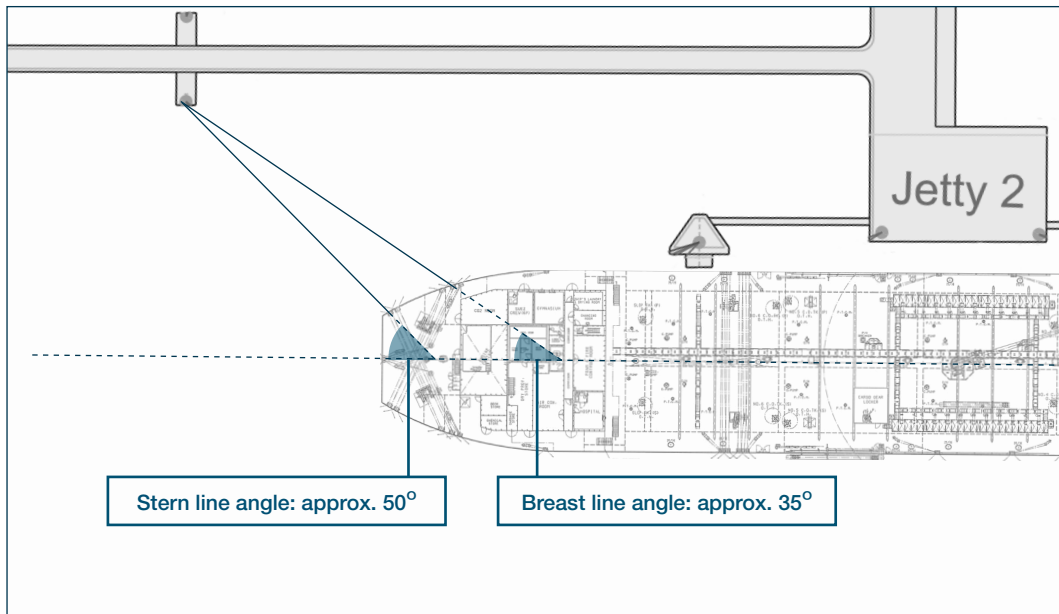
Figure 23: STONE I moored at Ensted Oil Terminal
Source: STONE I

An examination of the actual mooring configuration on STONE I at Ensted showed that it differed from the mooring configuration, which the master had initially planned, from the mooring pattern described in the ship's mooring management plan and from Ensted Oil Terminals' mooring plan. The main difference was that the intended breast lines on the aft deck had an angle of approx. 35° instead of the ideal 90°. In comparison, the stern lines had an angle of 50 approx., and was hence leading in a more perpendicular direction than the breast lines (figure 23).

The actual mooring pattern and the direction of the mooring lines from the aft deck had the effect that the aft moorings had significantly reduced transverse restrain capacity. This resulted in an increased load on the aft mooring winches. When the wind force suddenly increased, the wind direction and location of the accommodation exposed the aft part of the ship to a higher lateral force than on the forward. This added an increased load on the aft mooring winches.
