Report on the investigation of  
the fire and explosion on board

***Yeoman Bontrup***

Glensanda Quarry, Loch Linnhe, Western Scotland

2 July 2010

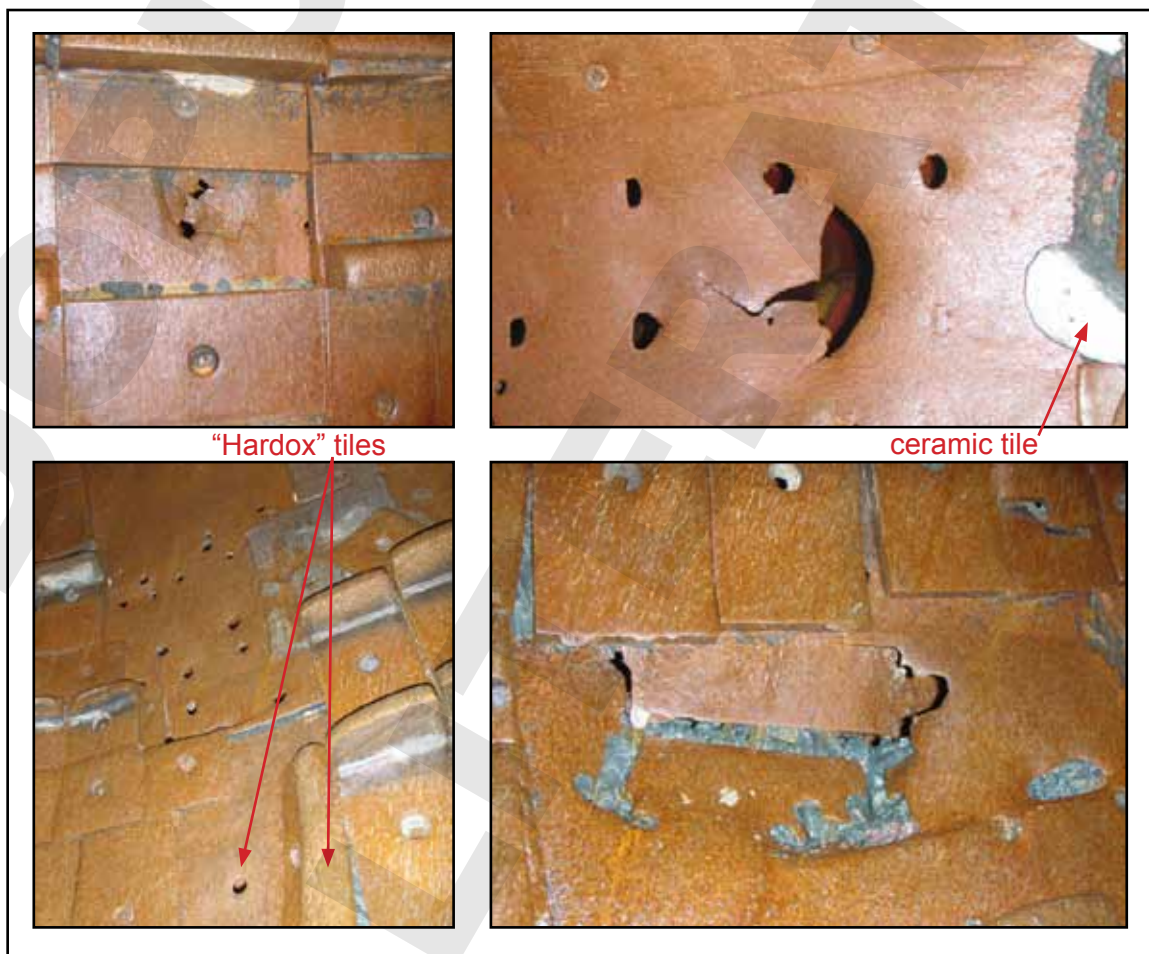
Figure 2

The inspection by the chief engineer and cargo engineer identified a small number of familiar defects associated with the SUS conveyor belts. It also identified that about 40 "Hardox" and 30 ceramic sacrificial tiles, fitted to the inside of the cargo discharge hopper, had been badly abraded or were missing. It was also found that the mild steel carcass of the discharge hopper had been holed in a number of places (**Figure 2**) by the hard sandstone cargo during the discharge operation. At 0807 on 1 July, the findings were reported, by e-mail, to the ship's manager and to the operator's technical manager.

Composite of photographs showing discharge hopper damage and wear to the "Hardox" and ceramic sacrificial protection tiles

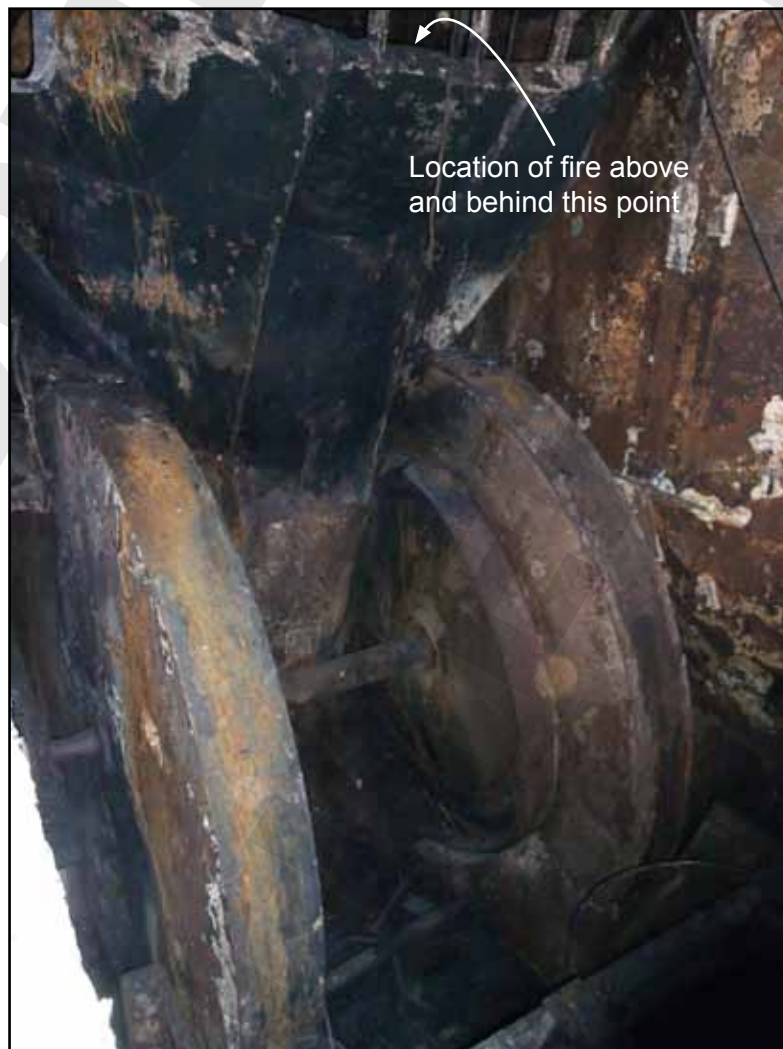
Figure 6

At 1519, the AB reached the lower platform of the vertical conveyor belt. He smelt smoke and, as he turned slightly, he saw a great deal of smoke developing and about 1.5m<sup>2</sup> of flame around the rising part of the vertical belt adjacent to the forward engine room bulkhead (**Figure 6**).

Area in which the fire was discovered

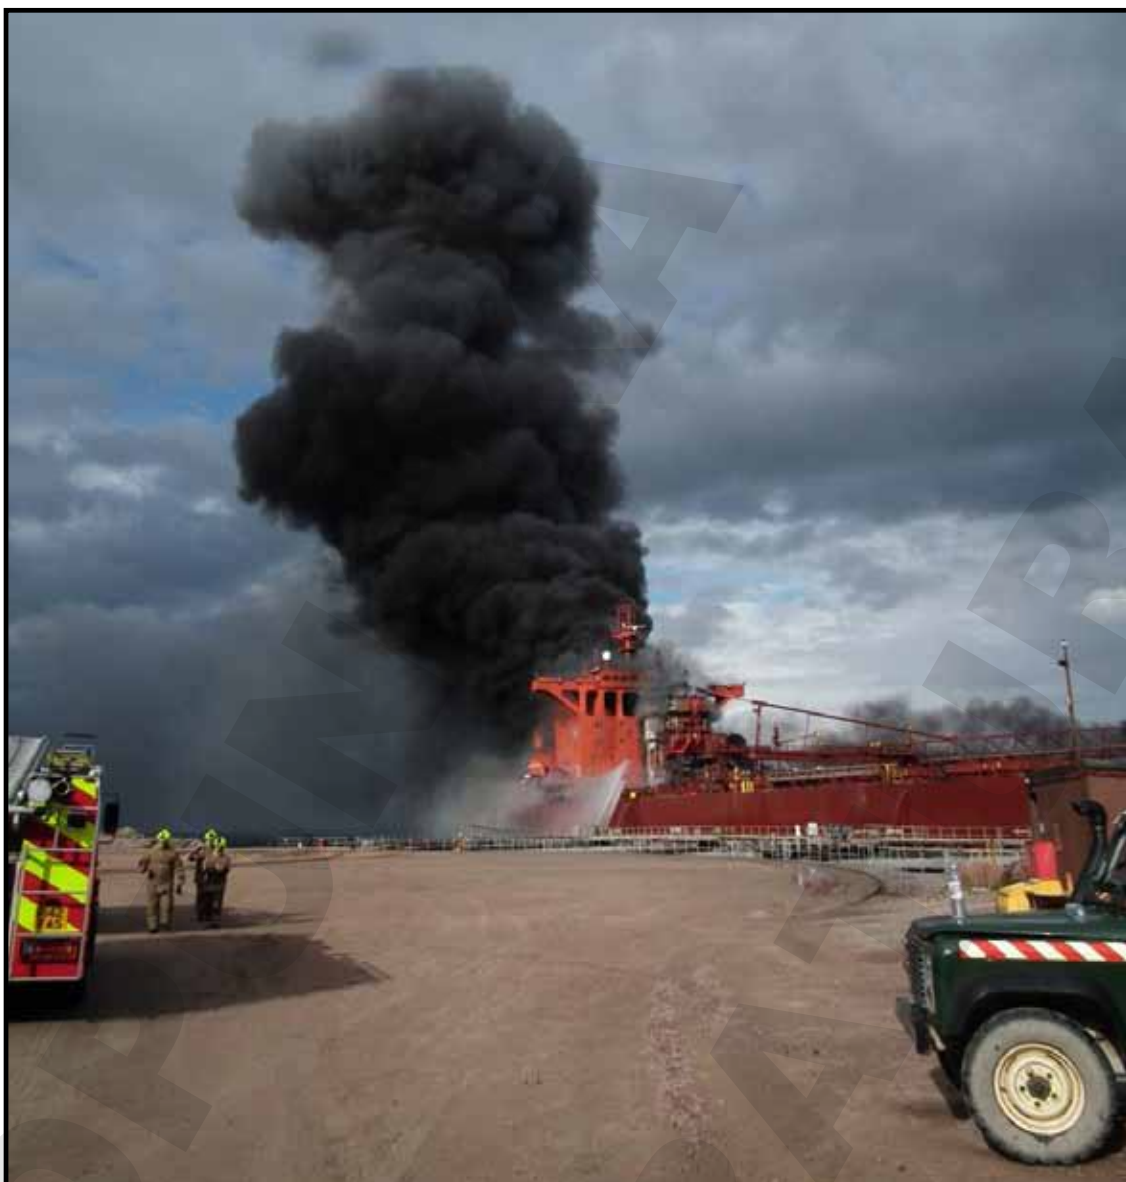
The HIFRS tenders arrived at 1825. The HIFRS had just established a 200m exclusion zone when a massive explosion (**Figure 11**) tore off the entire poop deck, projecting it up into the air and landing it on the port side of the funnel deck. Soon afterwards, flames were seen coming from *Yeoman Bontrup*'s stern area as the oils and chemicals stowed in the steering gear room, and the steering system's hydraulic oil charge, continued to burn.

Steering gear compartment explosion

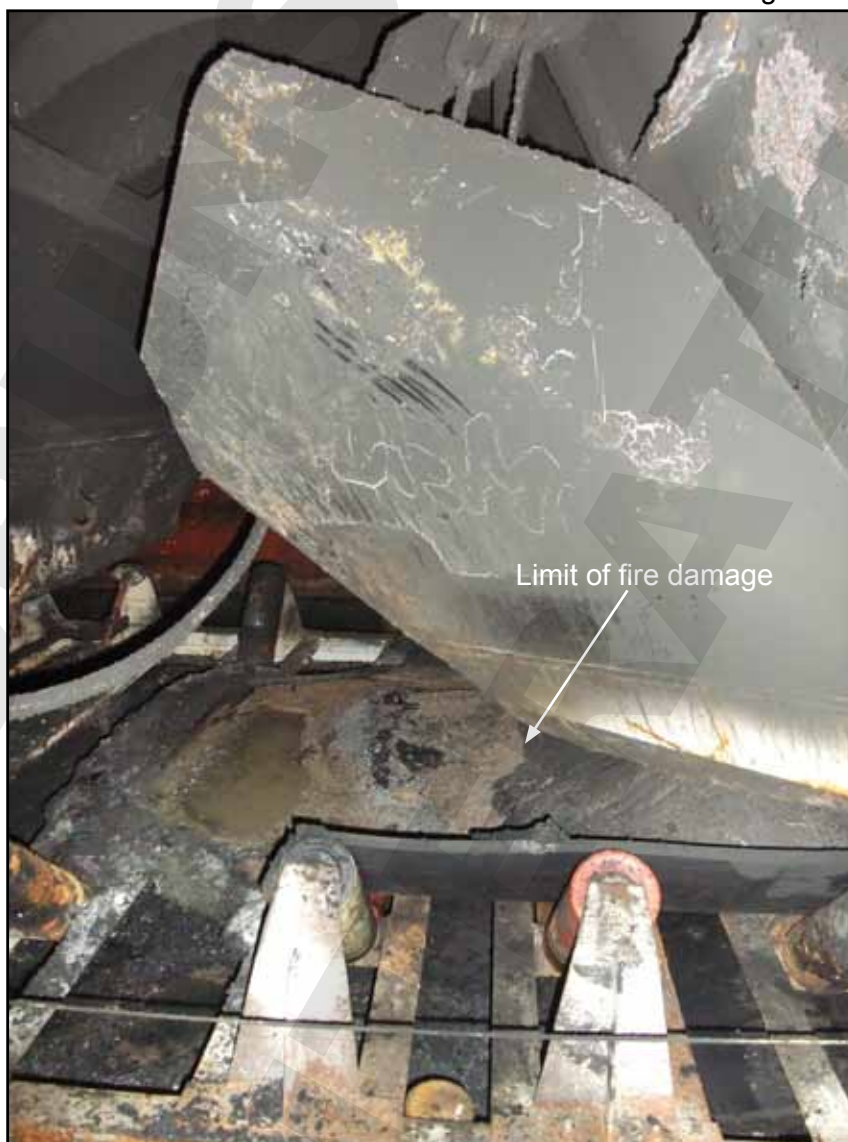
Figure 13

The fire damage in the hold tunnels reached as far forward as frame 167 with the port, starboard and centre hold conveyor belts being consumed from this point aft (**Figure 13**), as were the two cross-conveyor belts. The distinct line of the limit of damage suggests that the three tunnel belts forward of this point were covered by water that had accumulated in the tunnel<sup>4</sup>.

Extent of damage to tunnel conveyor belts

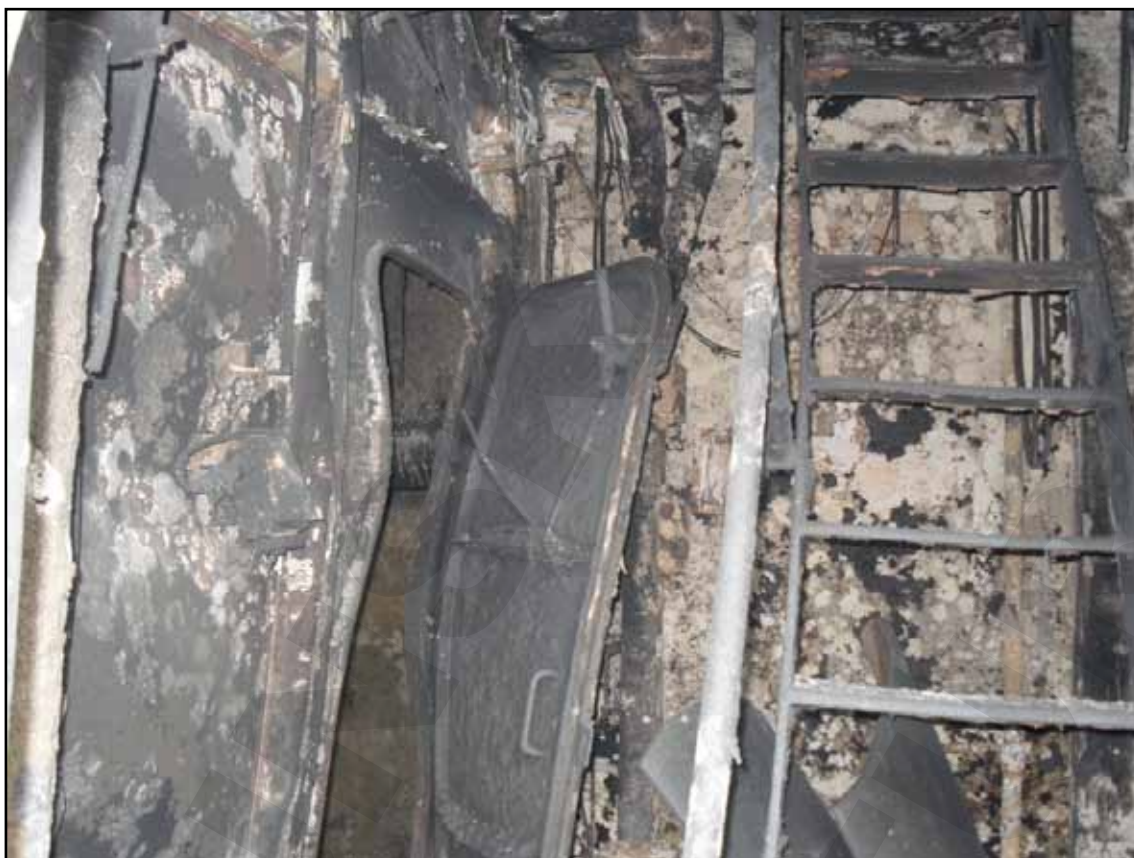
All flammable material in the vertical conveyor belt tower and the SUS hydraulic pump space was completely destroyed, and there was massive structural distortion to the steel doors, ladders and bulkheads (**Figure 14**).

Example of distortion in the SUS tower

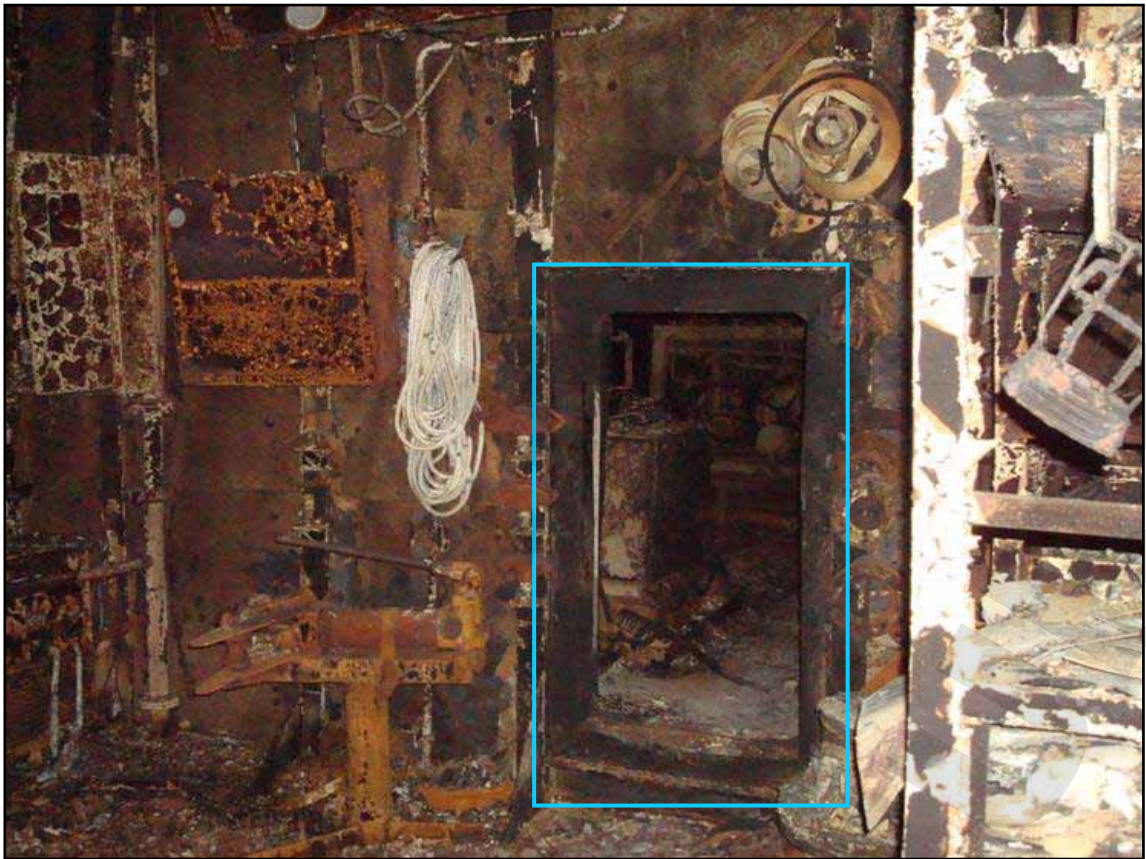
Figure 15

The engine room workshop contents were completely consumed as the fire passed through the open SUS hydraulic pump space door (**Figure 15**). The engine room forward bulkhead suffered distortion through heat transfer from the SUS tower. The fire consumed the ECR, electrical workshop and switchboard. The heat damage was especially severe at the upper levels of the engine room, which resulted in the overhead gantry falling to the lower level. The purifier room, situated on the starboard side, and the lower levels of the engine room escaped large-scale damage.

Engine room/SUS hydraulic pump space door

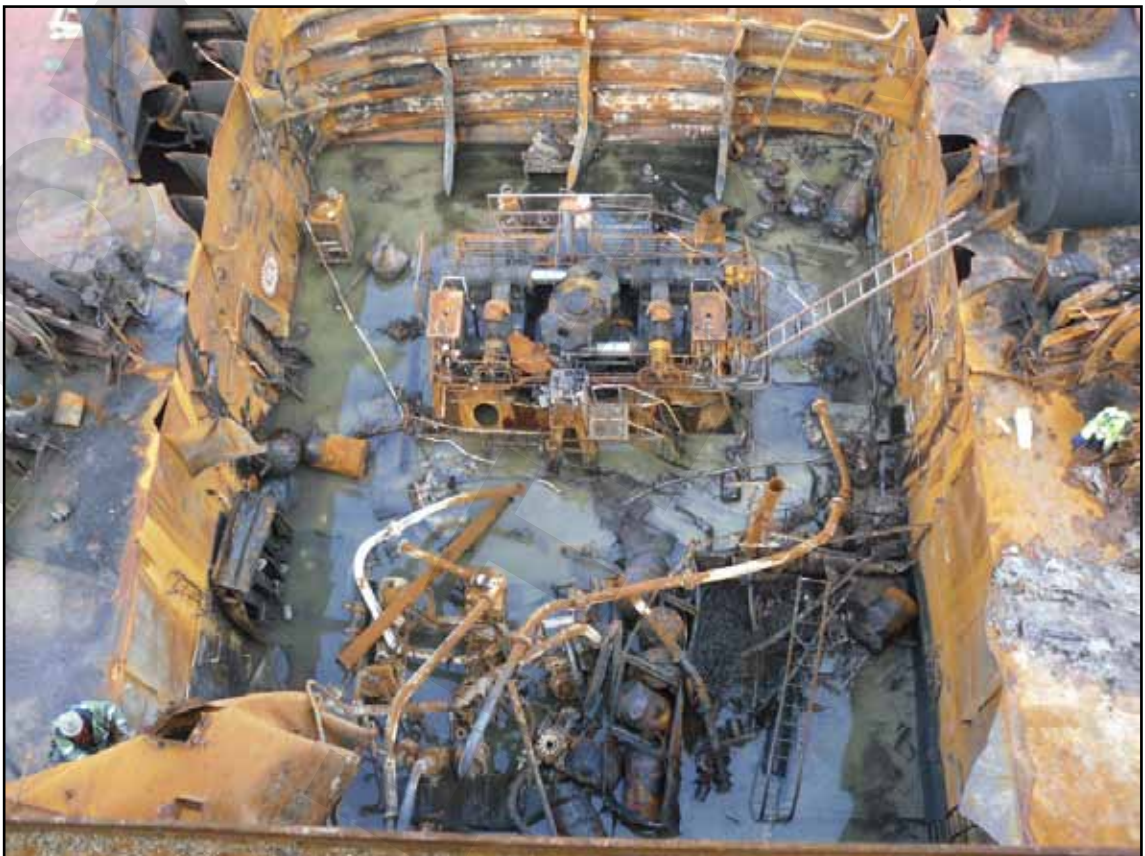
Figure 16

The numerous oil drums and chemical containers in the steering gear room were largely consumed by the fire or resultant explosion. There was nothing left of the racking used to secure these items, and the transom had been set aft by about 1 metre. There was massive over-pressure damage to fittings in the compartment and to the rope store. The poop deck was torn off, leaving the steering gear exposed (**Figure 16**). The deck areas above the port and starboard fresh water and after peak tanks suffered severe buckling and distress, and the plating at the after engine room bulkhead had split and had been torn upwards.

Exposed steering gear compartment

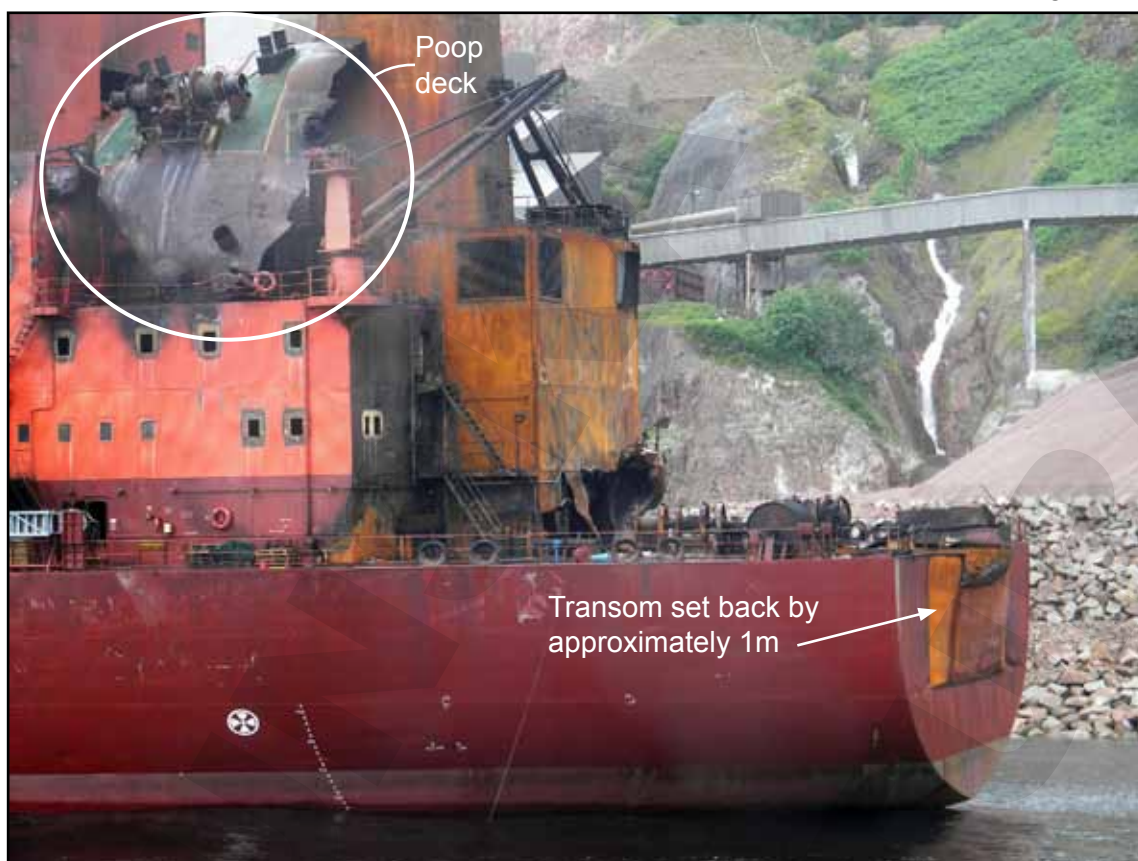
The poop deck itself had landed on the funnel deck, complete with its winches and mooring equipment (**Figure 17**).

View of poop deck relocated to the funnel deck

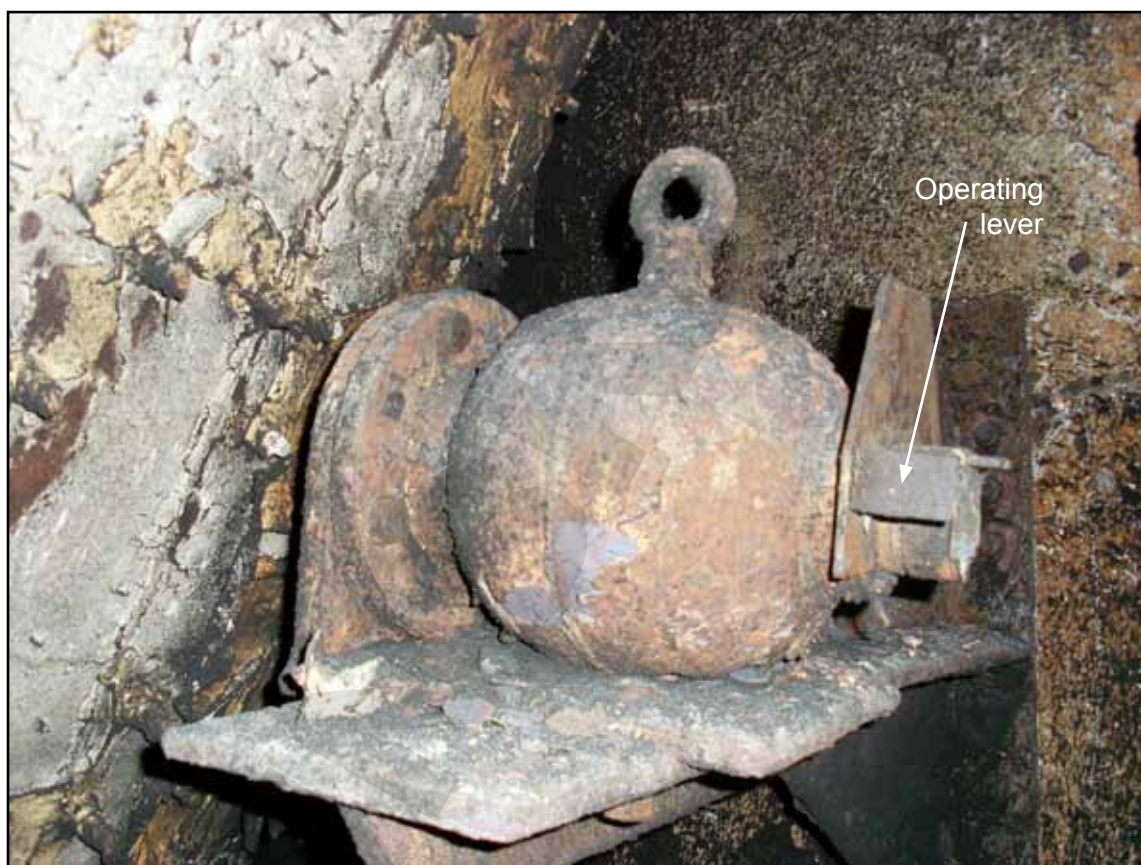
Figure 21

The access doors displayed “radioactive” warning signs, but there were none on the source containers.

*Yeoman Bontrup* - starboard silometer source container

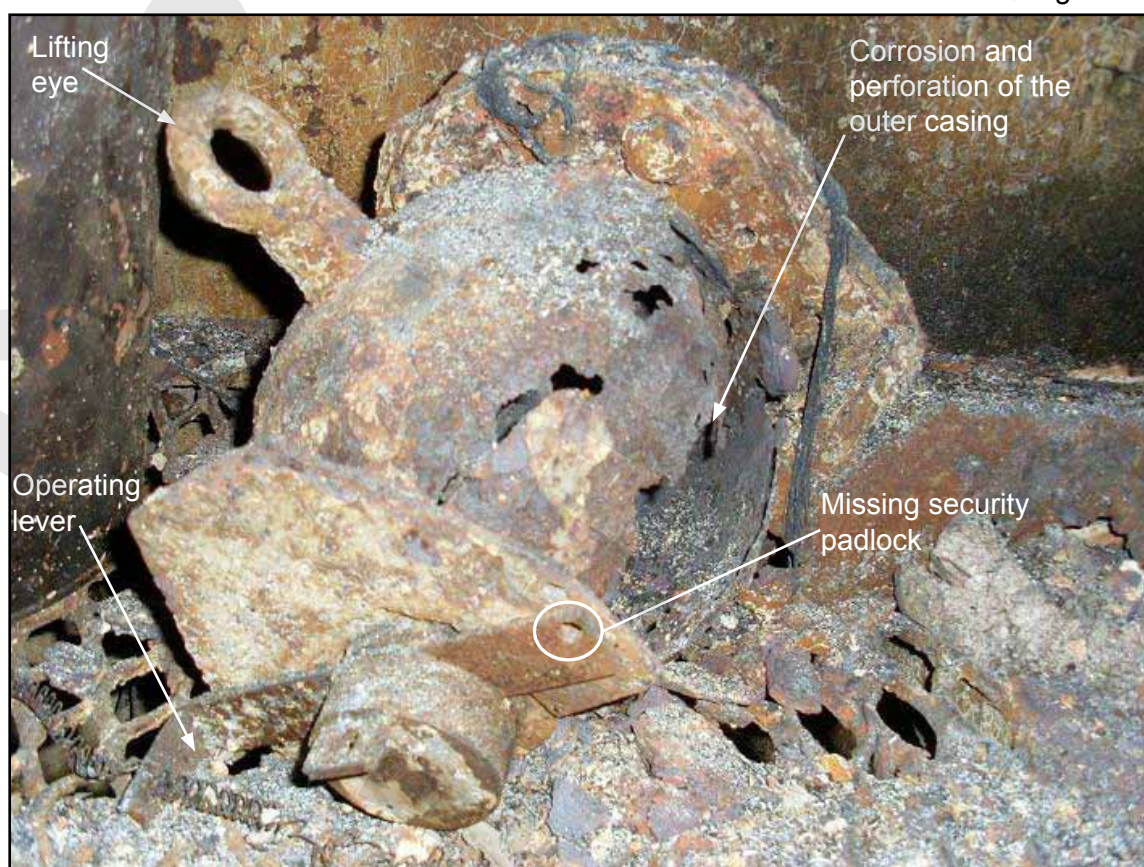
Figure 22

*Yeoman Bontrup* - port silometer source container

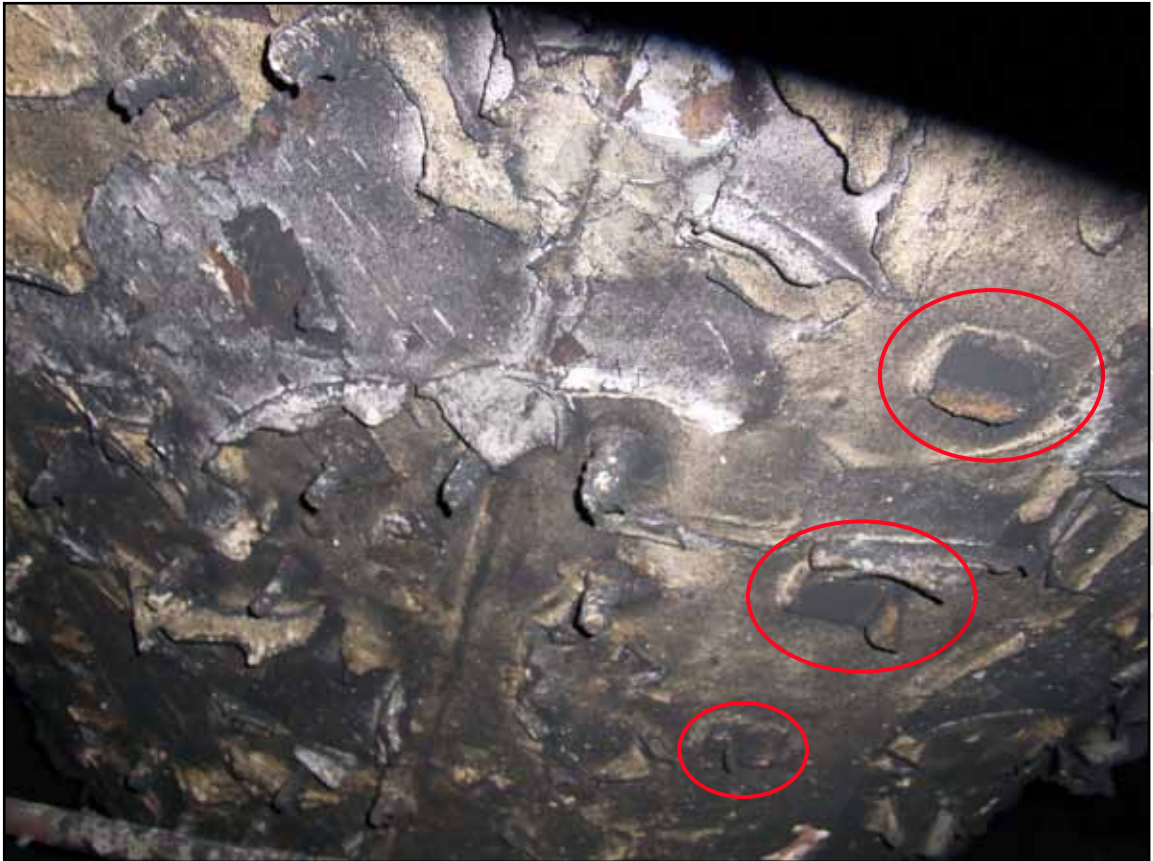
Figure 24

Doubler plates fitted to the outside of the hopper carcass

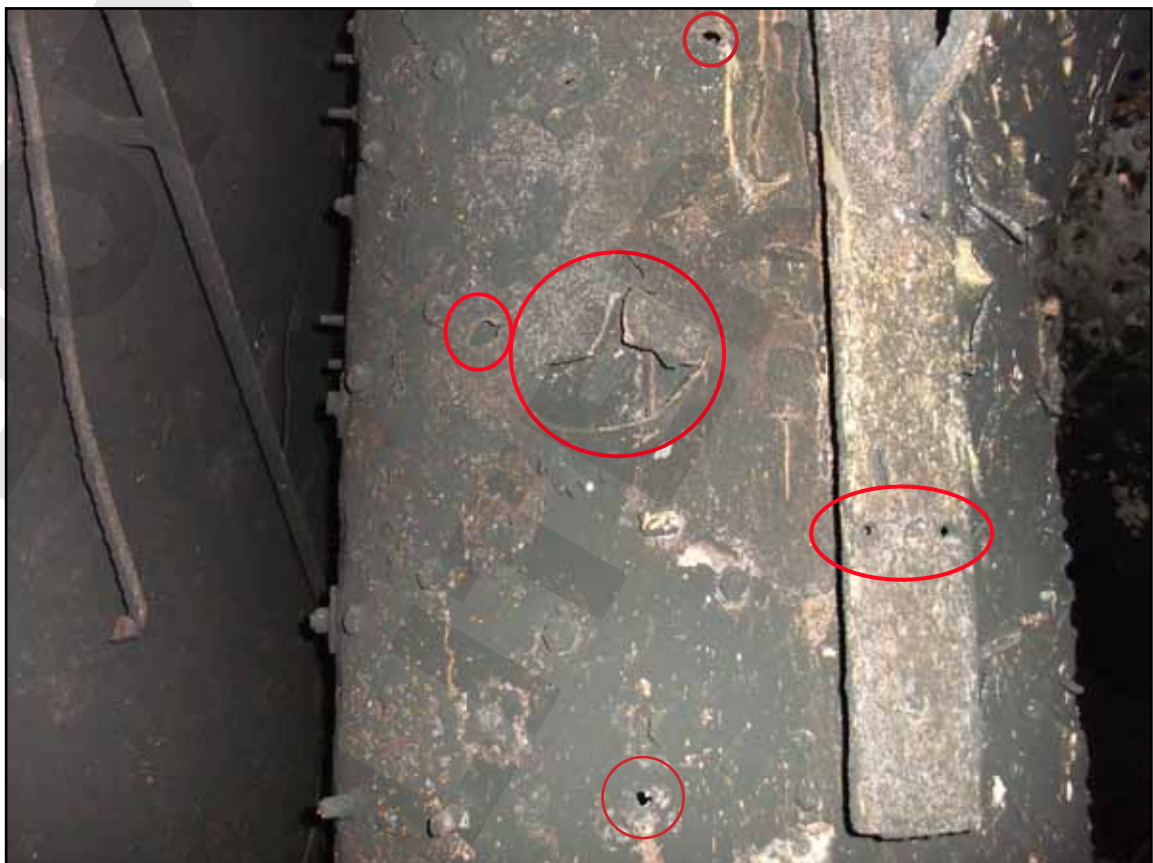
Figure 25

Hopper carcass penetrations

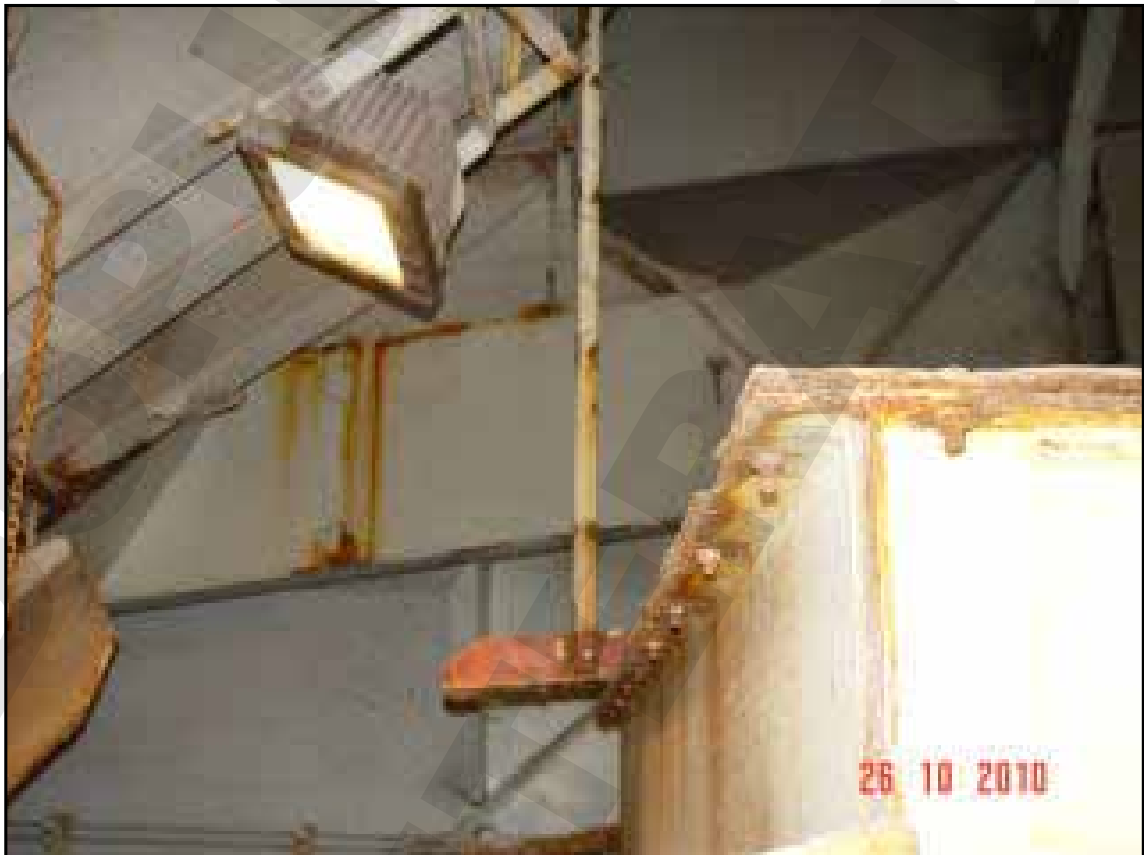
Figure 30

The surface temperature of the 500W tungsten halogen light lenses (**Figure 30**) was 135°C with the body of the light measuring 41°C. The temperatures measured at 100mm and 500mm from the halogen lights, in the direction of the vertical conveyor belt, were 40°C and 26°C respectively. The halogen lights were positioned approximately 1.3m from the vertical belt and about 2.9m from the pressured hydraulic system operating the ballast tank valves (Section 1.11.4)<sup>9</sup>.

500W halogen lamp fitted to Yeoman Bridge

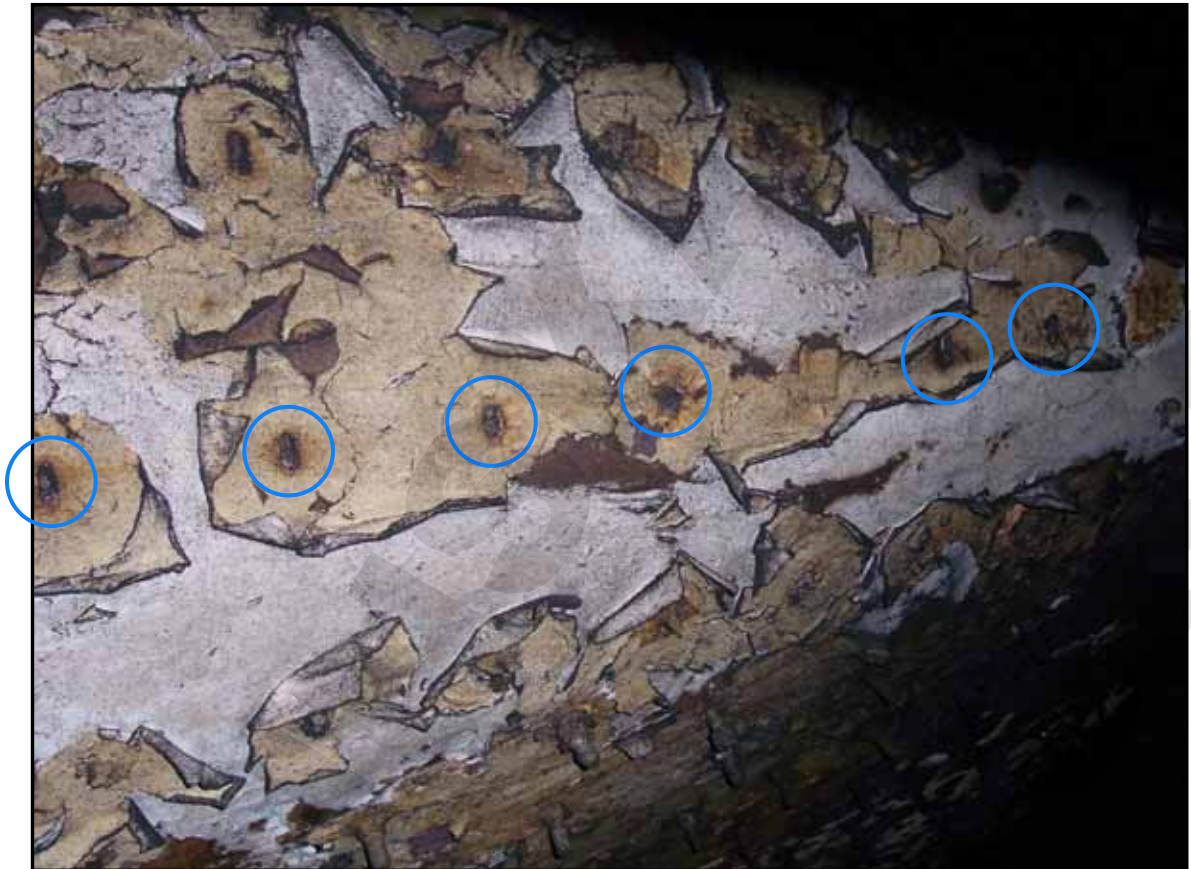
Figure 34

The repair party recognised the risk of hot debris falling onto the belt because the sloping area of the return belt was covered by a fire blanket. There is no doubt that there was a clear route for hot debris from the hopper to fall into cleats and land against the side curtain at the locus of the fire. Because of the concern over the veracity of the accounts, it is not certain whether or not oxy-acetylene equipment was used, for example to burn off "Hardox" studs, after 1400, the time at which all hopper hotwork was reportedly completed. Despite this, it was also stated that tack welding of the "Hardox" tiles took place after this time, when tack welding is clearly a form of hotwork.

Elongation of hopper carcass "Hardox" tile securing stud holes

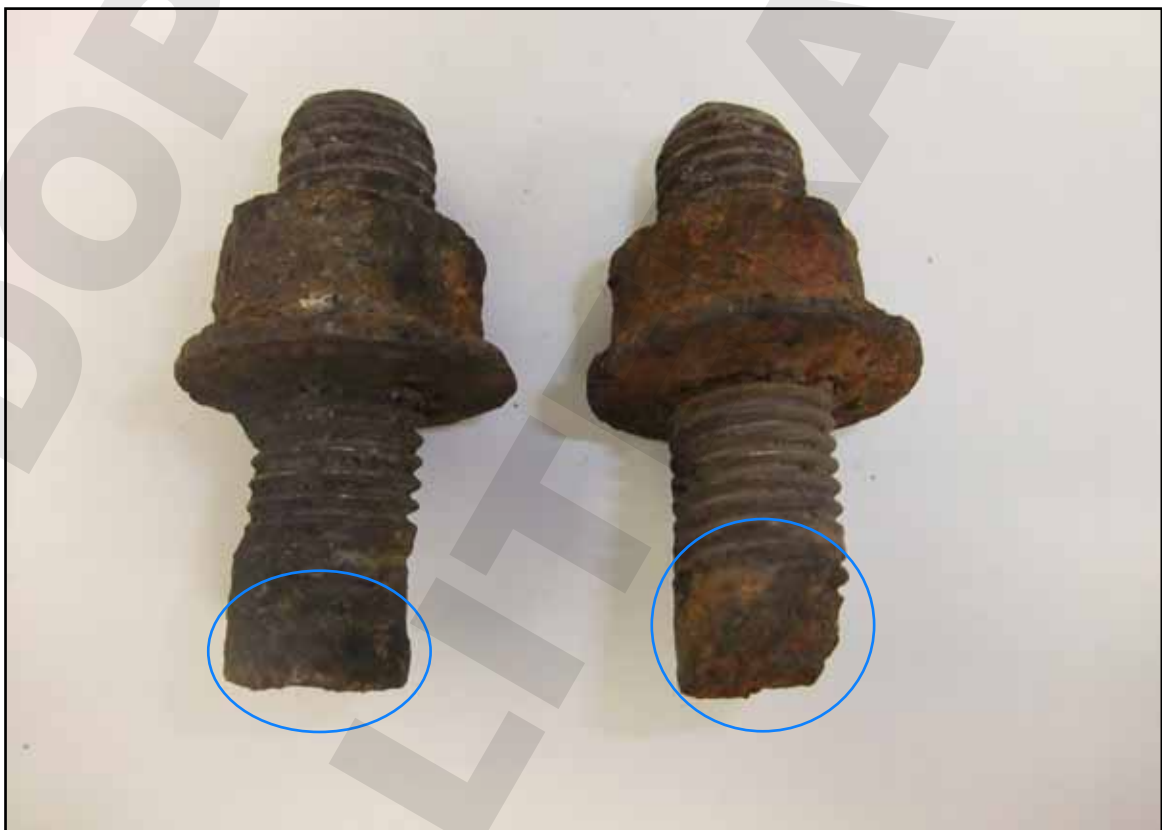
Figure 35

Flame cut bolts similar to those used to secure the "Hardox" tiles
