Report on the investigation of
a sea cadet's fatal accident on board
the sail training ship

TS Royalist

Stokes Bay in The Solent

2 May 2010

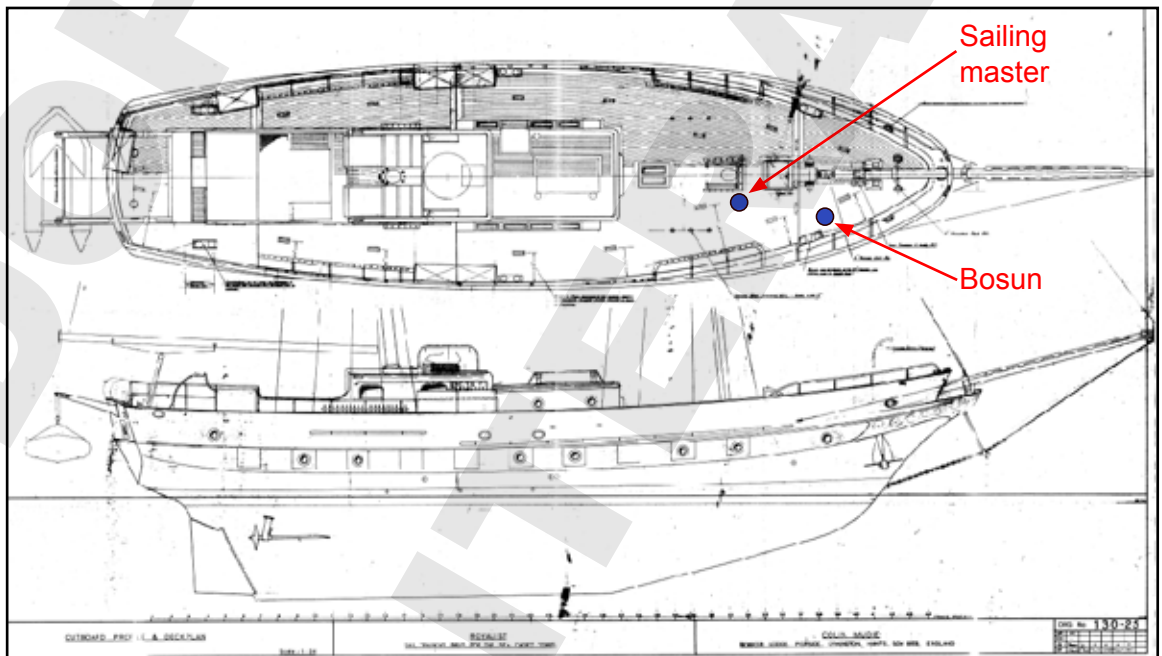
Figure 5

The main course was quickly furled and several cadets were sent from the main mast to assist the cadets working on the fore mast. The sailing master also went forward but remained aft of the bosun on the vessel's starboard side (**Figure 5**).

Approximate locations of sailing master and bosun

Although the sailing master and bosun were only about 8m below the cadets, it is highly likely that the effectiveness of their supervision was reduced by several factors. First, the view of some of the cadets aloft from the deck would have been partially obstructed by the fixed rigging. Second, it would have been extremely difficult to differentiate between the cadets and to monitor the actions of individuals because all the cadets were wearing red oil skins and were

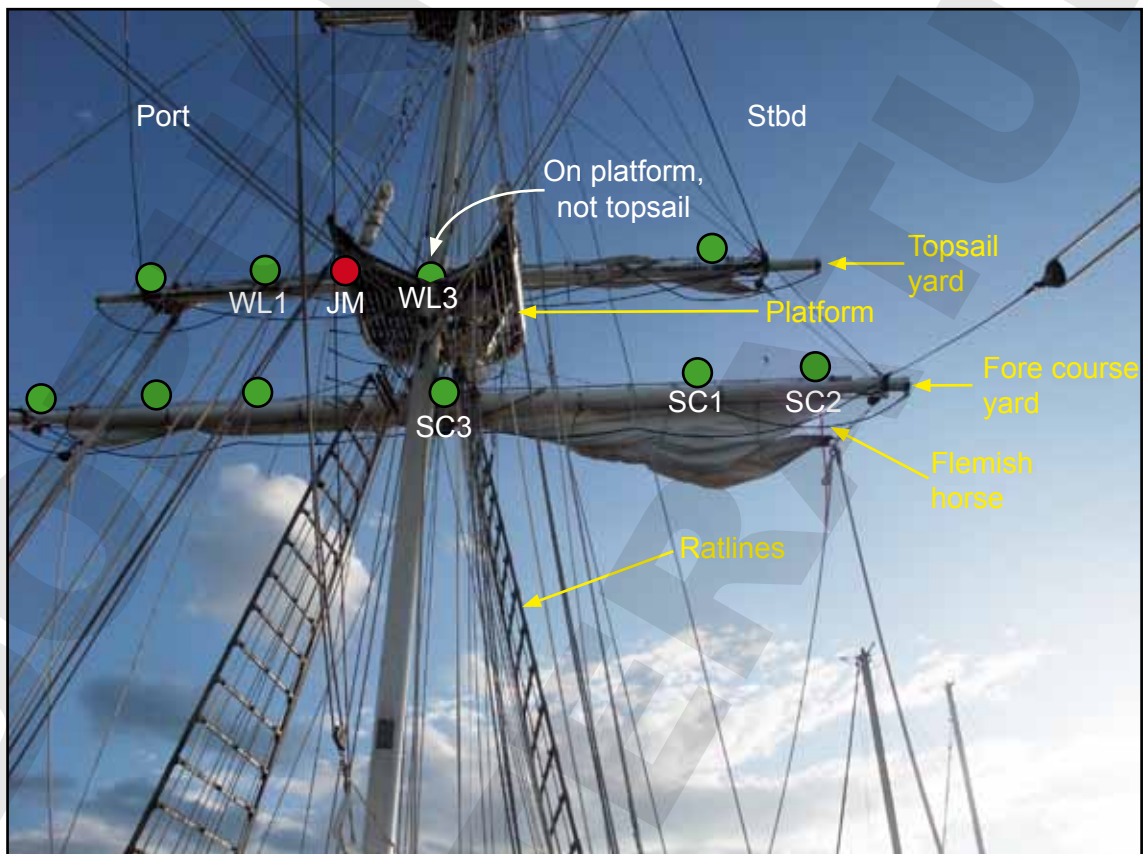
Figure 6

Six cadets were nominated to furl the fore course sail. Three cadets were on the port yard and two cadets (SC1 and SC2) were on the starboard yard; SC1 was about midway along the yard and SC2 was standing in the Flemish horse at the yard arm (**Figure 6**). SC2 was having difficulty in leaning over the yard to furl and secure the sail, and did not feel comfortable. The sixth cadet, the starboard forward watch leader (WL3), also felt uncomfortable aloft and remained on the platform or 'top' around the mast between the fore course and topsail yards.

Position of the cadets on the fore mast

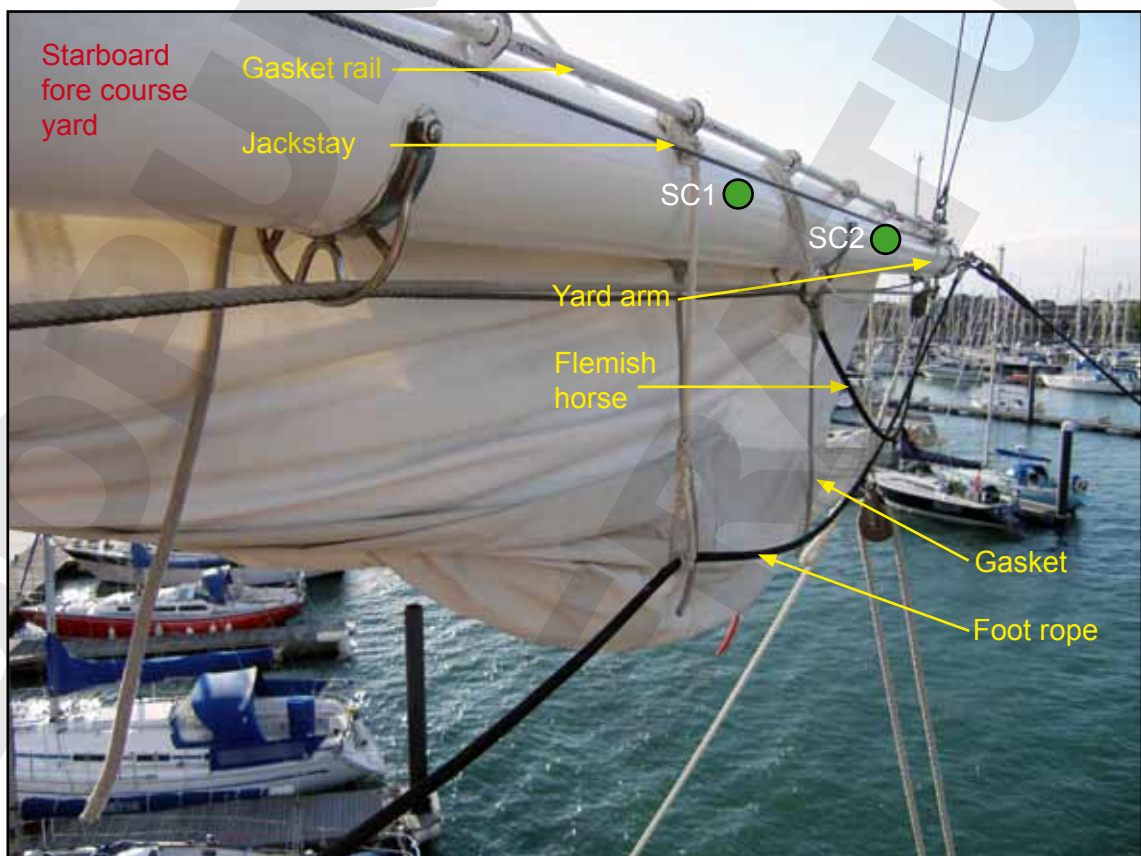
Figure 7

Jonathan climbed down from the platform via the futtock shrouds; it is not known if he clipped onto the vertical safety line available during this descent. He then stepped on the course yard foot rope between SC3, who was standing close to the mast, and SC1. Jonathan then clipped his belt harness lanyard on to the wire jackstay (**Figure 7**).

Starboard fore course yard

Jonathan started to help SC1 furl the sail. He then told her that he wanted to pass her so that he could assist SC2. SC1 told him not to; she would help the other cadet. Without further discussion, Jonathan unclipped his belt harness lanyard and tried to step around SC1, leading with his right arm and his right foot. SC1 immediately shouted to Jonathan to stop and to re-attach his belt harness. This instruction was heard by a cadet on the deck below. Jonathan managed to grab the metal gasket rail between the female cadets, but when his right foot stood on the foot rope between the girls, the foot rope swung forward causing Jonathan to lean backwards. Jonathan was unable to hold on and, although SC1 tried to grab his arm, she was unable to prevent him from falling towards the deck.

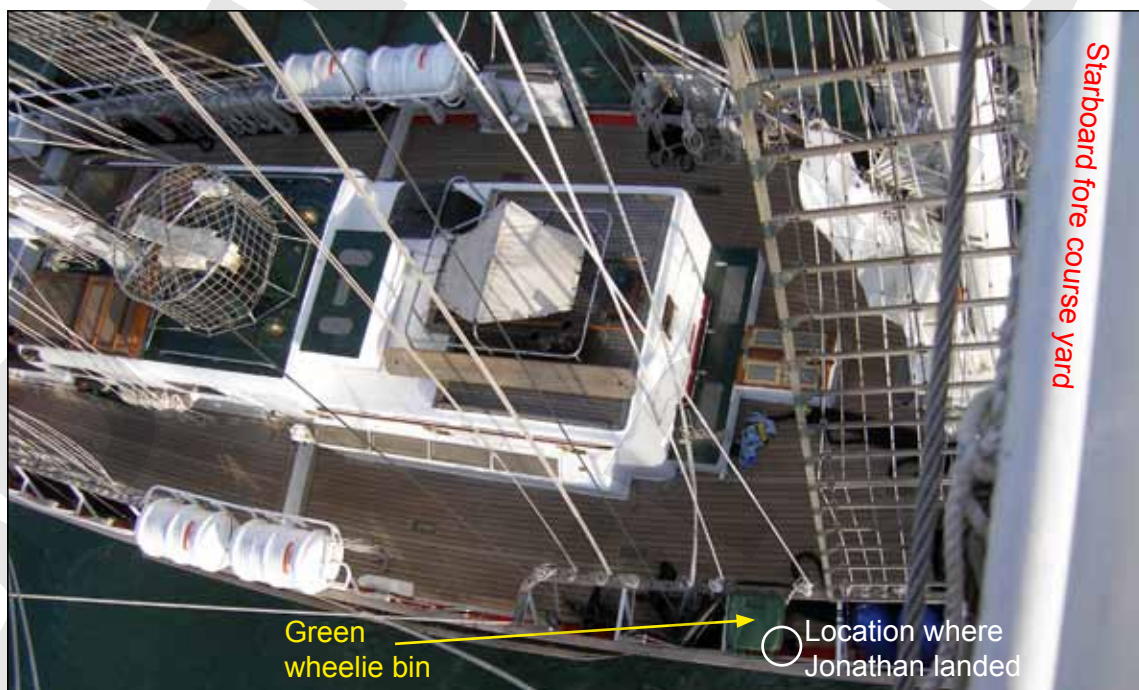
Figure 8

Jonathan landed face-down on the starboard gunwale and a green wheelie bin (**Figure 8**). He then fell in to the sea. Jonathan quickly surfaced face-up; his arms were outstretched and he showed no signs of movement. Although both the sailing master and the bosun caught sight of Jonathan as he fell, neither knew which yard he had fallen from.

View of deck from starboard fore course yard

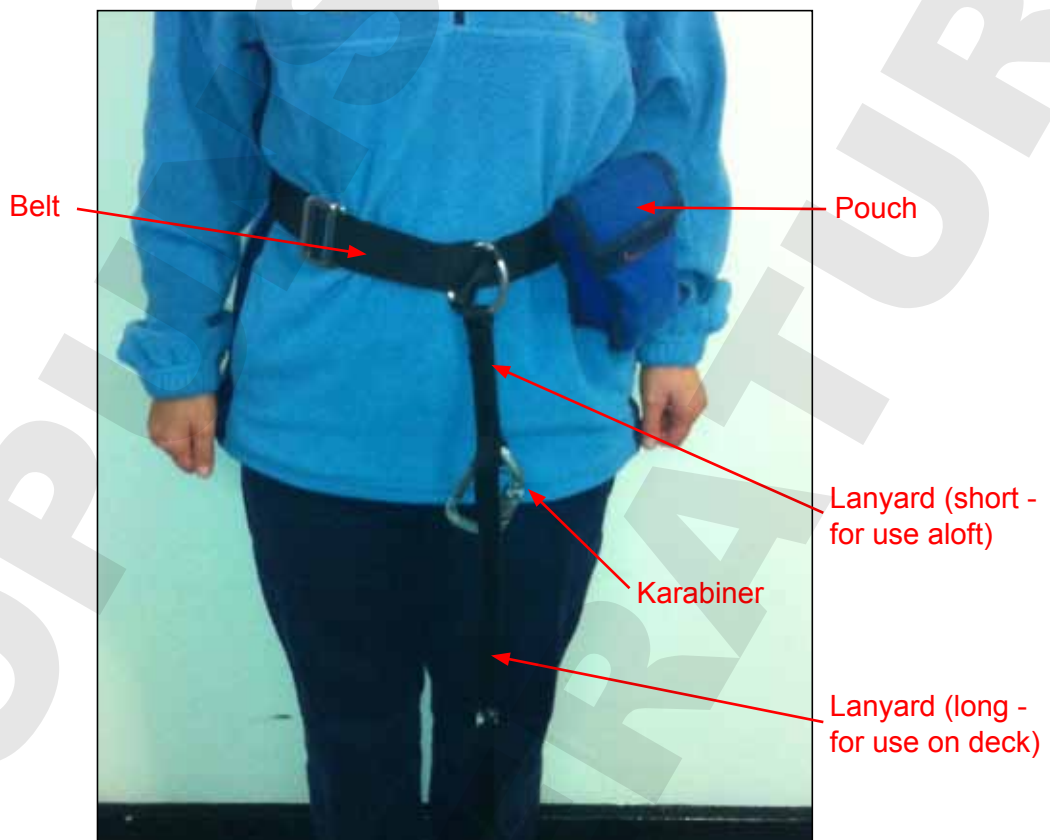
Figure 10

The harnesses used by the crew and cadets on board TS *Royalist* were interwoven polyester webbing belts fitted with a single lanyard (**Figure 10**).

The waist belt was 50mm wide and was fitted with a metal joining buckle. The lanyard was also made from polyester webbing and was 72cm long and 25mm wide, with a loop in the end. A self-closing karabiner⁷ was fitted on the lanyard⁸, 13cm from the waist belt, which could be operated with one hand. It also locked automatically when closed. A pouch on the side of the harness was used to store the lanyard and karabiner when not in use.

The belt harnesses with a single lanyard used on board TS *Royalist* were intended to prevent the cadets from falling when aloft. However, this type of harness is a fall restraint device, which is intended to prevent the wearer from getting to a position from where it is possible to fall. It is not suitable as a fall arrest device because the belt only supports the wearer by the waist, although the risk of injury is mitigated to some extent by the lanyard's short length, which thus restricts the distance a person can drop. However, the potential for injury remains. Furthermore, given the material breaking load of the lanyards and the absence of markings on the harnesses to indicate that they met the relevant EC standards (paragraph 1.7.1), their ability to withstand the shock loading of a person falling is questionable.

The provision of only one lanyard also necessitates the wearer to 'unclip' while moving around when aloft due to the arrangement of vertical safety lines and horizontal wire jackstays. During the periods a cadet is 'unclipped', the risk of falling is significantly increased.

However, the STI guidelines also state that account must be taken of the specific rig of a vessel. In this case, it is evident that MSSC preferred the waist belt with one lanyard to the recommended full body harness with two lanyards, which it had trialled and which is used by other operators, on the basis that it was simpler to use, less cumbersome, and suitable for use on deck as well as aloft provided the cadets were properly trained in their use. These were important considerations given the age range and mixed abilities of the embarked cadets and the limited space on the masts and associated rigging on board TS *Royalist*. Nonetheless, not only were the belt harnesses and lanyards unsuitable for fall arrest, they were neither manufactured nor tested to comply with current standards. In addition, despite the frequent on board inspections conducted, no records of these inspections were maintained. Consequently, despite their good safety record, the belt harnesses cannot be considered to have been fit for purpose.

Jonathan's belt harness and lanyard did not fail, and there was no record of a belt harness failing on board. However, despite MSSC's reviews of the harnesses, the continued use of the belt harnesses with single lanyards, and the maintenance regime followed, indicate that MSSC had not adopted best practice found elsewhere in the sail training sector of the marine industry. They also indicate that MSSC had not complied with the spirit of the regulatory standards for PPE applicable to the merchant marine industry and to adventurous training activities ashore.

Following discussions with the RN, MSSC withdrew TS *Royalist* from service in September 2010 for refit, and pending a review of the equipment and procedures used by cadets when aloft. It has also continued to investigate the provision of a suitable replacement harness and is progressing the development of an SMS for its offshore operations.
