Report on the investigation of
the grounding of

Antari

Near Larne, Northern Ireland

29 June 2008

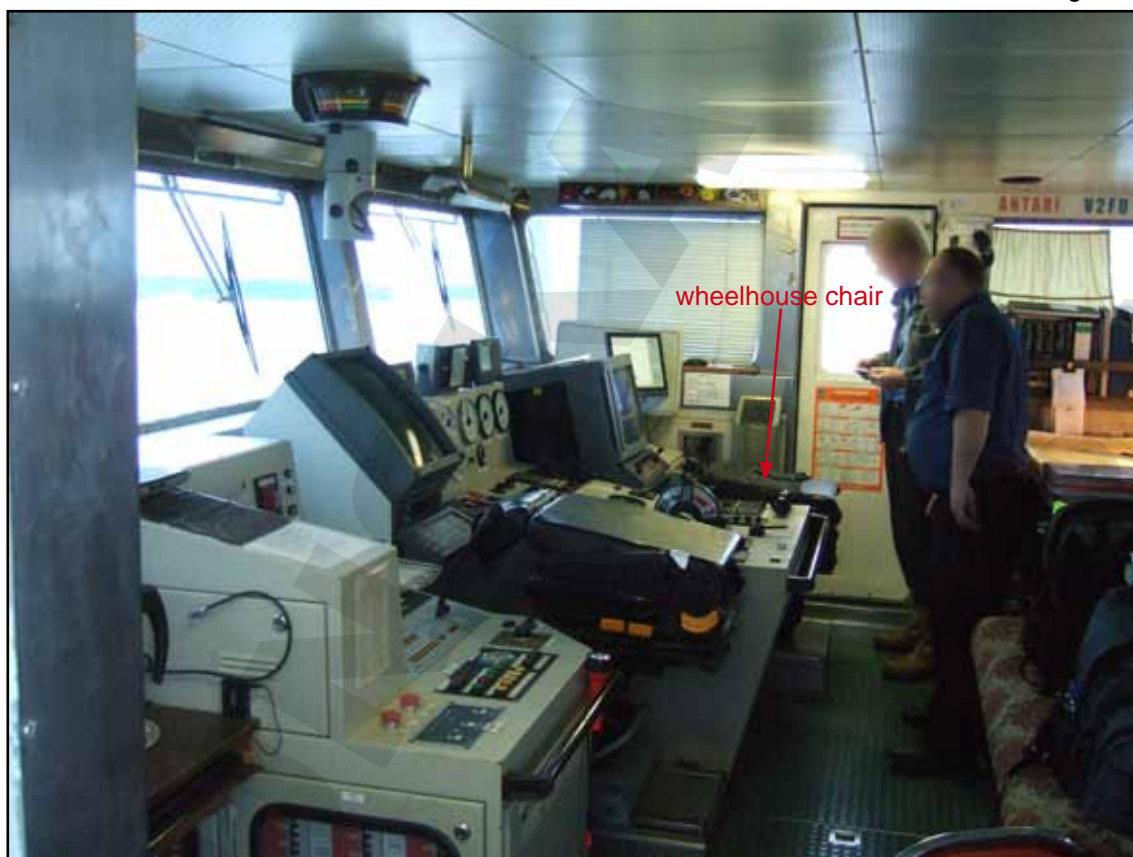
The chief officer was now the sole bridge watchkeeper. Both wheelhouse doors were closed, it was a clear, moonless night and the sea was calm with a slight westerly swell. He was sitting, as was his custom, in a chair on the starboard side of the wheelhouse, in front of one of the radar sets and the ECDIS unit (**Figure 2**). He fell asleep shortly after sitting down, and remained asleep until the vessel grounded at 0321.

Antari, wheelhouse chair in which chief officer fell asleep

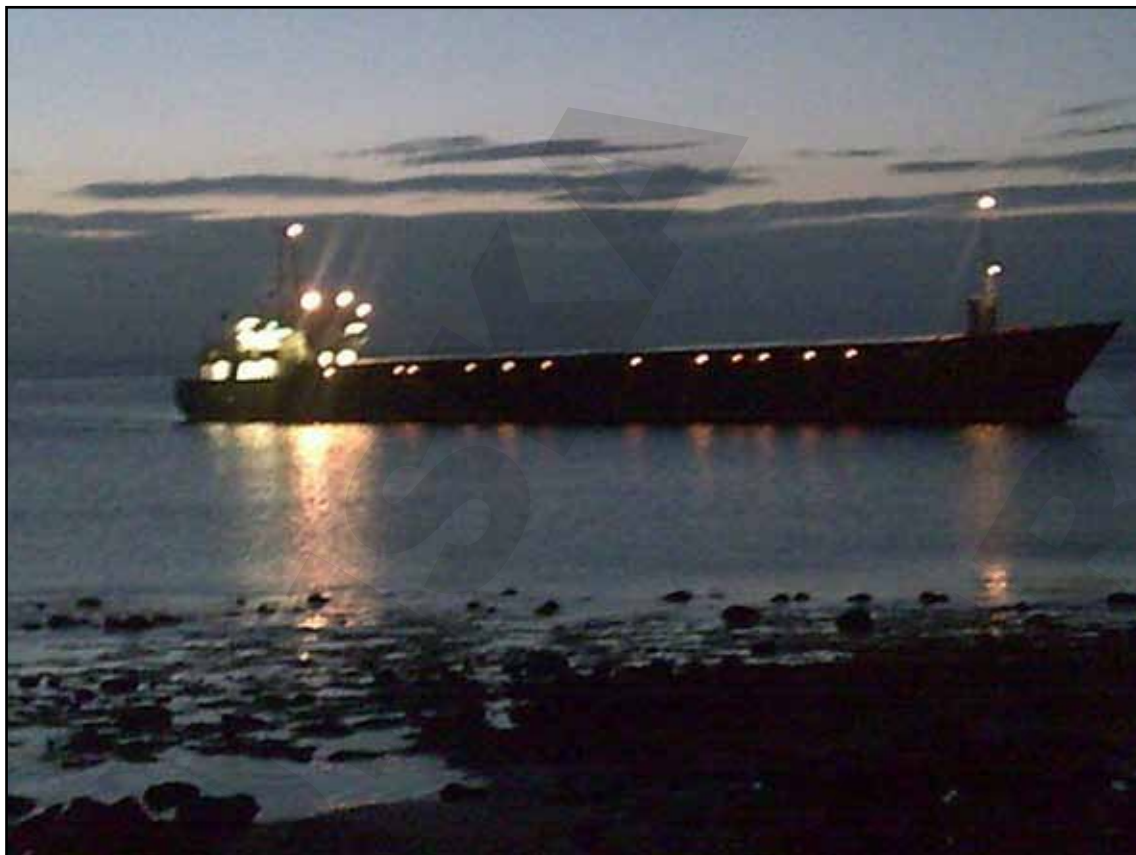
At 0407 a motorist driving along the coast road between Larne and Glenarm reported to Belfast coastguard that he could see a vessel aground on the beach, close to the road at St Drumnagreagh Port (**Figure 3**).

Antari aground on the Antrim coast

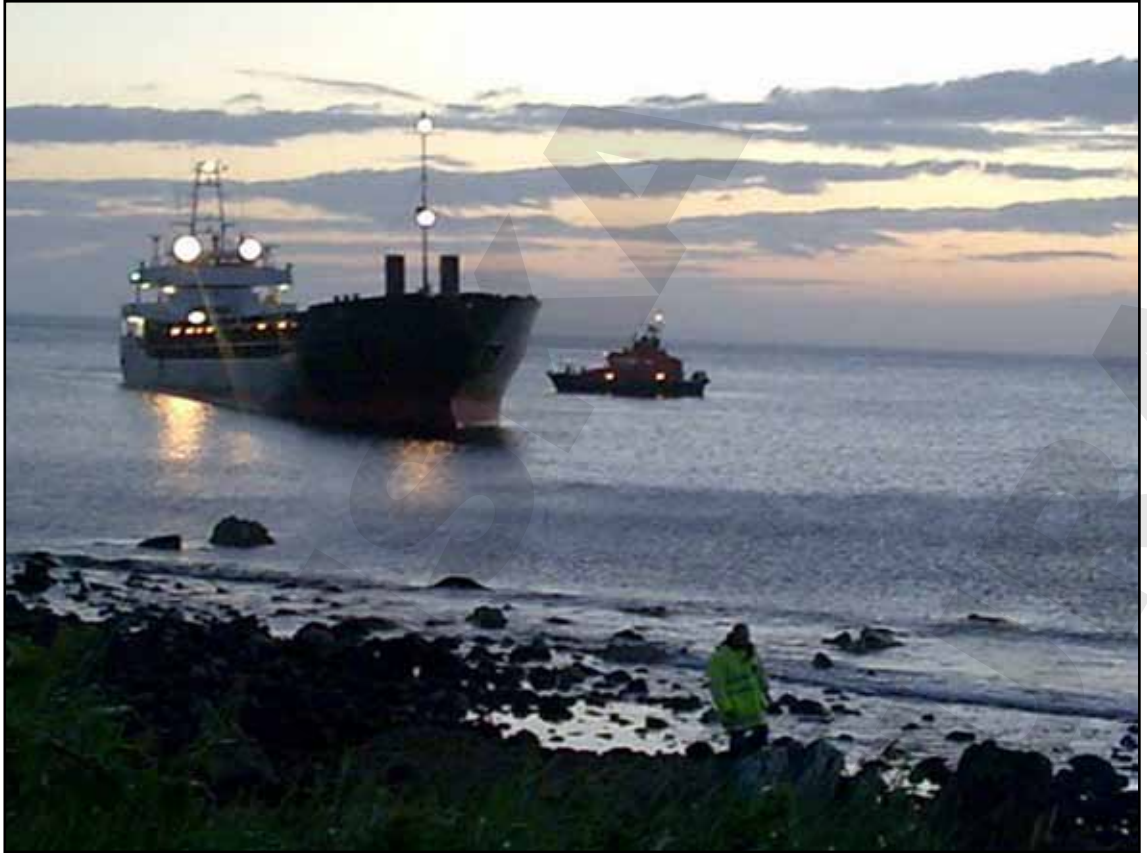
The Larne lifeboat arrived at 0512 and carried out a check, by searchlight, of the vessel for damage and pollution (**Figure 4**).

Larne lifeboat checks *Antari*'s hull for damage

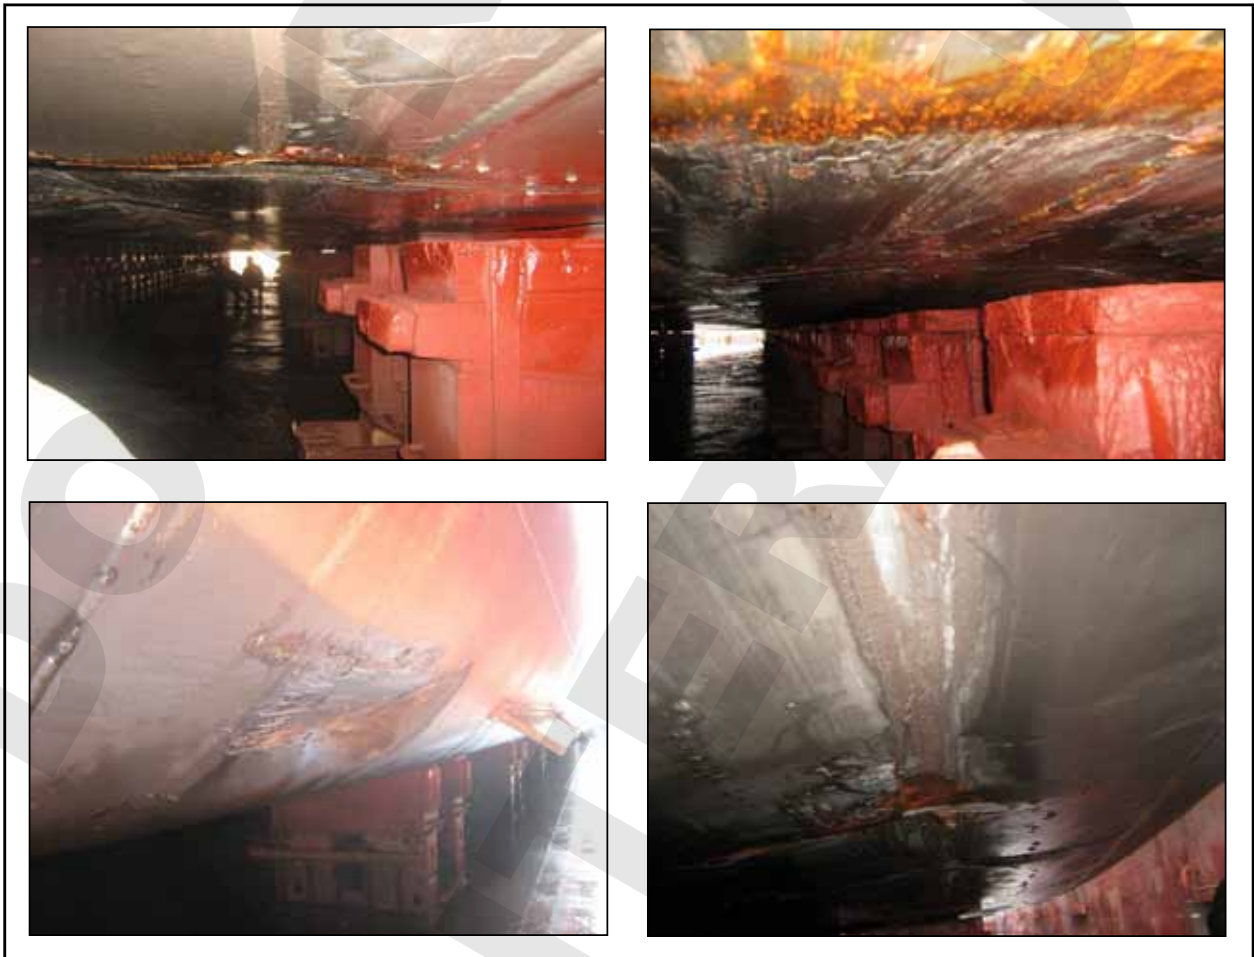
Figure 5

The results of the survey showed indentation damage to the bottom of the hull over 70% of the vessel's length from forward, and found that there was a small hole in number 3 double bottom ballast tank.

Damage to bottom

The vessel departed for Ghent later that day, where she arrived on 3 July. On completion of discharge of the cargo, she proceeded to Swinoujscie, Poland where permanent repairs, lasting several weeks and requiring 25 tonnes of new steelwork to the vessel's bottom (**Figure 5**), were carried out before she was able to resume service.

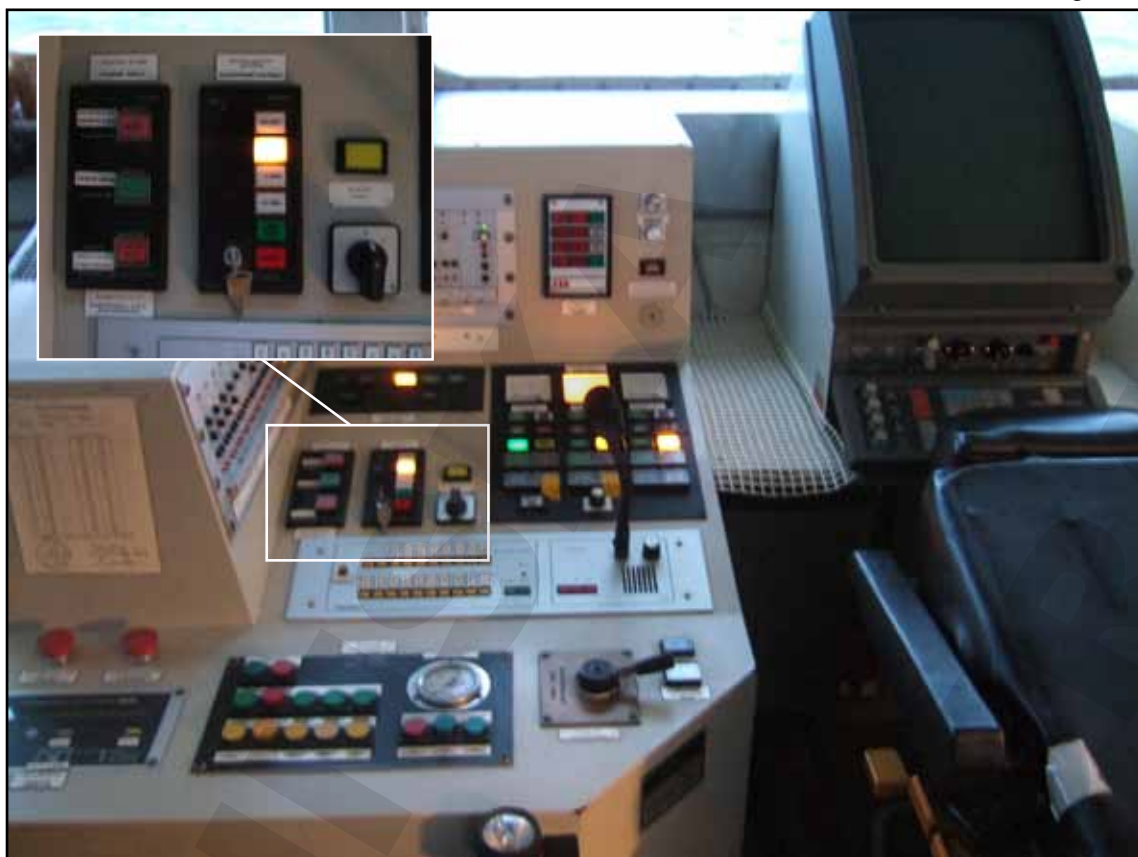
Watch alarm in wheelhouse

However, the audits carried out on *Antari* failed to identify that the watch alarm was not being used or that lookouts were not being routinely posted.

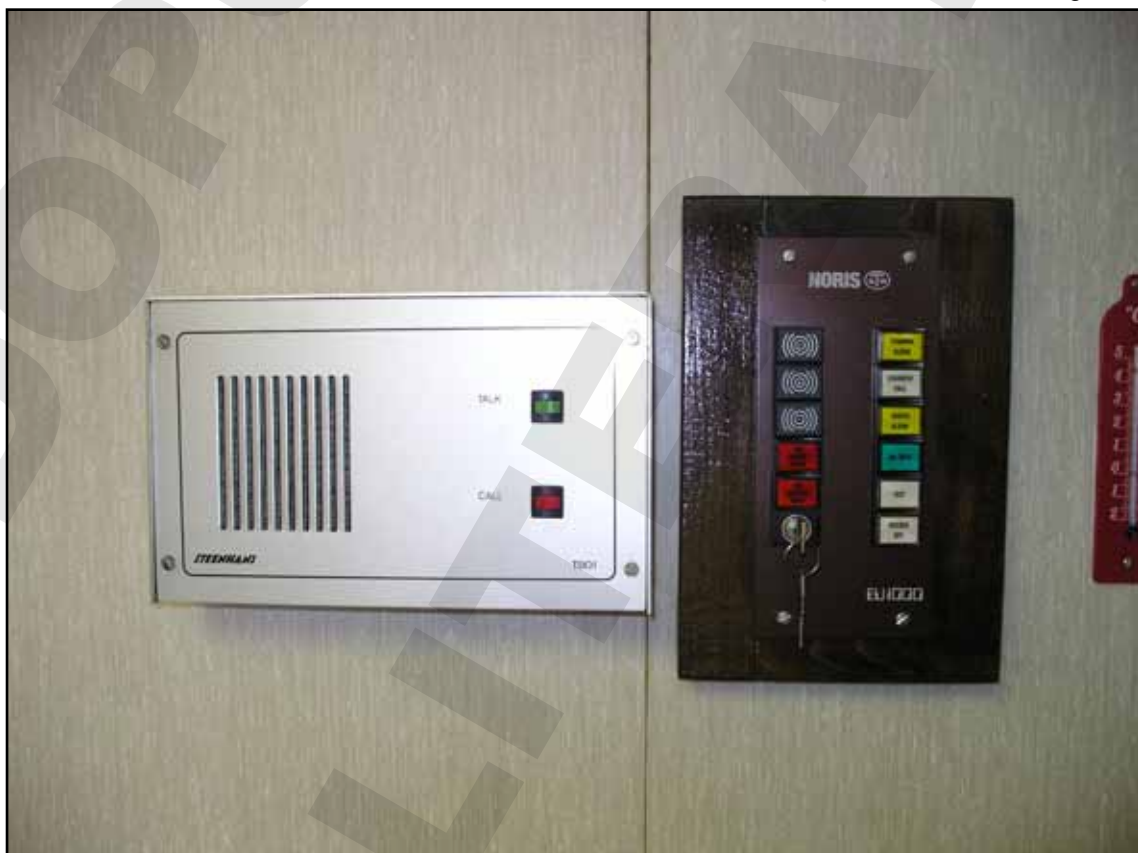
Watch alarm repeater in master's cabin
