MARINE TRANSPORTATION SAFETY INVESTIGATION REPORT M18C0240

Crew member seriously injured

Passenger vessel *Amadea*

09 September 2018

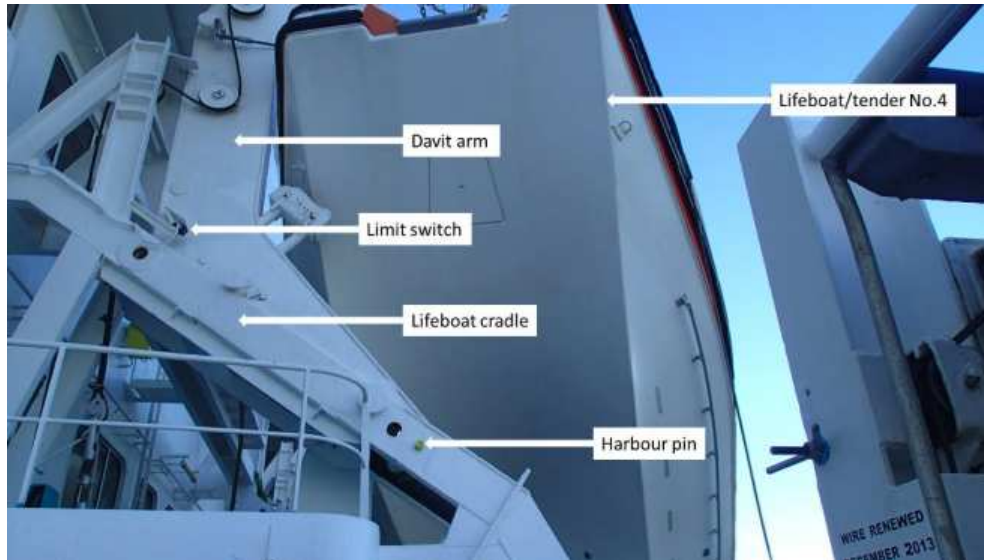
While at sea, gripes ensure that the lifeboats remain in their stowed positions. In addition to the gripes, 2 harbour pins can be inserted in holes that are aligned on each davit arm and the davit frame, to lock the lifeboats in their stowed position while the vessel is in port or during maintenance (Figure 2).

Figure 2. Lifeboat/tender No. 4 shown in its stowed position with harbour pin installed
(Source: TSB)

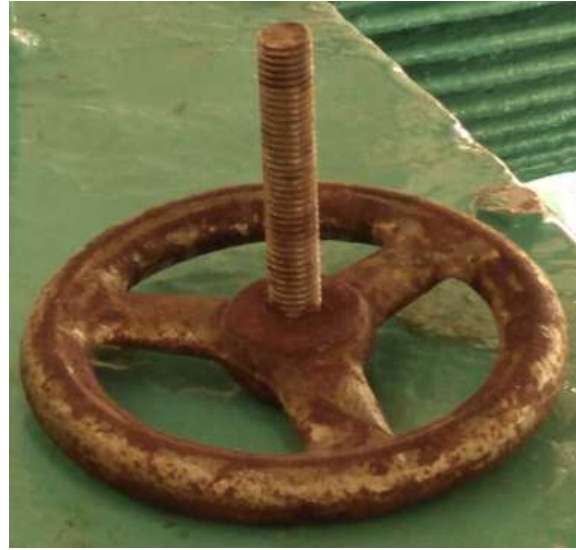
The electromagnetic brake is manually released using a tool consisting of a small-radius hand wheel attached to a threaded rod (Figure 3). The brake release tool is screwed into the brake casing at the free end of the winch motor, partially compressing the electromagnetic brake's spring. The winch instruction manual warns that the brake release tool is the only tool that should be used, that the tool must be turned only by hand, and that using "extreme power"¹³ could damage the internal components of the electromagnetic brake.

Figure 3. Brake release tool for the winch motor's electromagnetic brake (Source: TSB)

During the lifeboat stowage trials, the TSB observed that the crew used a lever-type tool³⁵ in the spokes of the electromagnetic brake release tool's hand wheel to create additional torque when releasing the electromagnetic brake. Using this lever on the hand wheel allowed crew members to disengage the electromagnetic brake further than what would normally be accomplished by hand alone, because some drag within the electromagnetic brake is required to prevent or control backlash in the system. Using the lever-type tool was routine practice, including during the occurrence.

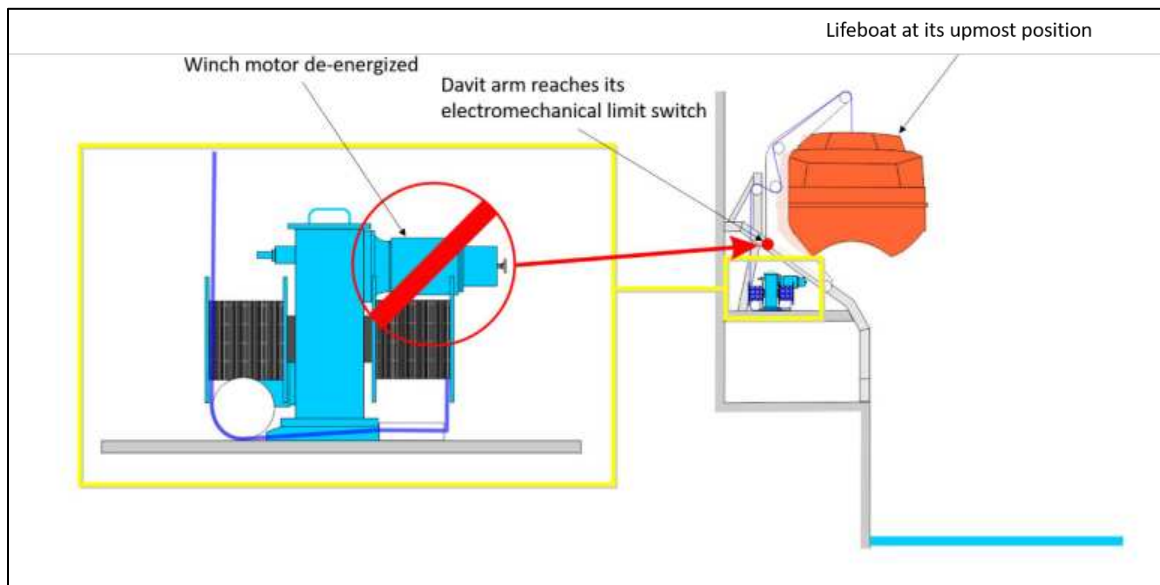
Both electromechanical limit switches are adjustable, and their levers can be repositioned to vary the point at which the winch motor de-energizes before the davit arms reach their stops. At the time of the occurrence, the switches were adjusted so that the winch motor would de-energize 20 cm before the davit arm reached its stop.

Figure 7. Diagram illustrating the lifting of the lifeboat: when the lifeboat is in its uppermost position and the davit arms reach the levers of the electromechanical limit switch, the winch motor is de-energized automatically (Source: TSB)

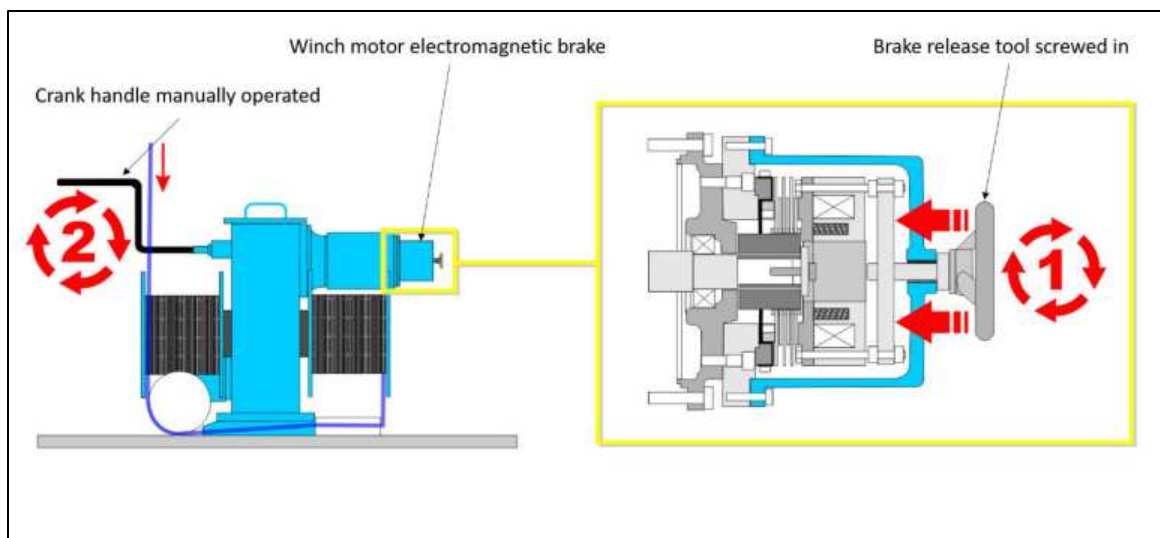
Operators must then secure the lifeboat by manually winching it up to its final stowed position. To facilitate manual winching, the electromagnetic brake is manually disengaged using the brake release tool, which is screwed into the winch motor (Figure 8, Step 1), and the crank handle is installed to its coupling on the winch gearbox and turned by hand (Figure 8, Step 2).

Figure 8. Diagram illustrating Steps 1 and 2 of the sequence of operation for manually disengaging the electromagnetic brake so that the lifeboat can be winched manually (Source: TSB)

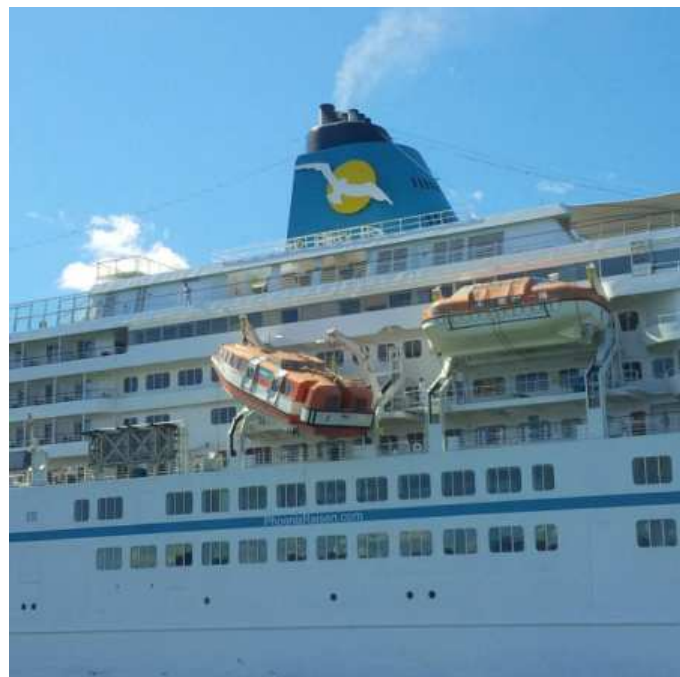
Figure 10. Lifeboat No. 4 following the uncontrolled lowering of the davit's aft arm (Source: TSB)

About a minute later, the relief OS and the AB lost their grip on the crank handle. The crank handle kicked back and freewheeled in a counter-clockwise rotation, hitting the relief OS on the head and knocking him unconscious. The davit's aft arm lowered uncontrollably and the lifeboat's stern lowered with it, eventually coming to a stop (Figure 10).

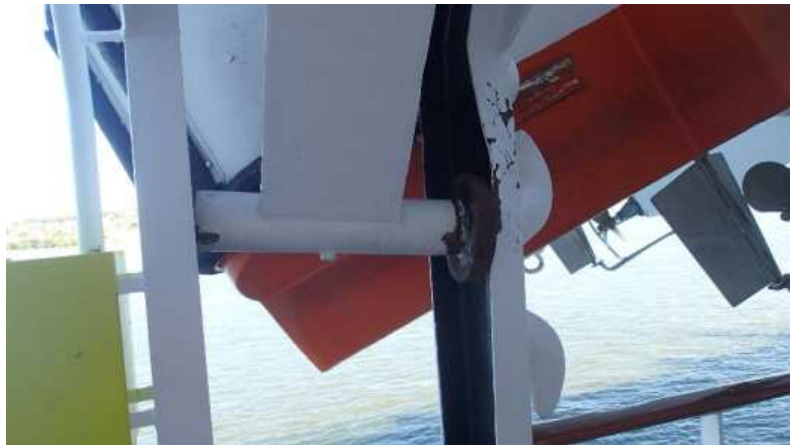
Following the uncontrolled lowering of lifeboat No. 4's aft davit arm, one of the arm's roller tracks was bent close to the shipside handrail (Figure 11).

Figure 11. Damage sustained to lifeboat No. 4 davit aft roller track (Source: TSB)

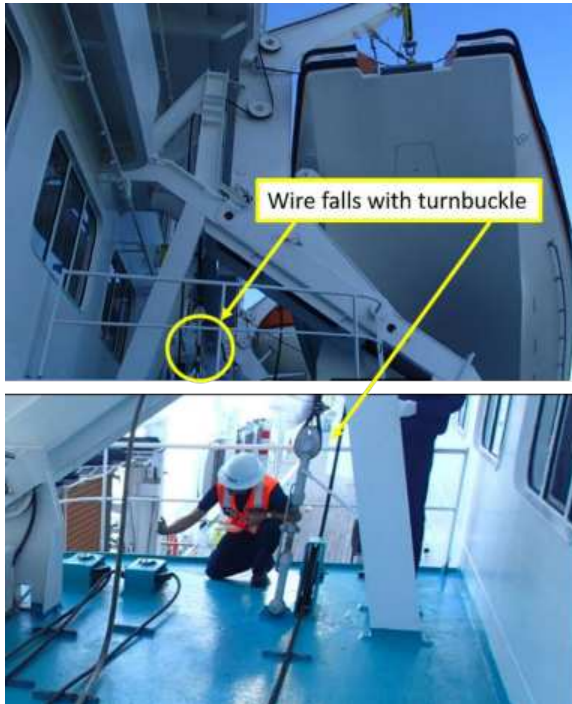
Figure D1. Photographs of the wire falls and turnbuckle (Source: TSB)

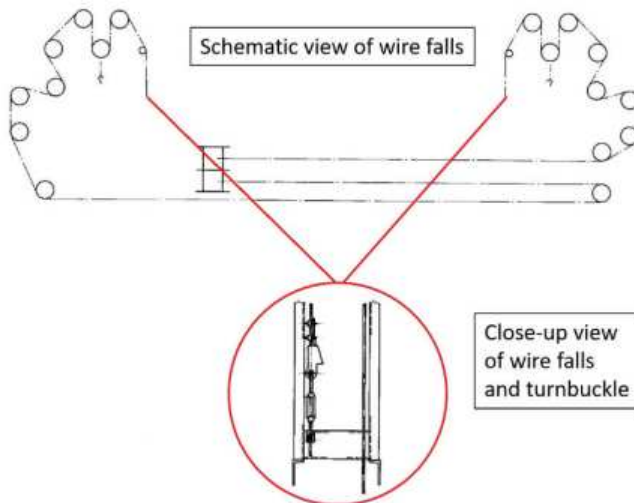
Figure D2. Technical drawings showing schematic and close-up views of the wire falls and turnbuckle (Source: D-I Davit International-Hische GmbH, with TSB annotations)
