DANISH MARITIME ACCIDENT  
INVESTIGATION BOARD

# EXPRESS1 & BALTIC CONDOR

Summary report on collision

10 MAY 2019

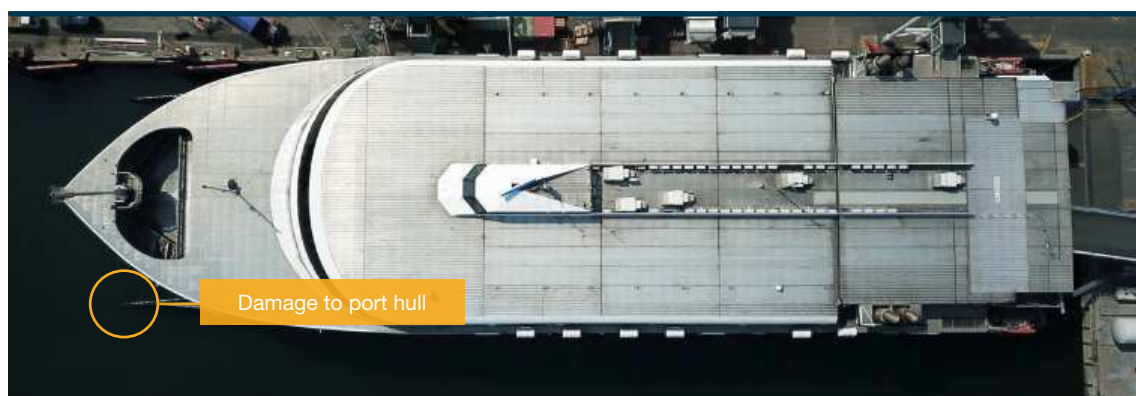
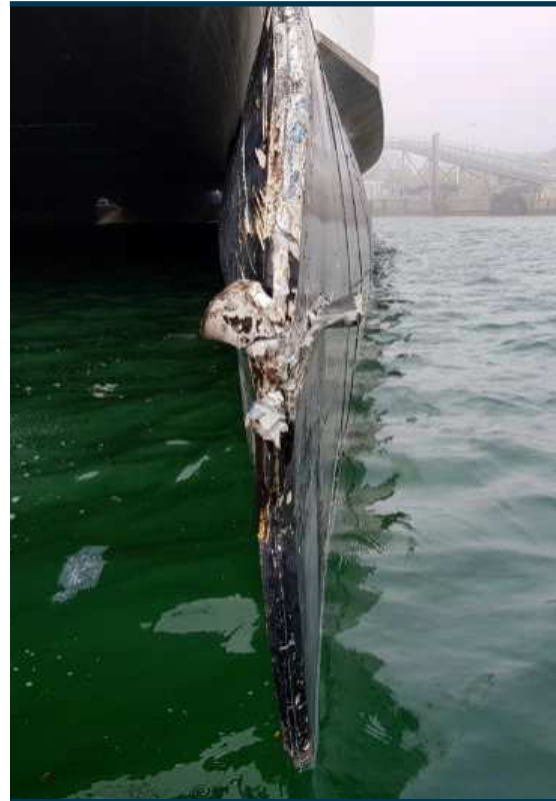
ship's car deck was cleared and the passengers transferred to another ship. No one was injured on the EXPRESS 1 in connection with the accident, and the ship only suffered minor damage to the port hull (figure 3).

Figure 3a: Damage to EXPRESS 1, port hull

Figure 3b: Damage to EXPRESS 1, port hull  
Source: Molslinjen, 2019

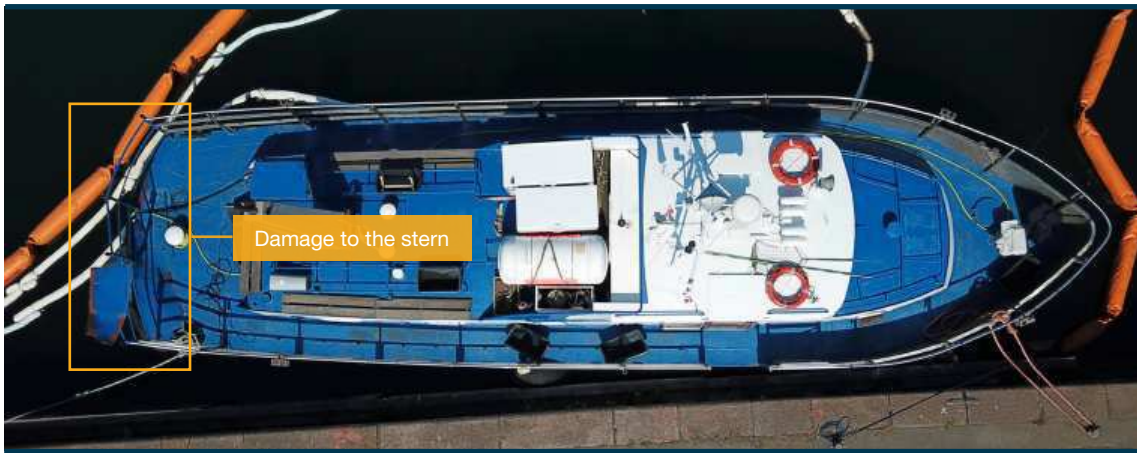
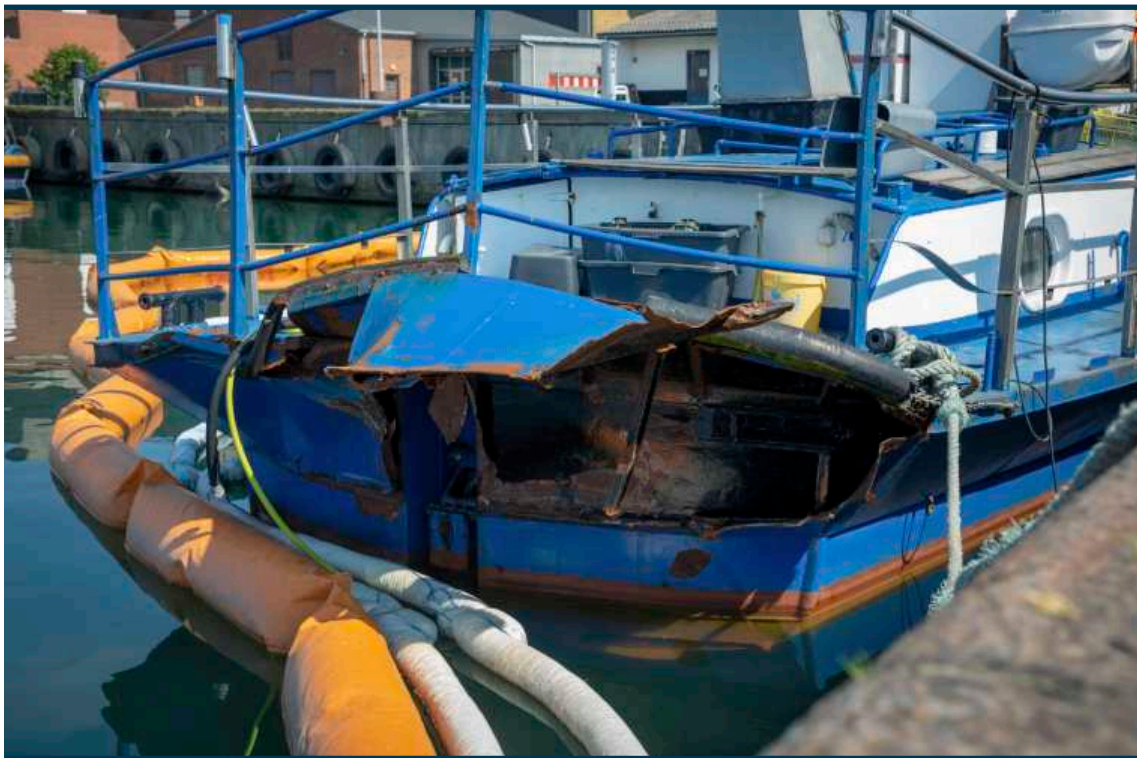
One passenger suffered more serious injuries while other passengers sustained minor bruises. In the collision, the ship sustained damage to the hull and rudder and was towed ashore after the accident (figure 5).

Figure 5a: Damage to BALTIC CONDOR's stern  
Source: DMAIB, 2019

Figure 5b: Damage to BALTIC CONDOR's stern  
Source: DMAIB, 2019

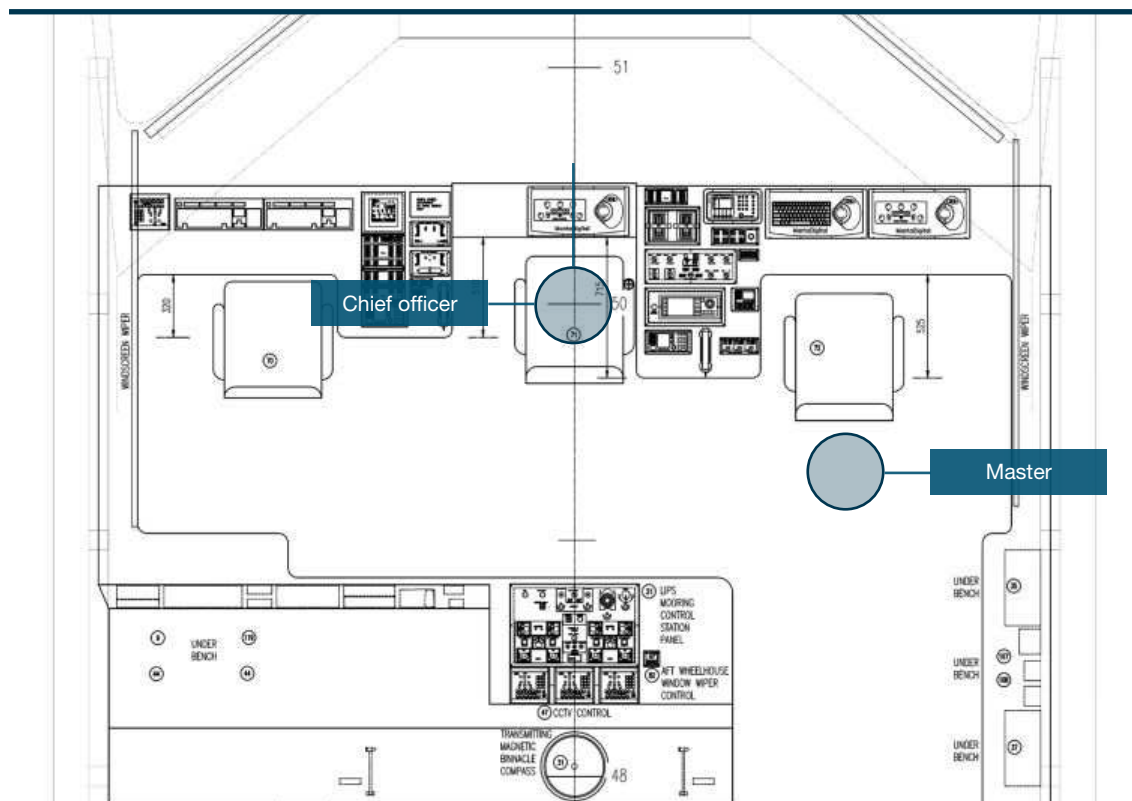
Figure 6: Location of the navigators on EXPRESS 1 on the day of the accident  
Source: DMAIB, 2019

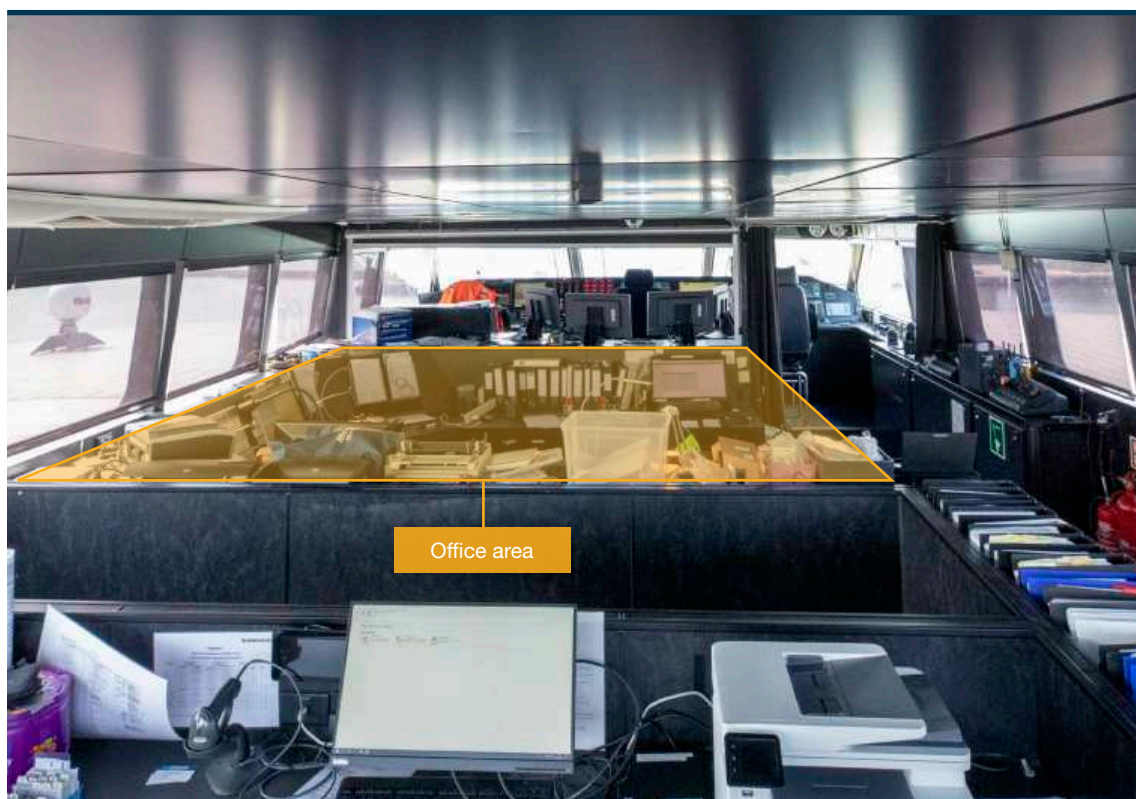
The master thus left the position behind the starboard steering chair and walked into the office area from which the information was to be sent (figure 7). While in the process of sending the information, he was interrupted by an alarm that had to be addressed. When that had been taken care of, he returned to the service computer and sent the information. The master was engaged in these chores for about 1-2 minutes. During that time, EXPRESS 1 travelled a distance of more than one nautical mile.

Figure 7: Office area seen from the aft of EXPRESS 1's bridge  
Source: DMAIB, 2019

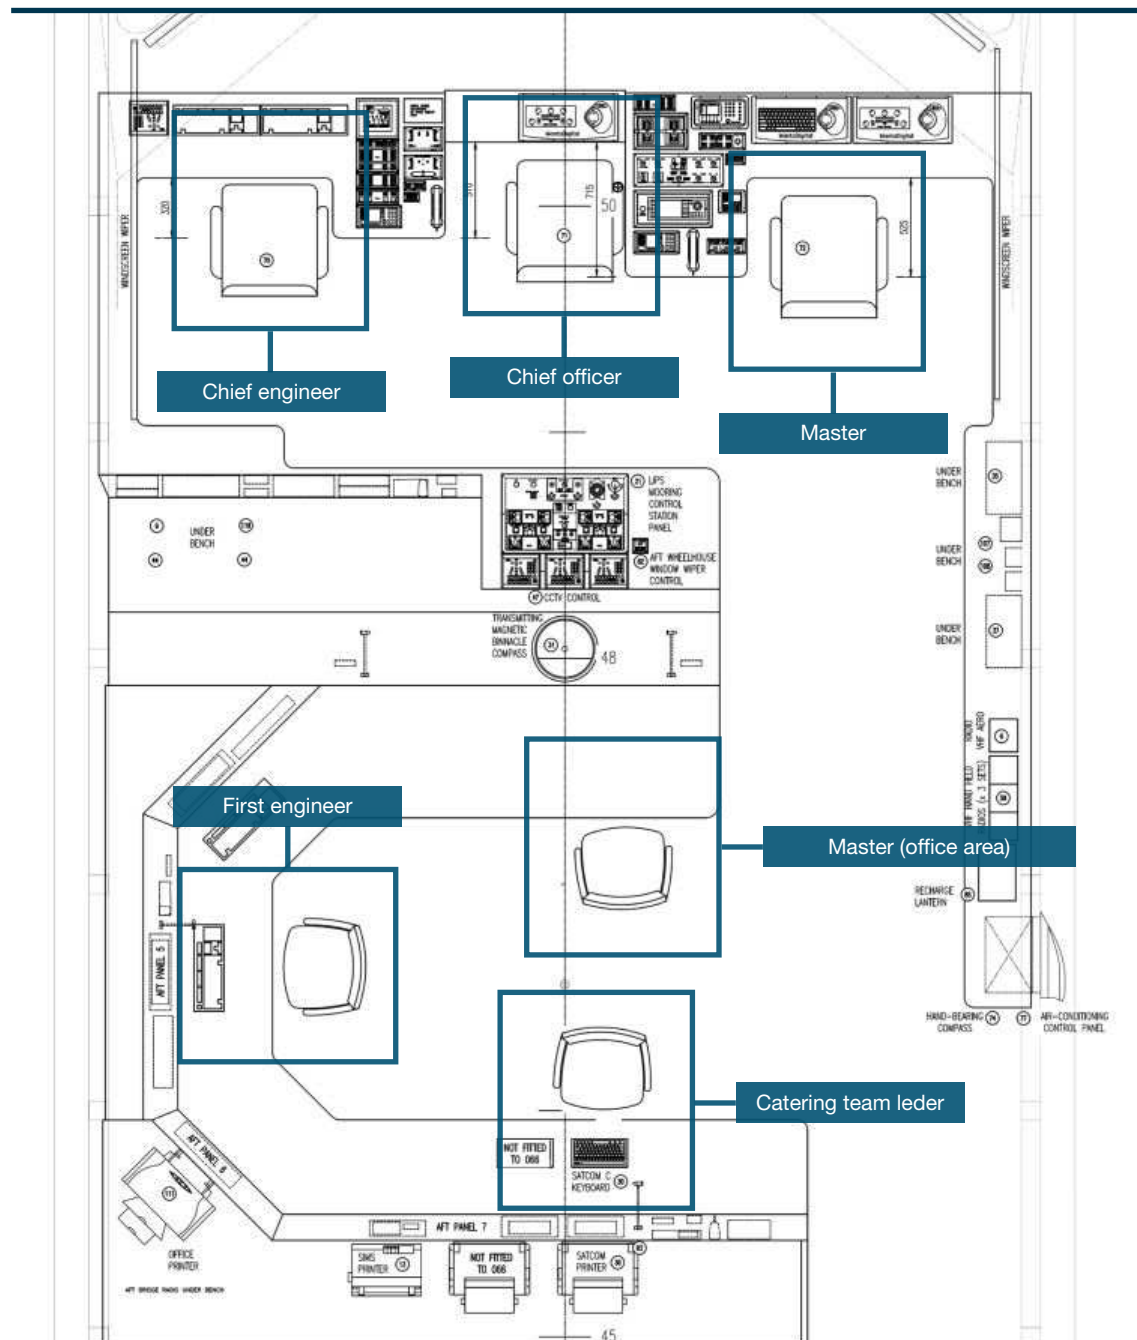
The HSC code requires that the area from which the ship is navigated is sterile in relation to activities that are not essential to the safe operation of the ship. The bridge on the EXPRESS 1 was furnished with three front operating stations: two for the navigators and one for the chief engineer. Behind the operating stations there was an area with three office spaces for the navigators, the first engineer and the team leader of the catering

staff (figure 8). This meant that there was often a lot of activity on the bridge when the catering staff needed to contact their team leader, and when the engineering personnel had to solve technical problems during the crossing. In addition, the proximity to the navigators' office computer made it possible to handle administrative tasks, while they were on duty on the bridge.

Figure 8: Bridge layout on EXPRESS 1  
Source: Molslinjen/DMAIB, 2019

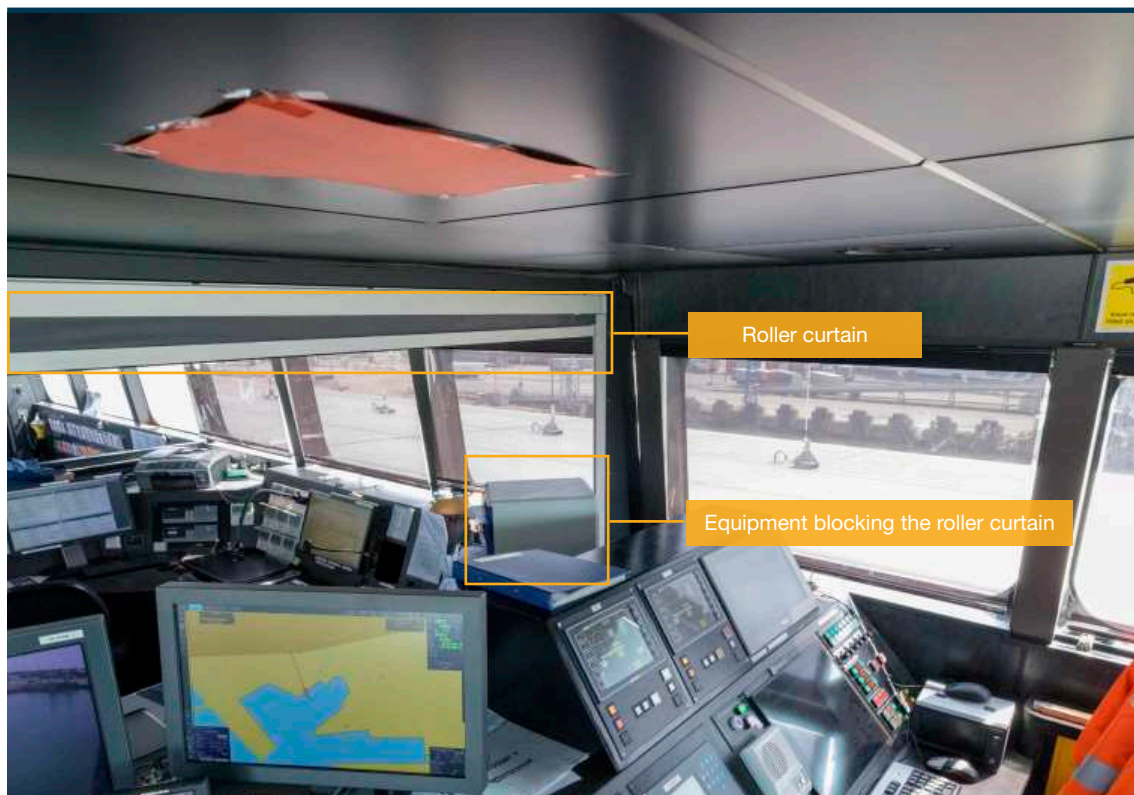
A roller curtain was installed on the bridge, which allowed a partial shielding between the operating stations at the front of the bridge and the office area behind it. However, it was not possible to roll down the curtain without moving equipment that was placed in the opening between the two areas (figure 9). The curtain would not necessarily offer significant shielding, since the engineering personnel's conversations would then be shifted from being going back towards the office area to going over the navigators, due to the location of the chief engineer's steering chair.

Figure 9: Shielding roller curtain on EXPRESS 1's bridge  
Source: DMAIB, 2019
