Report on the investigation of
the collision between

Scot Isles

Wadi Halfa

Dover Strait

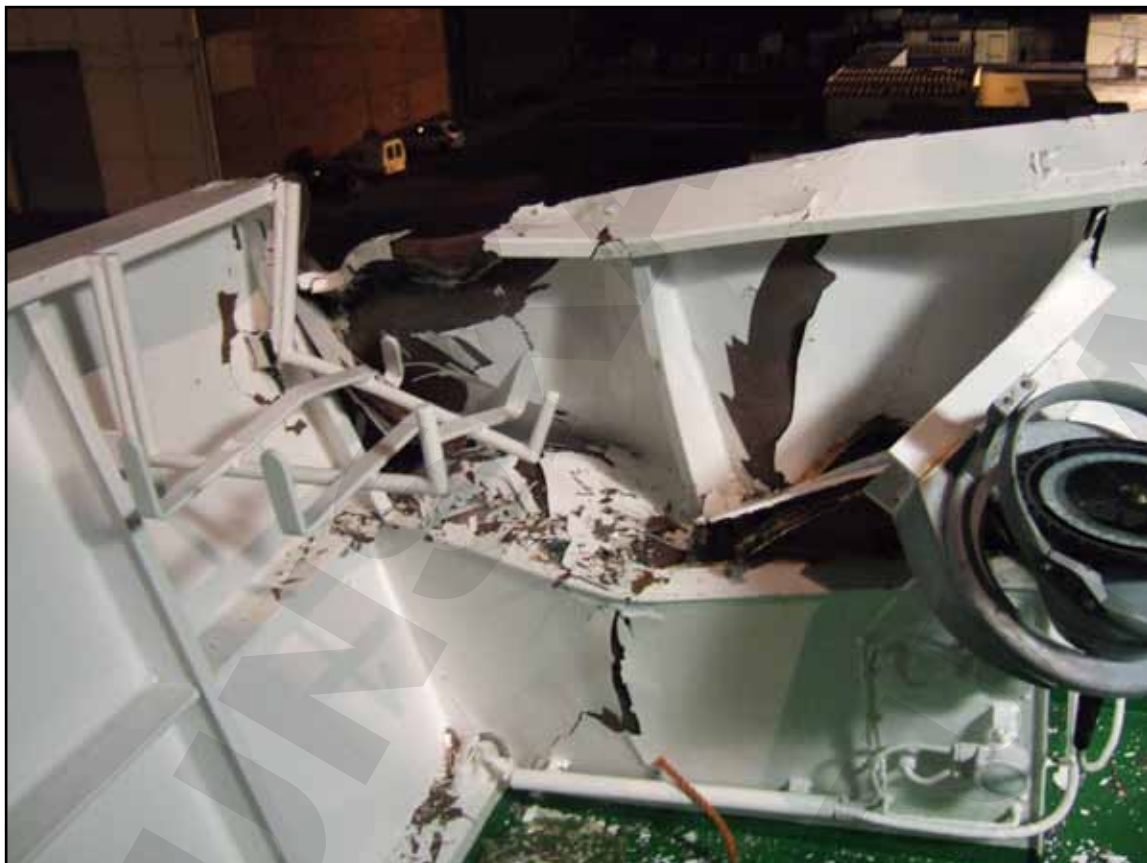
The master asked the chief officer what had happened and was informed that an overtaking vessel had collided with *Scot Isles*, causing damage to the starboard bridgewing. The master looked at this damage (**Figure 5**) and realised that the smoke, which the second officer had initially thought to be a fire, was in fact from the bridgewing smoke float which had been activated by the collision.

Scot Isles - damage to starboard bridging

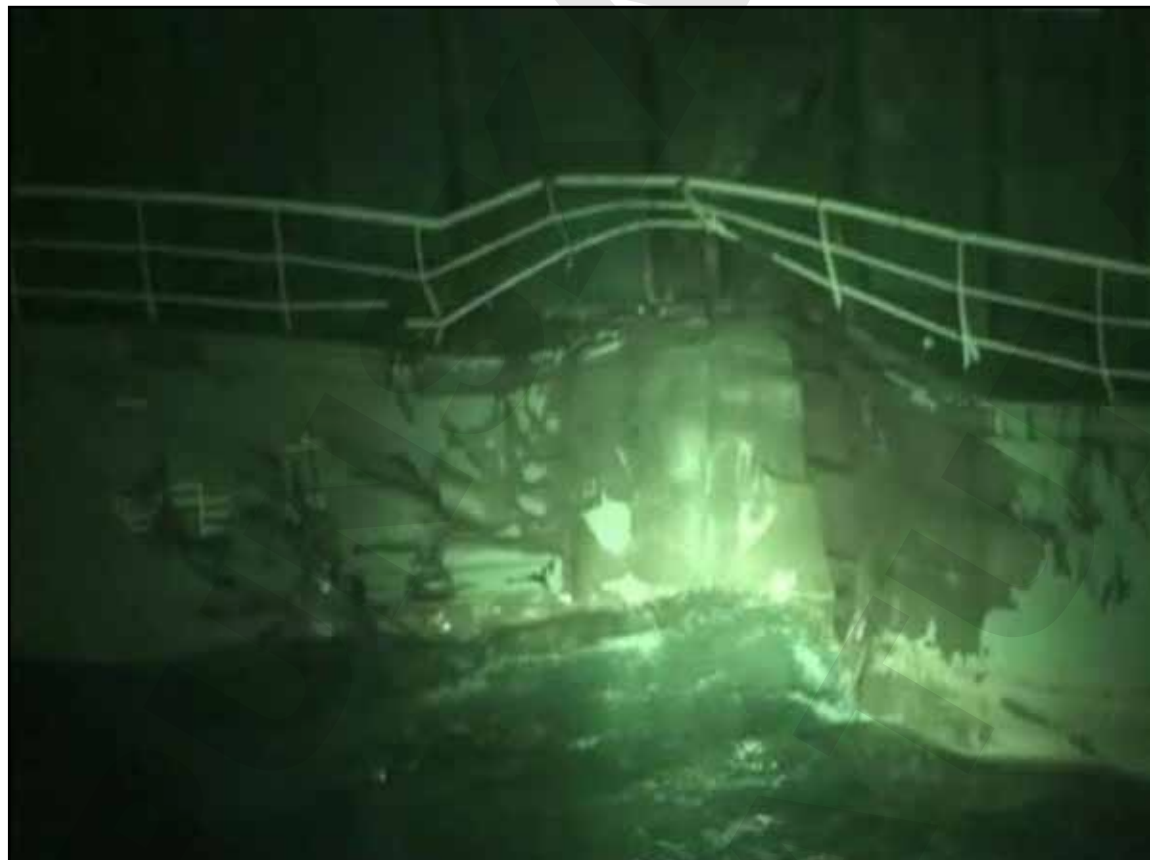
Figure 6

At 0630 a French naval helicopter arrived overhead of *Scot Isles* and carried out a searchlight inspection of the hull. The extensive damage to the starboard side shell plating, amidships, was now illuminated (**Figure 6**).

Scot Isles - photograph of damage to the hull

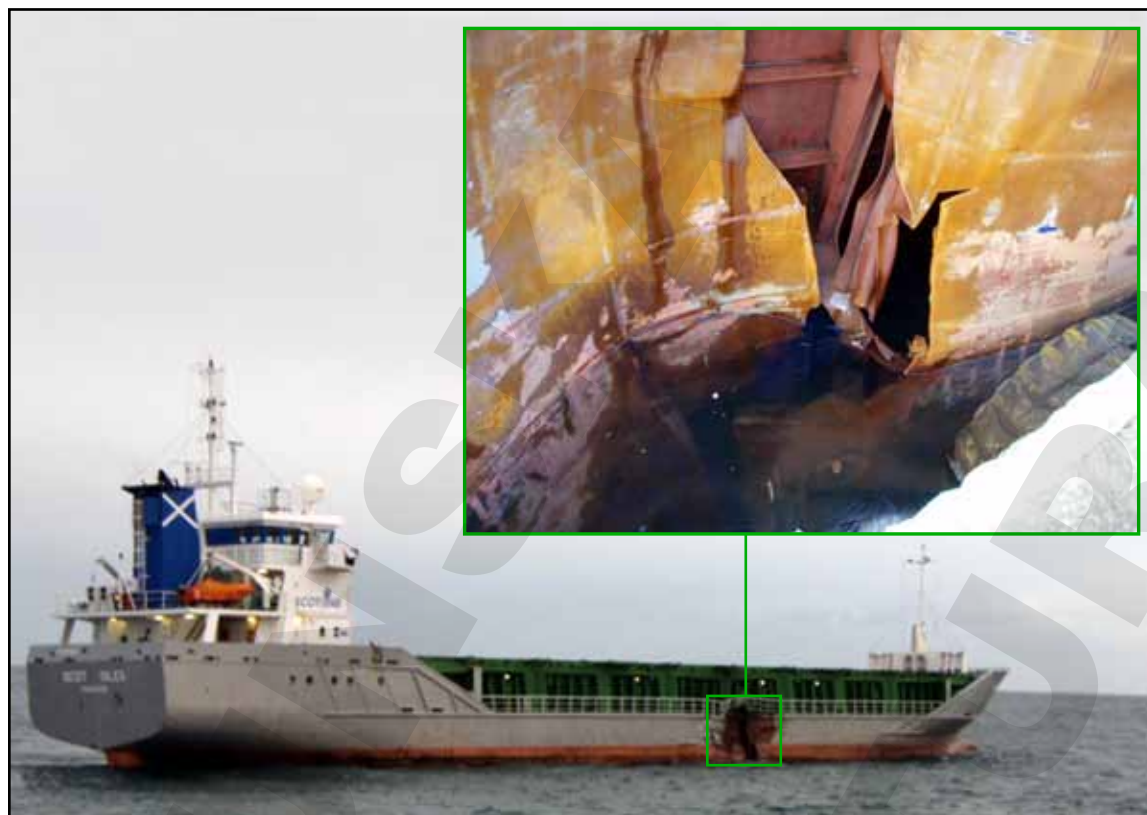
At 0850, two French marine officials boarded *Scot Isles* to inspect the damage and assess the pollution. They informed the master that, due to the extent of the damage (**Figure 7**), all the oil in the tank had been lost into the sea and that he should cease transferring from the tank.

Scot Isles - damage overview

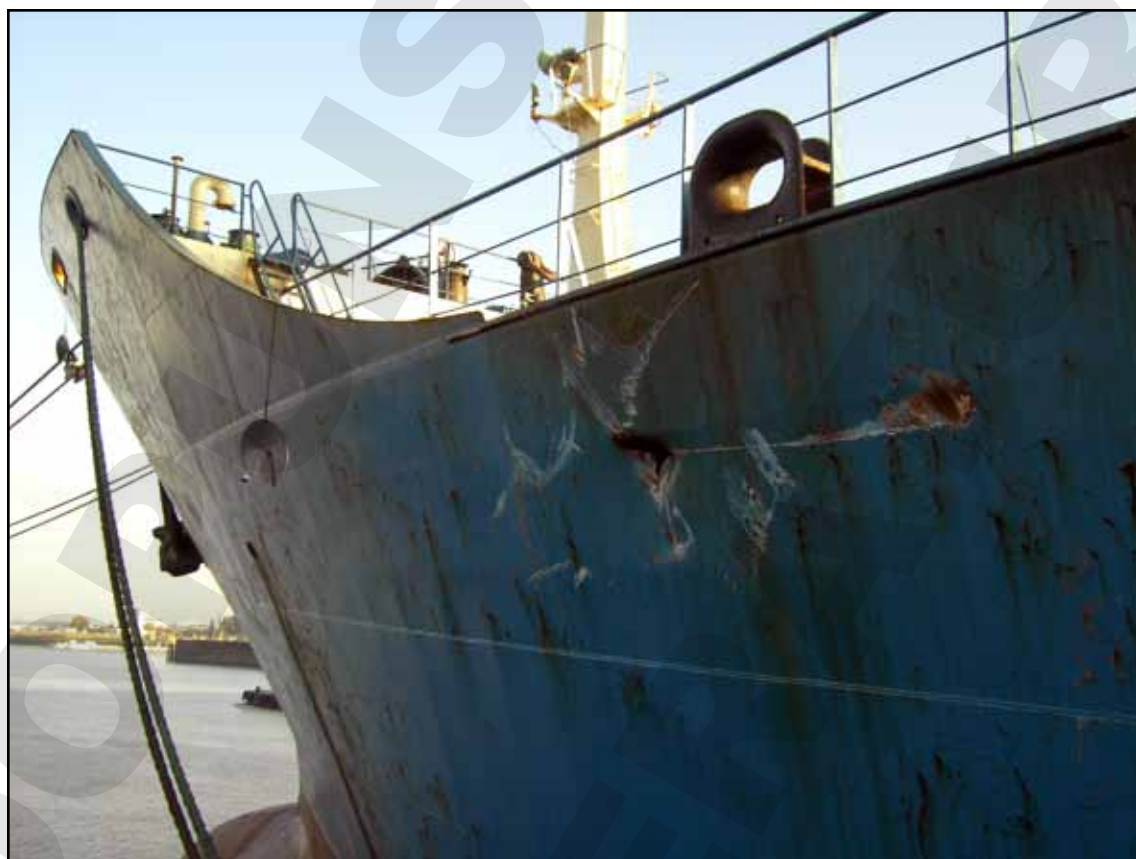
Figure 8

The chief officer returned to the bridge and told the master that the only apparent damage to *Wadi Halfa* was a small hole in number one port wing ballast tank, approximately 25cm long and about 50cm below the main deck level (**Figure 8**).

Wadi Halfa - shell plate damage to number one port wing ballast tank

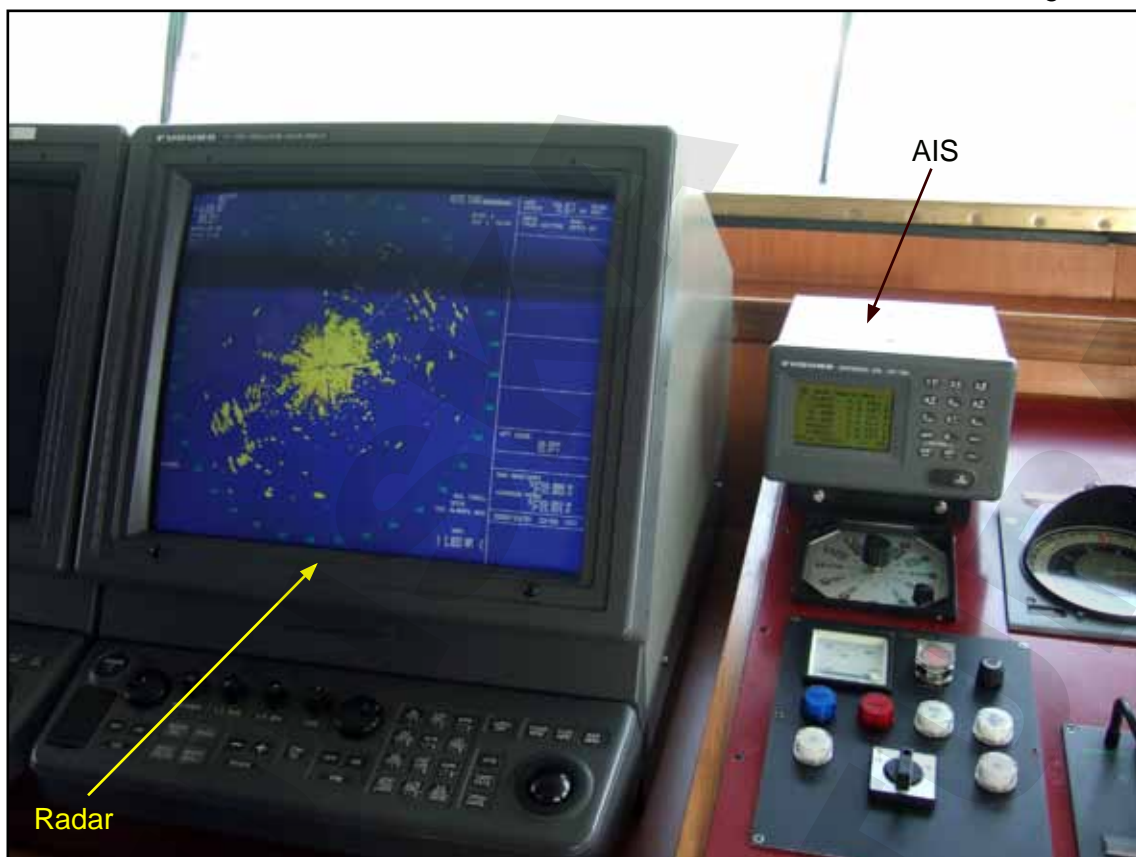
The chief officer was sitting in front of a radar fitted with ARPA, but this facility was not used to acquire and plot any of the radar targets, which could have enabled an early assessment of risk of collision to be made. The information displayed on the AIS receiver (**Figure 10**), located beside the starboard radar, giving the names and relative positions of the closest six vessels, was also not used.

The chief officer failed to maintain a proper lookout by sight or use of the navigational equipment available to him. This was contrary to Rule 5 of the COLREGS.

Scot Isles - wheelhouse, location of AIS receiver

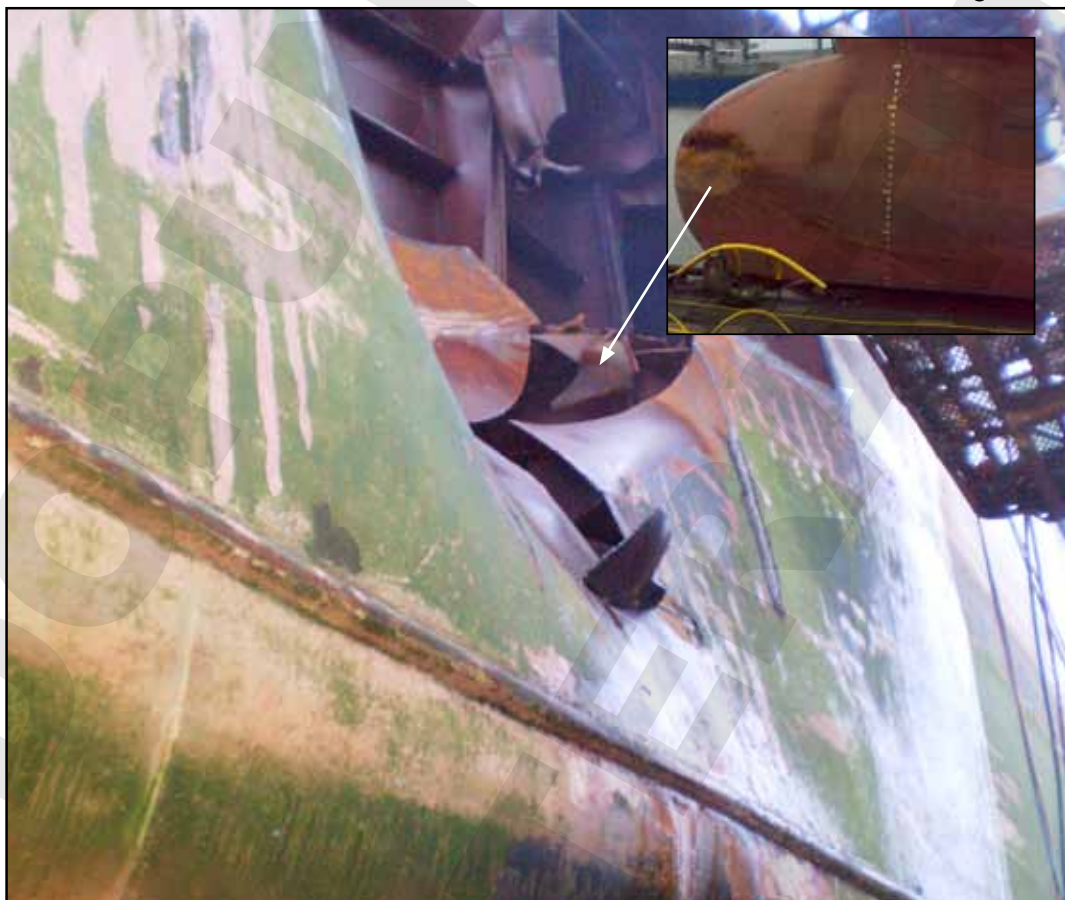
Figure 12

The shape of the damage caused to the shell plating of *Scot Isles* (**Figure 12**) matched the profile of *Wadi Halfa*'s bulbous bow. The distance, measured from the bulbous bow to the hole in number one port wing ballast tank on *Wadi Halfa*, corresponds with that from the hull damage on *Scot Isles* to her starboard bridge wing.

Scot Isles and *Wadi Halfa* - comparison of damage

From this evidence it can be seen that the initial point of contact was between the port side of *Wadi Halfa*'s bulbous bow and the starboard hull, amidships, of *Scot Isles*. The two vessels then came together bodily, which resulted in the secondary damage to *Scot Isles*' starboard bridgework and to *Wadi Halfa*'s shell plating in way of number one port wing ballast tank.

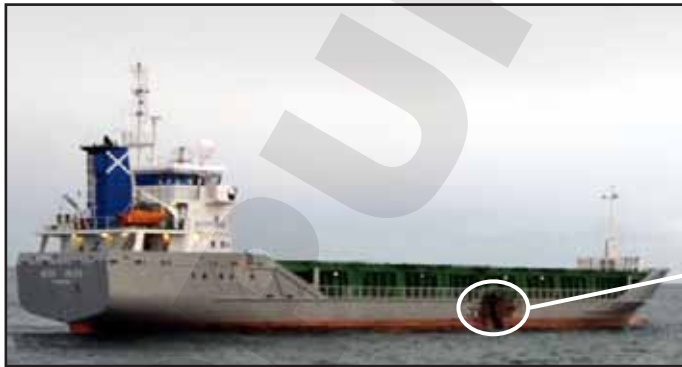
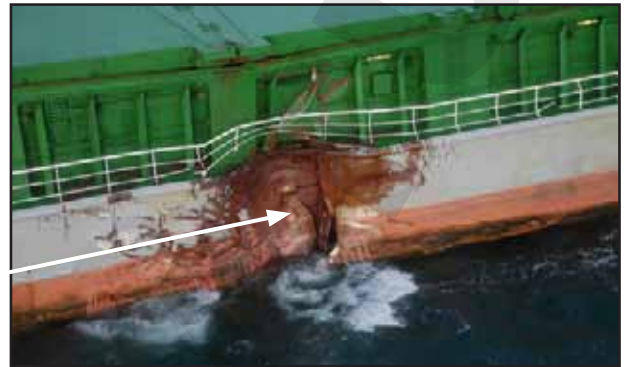
Damage to *Scot Isles*

Scot Isles was struck amidships and a fuel tank was breached, causing pollution, but the full extent of the damage was not discovered for some time due to ineffective post collision checks. The Coastal State subsequently directed the vessel to proceed to Dunkirk for a full damage survey and repairs, which kept the vessel out of service for several weeks.

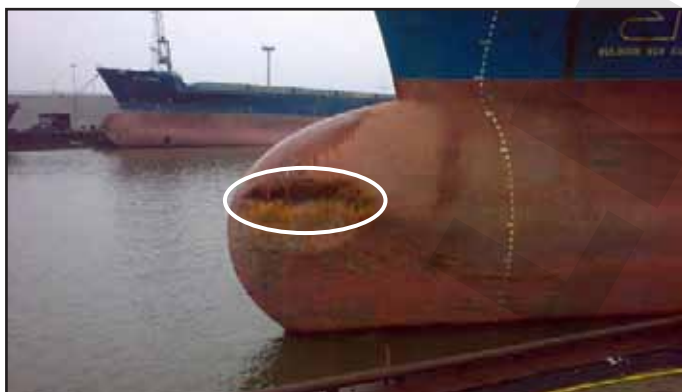
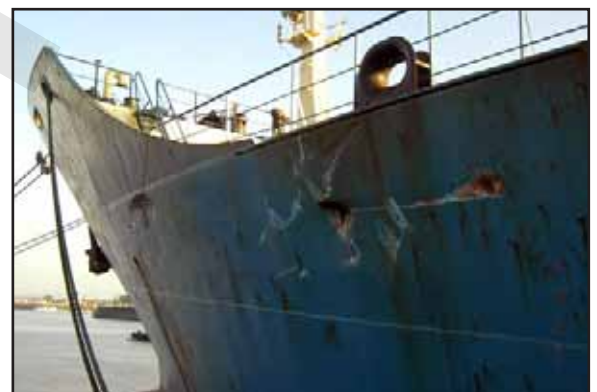
Damage to *Wadi Halfa*, although less severe, took more than a week to repair on arrival at her next port in Germany.

Damage to *Wadi Halfa*
