SAFETY INVESTIGATION REPORT

REPORT NO.: 22/2020

MV ALMA
Fatal fall from the
accommodation stairway
in position 47° 38.1' N 008° 51.8' W,
22 November 2019

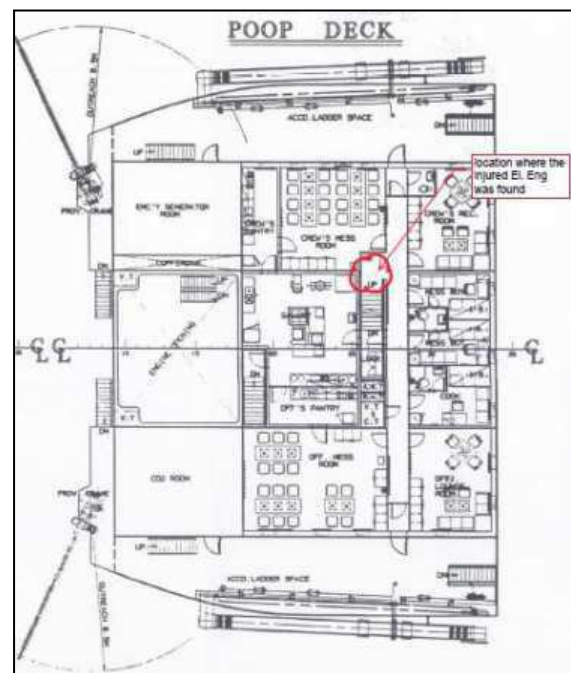
Figure 2: Location where the electrical engineer was found

At around 1953, while on his way to the bridge to take over the watch, the third officer met the electrical engineer in the stairway landing of deck 'A', wearing his overalls and safety shoes. Nothing peculiar was observed. However, at about 1955, the bosun, who was in his cabin on deck 'A', heard a sound emanating from the accommodation stairway. On checking, he noticed the electrical engineer on his back, at the bottom of the stairway, on the poop deck (Figure 2).

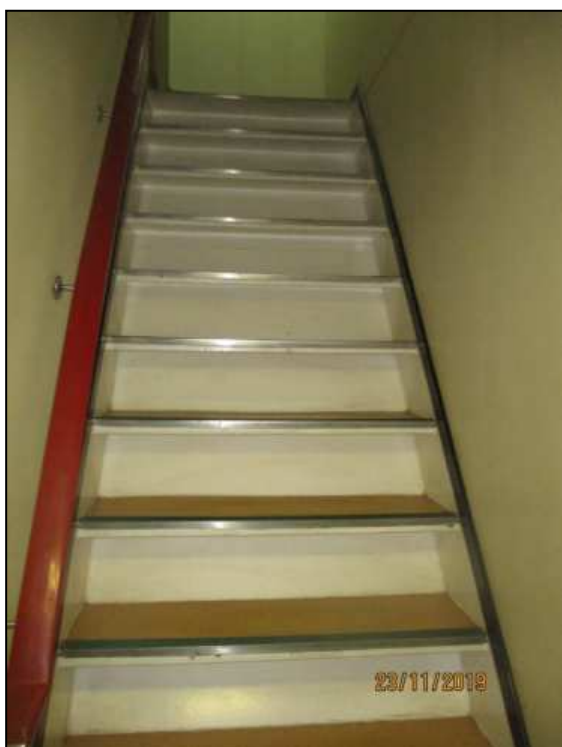
Figure 3: Section of the stairway, seen from the bottom (poop deck level)

The section of the stairway, at the bottom of which the fatally injured electrical engineer was found, was inclined at an angle of 50° to the horizontal. This section of the stairway consisted of 10 steps, with a riser height of 250 mm and fitted with a handrail on one side (Figures 3).

Reportedly, the stairway was well lit and free of defects and slippery substances.

As mentioned earlier in this safety investigation report, the stairway was fitted with a handrail and its risers were evenly spaced. Furthermore, it was reportedly well-lit and free of defects and slippery substances.

The investigation report emphasised the importance of serving crew members to exercise caution while using the vessel's stairs, especially when the vessel is experiencing rolling and pitching motions, and to hold onto the handrails for support.

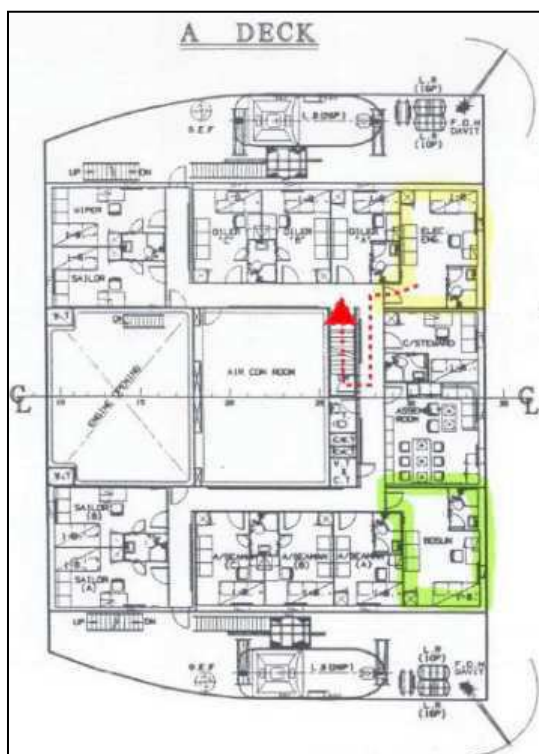
Figure 4: Reported path followed by the fatally injured crew member

Reportedly, the crew member was walking down the stairway from his cabin on deck 'A' to the poop deck (Figure 4), when the bosun heard him falling down the stairway.

The safety investigation hypothesized that the fatally injured crew member either lost his stepping or balance, while walking down the stairway, as a result of the rolling and pitching motions of the vessel. The safety investigation did not rule out the possibility that the crew member was not holding on to the handrail, while going down the stairs. It is highly likely that he subsequently toppled down to the bottom of the stairway, fracturing his skull at some point during this fall.

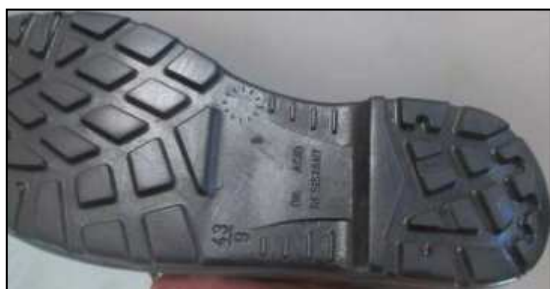
Figure 5: Sole of the fatally injured crew member's shoe

No items were found in the vicinity of the stairway, which could have indicated that the fatally injured crew member was carrying any items in his hand while walking down the stairway. The shoes worn by the fatally injured crew member were in good condition, with the treads on the soles free of wear (Figure 5).
