National Transportation Safety Board

Marine Accident Brief

Overpressurization and Rupture of Cargo Tank on Cargo Vessel *Fairchem Filly*

Accident type	Hull/Machinery/Equipment Damage	No. DCA19FM037
Vessel name	<i>Fairchem Filly</i>	
Location	Vopak Terminal, Ship dock 5, Houston Ship Channel, Deer Park, Texas 29°44.95' N, 95°05.76' W	
Date	May 30, 2019	
Time	0750 central daylight time (coordinated universal time – 5 hours)	
Injuries	None	
Property damage	Est. \$750,000 to vessel and \$100,000 in cargo	
Environmental damage	None	
Weather	Temperature 83°F, winds from the north at about 5 miles per hour, clear visibility	
Waterway information	Houston Ship Channel at the Vopak Tank Terminal facility. The terminal has four deep-draft tanker berths and eight barge docks located on the south side of the channel.

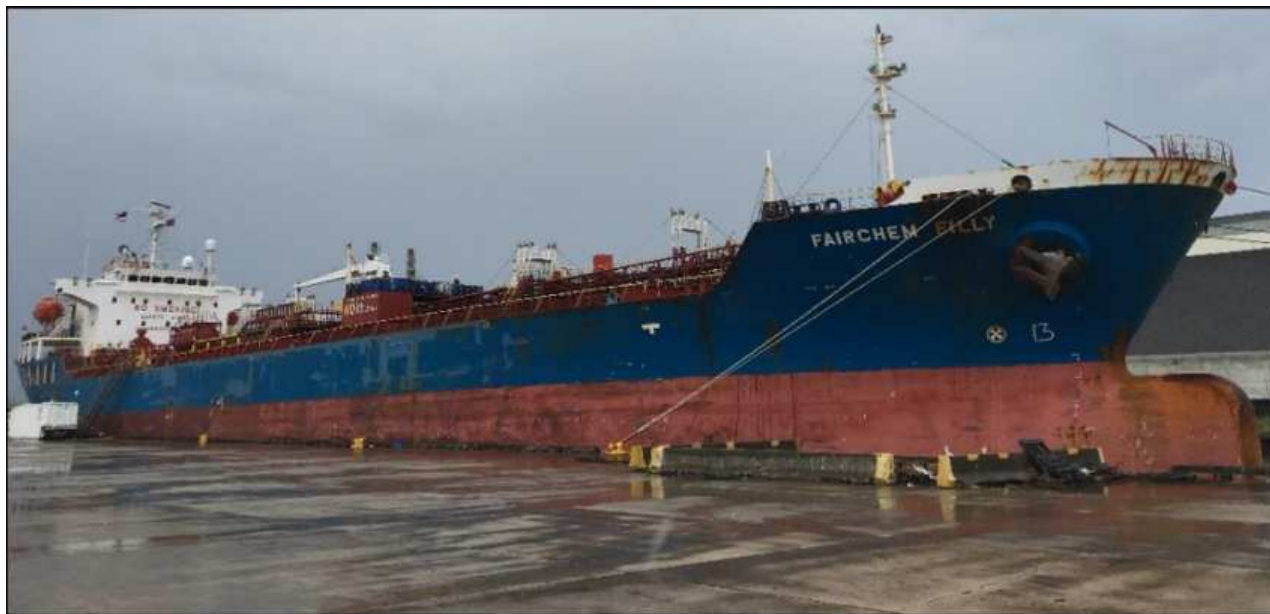
Chemical tanker *Fairchem Filly* after the accident in Galveston, Texas.

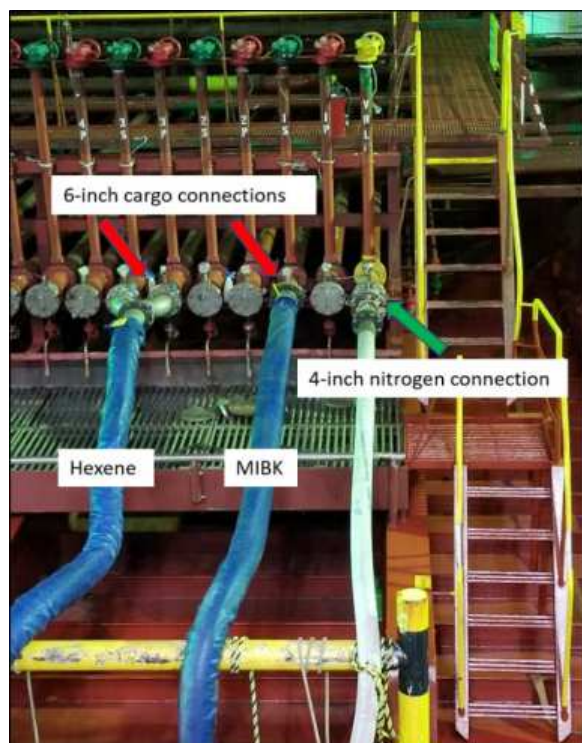
Cargo manifold configuration on board the *Fairchem Filly* at the time of the accident.
(Source: Vopak)

Utilizing the shoreside crane, Vopak's dockman and the *Fairchem Filly*'s pumpman began making hose connections. The 6-inch hexene and MIBK cargo discharge hoses were connected directly to flanges on board the vessel. A 4-inch nitrogen hose was connected via a reducer to the vessel's 6-inch vapor recovery line. To control the flow of the nitrogen, the shore used a 4-inch gate valve, and the vessel used a 6-inch butterfly valve. The ship's pumpman was assigned to operate the cargo manifold valves on the ship, including the nitrogen supply valve, and the Vopak PIC was responsible for the shore valves. All hoses were connected by 0540, and shortly afterward, the terminal completed a personnel shift change. The relieving dockman assumed the role of Vopak PIC from the dock supervisor and completed a handover with his counterpart. There was no requirement to inform the vessel of the shift change at that time, and no attempt was made. Over the next hour, terminal employees on the dock made physical checks of the cargo hoses and communicated with the terminal control room to verify that the terminal's piping system was lined up correctly.

Although both the terminal and operator of the vessel had procedures and control measures in place that clearly outlined a nitrogen blanketing operation, the procedures were not followed on the day of the accident. The terminal’s crew had work instructions that required that a 2-inch nitrogen hose be used to transfer liquid cargo, and the ship’s QHSE manual required its crew to use a 1-inch hose or orifice. However, on the day of the accident, a 4-inch nitrogen hose was

connected to the vessel with no orifice, which removed engineered controls designed to limit the flow rate of nitrogen to the cargo tanks safely below their relief capacity. Additionally, the ship's QHSE guidelines included a "Nitrogen Handling Checklist," which outlined the flow rate and other information associated with a nitrogen operation, but the ship's crew did not complete this checklist on the day of the accident. Had the crew referenced this checklist, it is likely that they would have known that the potential flow rate of nitrogen would have exceeded the cargo tanks' PV valve relief capacity, and they may have reassessed and corrected the configuration by using the correct hose size or a reducing orifice.

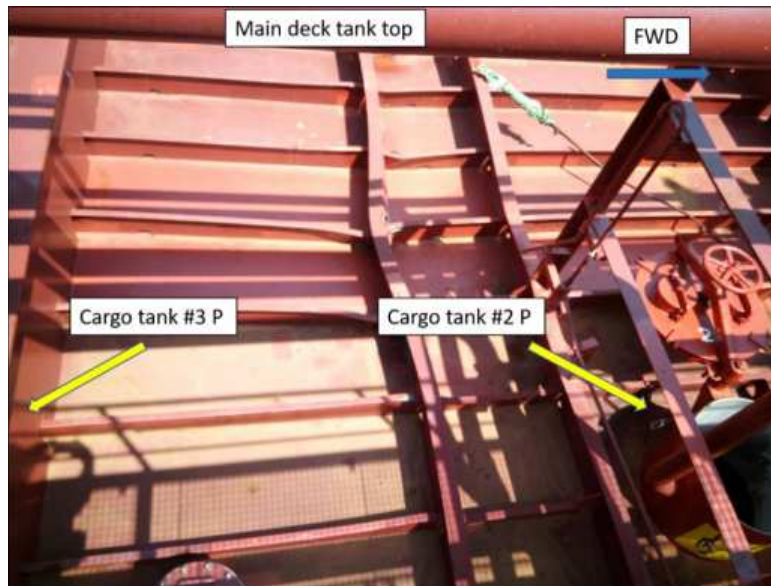
In addition to individual cargo tank pressure indicators in the cargo control room, the *Fairchem Filly* was equipped with an independent cargo vapor pressure-monitoring alarm and recording system, which automatically recorded and stored tank pressure data. After the accident, the system data showed a highest recorded pressure of 15.8 psi (109 kPa) in the 3P and 3S cargo tanks.

Main deck tank top deformation on the port side of *Fairchem Filly*.

Vessel. After the accident, the *Fairchem Filly* proceeded to shipyard for repairs. The overpressurization of the 3P cargo tank caused the transverse bulkhead between 2P and 3P to buckle and ruptured the tank's inner bottom plating. In addition, the tank rupture damaged the bulkhead between the 3P cargo tank and the numbers 2 and 3 port wing ballast tanks. The main deck plating, deck transverse section, and deck longitudinals adjacent to the ruptured cargo tank and damaged ballast tanks were also damaged. Repairs required that all affected steel be cropped out and repaired with new material.

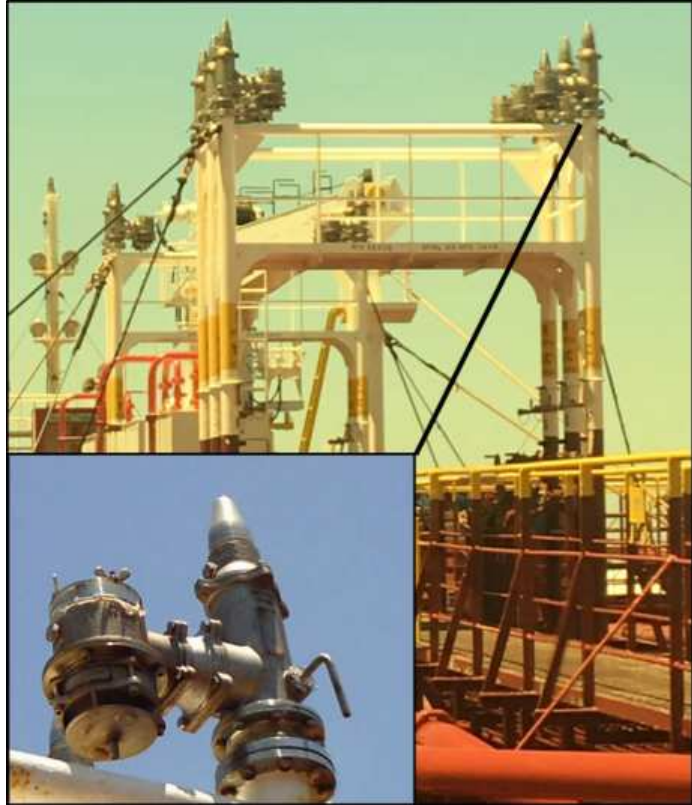
Each cargo tank on the *Fairchem Filly* was protected from low and high pressure by a single bullet-style pressure/vacuum valve (PV valve). The PV valves were set to open at a high pressure of 2.9 psi (20 kPa) or at a low pressure of -0.51 psi (-3.5 kPa). The pipe diameter where the PV valve connected to the tank had an inside diameter of 4 inches. The seat diameter for the pressure relief port was 3.35 inches, and the seat diameter for the vacuum relief port was 5.9 inches. All PV valves on board were successfully overhauled and pressure-tested in early April 2019. In addition, in accordance with the vessel's pre-arrival checks, all the ship's PV valves were manually operated and visually inspected 10 days prior to the accident, when they arrived in Galveston anchorage, with no deficiencies noted.

Pressure/Vacuum valves on board the main deck of the *Fairchem Filly*.

Relief valves are fitted to cargo tanks to protect the tanks from an overpressurization event. The ship’s PV valves were overhauled and pressure-tested in April 2019 and had been inspected 10 days prior to the accident, with no deficiencies noted. Therefore, it is likely that the PV valves performed as designed. The terminal had no recent history of terminal equipment failure.

Relief valves have a maximum flow rate that cannot be exceeded, or the pressure will rise in the tank(s) that the valves protect. The terminal’s Nitrogen Supply Acknowledgement form indicated that the terminal could move 250,000 ft³ per hour through the hose for a purge, and their liquid cargo work instruction stated that a 2-inch hose must be used for blanketing. However, a 4-inch hose was used for the nitrogen blanket supply during the liquid hexene cargo transfer. Since the nitrogen pressure at the dock would not change whether completing a purge or a blanket operation, the use of a larger 4-inch hose on the morning of the accident would have likely allowed for a flow rate near the purge maximum. The ship’s cargo tank relief valves had a capacity of 17,057 ft³ per hour, as indicated on the cargo control room placard on board the vessel. Therefore, this arrangement allowed for a potential nitrogen flow rate well in excess of the maximum capacity of the cargo tank relief valves. Without accurate and ongoing throttling of the nitrogen control valves, the risk of overpressurization was constant.
