SAFETY INVESTIGATION REPORT

REPORT NO.: 23/2020

MV LA SOLOGNAIS

**Serious injury to a crew member
in the grey water tank
in position 07° 43.5' N 076° 08.0' E,
26 December 2019**

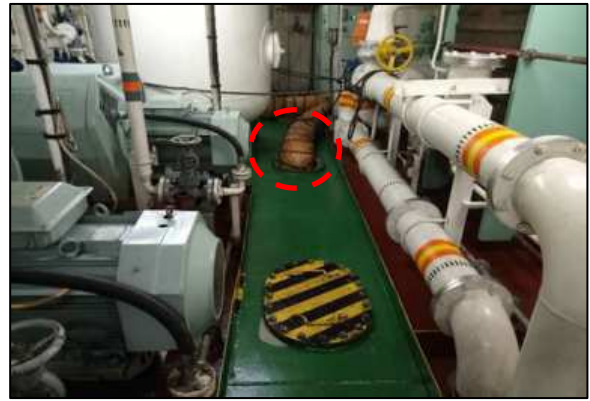
Figure 4: Access manhole of the grey water tank with the ventilation duct in place

Reportedly, on the day of the occurrence, the grey water tank was ventilated for about two hours, using a portable blower. During the safety investigation, it was revealed that the blower was supplying air into the grey water tank.

Considering that the grey water tank was fitted with only one access manhole and that its air vent extended up to the funnel, the safety investigation concluded that using the blower in 'supply' mode would not have generated an effective ventilation of the tank. This hypothesis was reached while considering the size of the portable ventilation duct in relation to the size of the manhole (Figure 9). It is highly likely that the supplied air would have escaped from

around the manhole perimeter rather than the from the air vent at the funnel (fitted 26.08 m above the grey water tank).

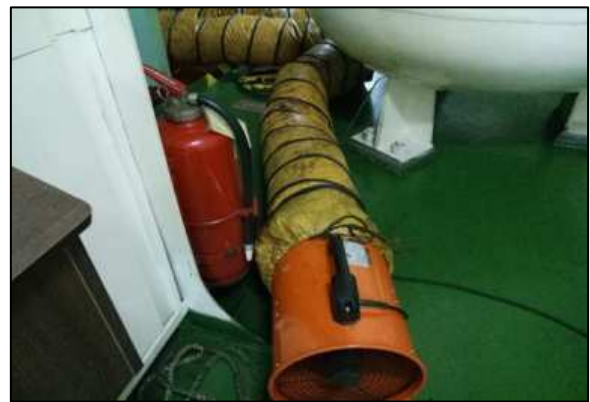
Figure 5: Portable blower used for ventilation

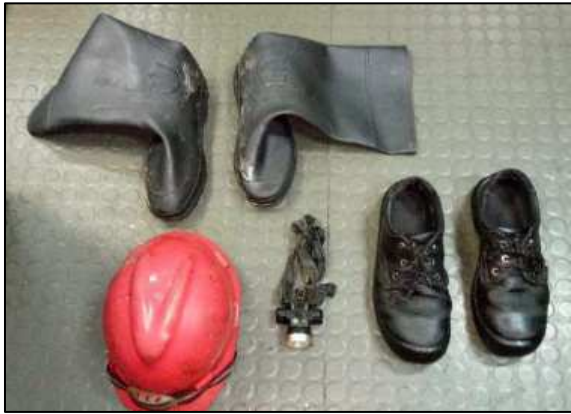
Figure 6: PPE worn by the injured wiper (the safety shoes were worn while he was outside the tank)

Considering the injury on the wiper's forehead, the safety investigation concluded that the chin strap of the wiper's helmet had not been properly secured when he entered the grey water tank. Consequently, the helmet slipped off his head at some point during the fall.

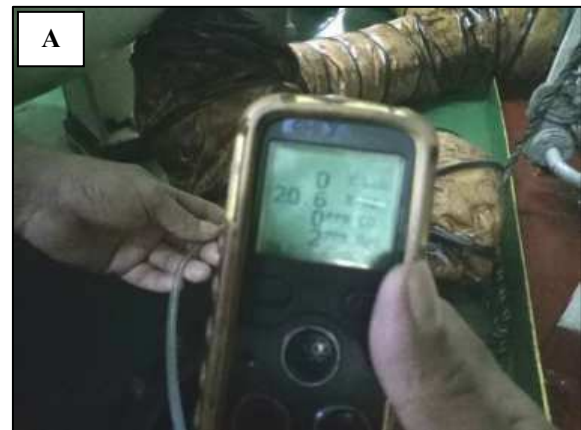
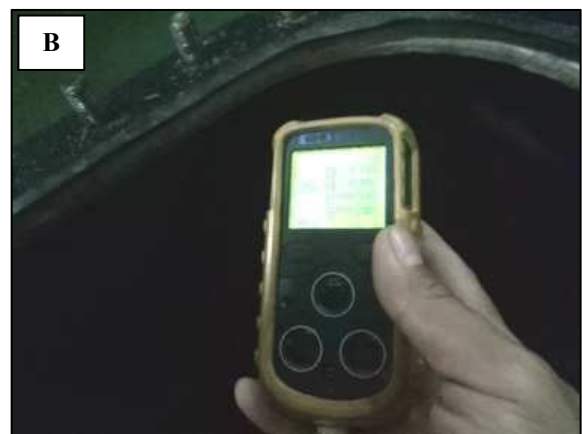
Figure 7: Multi-gas detectors on board (representative photographs)

While the enclosed space entry permit indicated that the grey water tank's atmosphere was safe for entry, the gas measurements were taken before the tank was washed from above, using a fire hose. It is highly likely that the jet of water disturbed pockets of H₂S, which may have gone undetected at the time of measuring the tank's atmosphere.

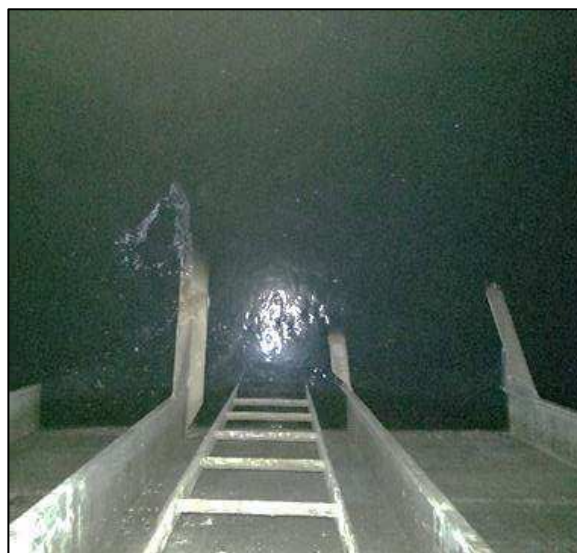
It is highly likely that the injury was sustained when the injured wiper struck his head either against the ladder or against the stiffeners in the grey water tank (Figure 8).

Figure 8: Ladder and fittings in the grey water tank, against which the wiper may have struck his head

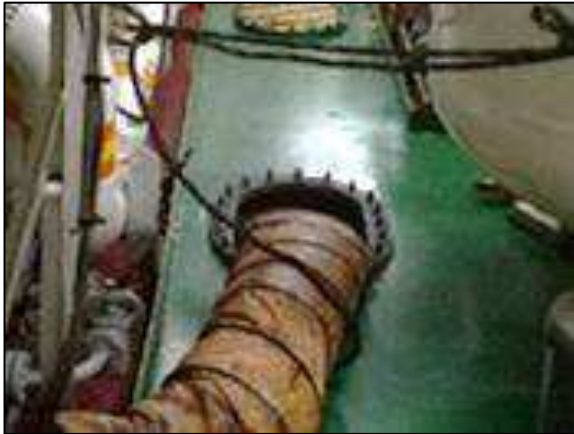
Figure 9: Ventilation duct passing through the grey water tank manhole
