**Final Report**

**FIRE**

**ON BOARD MAERSK HONAM**

MIB/MAI/CAS.035

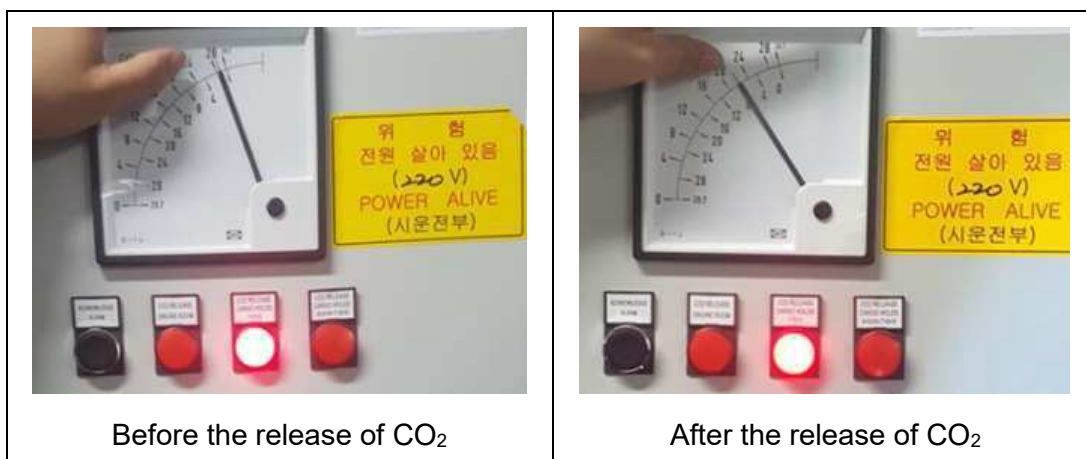
- 1.2.33 The CE reported the initial gauge reading for the CO<sub>2</sub> tank was about 28,500kg (about 28.5tons). As per the discharge table plan, a fully filled cargo hold<sup>77</sup> would require about 6,000kg of CO<sub>2</sub>. The CE stopped the release when the gauge indicated<sup>78</sup> 22,500kg of CO<sub>2</sub> remaining in the tank. (see **figure 10**).

Figure 10 – Photos of CO<sub>2</sub> gauge before and after the discharge

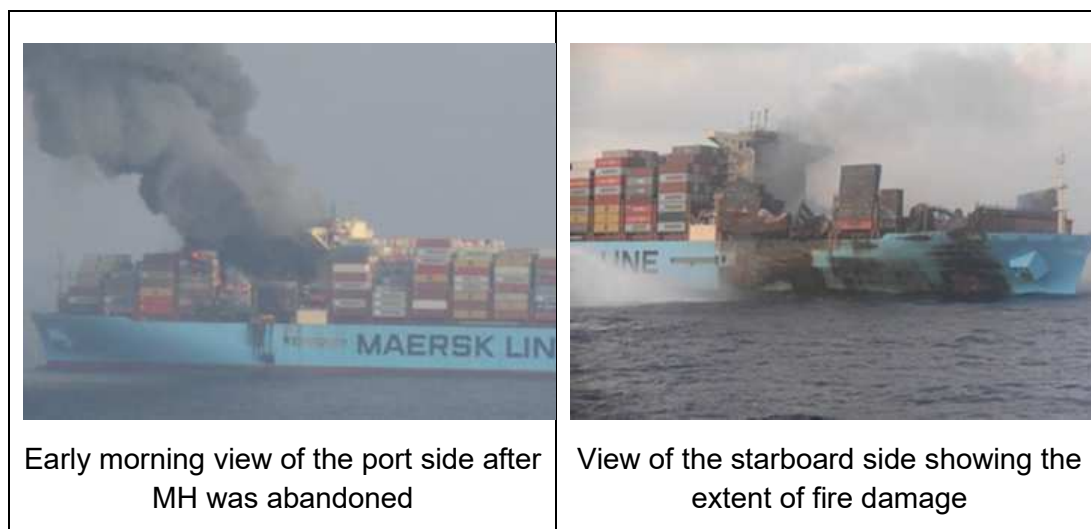
Figure 12 - Images of fire and its aftermath onboard MH

- 1.3.31 According to the 4E, looking from the forecastle deck, thick black smoke and flames were seen coming out from about the fifth tier between no.2 and no.3 cargo hold. Recalling further, the 4E mentioned that orange-coloured flames with burning were seen coming out from the top of the containers. The debris could also be seen being blown to the port side and into the sea (see **figure 12** showing fire and its aftermath on board MH).

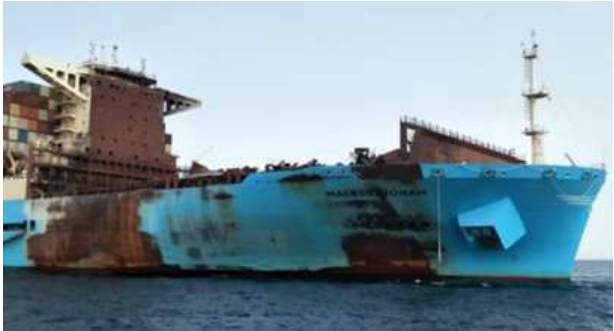
<p>View from sea level showing:</p> <p>Ship's starboard bow with burnt damages at ship's side and forward section of the accommodation</p>

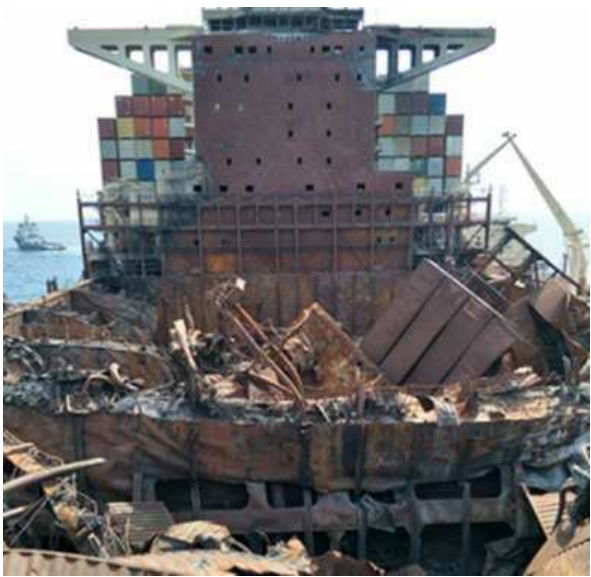
<p>View from the bow facing aft, indicating the extent of damage at the forward section that included:</p> <ul style="list-style-type: none"> <li>• Collapsed containers</li> <li>• No.1, 2 and 3 cargo hold structure and outfitting</li> <li>• Burnt damages at the forward of the accommodation</li> </ul>

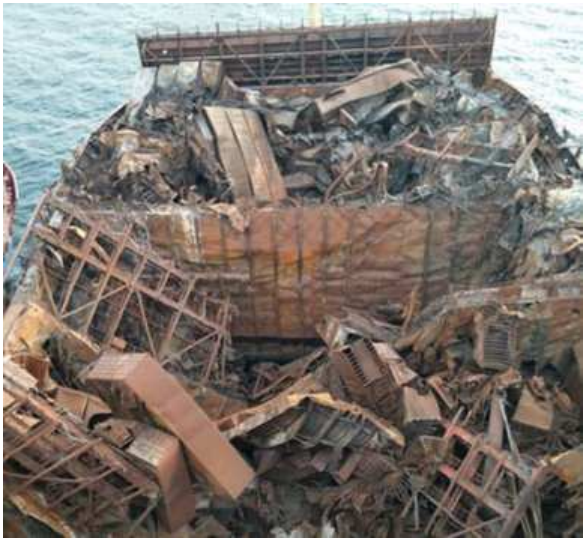
<p>Forward view from the bridge showing the ship's damaged section, which included:</p> <ul style="list-style-type: none"> <li>• Collapsed containers<sup>107</sup></li> <li>• No.1, 2 and 3 cargo hold structures and outfitting</li> </ul>

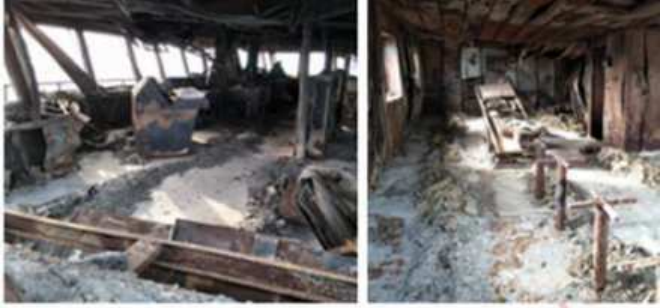
<p>View of the inside of the bridge and mess room (swept by salvors for access) showing burnt equipment, fittings, and structure</p>

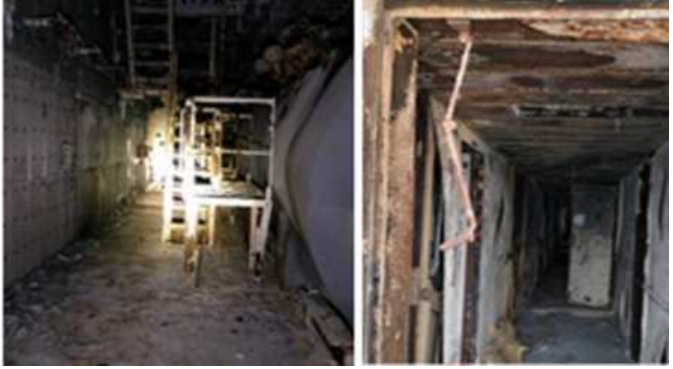
<p>View of the inside of the CO<sub>2</sub> room (swept by salvors for access) and the E-deck alleyway</p>

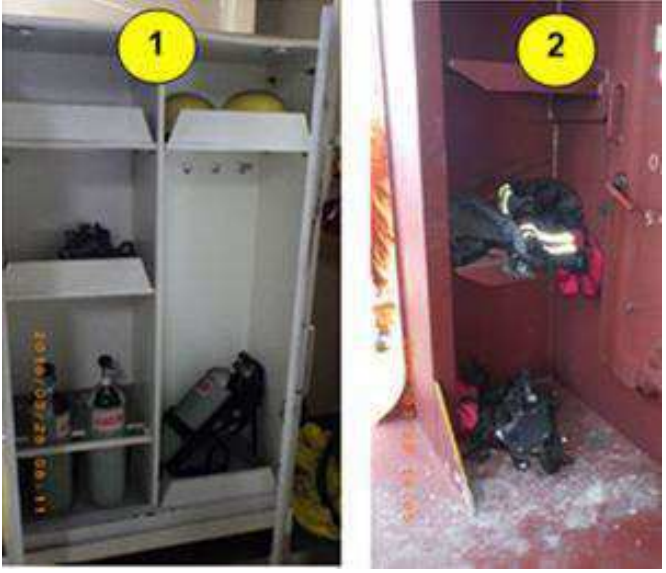
<p>The boiler suit indicated gross discolouration (caused by bleaching) to a near white colour from the original pale blue.</p> <p><i>Source</i> – Fire Forensic Expert</p>	 
<p>The inner lining of the fireman's jacket shows gross discoloration.</p> <p><i>Source</i> – Fire Forensic Expert</p>

<p>Photographs obtained by the investigation team:</p> <ul style="list-style-type: none"> <li>- Fire locker inside the Bosun store (forward) contains: <ul style="list-style-type: none"> <li>• one BA set with two spare bottles</li> <li>• one complete set of chemical suits</li> </ul> </li> <li>- Fire suit, BA set, and two sets of walkie-talkies found outside the forward store</li> </ul>

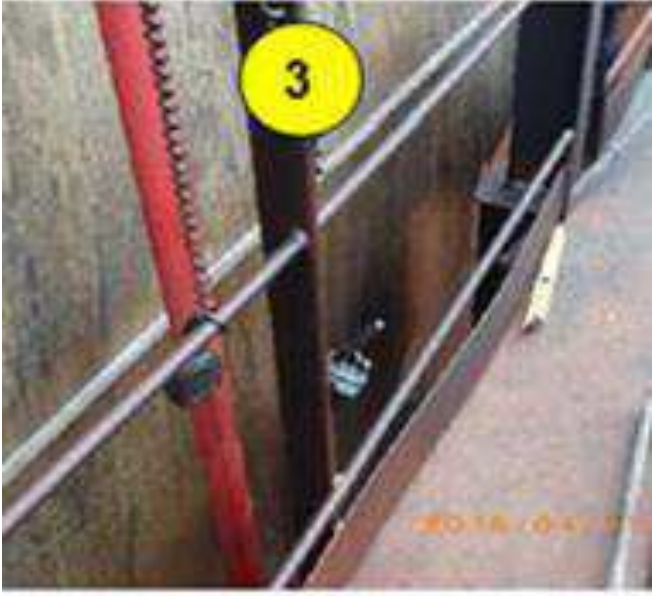
<p>Showing one set of walkie talkie bearing the 2M's tag (annotated no.3 by TSIB) was found at 3<sup>rd</sup> level lashing bridge forward of the accommodation.</p> <p>Additionally – Four sets of walkie-talkies tagged<sup>108</sup> with various ranks were discovered</p> <ul style="list-style-type: none"> <li>• One in the ECR</li> <li>• Two inside the ER; and</li> <li>• One in the accommodation</li> </ul>

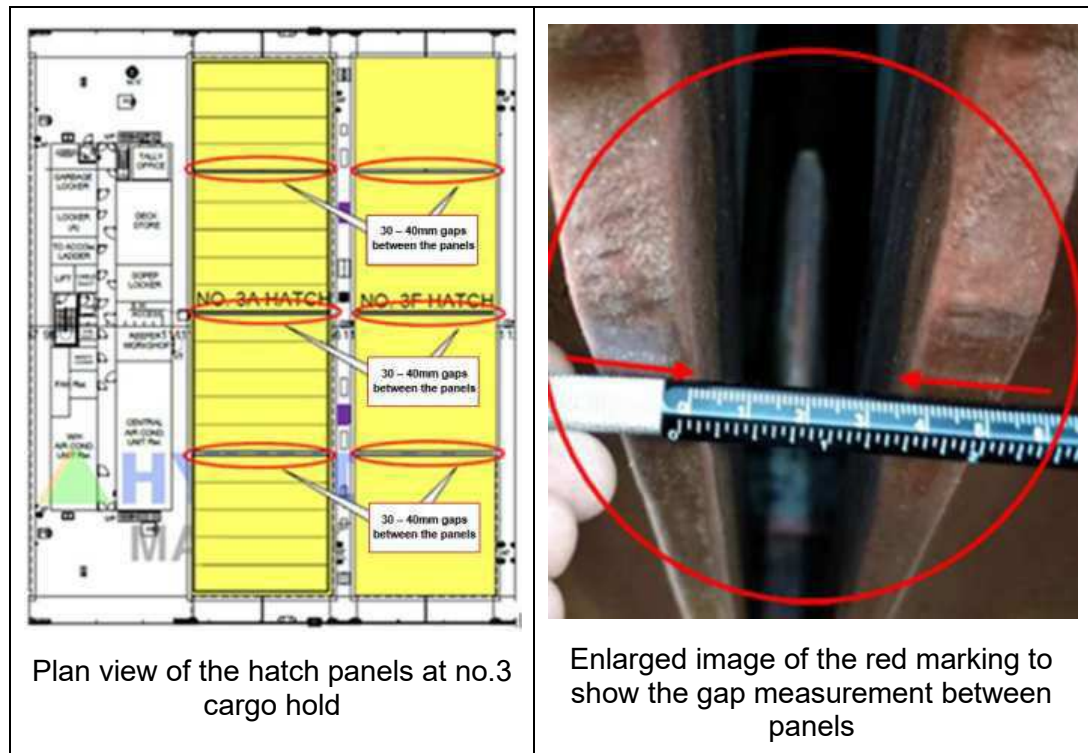
Figure 23 – Gaps between the hatch cover panels (annotated by TSIB with red markings)

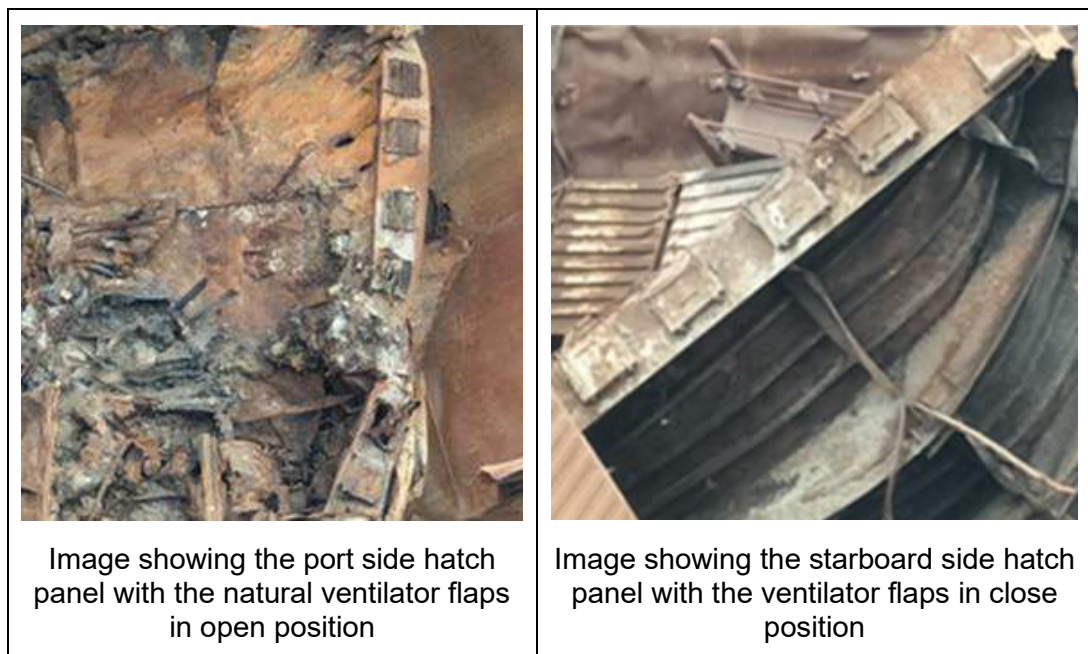
Figure 26 – Shows the condition of hatch panels during post inspection

- 1.8.21 The investigation team was able to confirm the account of the crew by an inspection of the ship post-incident, that the starboard side natural ventilator flaps were closed while those on the port side were open (see **figure 26**).

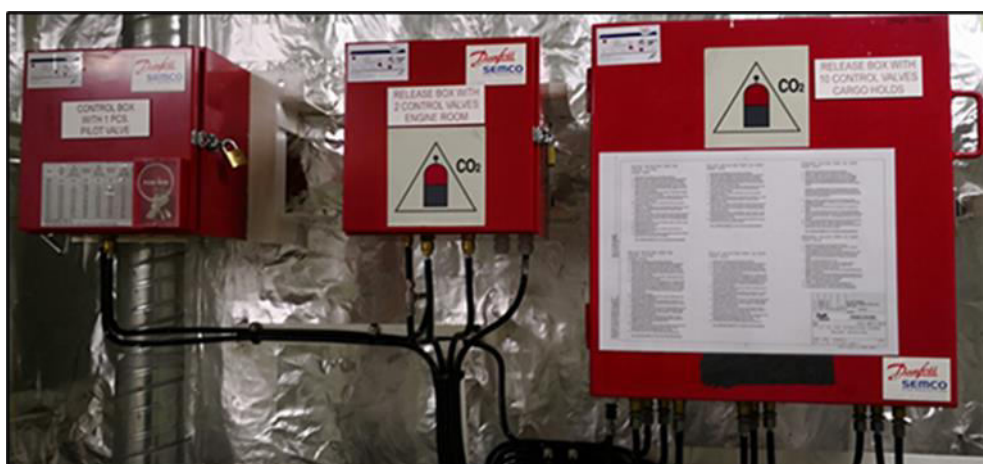
Figure 31 - Control cabinet for the CO<sub>2</sub> system with detailed and cluttered instructions

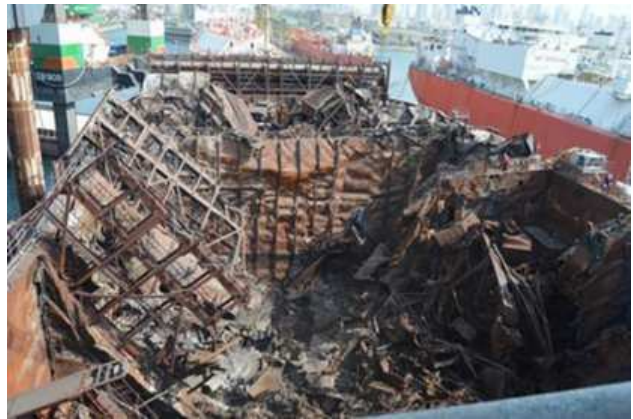
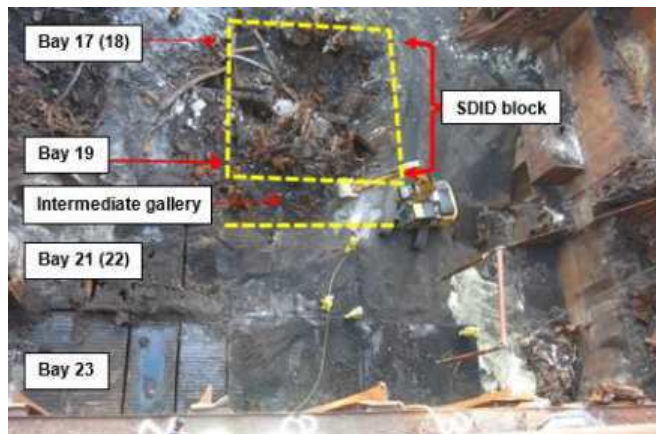
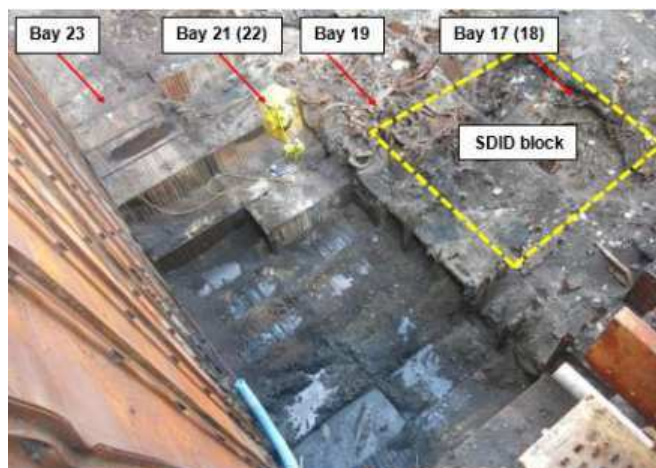
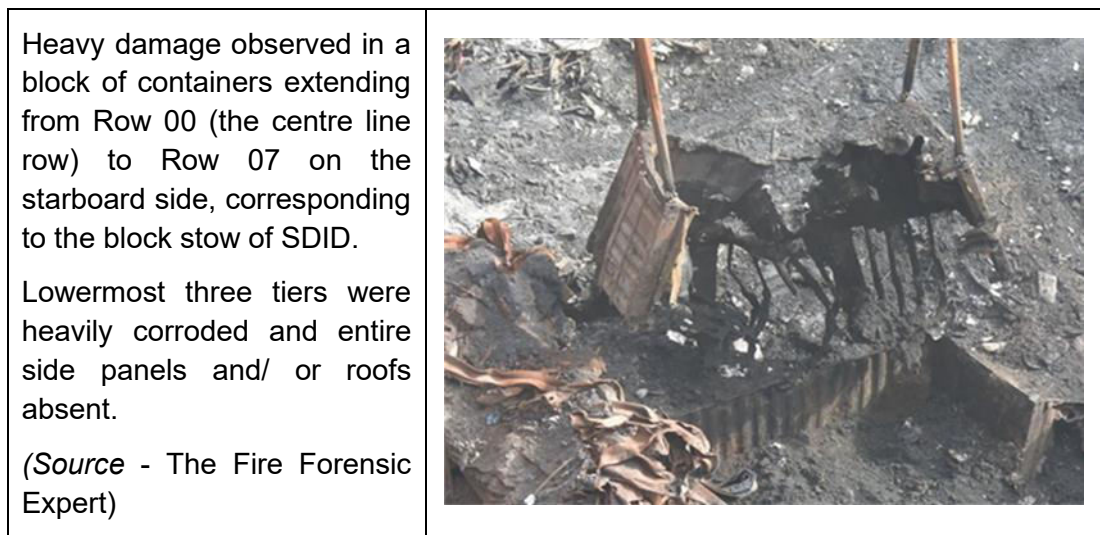
Figure 37 – Condition during excavation

Highlighting the SDID block in no.3 cargo hold at bay 17 (18) 19 as viewed from different angles.
