Report on the investigation into a serious injury on board

mv MINERAL TEMSE

at the South Atlantic Ocean with one victim on May 5th 2020.

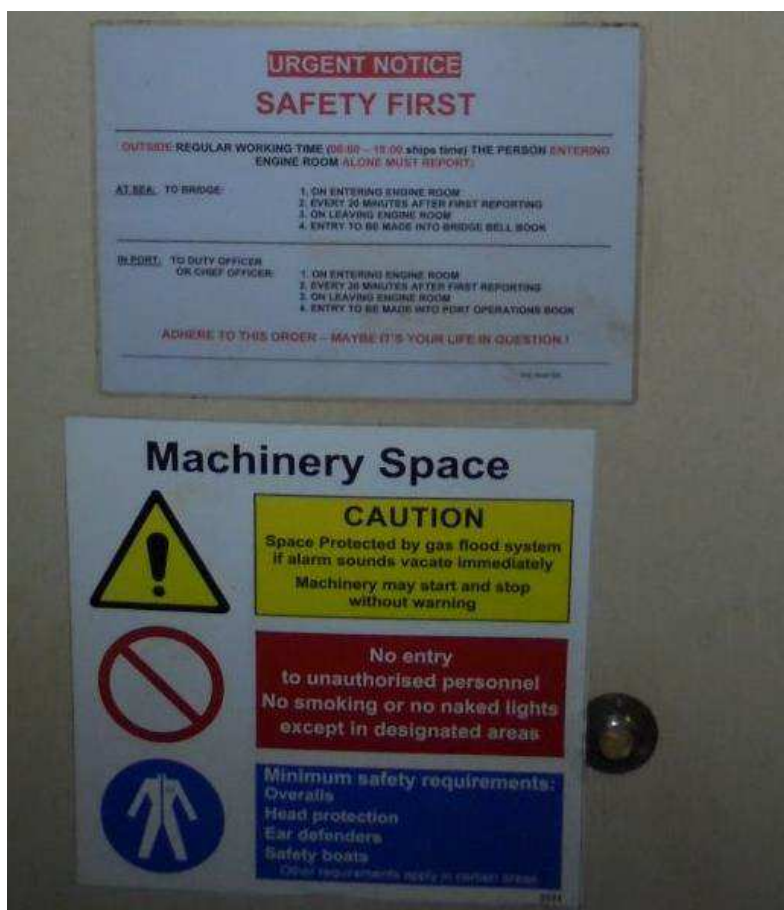
Figure 1 - Entrance door to engine room with instructions

Safety instructions on the door to the engine room, as indicated in Figure 1, were showing these instructions.

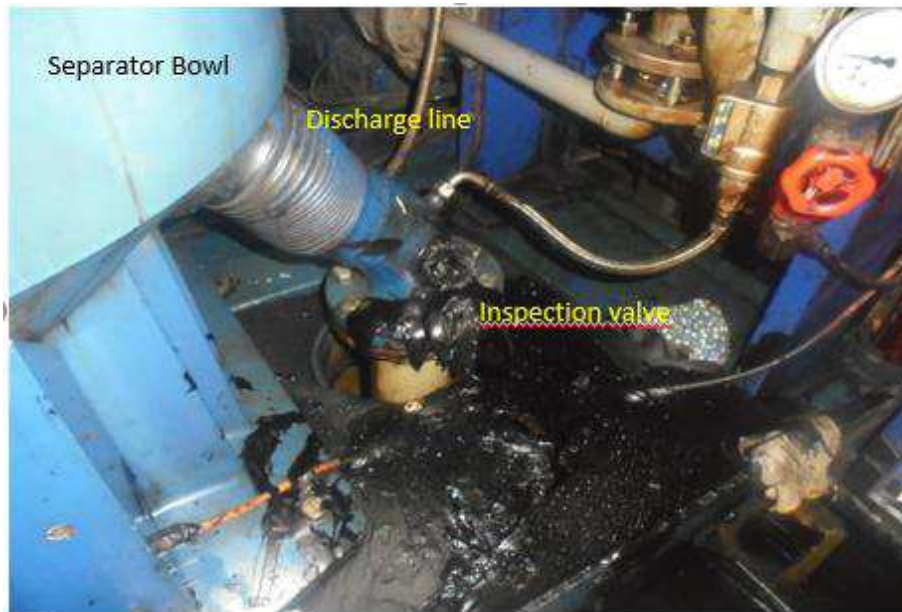
Figure 2 - Fuel oil separator and sludge discharge line after the accident

In Figure 2, the sludge discharge line is represented after the accident had taken place.

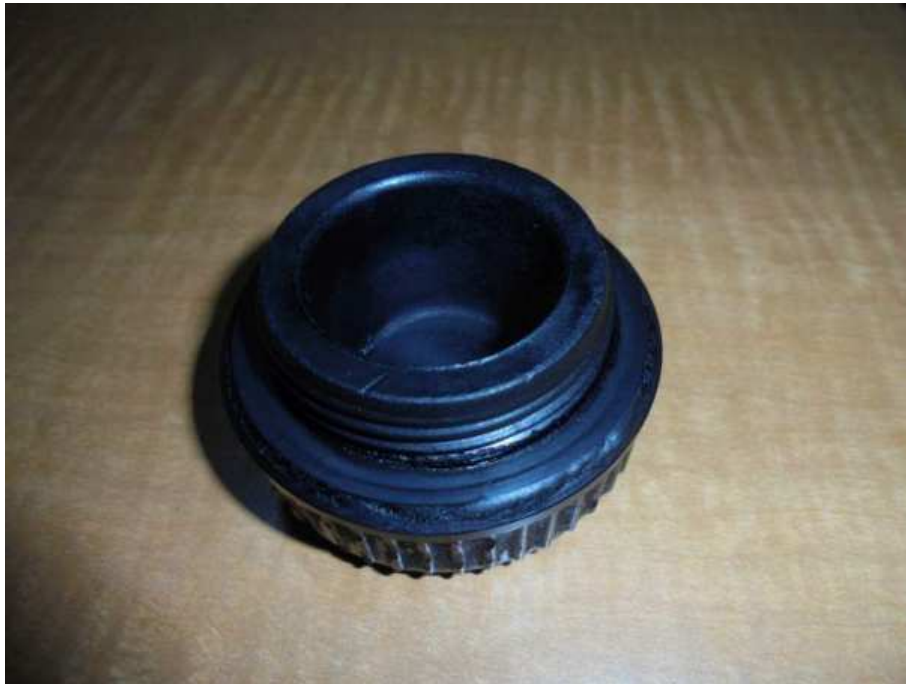
Figure 3 - Plastic plug covering the inspection hole of the sludge discharge line

An inspection opening covered by a plastic cap, as shown in Figure 3, made it possible to verify the condition of the discharge line.

Thereafter, he opened the plug of the inspection hole of the sludge discharge line in order to verify the condition.

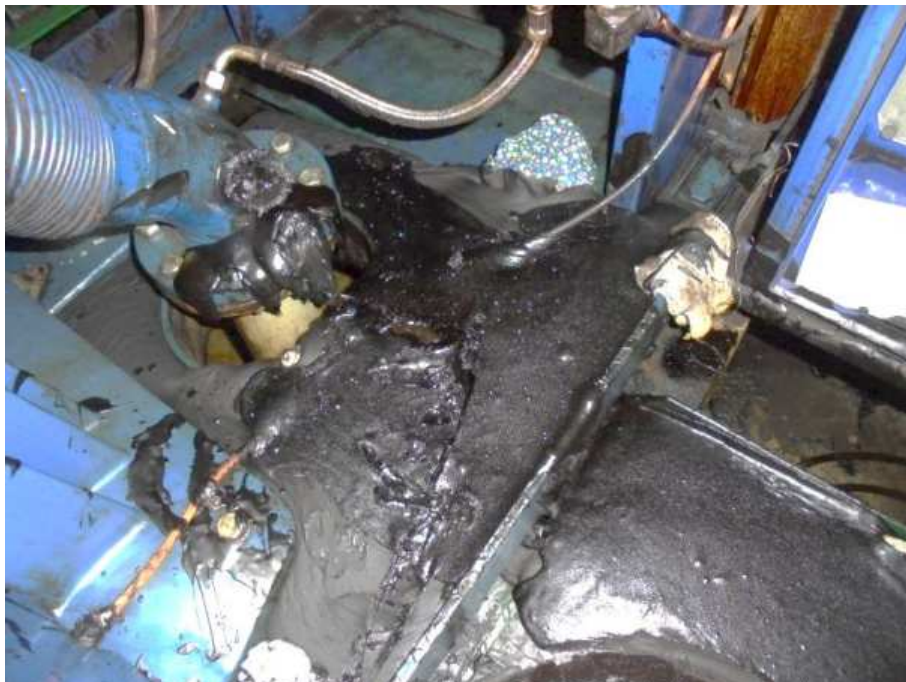
Figure 4 - Sludge gushed out of the inspection opening

Upon opening the plug, hot sludge oil gushed out of the inspection hole and covered the arms and legs of the engineer.

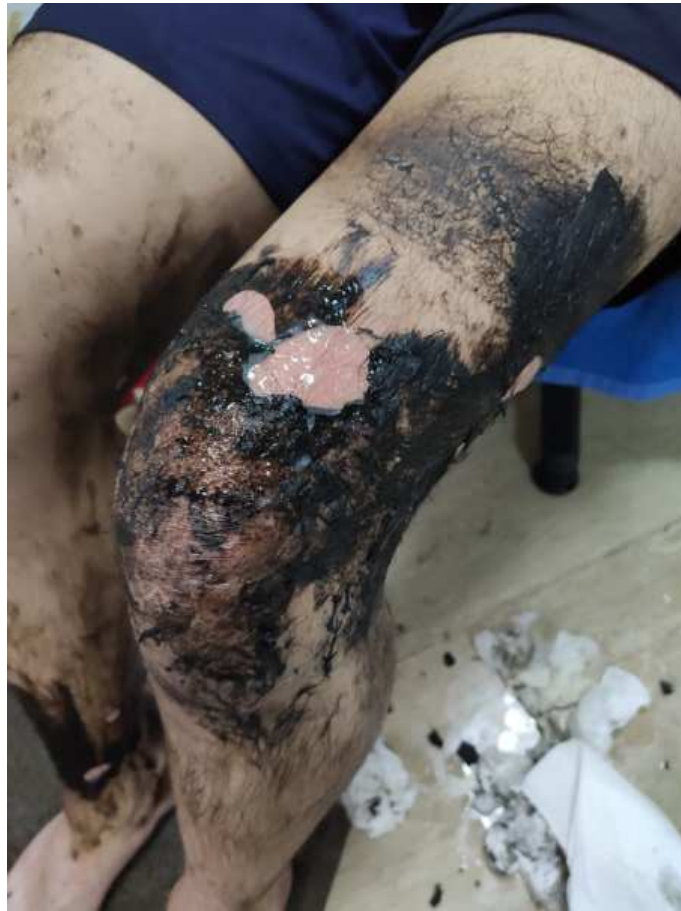
Figure 5 – Legs of the engineer covered with sludge

Large parts of his hands, arms and legs were covered with hot sludge, causing burns on 12% of the engineer's body surface.

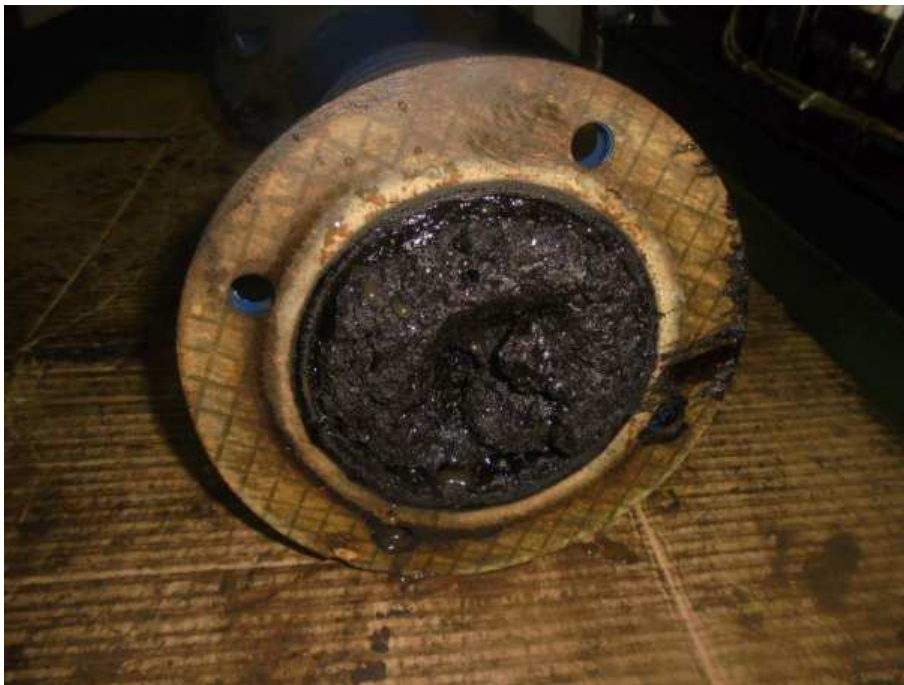
Figure 7 - Completely blocked sludge discharge line of separator N°1

From April 15th 2020 onward, the vessel was consuming this fuel and during the consumption the sludge discharge line of the fuel oil separators was clogged regularly. Figure 7 shows the clogged sludge discharge line.

Due to the cold flow characteristics of a certain blend of RMG 380 VLSFO, the separation of this fuel at $\pm 40^{\circ}\text{C}$ caused a blockade of the sludge discharge line.

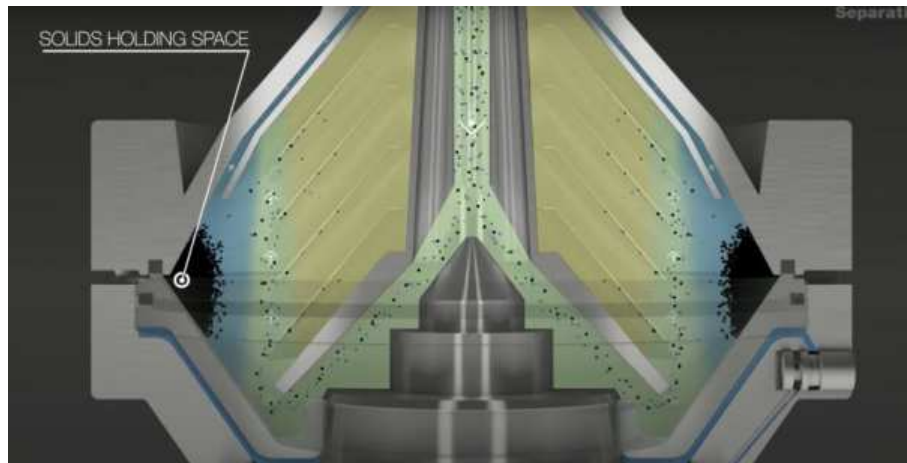
Figure 9 - Sludge accumulated inside the separator

During the cleaning process of the fuel oil in the separator, solids were accumulated on the outer side of the separator bowl due to the centrifugal force. This is represented in Figure 9. The sludge discharge opening is closed.

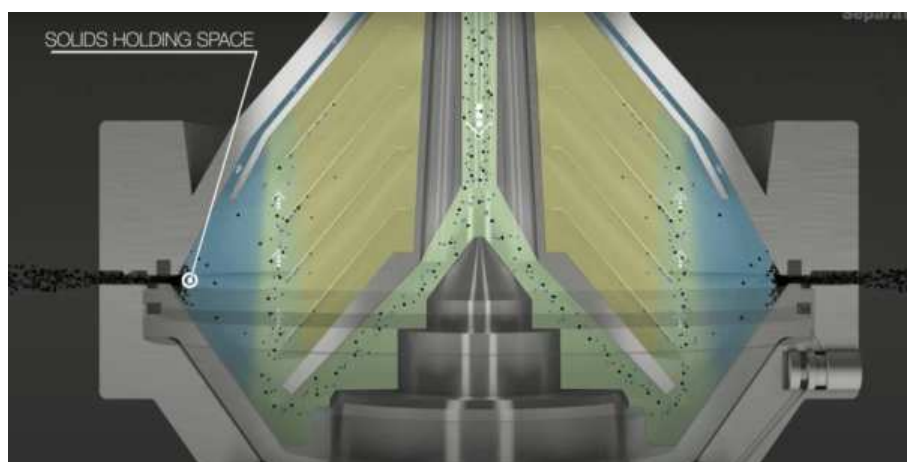
Figure 10 - Sludge discharge phase of a separator

At regular intervals, the sludge is removed from the bowl through the discharge line, as represented in

Figure 10. Solids and water flow into the sludge discharge line.

When the discharge line is blocked, sludge can no longer be removed from the bowl and the bowl becomes contaminated. When that happened, an alarm was triggered. In this case a *Separator Fail* alarm and a *FO Bowl Leakage* alarm were triggered.

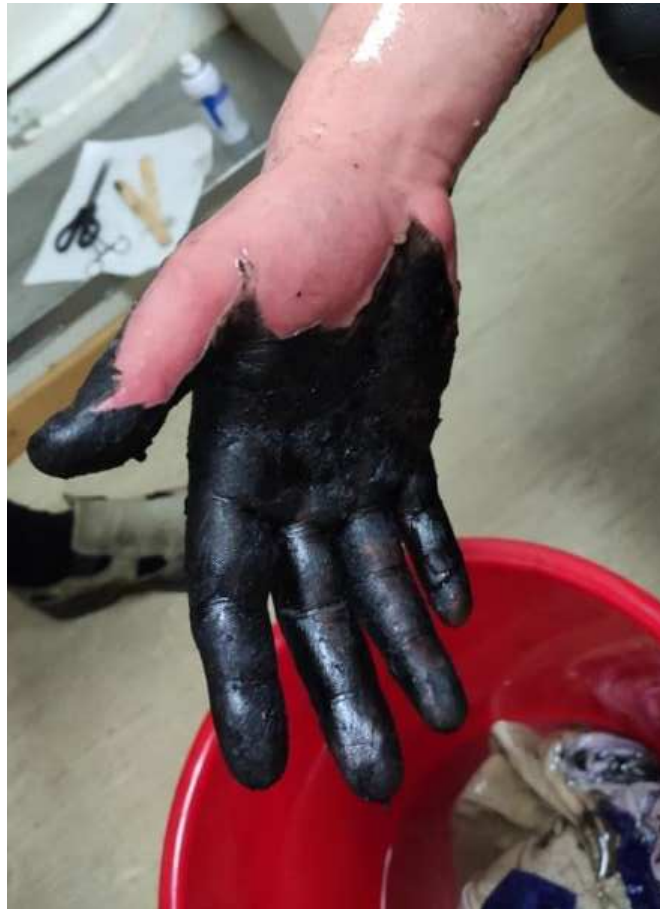
Figure 11 - Hand of victim covered with sludge

According to medical advice, prolonged direct skin contact with sludge derived from this fuel, could cause chemical burns as well, even at temperatures around 40°C.

It can be assumed that the direct skin contact with sludge during several hours, or even days for some parts where it was not possible to remove the sludge from the skin, contributed to the severity of the burns.

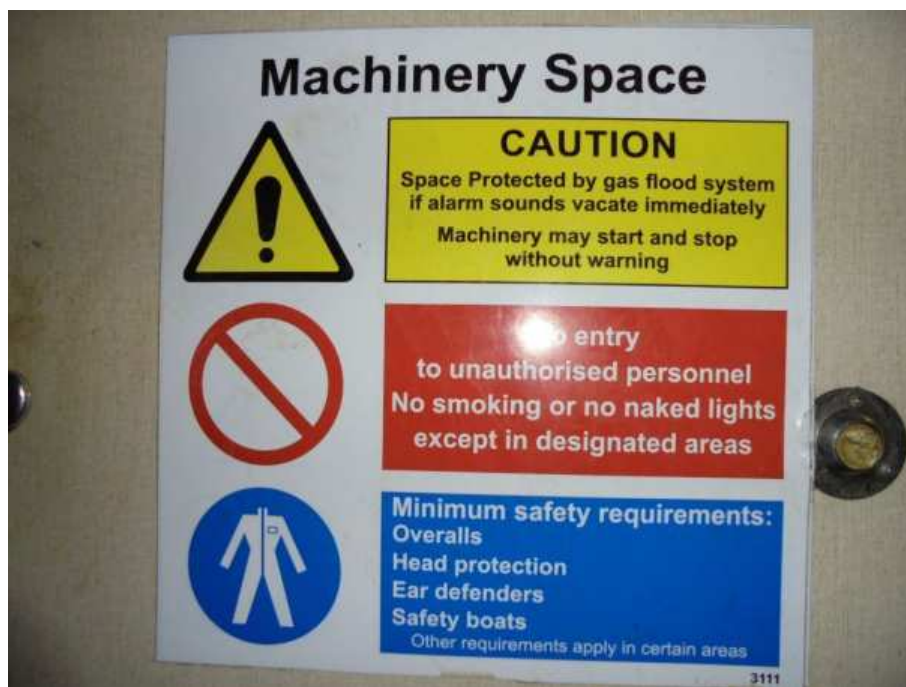
Figure 12 - PPE zone identification

The engine room was identified as a PPE zone. This means a zone where personal protective equipment needed to be worn all the time.

Figure 12 shows the label on the entrance door of the engine room indicating that appropriate PPE has to be worn.

At the time of the accident, the victim was wearing loose short pants and a t-shirt, no gloves, no overall and no helmet.

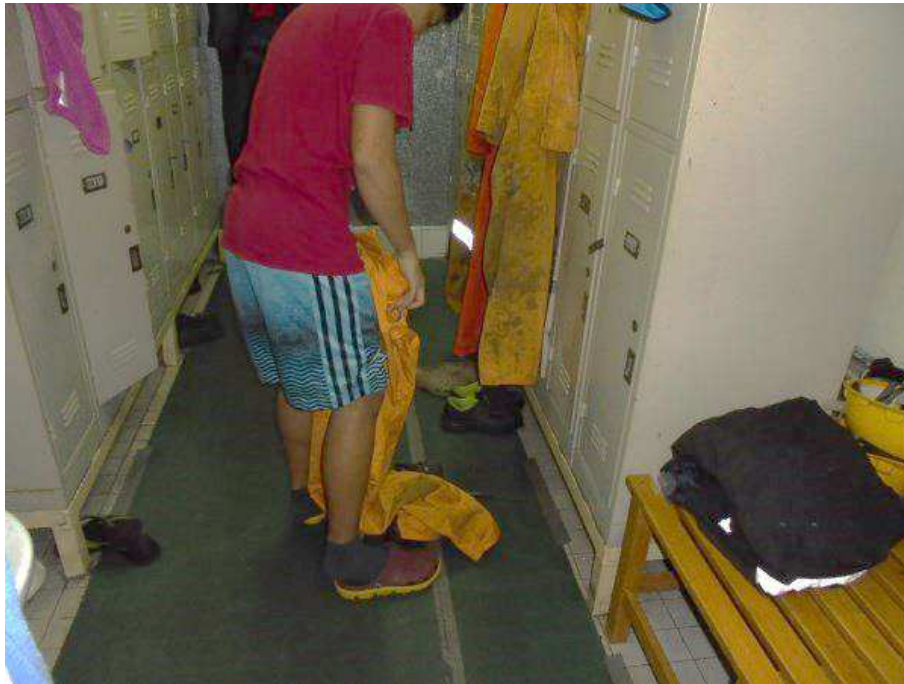
Figure 13 - Engine changing room

The engine changing room is the place where every engineer has a personal locker containing the necessary PPE, as indicated in Figure 13 .

A simulation on board indicated that putting on an overall, gloves and head protection only takes 20 seconds extra time.

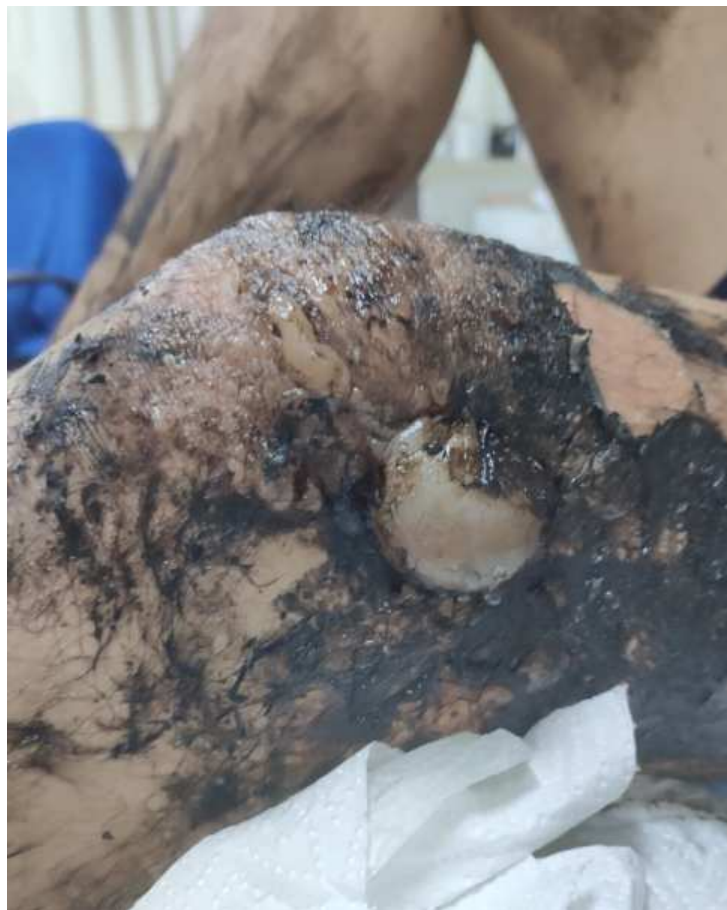
Figure 14 - Burns on left knee

Left knee: 3% TBSA MPT burn. Lateral aspect of knee had a deep partial thickness burn.
