SAFETY INVESTIGATION REPORT

REPORT NO.: 19/2020

MT RUBY-T

**Serious injury to crew member
while alongside at the port of Nikolaev, Ukraine
20 October 2019**

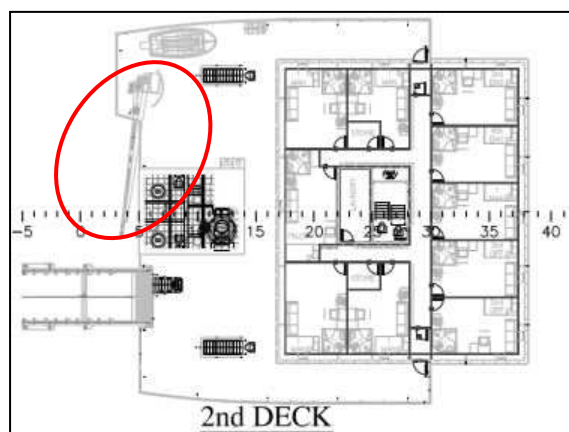
The crane was installed on the second deck, on the vessel's port quarter (Figure 1). It was designed to hoist and lower the rescue boat and liferaft, and also to transfer stores, provisions, etc.

Figure 1: Extract from the General Arrangement Plan, indicating the position of the crane

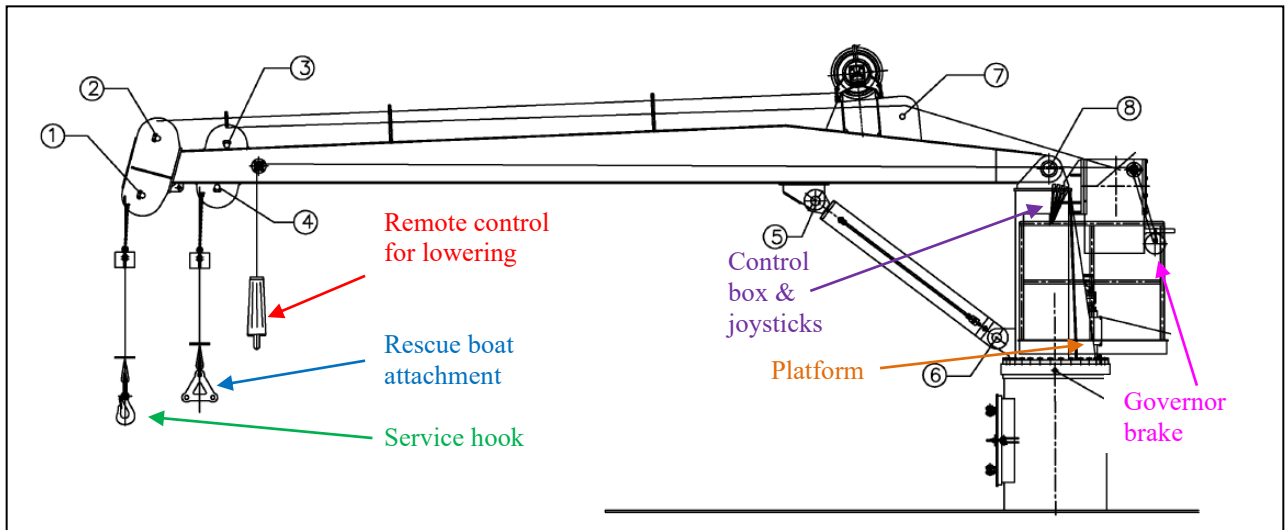
The crane was fitted with two hooks. The foremost hook was used as a service hook for provisions and stores; while the hook behind it (the rescue boat attachment) was used for handling the davit launched liferafts and the rescue boat (Figure 2).

Figure 2: General arrangement of the crane

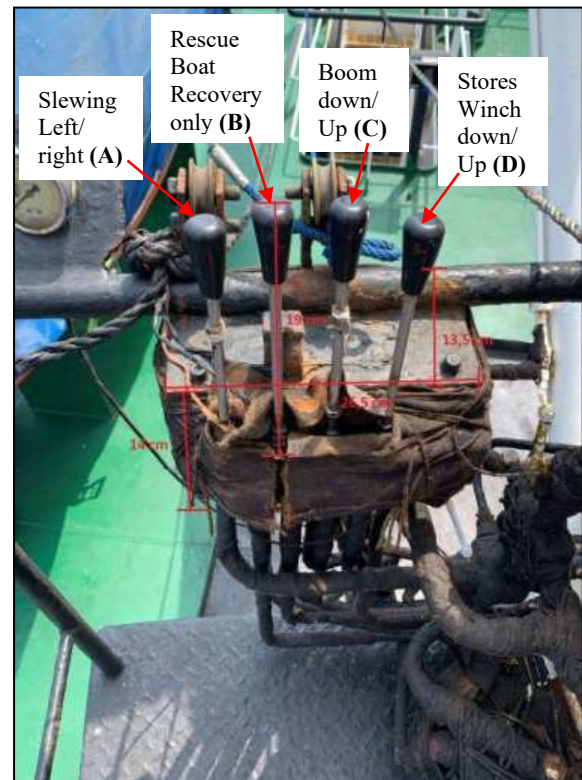
Figure 3: The joysticks on the control box mounted on the platform

The chief officer was initially handling the joysticks from the control box and, while testing the rescue boat limit switch, joystick (B) was damaged to the extent that it was displaced from the crane control box.

The MSIU could not establish the extent of damage caused to the crane control box's joystick (B). It was understood that joystick (B) was displaced from the control box, possibly during a jerking movement. Following the accident, the crew had fixed the joystick back onto the control box.

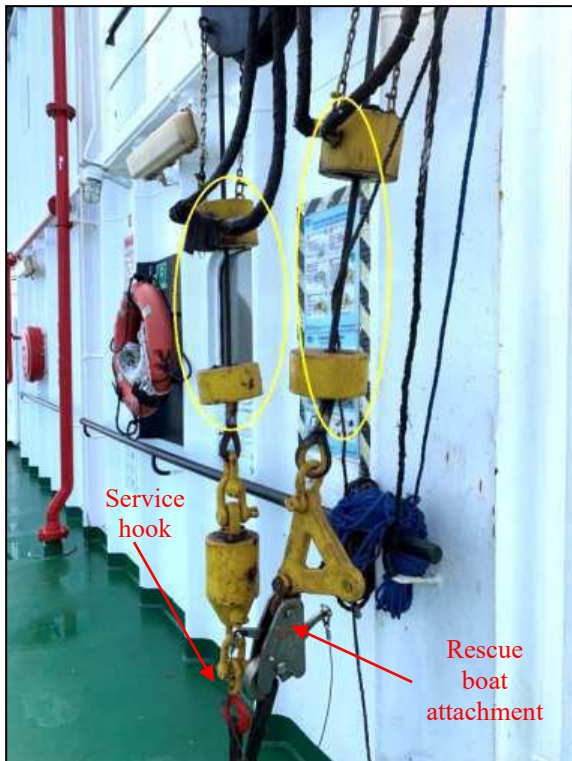
The hydraulic circuit of the crane incorporated two separate limit switches (Figure 4), which limited the travel-up movement of the service hook and rescue boat attachment. Once these limit switches

were activated², the hydraulic circuit becomes isolated, thus stopping all movement before the extreme point of travel could be reached.

Figure 4: Limit switches for hook travel circled in yellow

19/2020_R1 Develop detailed written procedures for the testing of the crane's limit switches.

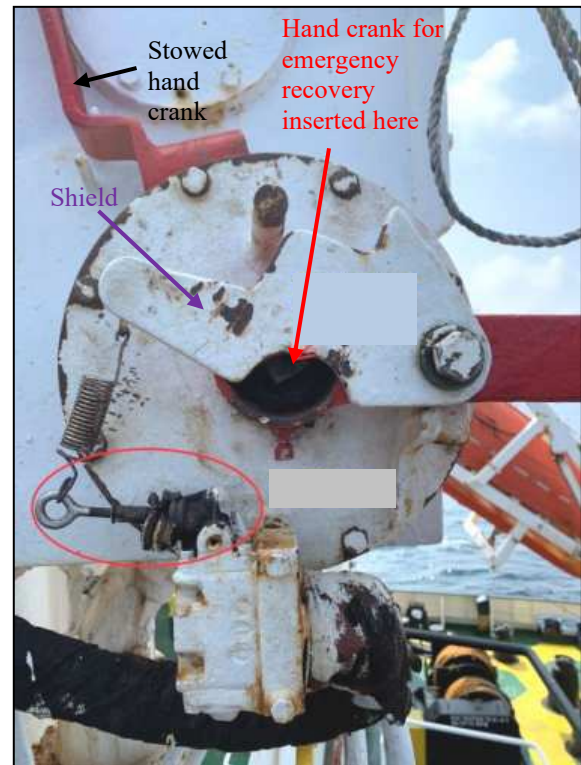
A mechanical safety device, in the form of a shield, protected the access to the squared spindle where the hand crank for rescue boat manual recovery could be inserted and engaged (Figure 5). If this shield had to be lifted, the (electrical) safety device actuator would turn, resulting in the disconnection of the motor control and power circuits, preventing any movements induced by the R/B winch. In the manufacturer's manual this was also referred to as the limit switch for the R/B winch.

Figure 5: Mechanical safety device – shield for the squared spindle. Once the shield is lifted, the spring deactivates the electrical circuit and the R/B winch is isolated

The limit switch of the R/B winch was disengaged, allowing the winch to rotate even though the shield was lifted, due to the hand crank being inserted in the squared spindle.

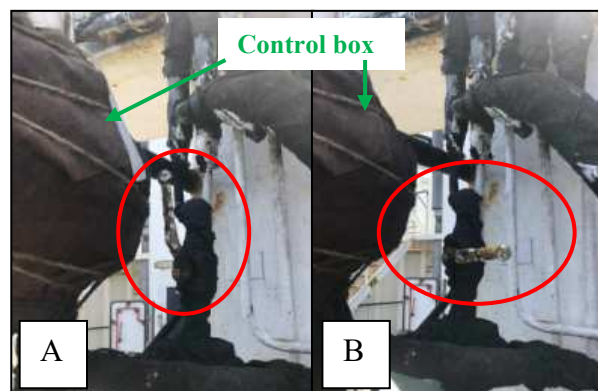
Thereafter, the chief engineer closed the switch disabling valve (Figure 6), to reset the limit switches. The wire of the service hook was successfully lowered and secured using joystick (D).

Figure 6: (A) showing switch disabling valve in the open position and (B) showing switch disabling valve in the closed position

Rightly so, the switch disabling valve had to be closed to allow resetting of the limit switches which were tested; therefore, in that moment, all limit switches ceased to function, hence eliminating the protection which they offered. Joystick (B) was damaged and dislodged. By improvising with the use of an adjustable wrench, the obstruction barrier was by-passed, as the wrench was not affected by it. In the opinion of the safety investigation, the use of the wrench was deemed necessary by the crew at that time, as this was the only means of operating the R/B winch until joystick (B) was repaired.

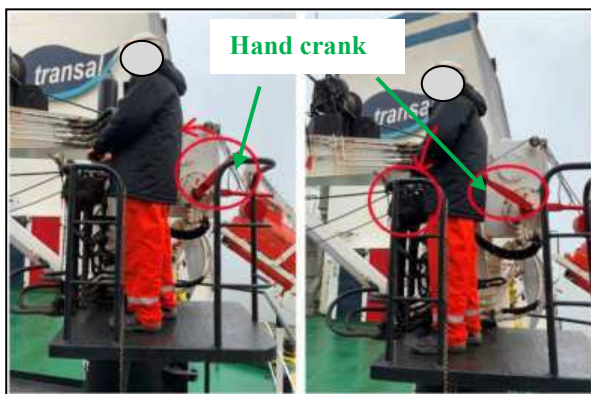
Several minutes later, he turned towards the control box and as soon as he used the adjustable wrench to engage the R/B winch, the hand crank struck him on his back (Figure 7). This action threw the bosun forward onto the control box from where he fell down. The crew members, who were close by, helped him onto the deck and provided assistance, as he seemed to have been in significant pain.

Figure 7: A simulation of the bosun's position while handling the control box, with his back to the hand crank

At the time of the accident, the bosun was standing in a relatively restricted space of the crane's platform, facing the control box. The switch disabling valve was closed and the hand crank was left mounted in the squared spindle. As soon as the bosun induced the R/B winch, the hand crank rotated and hit the bosun on his back.

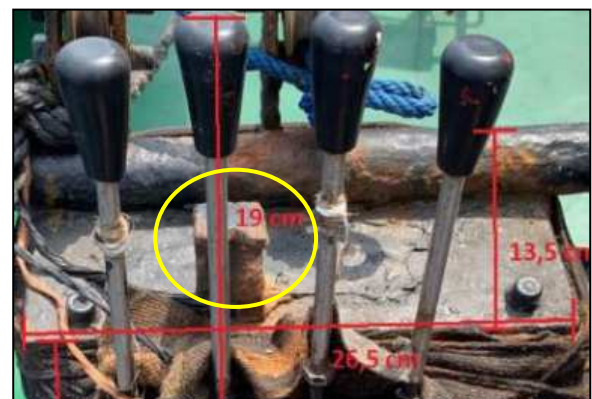
Joystick (B) was damaged and out of position, and in lieu, a wrench was used. As joystick (B) was barred from moving in the 'lowering' direction on the control box, due to a built-in physical barrier (Figure 8) and thus prevented lowering of the wire under power, the option to lower this wire by using the winch was not available before. However, with the use of an adjustable wrench, this physical barrier could be bypassed.

Figure 8: Built-in physical barrier circled in yellow

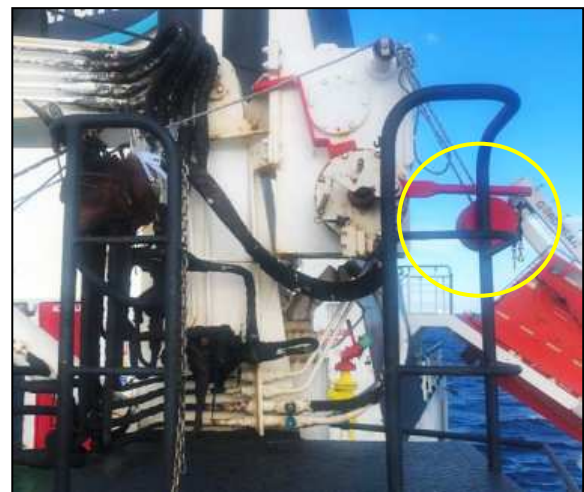
Figure 9: Governor brake circled in yellow

The manufacturer's manual indicated that in order to check the reliability of the governor brake functions, the hand crank should be engaged onto the squared spindle and turned in the opposite direction, as if to lower the rescue boat attachment. The manual specified that the hand crank should not turn in this direction, even under heavy effort. However, in the case of *Ruby-T*, the bosun was able to turn the hand crank in the opposite direction, and successfully lower the rescue boat attachment wire.

This would normally be an indication that the brake system's inner or outer race was badly indented and that the clutch required immediate replacement. However, after this accident, the Company had carried out an investigation on the brake system and found no wear-down. The Company, therefore, concluded that operation of the hand crank in opposite rotation could only have been possible if the brake was loosened.

19/2020_R2 Put in place a distinctive arrow marking to indicate the correct direction of rotation of the crank handle.
