Bundesstelle für Seeunfalluntersuchung
Federal Bureau of Maritime Casualty Investigation
Federal Higher Authority subordinated to the Ministry
of Transport and Digital Infrastructure

Investigation Report 241/18

Serious Marine Casualty

Grounding of the motor tanker PAZIFIK off Indonesia on 9 July 2018

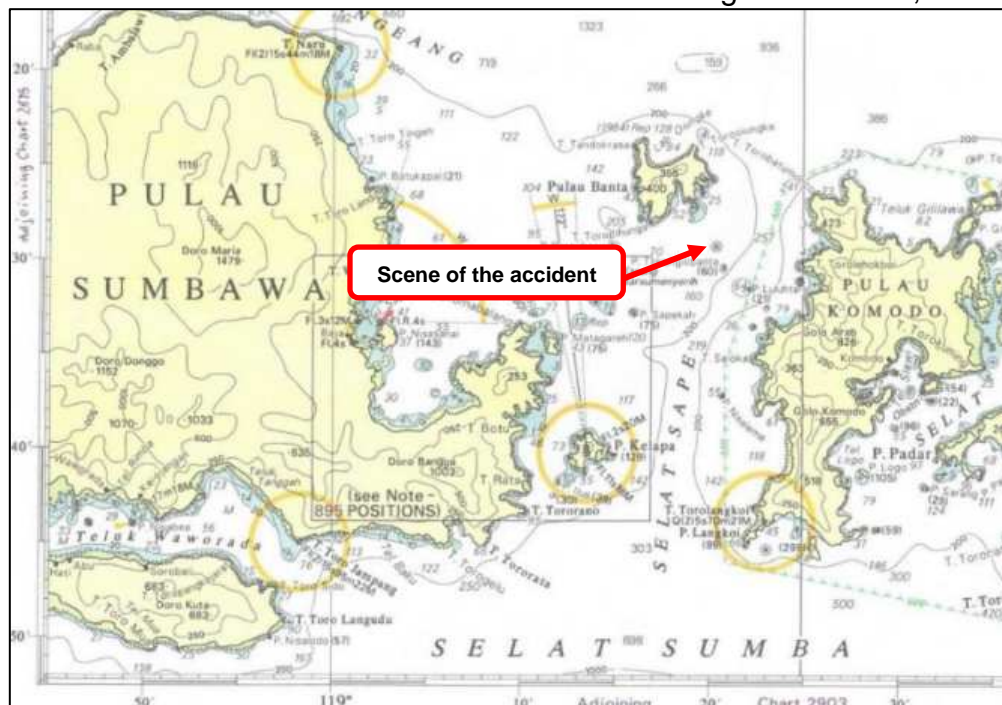
Figure 2: Navigational chart

Extract from the Pulau Jailamu to Pulau Serbete navigational chart, BA 2910

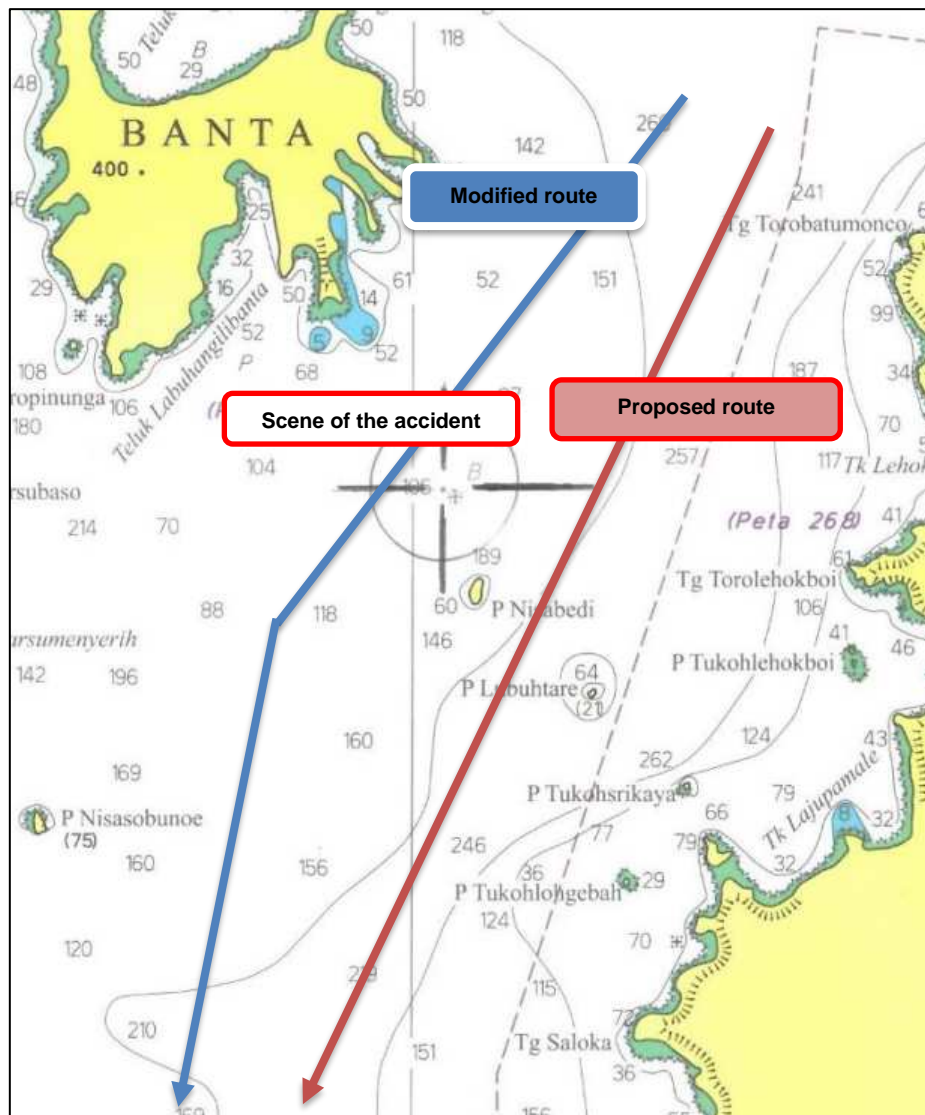
Figure 7: Navigational Chart ID 295

The master and the second officer agreed to follow the Selat Sape route proposed by the system with one modification. The route proposed by the PassageManager passed between the islands of Nisabedi and Lubuhtare. The distance between the two islands is only about 1.5 nm. The passage between the islands of Nisabedi and Banta, which was then used, is about 2.5 nm.

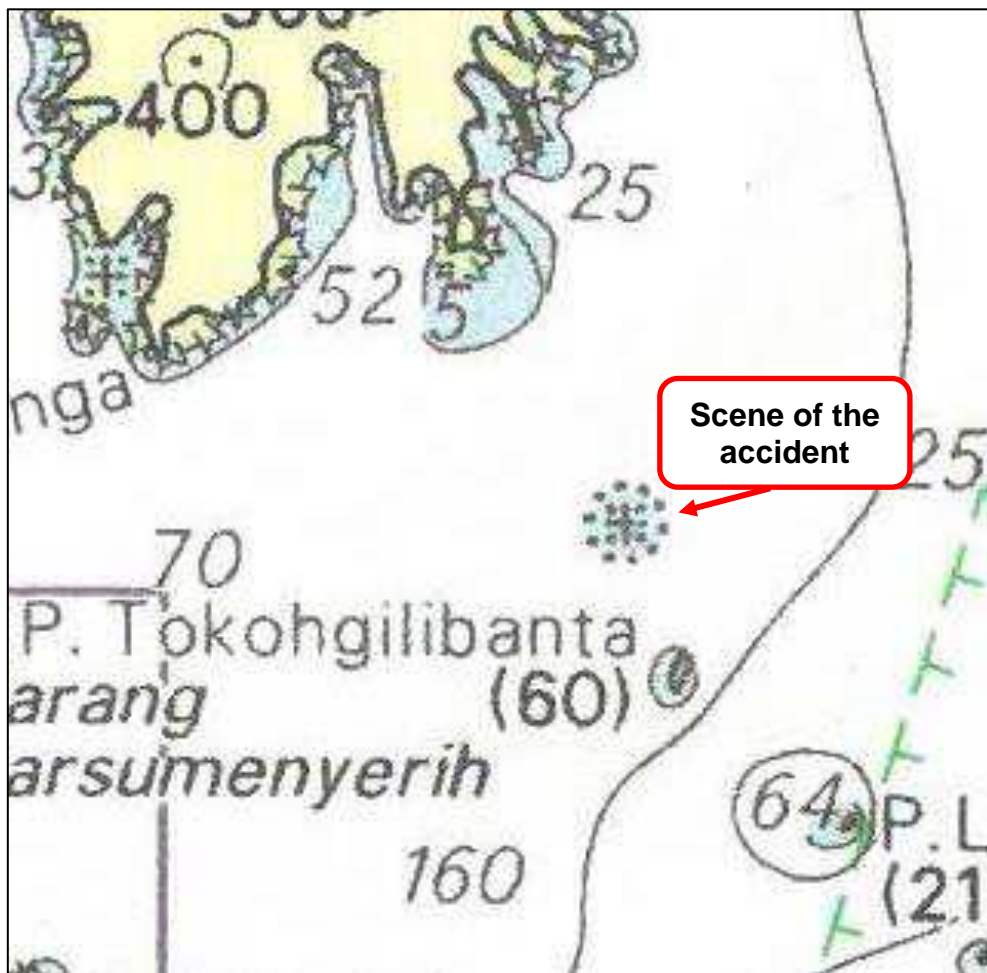
Figure 8: Navigational Chart BA 2910; scale: 1:500,000

Charts BA 2903 and BA 2910 (scale: 1:500,000) show the 'rock awash' symbol, i.e. a rock submerged temporarily or during high tide, at the scene of the accident.

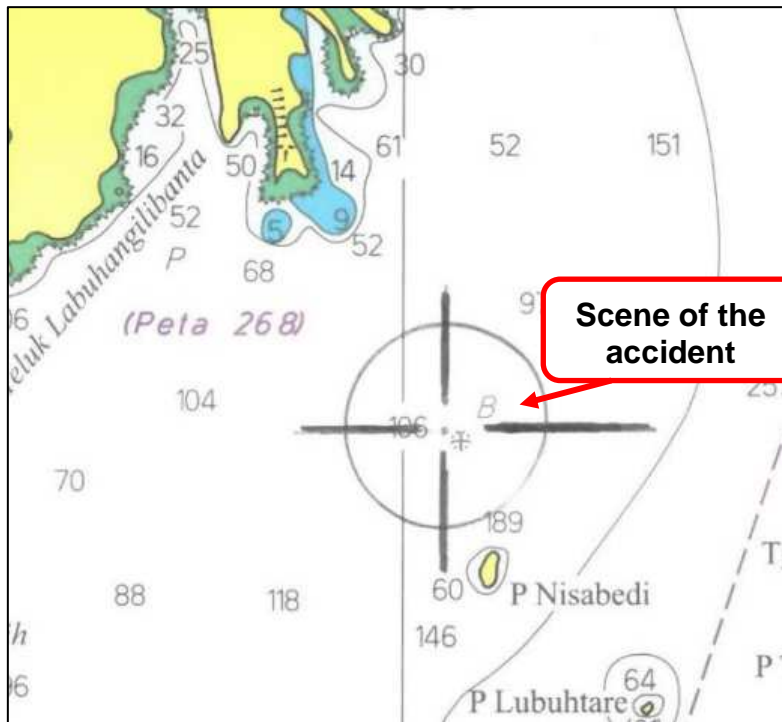
Figure 9: Indonesian Navigational Chart ID 295; scale: 1:200,000

The Indonesian Navigational Chart ID 295 (scale: 1:200,000) shows a rock symbol but it is not clear whether the rock is submerged from time to time. The Indonesian Navigational Chart ID 268-2 (scale: 1:50,000) does not show the 'rock awash' symbol but merely a shallow area with a water depth of 9 m.

According to the UKHO, the position of the rock shown on ENC-ID300295 is taken directly from the Indonesian Navigational Chart ID 295 at a scale of 1:200,000. This position differs with a 9 m shoal, which is plotted on the paper-based Navigational Chart ID 268-2 with a larger scale of 1:50,000. Although both Indonesian charts are compiled using the WGS 84 datum, there is a discrepancy between them in respect of position.

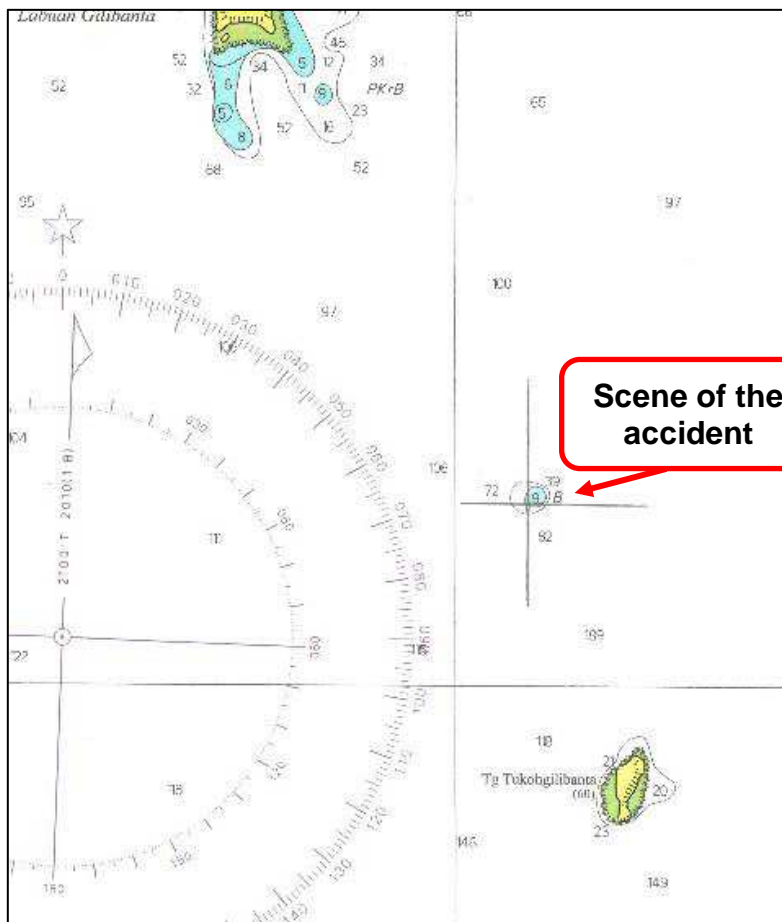
Figure 10: Navigational Chart ID 268-2; scale: 1:50,000

Chart ID 268-2 shows a depth of 9 m at this position. The chart indicates that this depth measurement dates back to 1904. Chart ID 295 – with a smaller scale – shows a rock in unknown depth in the form of a 'rock awash' symbol permanently submerged (depth: 0). It is likely that the rock symbol was consciously used in the small-scale charts for reasons of generalisation. The reason why one chart shows 'rock awash' and the other a permanently submerged rock ('underwater rock') is unclear. The UK charts use Indonesian charts as a basis but show the more dangerous scenario, 'rock awash'. The UKHO is not responsible for updating the ENCs of other nations but has forwarded the information to the Indonesian Hydrographic Office for review. Surveying of the area around the island of Komodo is planned for the near future and this will be used as an opportunity to map the position and minimum depth of these rocks precisely.

In contrast, the best scale (1:50,000) of the Indonesian paper-based Navigational Chart 268 (WGS 84, 2012) even shows the shoal at a specific depth of 9 m. The chart stems from Dutch surveys carried out in 1904. In the Indonesian paper-based Navigational Chart 295 (WGS 84, 2016) at a scale of 1:200,000, the shoal is plotted without a specific depth and about 2 cbl further southeast as compared to the larger scale 268, i.e. as in the ENC, obviously incorrectly, otherwise the PAZIFIK would not have run aground. This chart is also based on Dutch surveys carried out in 1904-1908. In the British paper-based Navigational Chart 2910 (WGS 84, 2012) at a scale of 1:500,000, the shoal is correctly plotted without a specific depth. This chart refers to Indonesian charts from 1981 to 2011 and is based on surveys carried out between 1901 and 2011.

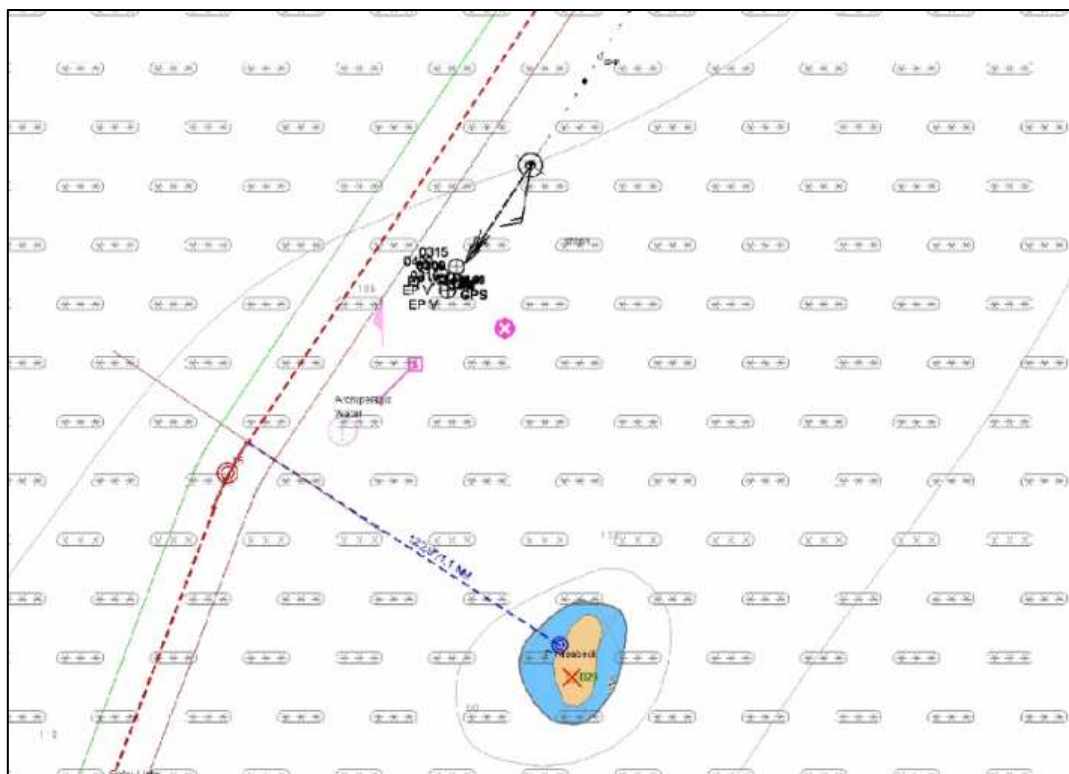
Figure 12: Deviation from route planning up until grounding

Using the information available on board, it was impossible for the crew to obtain accurate information about the actual navigational danger. When the passage was planned and executed, it was assumed that sailing through the plotted isolated danger did not entail any risk, especially since this isolated danger was shown to be permanently submerged. In view of the information from other sources, which did not have to be available on board, the information is insufficiently described in the latest ENC, i.e. the one used. The crew did not believe the plotted isolated danger posed a risk during the passage. On the planned route the isolated danger was passed at a distance of about 0.7 nm. The distance to the nearest shallow waters of the island of Banta was about 0.8 nm. The CATZOC (category zone of confidence) for this area is assigned a 'C', indicating a positional inaccuracy of +/- 500 m or 0.27 nm. This means that a safe CPA (closest point of approach) to the island of Banta and to the plotted isolated danger is reduced to 0.53 nm and to 0.43 nm, respectively, in the worst case.

When the passage route was entered into the ECDIS, the cross track distance was set at 0.1 nm from Waypoint 14 (Banta Island) to Waypoint 18 (Sumba Strait), which corresponded with the owner's procedural specifications for this part of the voyage. Although not as defined in the manual on board, the cross track distance setting in the ECDIS of 185.2 m is explicitly appropriate for the relevant part of the passage because it exceeds the cross track distance required.

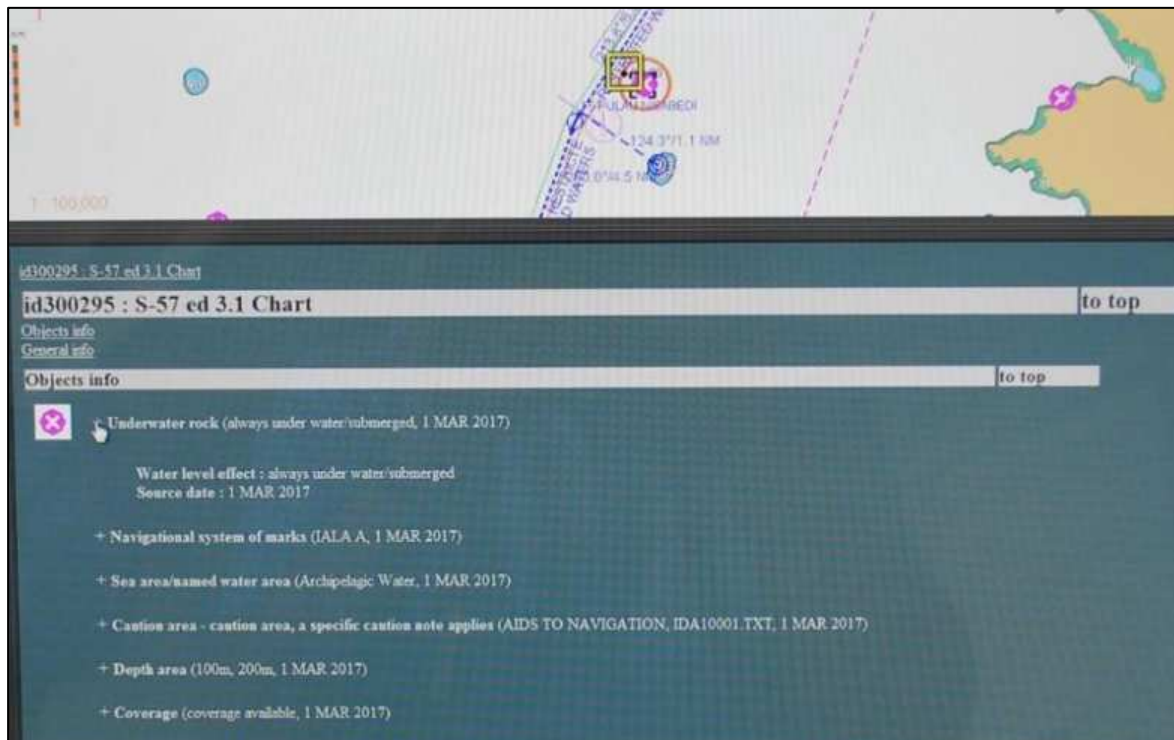
Figure 13: Information stored in the ENC

"Underwater rock (always under water/submerged 1 MAR 2017)"

There is no additional depth information or depth contours for or near the isolated danger area. The general water depth in the Selat Sape passage around the isolated danger is specified at about 100 m.

The master and the second officer did not consider the plotted isolated danger, which is near the place of grounding, a threat to safe passage when they planned the passage. The information in the explanatory note about this isolated danger in the ECDIS/ENC did not cause the crew to conclude that it would pose a hazard to them or their ship. The master and the second officer stated that the lack of depth information for the isolated danger or area surrounding it prompted the assumption that the water depth corresponded to the surrounding area. There was no appropriate designation around the isolated danger, nor was there any highlighting by a safety contour or the like for lack of depth contours.

Masters were reminded to look upon any isolated danger as being an actual hazard to the ship. The CATZOC usage instructions were reviewed.

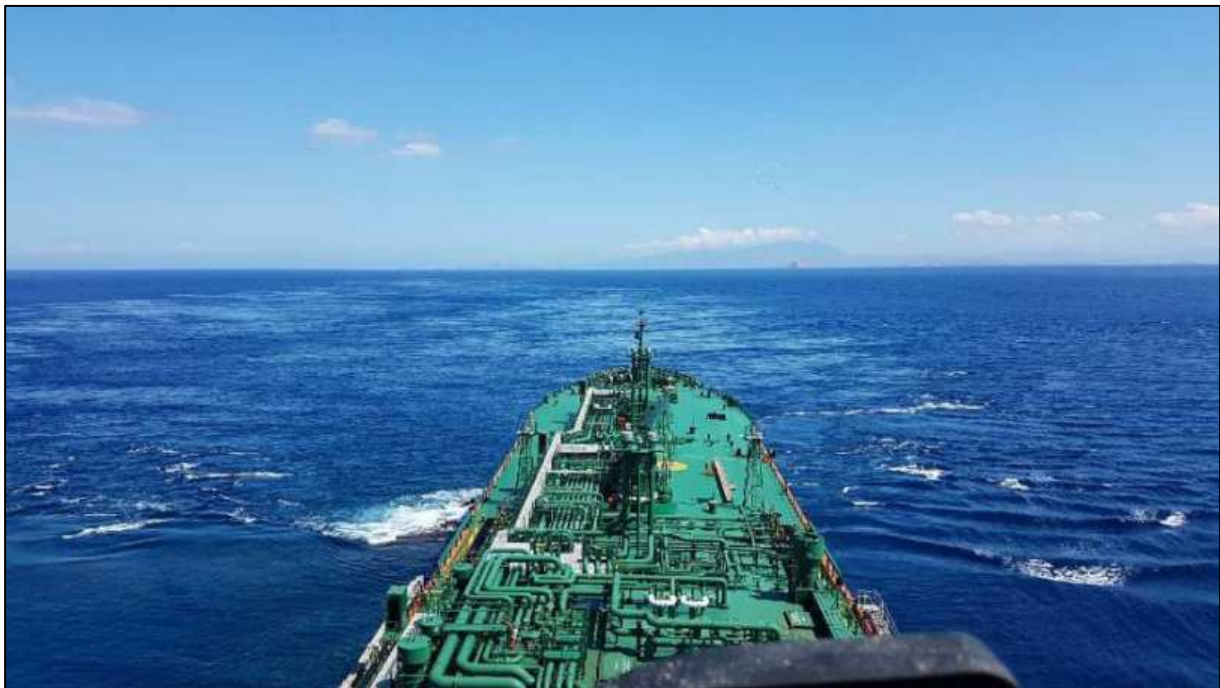
Figure 15: Waves breaking on rocks

"A drying rock, 1 mile farther NNW, is small and dangerous; the breakers on it being indistinguishable from the normal overfalls and sea conditions in the area."

This account corresponds entirely with the situation found at the place of grounding.
