SAFETY INVESTIGATION REPORT

REPORT NO.: 06/2020

MV VERMONT TRADER Serious injury to crew member in position 22° 09.63' N 114° 09.44' E 21 March 2019

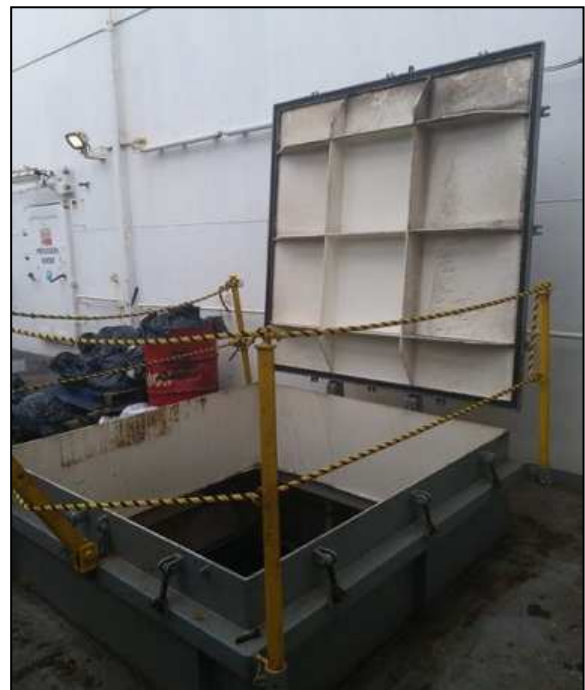
Figure 1: The engine-room hatchway in the open position

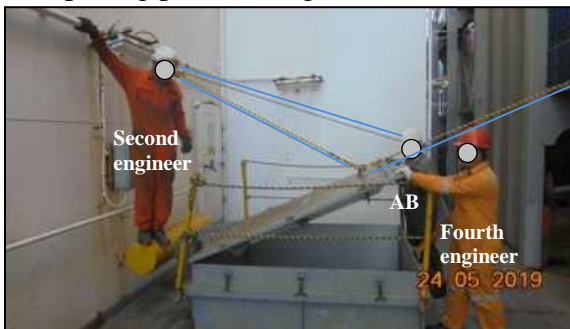
The fourth engineer and the AB lifted the hatchway cover from the front access of the opening, while the second engineer put his weight on the counterweight to assist with the opening process (Figure 2).

Figure 2: Simulation of the accident (the line traced in blue was used as a safety measure during the crew's simulation of the accident)

When the hatchway cover reached in level with the height of the stanchions (Figure 2), the downward force of the counterweight still

did not start acting. The second engineer opted to stand up on the counterweight to continue assisting during the opening. As the counterweight began to act, it caused the cover to swing open, probably during which time, the second engineer fell.

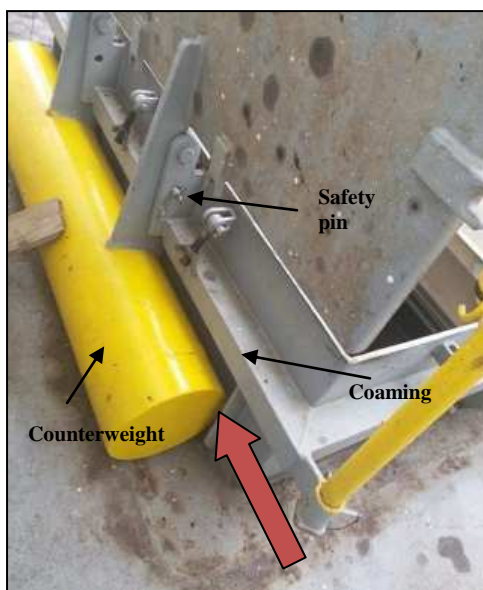
The second engineer intended to secure the hatchway cover in the open position by inserting a safety pin, at the hinge of the hatchway. However, the second engineer fell during the opening and his left leg was caught in between the counterweight and the hatchway coaming (Figure 3).

Figure 3: Red arrow showing the location where the lower leg of the second engineer was stuck

The counterweight created a downward turning lever, which eventually takes over the need to lift the hatchway cover from the front access. The movement may become uncontrollable if remained unchecked and the counterweight would eventually slam with the hatchway coaming. It is highly likely that the second engineer was thrown off balance once the rotational movement of the counterweight took effect.

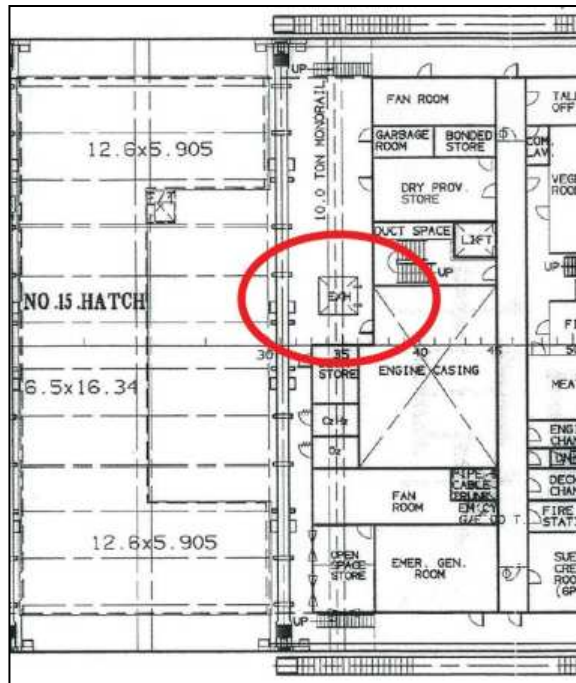
Figure 4: Extract from the GA plan showing the location of the engine-room hatchway

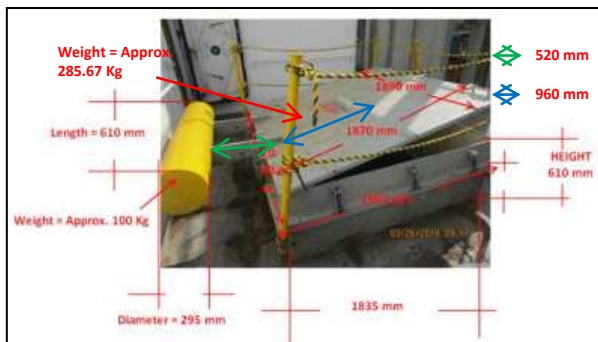
Figure 5: Dimensions of the engine-room hatchway

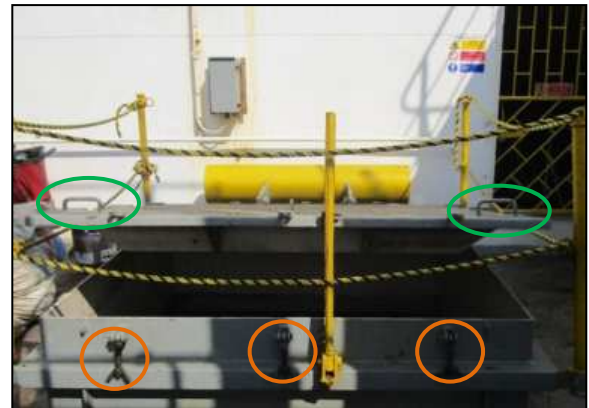
c) Lift the hatch manually by pulling it upwards from the handgrips (Figure 6) (can be done by a single person as the weight of the hatch is countered by the counterweight);

Figure 6: Handgrips on either side of the opening, circled in green, butterfly nuts circled in orange

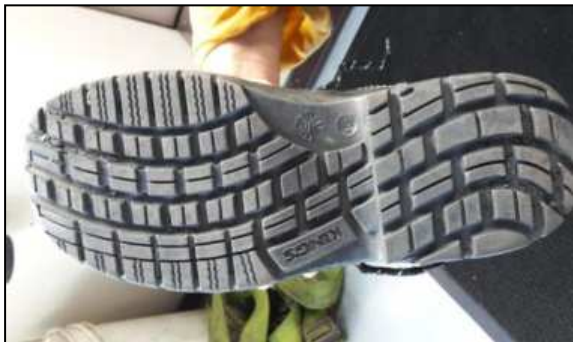
Photographic evidence of the second engineer's safety shoes indicated that there was adequate depth to the shoe's sole (Figure 6).

Figure 6: Shoe's sole in good condition

The second engineer was standing on a cylindrically shaped counterweight. It cannot be excluded that the safety shoes could not be placed flat on the counterweight, thus reducing the surface area whereby friction could have been provided.

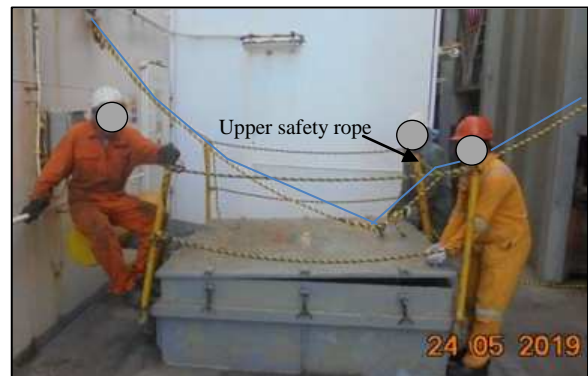
The AB and the fourth engineer were positioned directly in front of its opening. While passing their hands in between the stanchions and safety ropes, they cracked open the hatchway cover by the use of the handgrips, (Figure 7).

Figure 7: Simulated opening – crew lifting the hatchway cover; with their hands passing in between the stanchions and rope (the line traced in blue was used as a safety measure during the crew's simulation of the accident)

To be able to lift the hatchway cover to a higher level, the AB and the fourth engineer had to place their hands over and above the upper safety rope (Figure 7) to access beyond the physical safety barrier and resume lifting unhindered. This operation in itself would have been strenuous to the crew, as the weight of the hatchway cover was not yet taken by the counterweight at that level. The second engineer, at this point, was in a sitting position on the counterweight, with the intention to ease off the weight of the hatchway cover while the crew handle an awkward part of the opening.

In addition, as much as they served as a passive physical safety barrier, the presence of the stanchions and safety lines, and the absence of additional systems to facilitate opening of the cover, could have made it more strenuous for the crew to open the cover through the initial stage.

06/2020_R2 Reassess the opening procedure of the engine-room hatchway and consider other means to facilitate its opening;

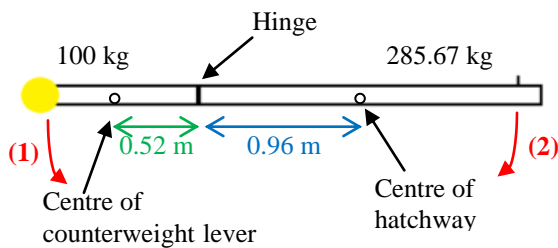
Figure 8: Anti-clockwise and clockwise moments experienced by engine-room hatchway cover

Moment (1) refers to the anti-clockwise rotational force in play by the counterweight, while, moment (2) refers to the clockwise rotational force present by the engine-room hatchway cover.

The calculations revealed that an additional anti-clockwise moment of 2178 Nm would have been required at the engine-room hatchway cover, to open it. This meant that a mass of 231.5 kg would still be required to lift the cover from its front access, despite the counterweight being installed.

While the Company's safest manner to open the engine-room hatchway seems to indicate that this may be lifted by one person alone, to the safety investigation this seemed impracticable.

Furthermore, whilst noting that this engine-room hatchway cover was fitted with a counterweight, in the opinion of this safety investigation, the counterweight did not prevent straining or endangering personnel while opening it.
