MARINE TRANSPORTATION SAFETY INVESTIGATION REPORT M19P0020

STRIKING OF BERTH AND SHORE GANTRY CRANE

CONTAINER VESSEL *EVER SUMMIT*

Vanterm, Port of Vancouver

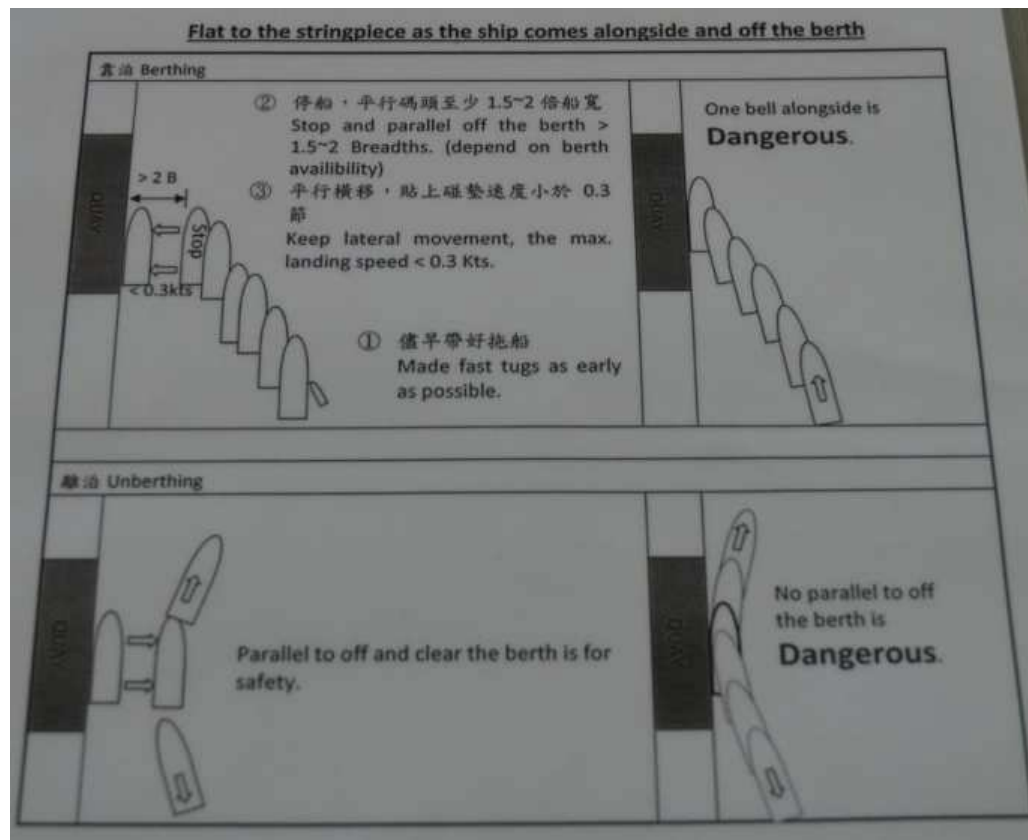
Figure 2. Photograph of berthing guidance on the pilot card (Source: TSB)

The back of the pilot card included brief guidance for approaching and leaving a berth (Figure 2). The guidance indicated that, for berthing, the vessel was to be stopped parallel to the berth at a distance of approximately 1.5 to 2 vessel breadths (64 to 86 m). Tugs were to be made fast as early as possible, and the vessel was to be manoeuvred laterally into the berth at a maximum landing speed of less than 0.3 knots (15.4 cm/s). The guidance also highlighted manoeuvres for berthing and unberthing that were considered dangerous for this particular vessel.

In the case of the *Ever Summit*, the company guidance recommended the vessel be stopped parallel at least 1.5 vessel breadths (64 m) off the berth and then pushed in laterally using tugs. However, the vessel transited the berth approximately 10 m off, an approach which limited the time to respond to any deviations during the berthing manoeuvre. In the master's experience, it was not uncommon for pilots to approach the berth at Vanterm at distances less than described on the vessel's pilot card, and he did not express concern during the berthing of the *Ever Summit*.

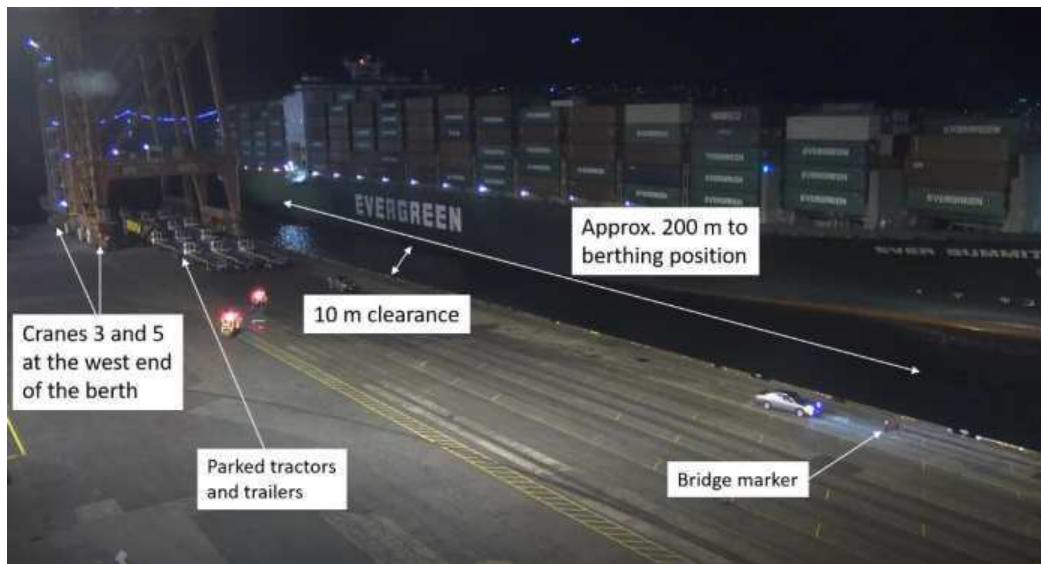
Figure 4. Capture from the closed-circuit television footage of the *Ever Summit* approaching Vanterm (Source: GCT Canada, with TSB annotations)

The pilot and tugs were all using VHF channel 17 for communications. At approximately 0343, after experiencing some disturbance on this channel, they switched over to another working channel. At this time, the *Ever Summit* was approaching the berth on a course that was nearly parallel to it and approximately 10 m off (Figure 4).

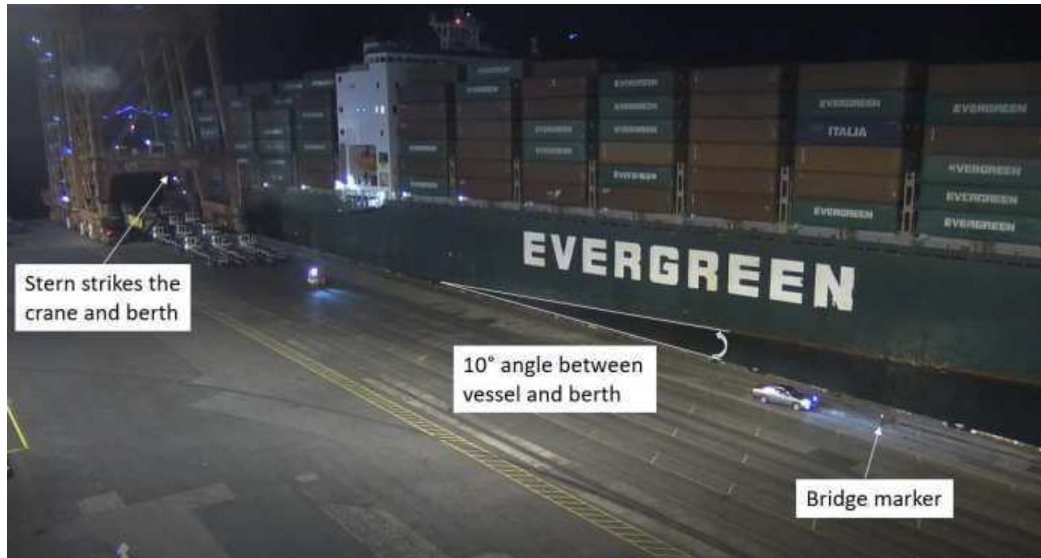
Figure 5. Capture from the closed-circuit television footage of the *Ever Summit* at the time of the striking (Source: GCT Canada, with TSB annotations)

Corrective action using the vessel's engine, rudder, and thruster had insufficient effect, and the vessel's stern struck the dock at an angle of 10° with the berth line and a speed of approximately 0.4 knots. The vessel's large overhang and the proximity of the crane to the berth line resulted in the vessel's hull striking the berth and the crane, which caused the gantry bogies to collapse and the boom to fall onto the vessel.

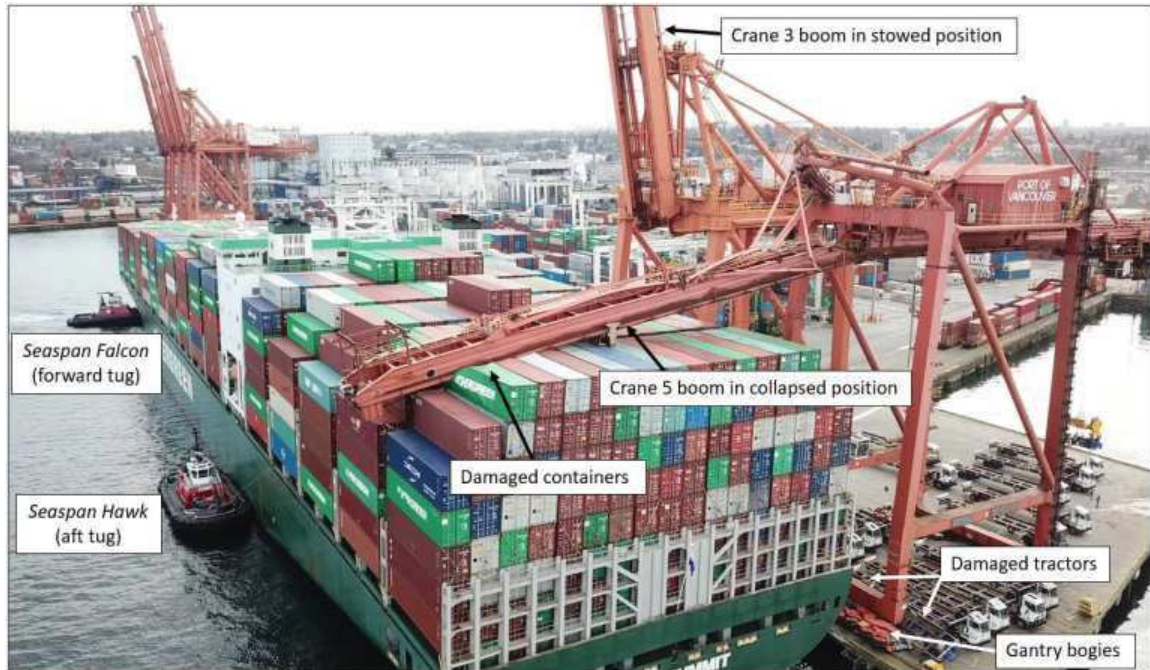
Figure 6. The *Ever Summit* maintaining position after the occurrence (Source: GCT Canada, with TSB annotations)

Approximately 6 containers stowed in the uppermost bays were damaged when the crane boom fell onto the vessel (Figure 6).

Crane 5 was declared a total loss, and Crane 3 sustained minor damage. In addition, numerous tractor-trailers stowed below Crane 5 were damaged (Figure 6).

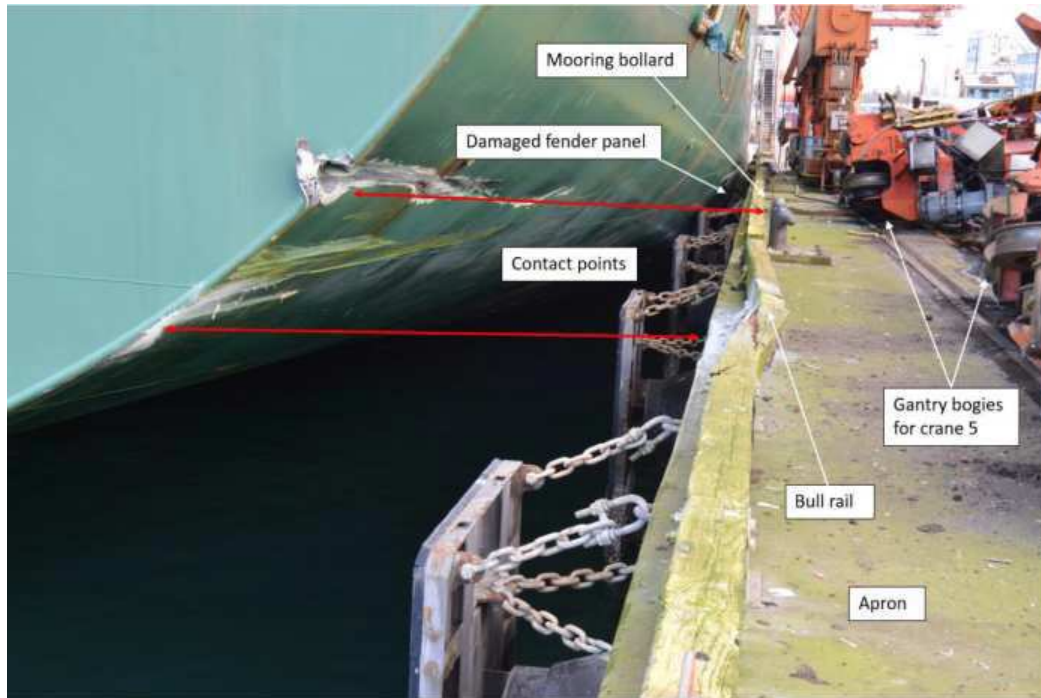
Figure 7. Damage to the vessel's starboard aft shell plating. The red arrows show the points where the vessel came into contact with the berth. (Source: TSB)

In addition, the vessel sustained the following damage (Figure 7):

The concrete edge of the berth sustained impact damage, and the wooden bull rail was cracked and pushed back by approximately 8 cm at the point of contact (Figure 7). The mooring bollard showed signs of abrasion (Figure 7), and 2 of the fender panels were bent and had topside damage.

The apron (the horizontal surface forming the topside of the berth) was punctured and some of the concrete pre-cast panels were damaged.

Before the vessel departed for its next voyage, temporary repairs to the hull were completed on 06 February in Vancouver, BC, to the satisfaction of the attending classification society surveyor.

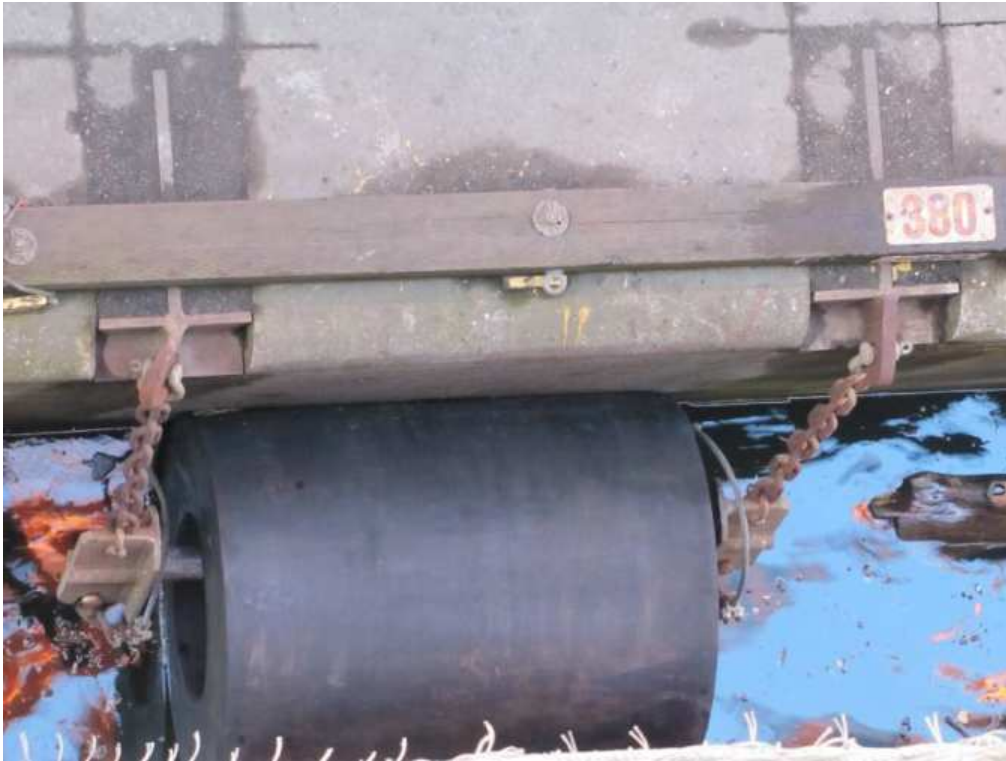
Figure 8. Cylindrical fender on Vanterm berth 5 (Source: TSB)

As part of an upgrade in 1990, berths 5 and 6 were fitted with hollow rubber cylindrical fenders (Figure 8). The fenders are 120 cm in external diameter and 150 cm long. They are draped along the side of the berths at 18.3 m intervals. Each fender hangs on a steel bar that is anchored to the berth with chains. The energy absorption capacity of the fenders is rated at 243 kilonewton metres (kN-m).

When a vessel's hull presses on the cylindrical fenders, they will compress up to a maximum of 60 cm, which is equal to the inner diameter of the fender, leaving a clearance of approximately 60 cm between the vessel's hull and the berth face. Once the fender is fully compressed, it behaves as a solid rubber element. Any further compression past this point causes pressure on the vessel's hull.

The cylindrical fenders do not have a means of reducing sliding friction. Large friction forces can develop as the rubber fender is compressed between the vessel hull and the concrete berth face, resulting in damage to the anchoring chains or plates. The fenders are known to the pilots as being "sticky," meaning that the vessel's hull does not slide easily along the fenders, but rather "sticks" on them, which can make berthing more difficult.

The review concluded that the damage was a result of the existing fendering system not having sufficient capacity to absorb the kinetic energy of the large vessels berthing at the terminal. Specifically, when the fenders are compressed to their maximum, large vessels can make contact with the berth face, causing impact damage to both the berth and the vessels.

The review also identified that the existing cylinder fender system was inappropriate for the size of container vessels that dock at the berth. The energy absorption capacity of the fenders was significantly less than the required energy absorption for the maximum design vessel³⁰ (1662 kN-m). The fender stand-off distance³¹ was inadequate, and the fender spacing was too far apart considering the size of the fenders and the heavy loads placed on them.

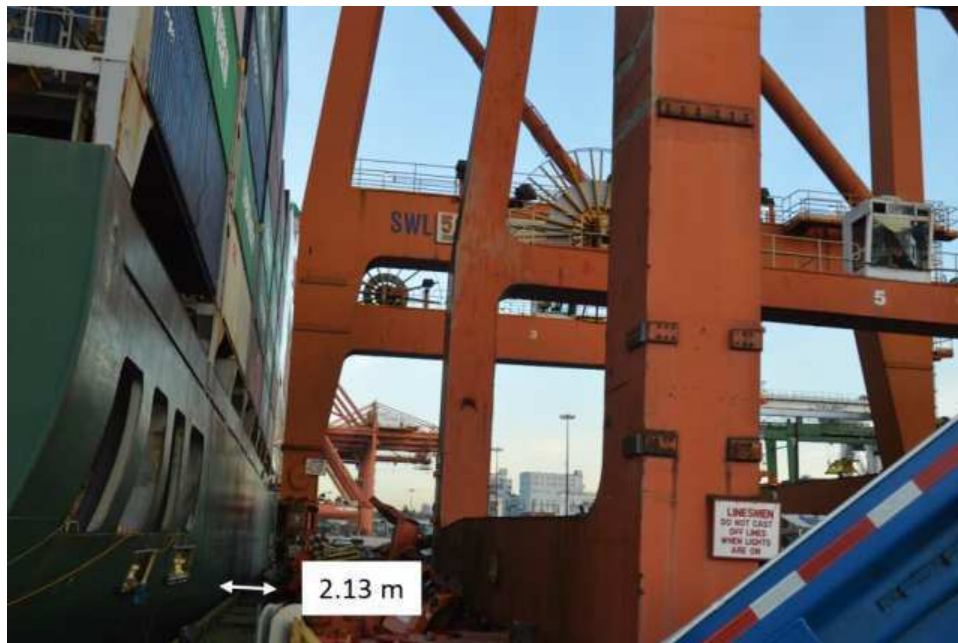
Figure 12. Distances between the berth line and crane rail at Vanterm (Source: TSB)

Deltaport 3 was designed for a maximum approach angle of 5° at a velocity of 12.5 cm/s. The bollards are rated for 125 tonnes safe working load, with 200 tonnes safe working load bollards at the ends of the berth. The distance from the waterside crane rail to the berth line is approximately 6.96 m at Deltaport 3, whereas the distance from the crane rail to the berth line at Vanterm is 2.13 m (Figure 12 and Figure 13).

The distance from the crane rail to the berth line at Vanterm is only 2.13 m, which means that even a slight angle on a vessel while berthing could cause the flare of its bow or stern to come into contact with a crane if one is in the vicinity. At Deltaport, by comparison, the distance from the crane rail to the berth line is 6.96 m.

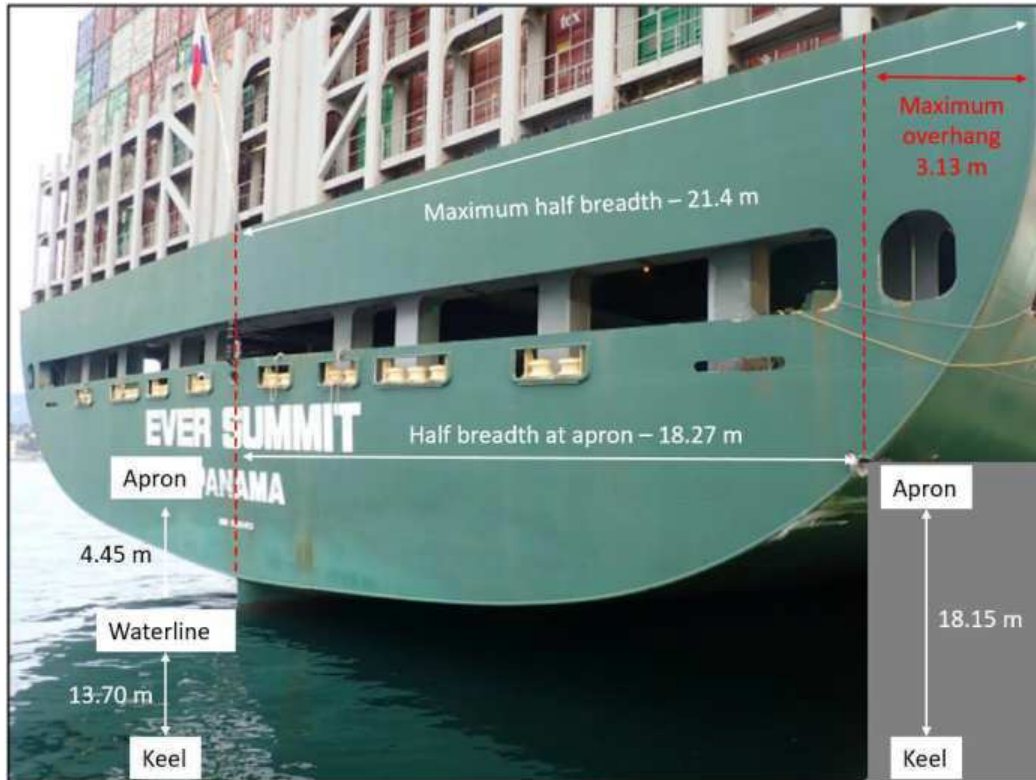
Figure 15. The *Ever Summit*'s maximum overhang at the stern at the time of the occurrence
(Source: TSB)

The TSB determined that, at the time of the occurrence, the *Ever Summit's* maximum possible overhang at the stern was approximately 3.13 m (Figure 15 and Appendix D).

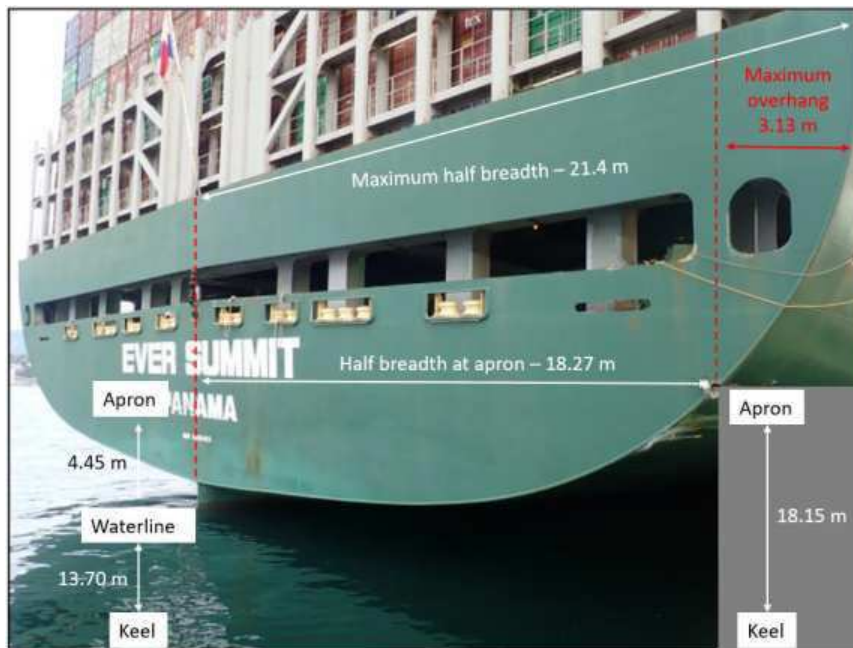
Figure D1. The *Ever Summit*'s maximum overhang at the stern at the time of the occurrence (Source: TSB)

To determine the maximum overhang at the transom, the difference between the half-breadth of the vessel at the apron level and the maximum half-breadth of the vessel was calculated. The maximum possible overhang at the transom was determined to be **3.13 m** (Figure D1).
