Marine Safety Investigation Unit

SAFETY INVESTIGATION REPORT

REPORT NO.: 15/2020

MV KLIMA
Allision with the Marshall Island
bulk carrier *SPRING SNOW* and the
Singapore registered bunker barge *LIBRA*
in the Eastern Special Purpose Anchorage,
Singapore
05 July 2019

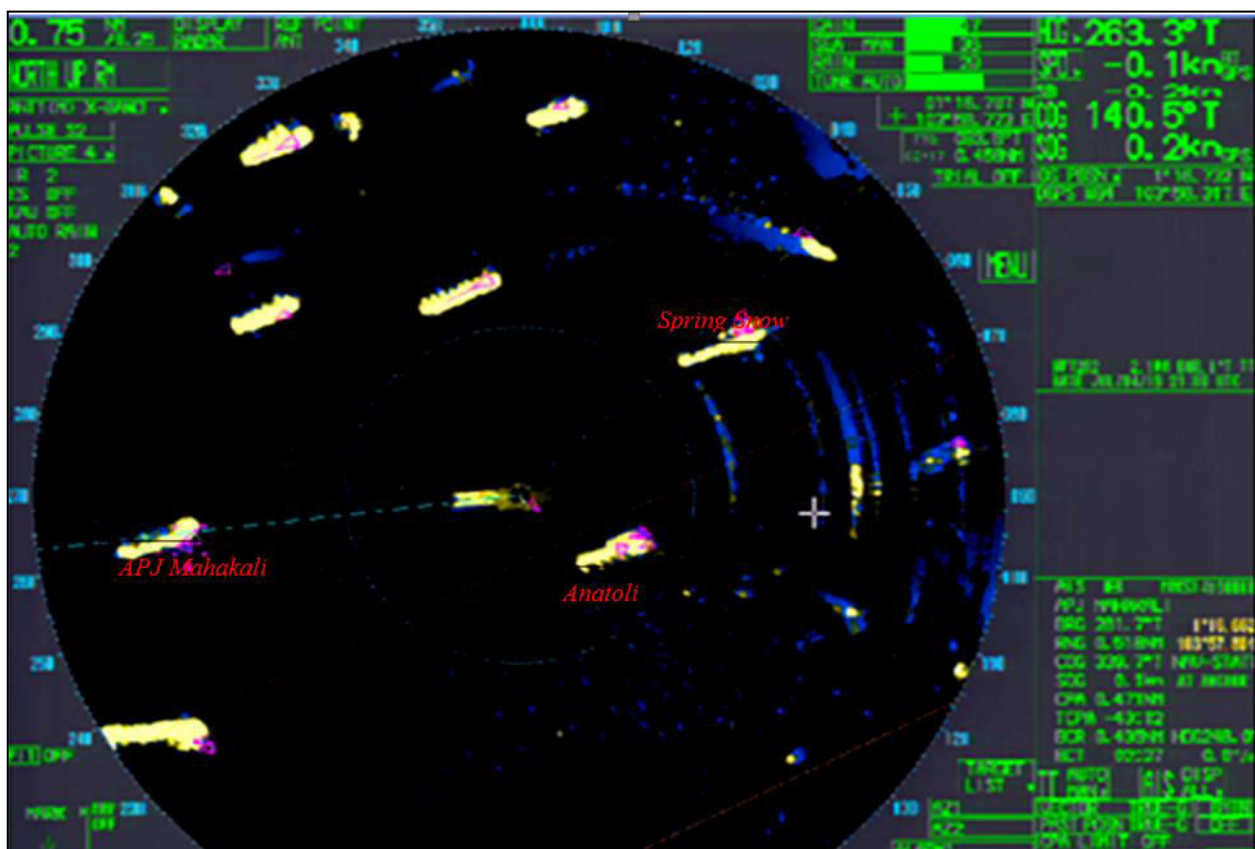
Available information suggested that shortly after 0500, severe yaw exacerbated the vessel's rotational motion towards *Anatoli* (Figure 4), which alarmed and induced the OOW to call the master on the bridge. Nonetheless, analysis of the prevailing conditions suggested that although the situation seemed alarming, *Klima* was in no immediate danger and *Anatoli* was nowhere near the 1.2 cables as reported by the OOW.

Figure 4: Image from X-band radar (Scale 0.75 nm) showing *Klima*'s anchor position at 0508

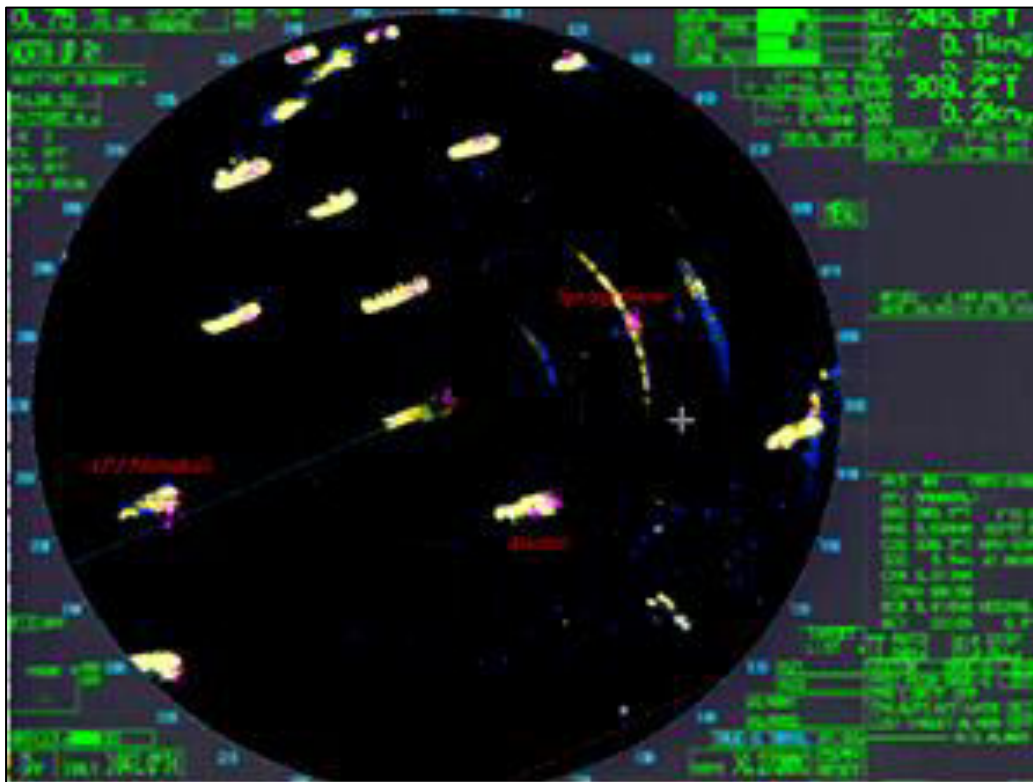
Evidence showed that the master observed the vessel's position on the radar and ECDIS upon being called to the bridge. At that moment, *Klima* was about two cables from *Anatoli* (Figure 5). As noted above, there was no immediate danger although yaw and sporadic rotational motion may have brought her unacceptably close to *Anatoli*.

Figure 5: Image from X-band radar (Scale 0.75 nm) showing *Klima*'s position at 0520

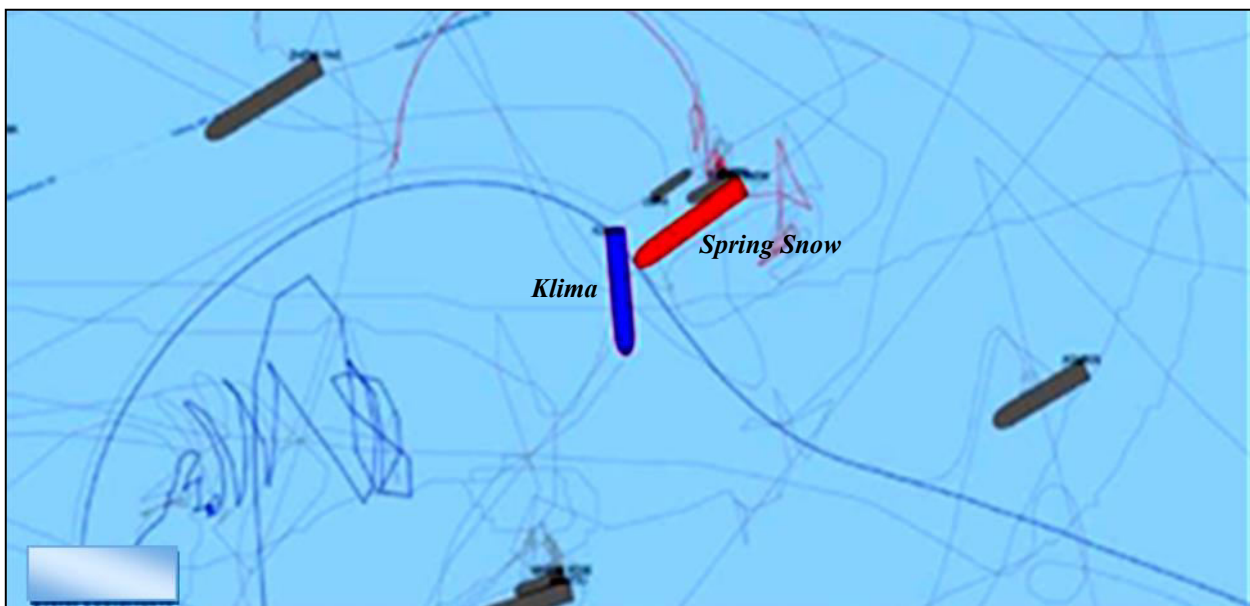
Thus, the perceived and actual situations were not aligned, leading to the allision. In particular, the course of *Klima's* movement to secure a suitable anchor position, proximity of anchored vessels, impact of tidal stream on manoeuvrability and the limited options available to the master to counter the vessel's drift towards *Spring Snow* (Figure 6) had contributed to the complexity of the already evolving situation.

Figure 6: AIS showing *Klima's* track and allision with *Spring Snow*
