DUTCH  
SAFETY BOARD

# Fatal outcome following parting of mooring line

Lessons learned from the accident  
on board the RN Privodino

*The Hague, November 2020*

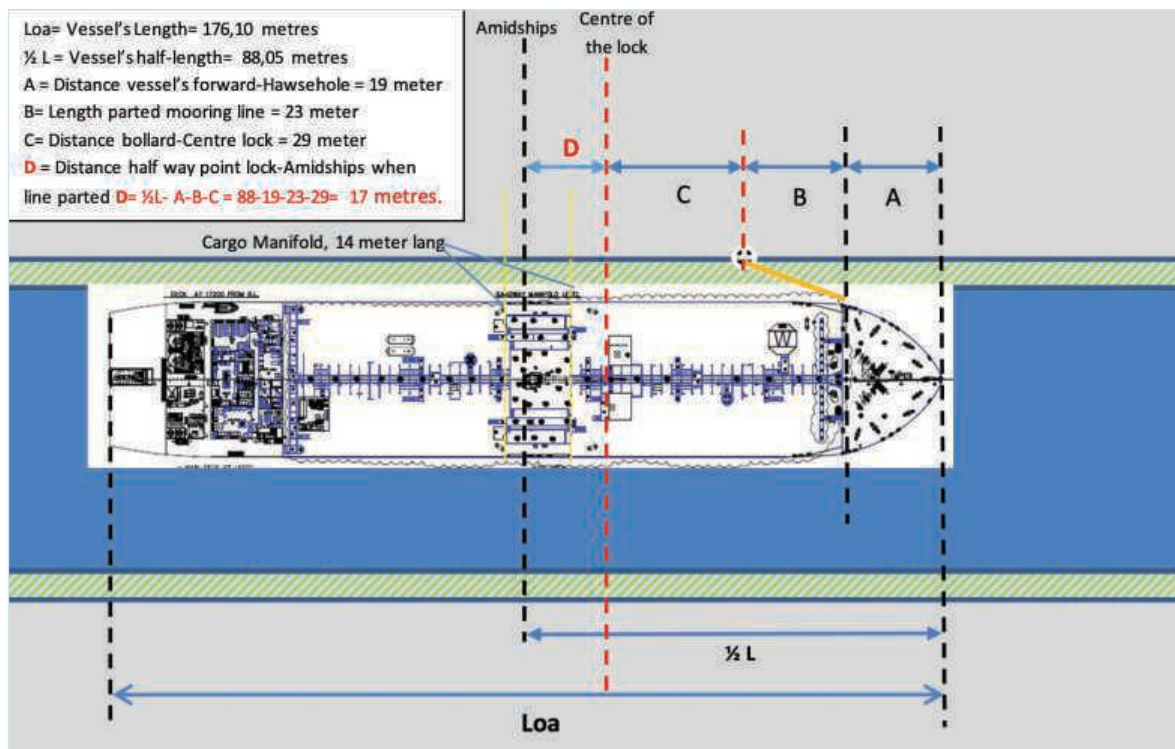
Figure 4: Position RN Privodino at the moment the mooring rope parted broke.

The investigation revealed that the mooring line parted at the hawsehole it was running through. The Amidships of the RN Privodino was, at that moment still about 17 metres away from the halfway position in the lock. This distance was, as been shown in figure 4, calculated by taking together the distance between used bollard and centre of the lock, the length of the parted shore side section of the mooring line and the distance between most forward point of the vessel and the hawsehole, and compare this total distance with the half-length<sup>5</sup> ( $\frac{1}{2} L$ ) of the vessel. This calculation revealed that the vessel should have proceeded 17 metres more in order to let the vessel's Amidships end up more or less in the halfway position of the lock, as discussed between master and pilot.

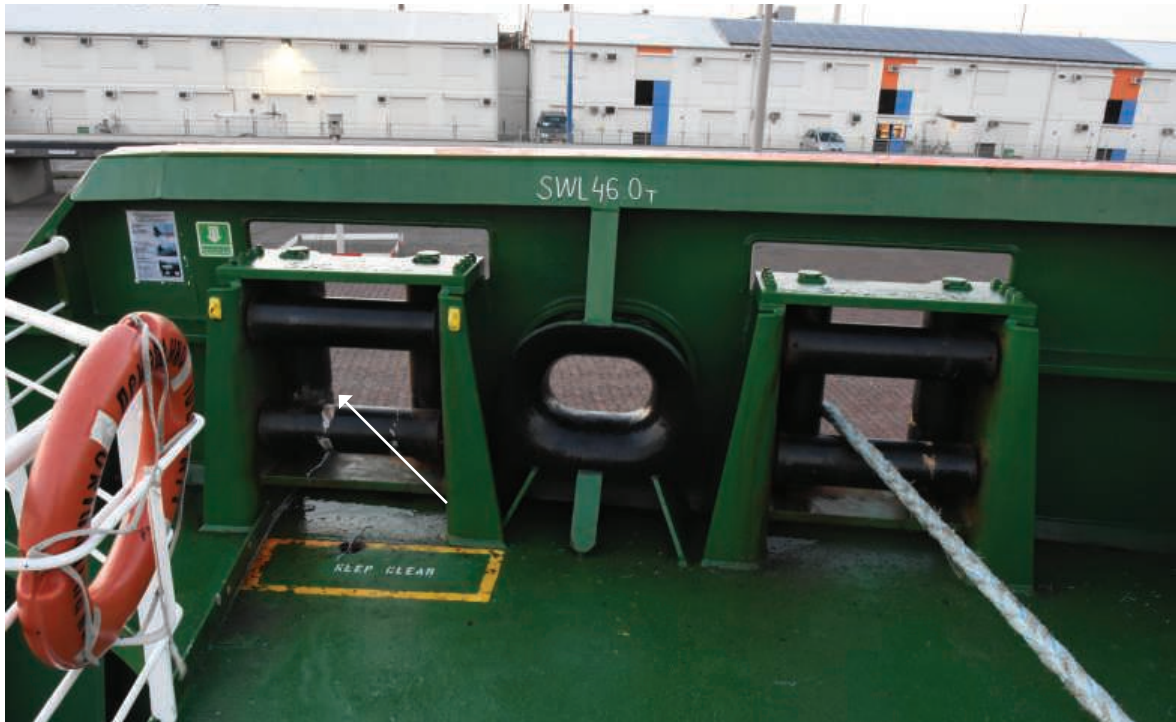
*Photograph 8: Location where the forward spring broke (Source: Police).*

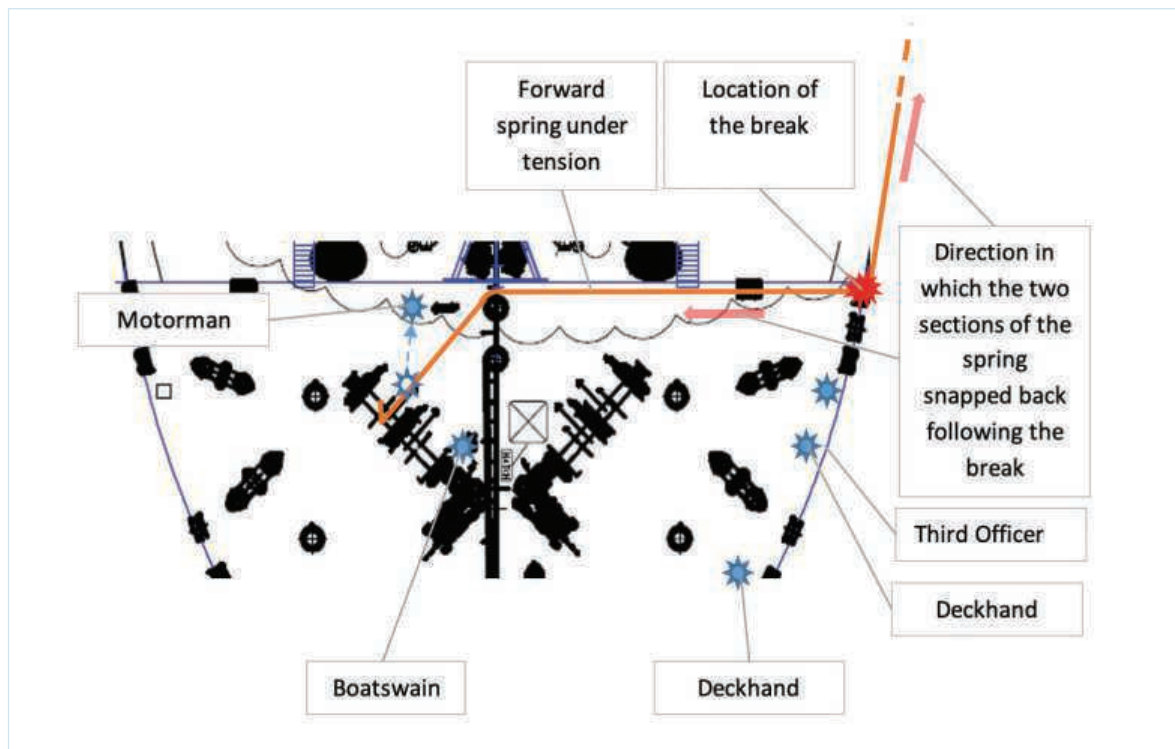
After completing three turns around the drum, the boatswain observed that the spring line was becoming far too tight. While attempting to release the spring as quickly as possible, with the winch, he received warnings both in the form of a shout from the third officer and via a call from the master on the portable radio. Within three seconds of these warnings, the spring line parted at the position of the fairlead. The section of the mooring line between the fairlead and the drum whipped back across the deck and hit the motorman full in the head. Figure 9 shows the situation on the foredeck at the moment when the spring broke.

Figure 9: Situation on the foredeck at the moment the forward spring broke.

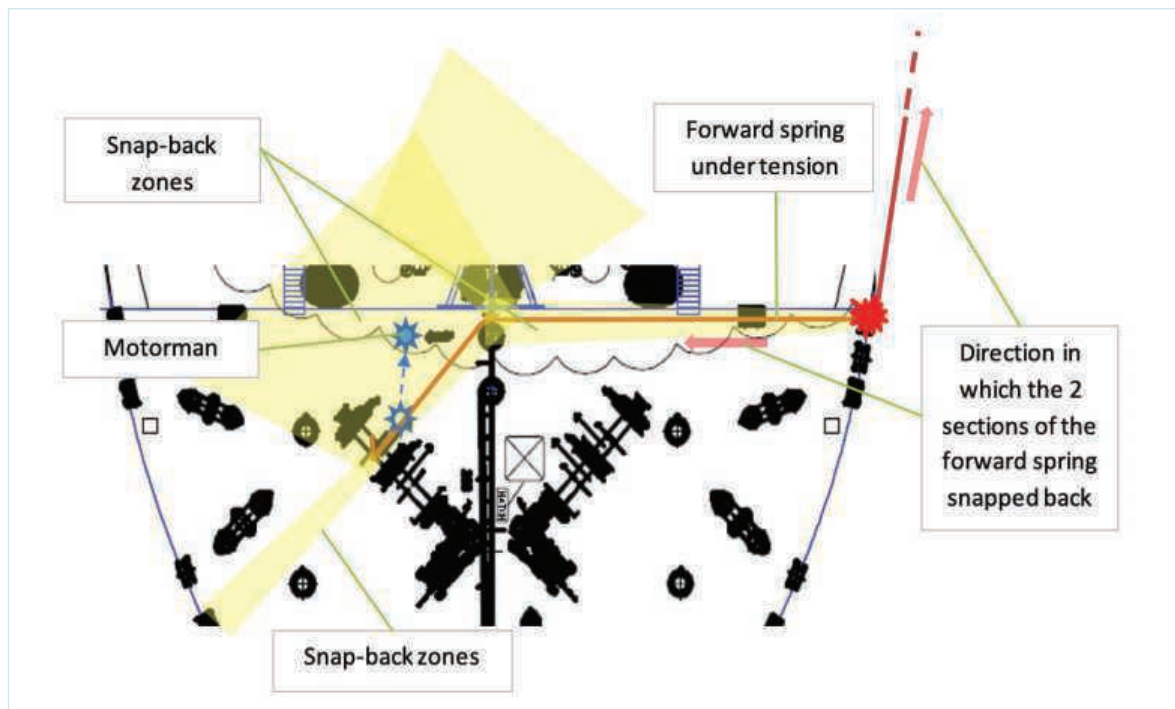
Figure 10: Snap-back zones of the forward spring at the moment when it broke.

One important barrier for preventing accidents due to a breaking mooring lines involves working with snap-back zones. Snap-back zones are marked zones within which broken mooring line can whip backwards. However, these zones were not marked as such on the deck. Instead, the entire foredeck was identified as a hazardous zone and marked accordingly. The vessel manager supported this approach in the SMS by arguing that due to the various different possibilities for passing a mooring line to the winches and the fact that multiple mooring lines are (or are placed) under tension at any one time, snap-back zones would in fact have to be marked out on large parts of the deck. Because of the many different situations, this would not provide increased clarity for the crew members at work on the deck, and in the judgement of the vessel manager, a false sense of safety would be created. For that reason, the decision was made to identify the entire foredeck as a potential snap-back zone, and to mark it accordingly.

During mooring and unmooring, large parts of the foredeck of the RN Privodino were considered unsafe working areas and marked accordingly. Because the areas that were actually dangerous changed depending on which mooring line was used and how it was guided over the deck, in the sudden occurrence of a dangerous situation, it was no longer possible to rapidly determine where a safe position could be sought. In addition, it was not possible to determine from which safe position the work could be carried out. During the accident, the motorman was located in the so-called snap-back zone of the breaking mooring line.

7. In areas with snap-back zones, identify or create safe workstations where those aboard cannot be hit by mooring lines and ropes if they snap back; mark these safe workstations in a recognizable manner and organize the work processes involving mooring lines and ropes in such a way that operations are always undertaken from these safe workstations.

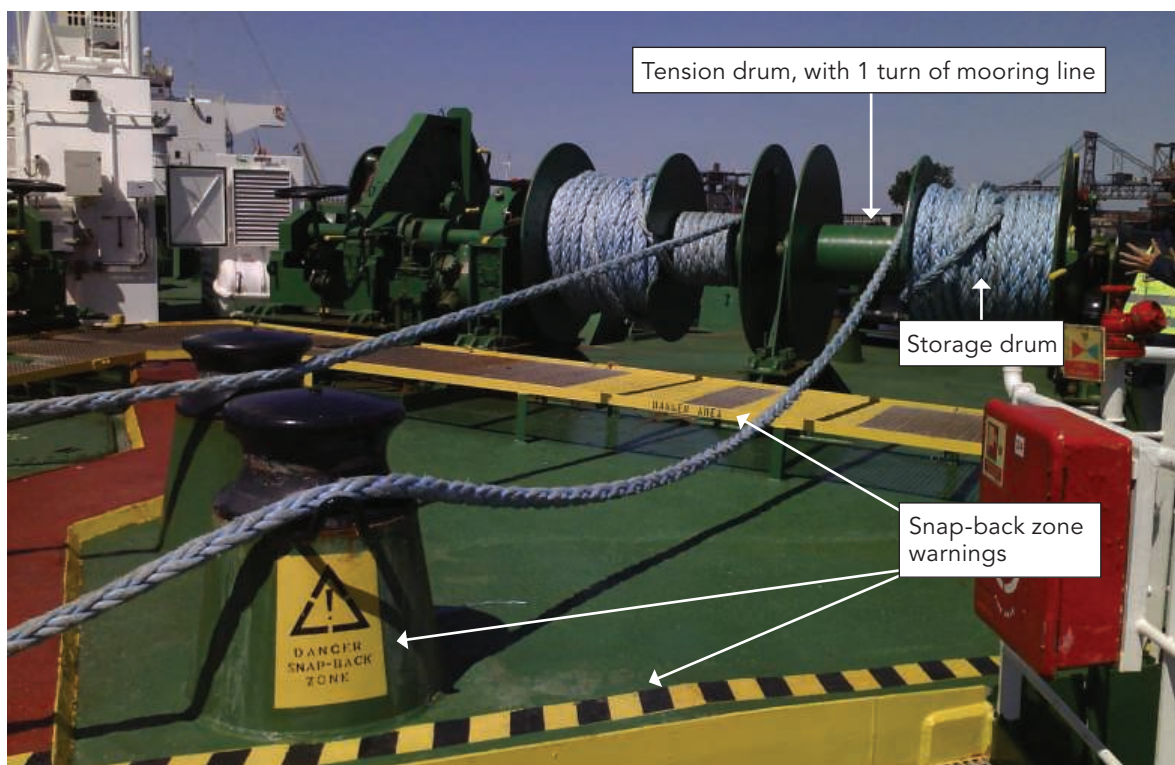
Photograph 11 shows the situation of the mooring line drum at the moment the spring line broke (right-hand mooring line winch on the photograph) This shows that there was only 1 turn around the tension drum at the time.

Photograph 11: Reconstruction and snap-back zone warnings on the foredeck (Source: Dutch Safety Board)

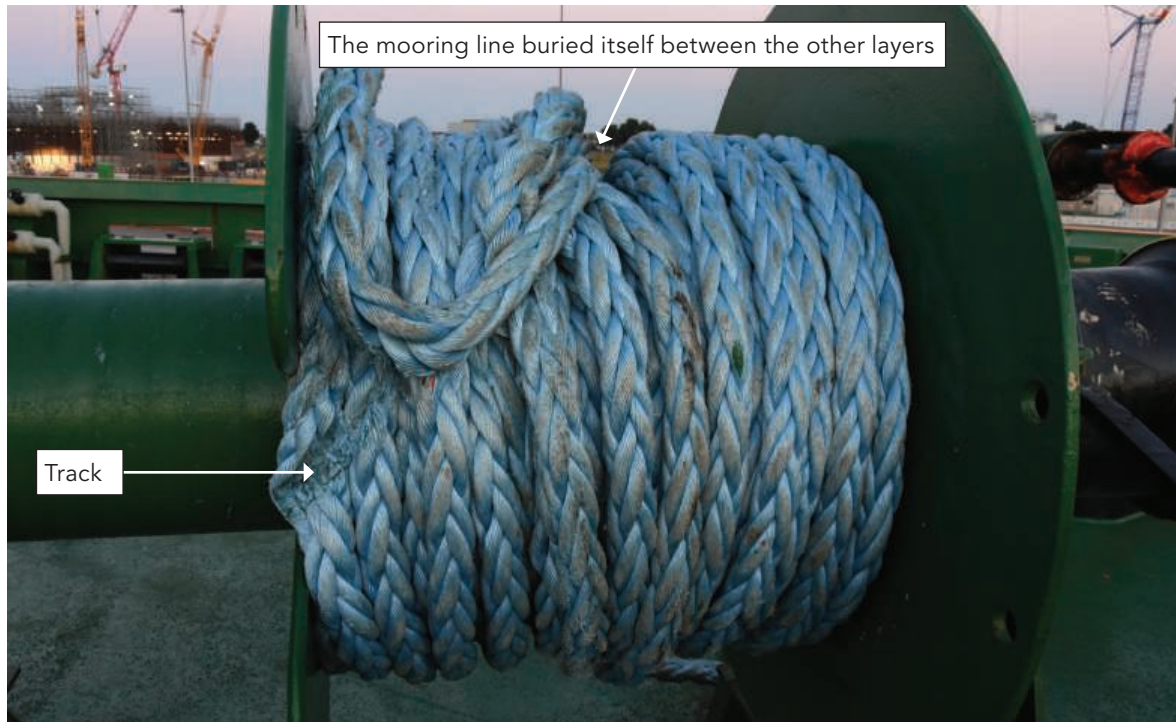
Photograph 12 shows that the mooring line on the storage drum left a clear mark where the line was pulled tight from the tension drum, over the other layers. In addition, the mooring line had been pulled between the layers on the storage drum. It can be concluded from these observations that the mooring line was pulled very tightly around the storage drum, from the tension drum, before the mooring line broke.

Photograph 12: SStorage drum with the mooring line that was used as the forward spring (Source: Police).

The boatswain attempted to prevent the accident by releasing the mooring line as *quickly as possible*. This failed because the winch was not able to turn quickly enough to release sufficient mooring line.

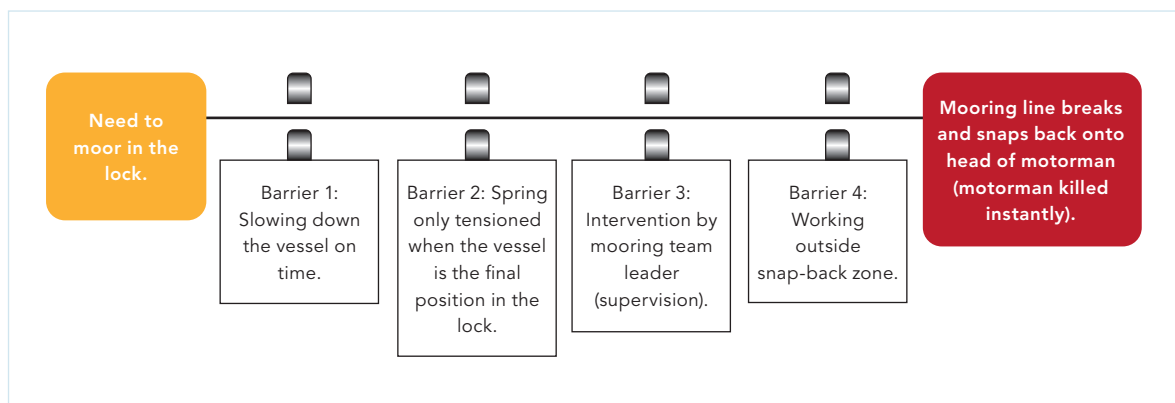
Figure 13: Overview of failed barriers.

As part of the analysis of the accident, four missing or failing barriers were identified. As a consequence, the following conclusions can be drawn:
