Report on the investigations of
heavy weather damage
on board the container ship

Maersk Newport

on 10 November 2008

on 15 November 2008

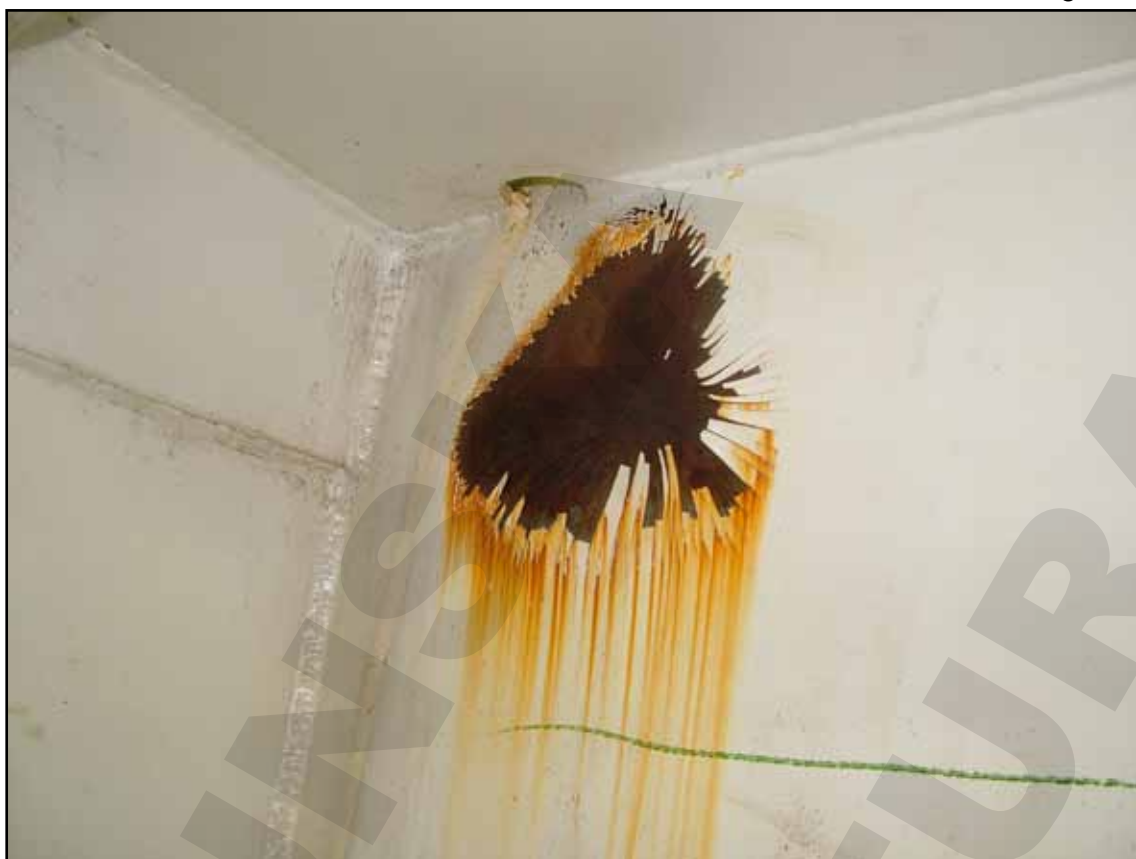
Figure 3

The outgoing chief engineer cautiously opened the bow thruster room hatch and, as there was no evidence of a fire, he went down the ladders. As he descended he immediately noticed three, 150mm by 250mm, holes in the port side of the hull. As the vessel pitched, water was sprayed into the compartment and over the electrical distribution and control panels. The chief engineer also noticed that there were numerous hull indentations (**Figures 3 and 4**) and that the bilge was full of water. He reported the damage to the master on the bridge and that he suspected that the port anchor had been released, causing the damage. He then instructed the fourth engineer to return to the ECR to fully isolate the electrical supplies to the bow thruster room. The bilge suction valve was opened and the 5 ton/hour bilge pump was started in an attempt to lower the water level.

Hull indentations - port side bow thruster room

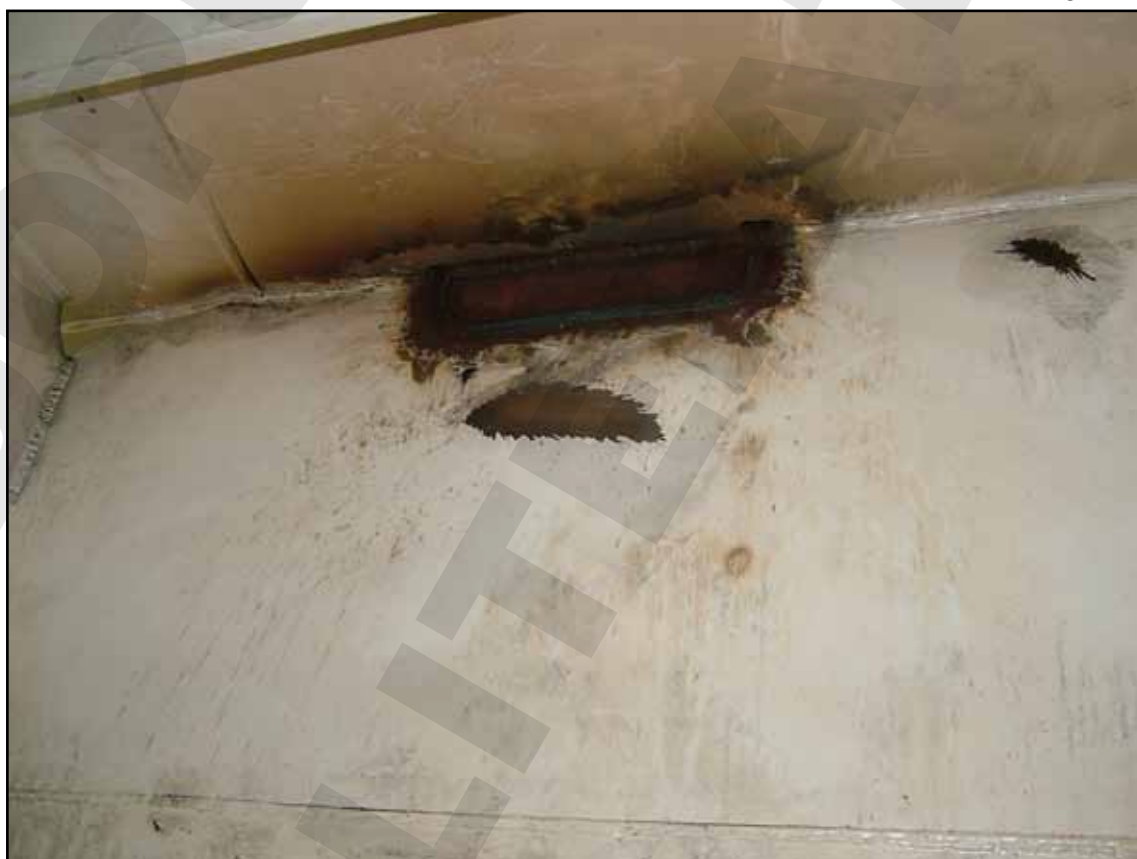
Figure 4

Hull indentations - port side bow thruster room

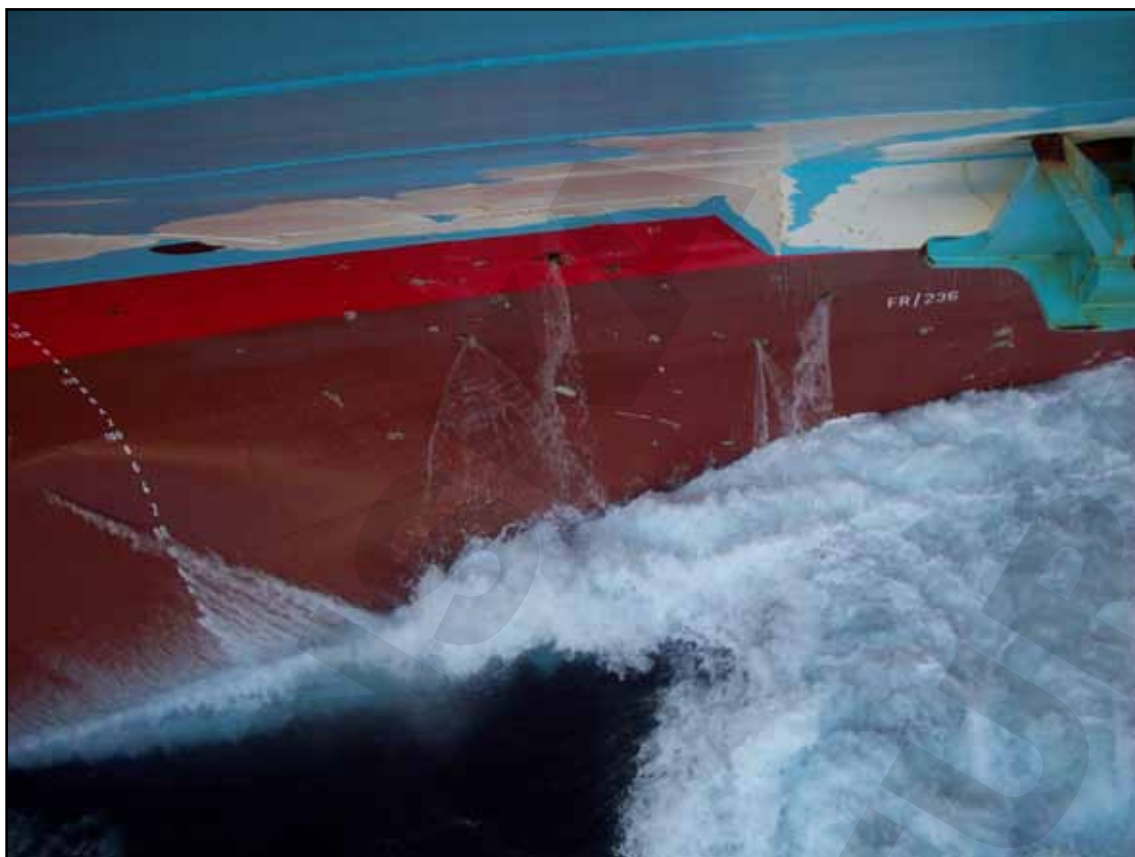
The bosun was sent to get wooden wedges and neoprene rubber with which to stem the flow of water. On his way he went to the forecastle head with the incoming chief engineer and chief officer to investigate the damage from the outside. On looking over the port side, the port anchor was seen to be below the sea surface, and there were numerous indentations and splits in the vicinity of the port side of the bow thruster room. As the bow pitched, water was seen spraying out from more holes in the forepeak area, **Figure 5**.

Damage to the port side of the hull seen from the forecastle

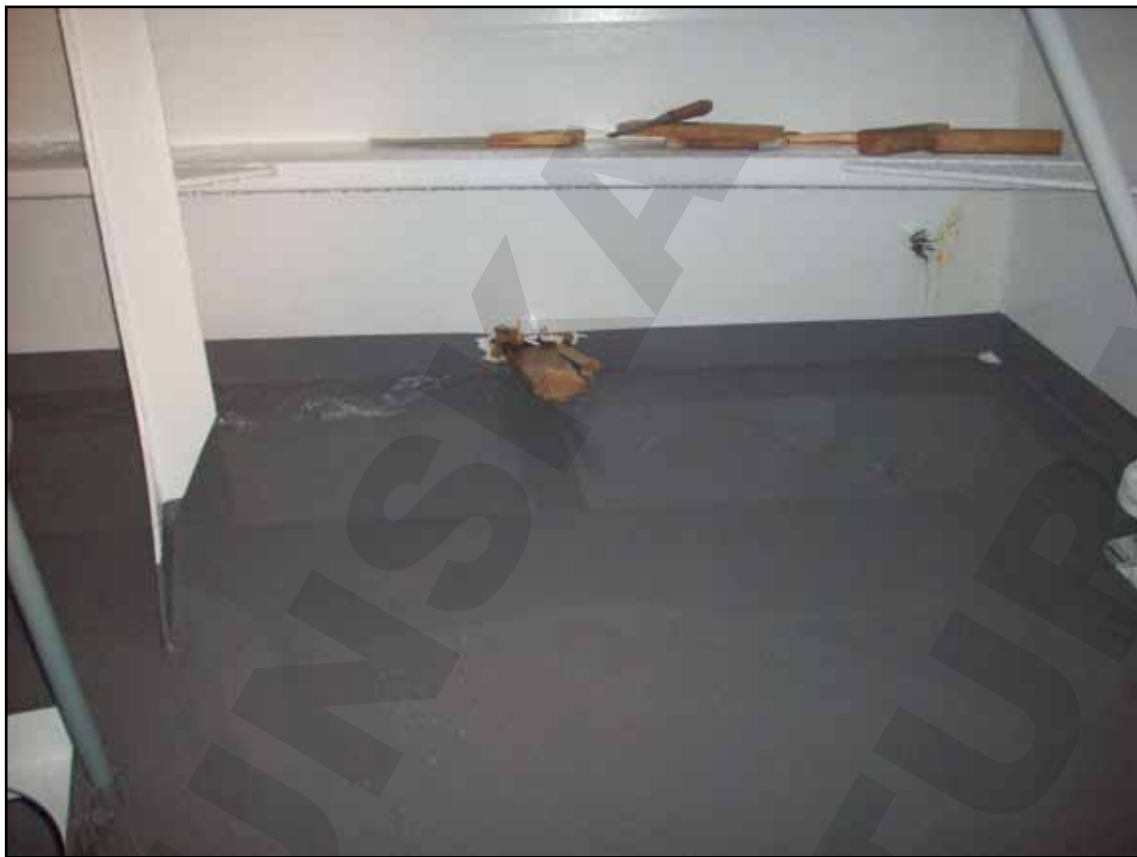
By about 1400 the team in the bow thruster room had managed to significantly reduce the inflow of water (**Figure 6**). The bilge water at this point was about 1.25m deep and appeared constant, so the engineering team believed that the bilge pump was coping with the rate of water ingress. In the meantime, the ship was ballasted with about 400 tonnes of sea water using the after ballast tanks.

Example of bow thruster room damage control measures

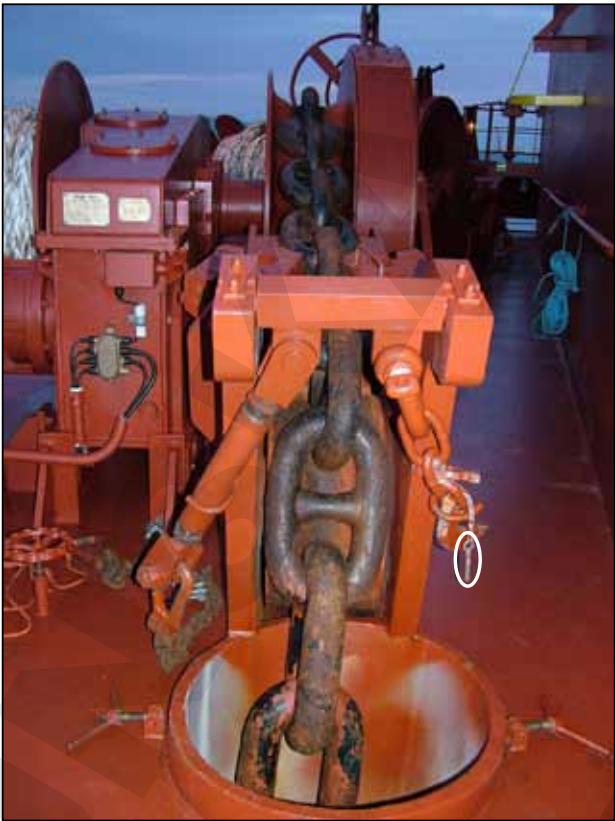
Figure 7

The forecastle team found that about $\frac{1}{2}$ to $\frac{3}{4}$ shackle of the port anchor cable had been released. The lashing chain Senhouse slip tapered securing pin had become detached from the slip and was hanging by its chain (**Figure 7**) and that the lashing chain was hanging loose. It was also found that the forward guillotine block was in the upright open position while the after guillotine block was in the horizontal closed position – **Figure 8**. Before the anchor cable was recovered, the chief officer checked the winch brake and managed to apply one full turn of the brake handwheel. After the port anchor was fully secured, checks were made to confirm that the starboard anchor was also fully secured.

Senhouse slip securing pin in detached position

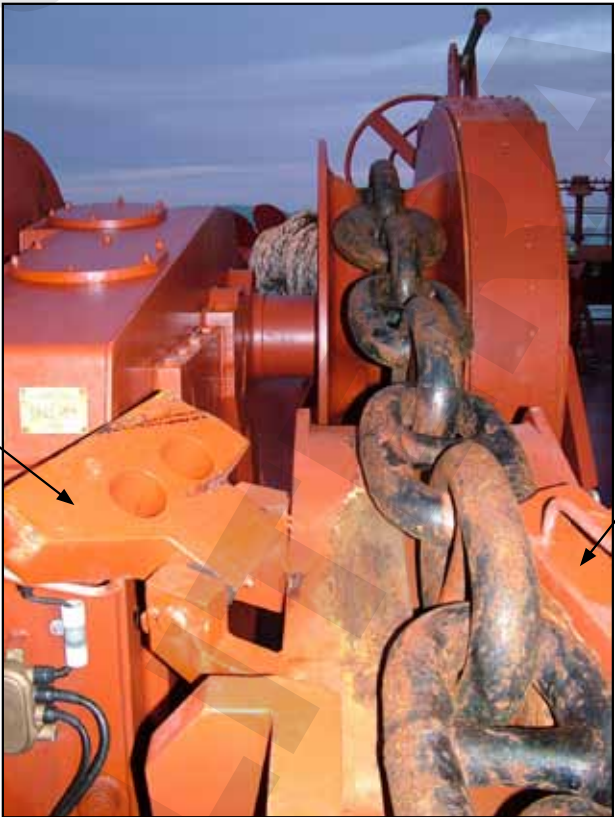
Figure 8

Position of the port anchor guillotine blocks

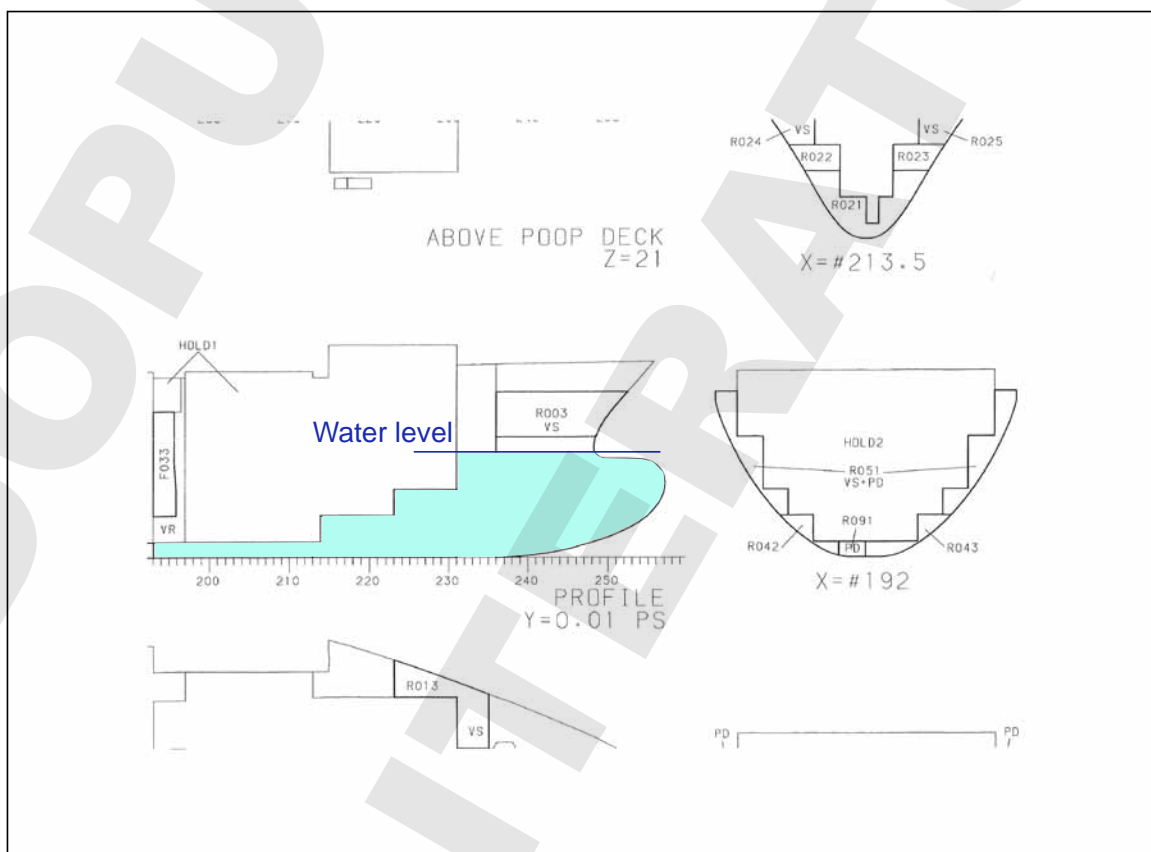
Figure 9

The water level in the bow thruster room was constantly monitored throughout the remainder of the day and night and was found to be slowly rising. By late evening the following tanks/spaces were found to have been breached (**Figure 9**):

Ship's section showing extent of flooding

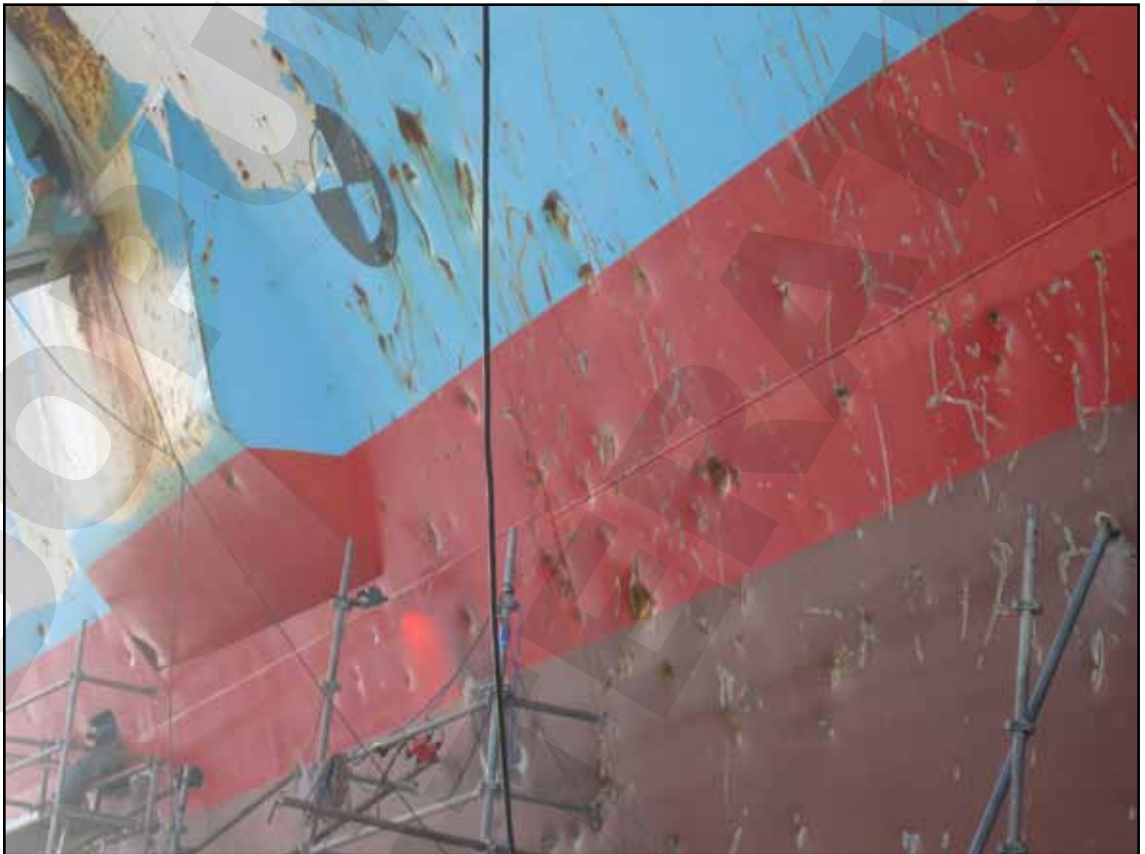
Figure 11

The survey identified numerous indentations and scoring of the shell plating (**Figure 11**) and more severely damaged areas that required 23 insert plate² repairs, to enable the ship to sail from Algeciras without a “Condition of Class”. The locations of the insert plate repairs are shown at **Figure 12**.

Hull indentations

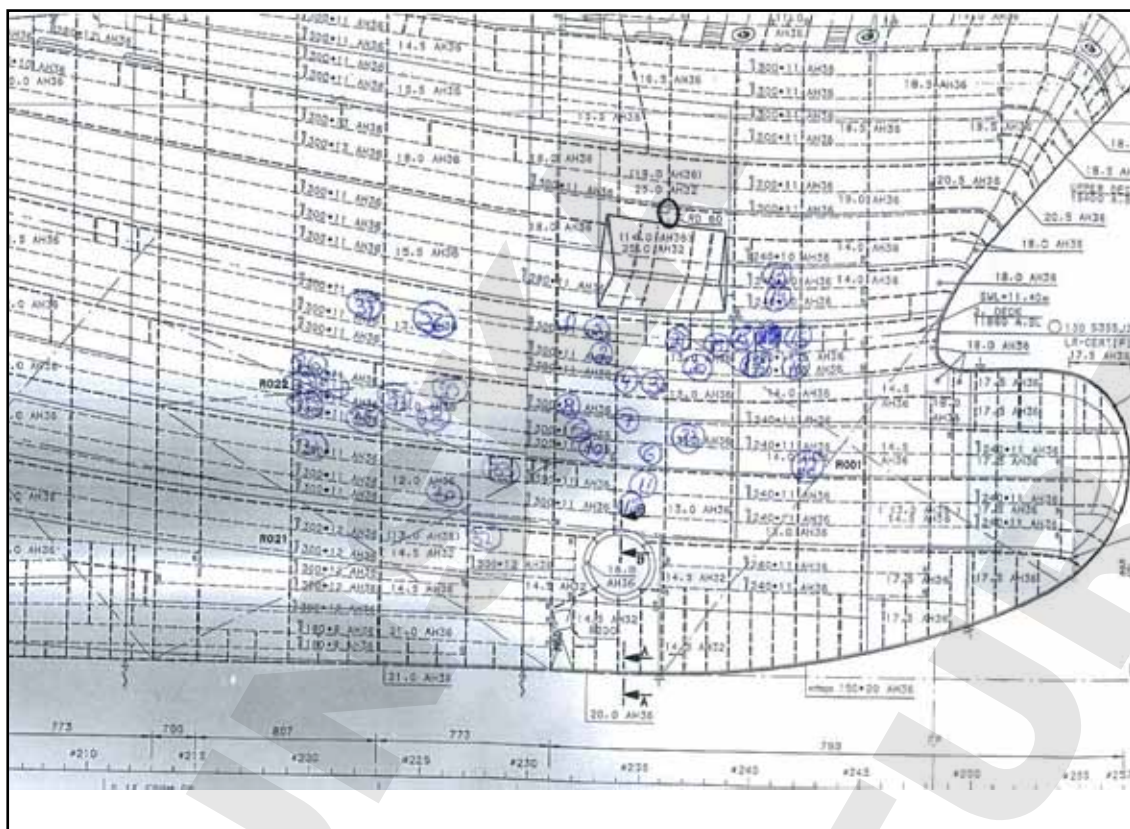
Location of insert plate repairs

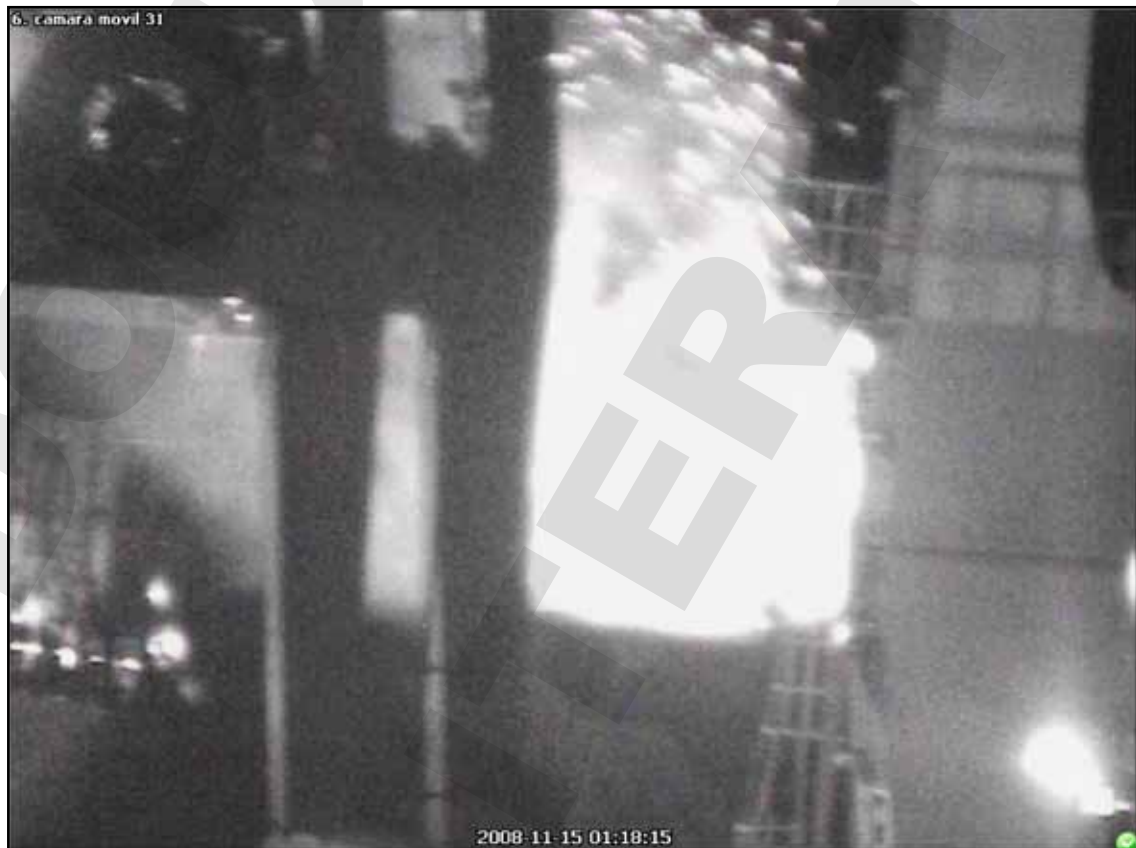
Figure 14

Still of acetylene bottle explosion taken from the APM Terminal's security camera video recording

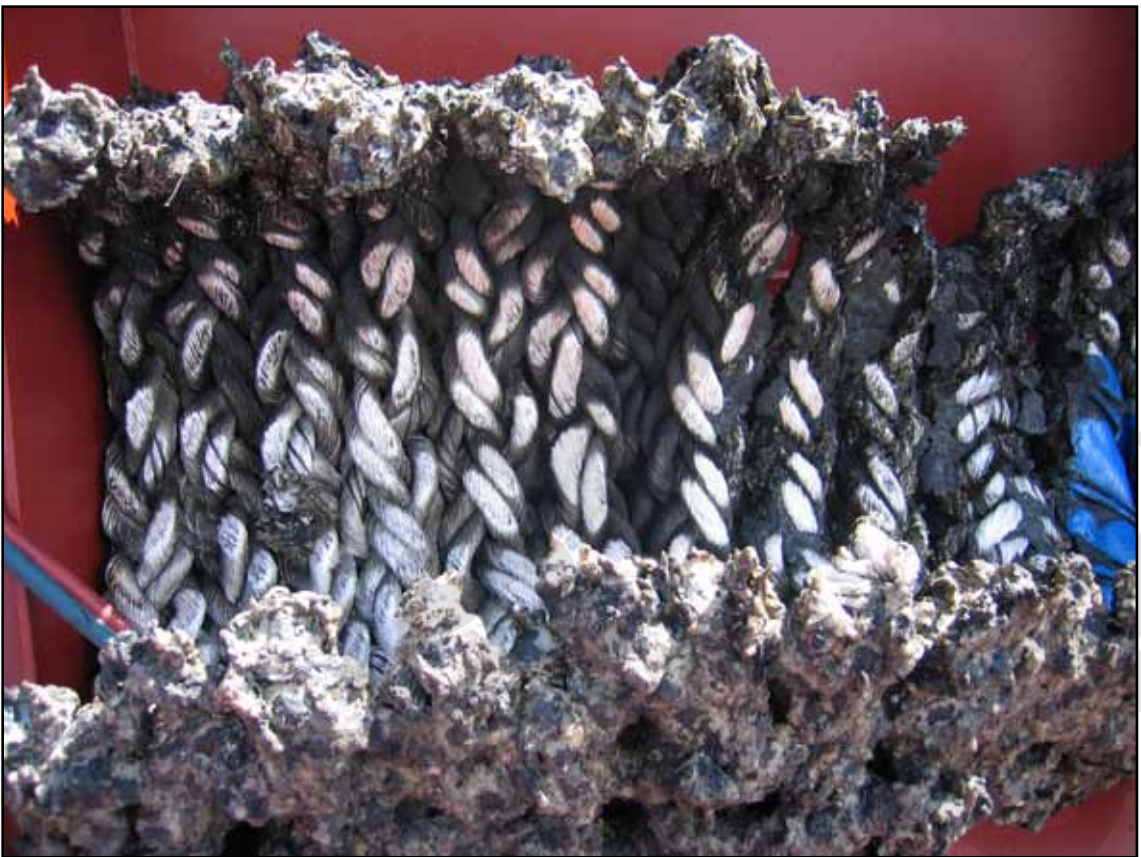
Fire damaged mooring rope from the port windlass winch drum

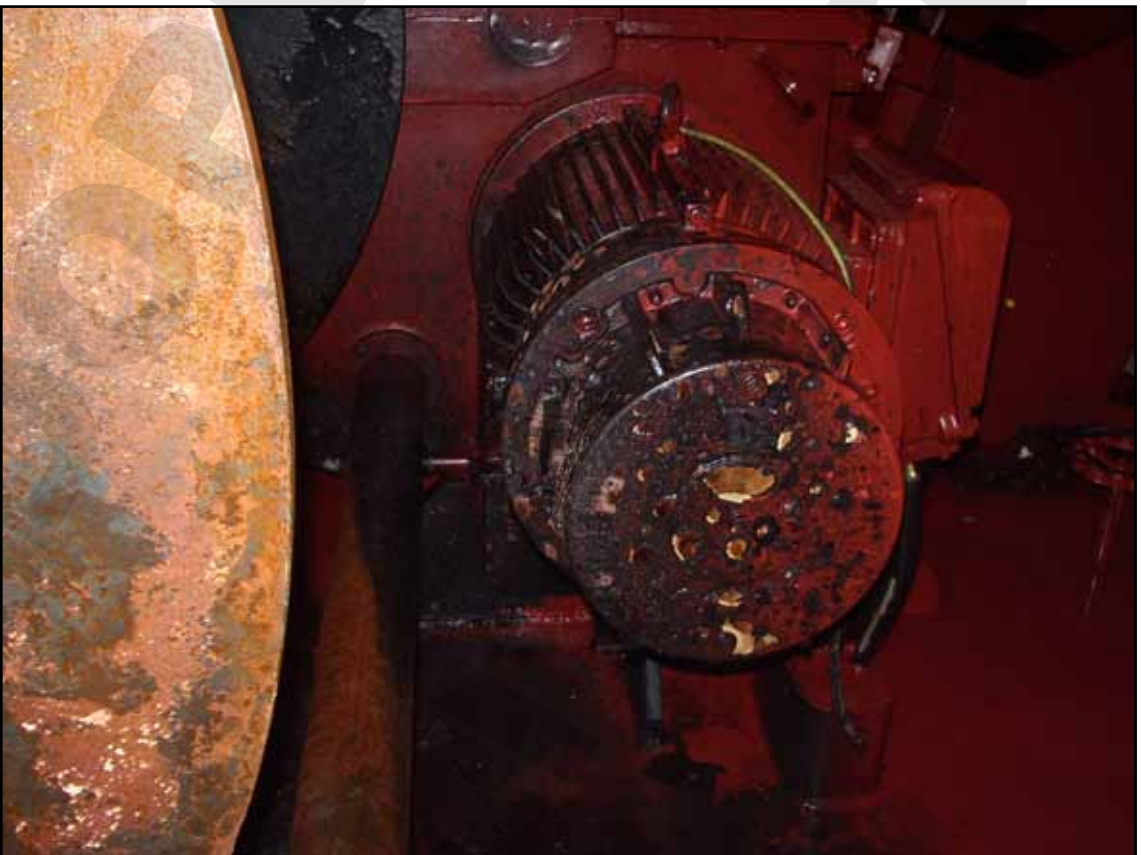
Figure 17

Heat damage was caused to the port windlass winch paintwork and also to the electrical cables supplying the winch motor and its control system (**Figure 17**).

Fire damage to the port windlass winch

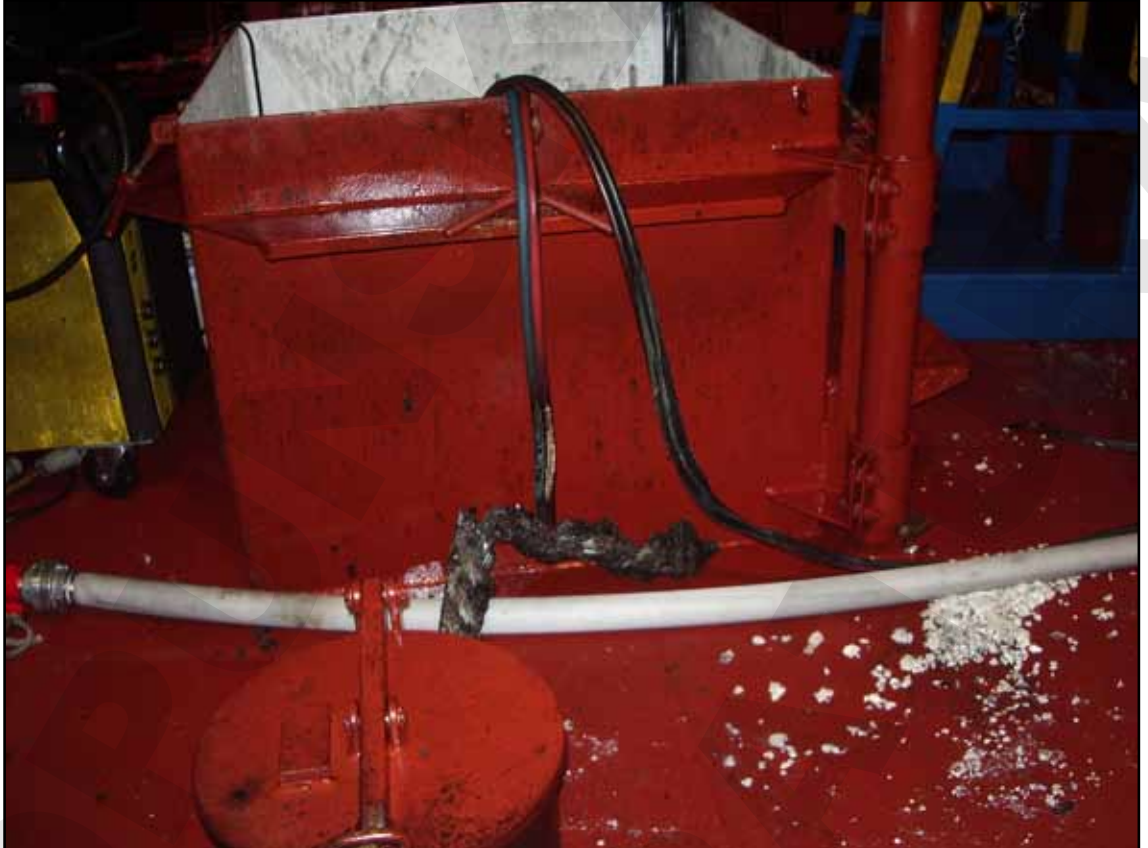
Figure 18

About 10m of the contractor's three oxygen and acetylene gas hoses were burnt through (**Figure 18**), but the remaining 40m were unaffected. The hose non-return valves and flame arrestors fitted to the bottle regulators had been largely destroyed as had most of the acetylene and oxygen bottle regulating valves.

Acetelyne and oxygen hose fire damage

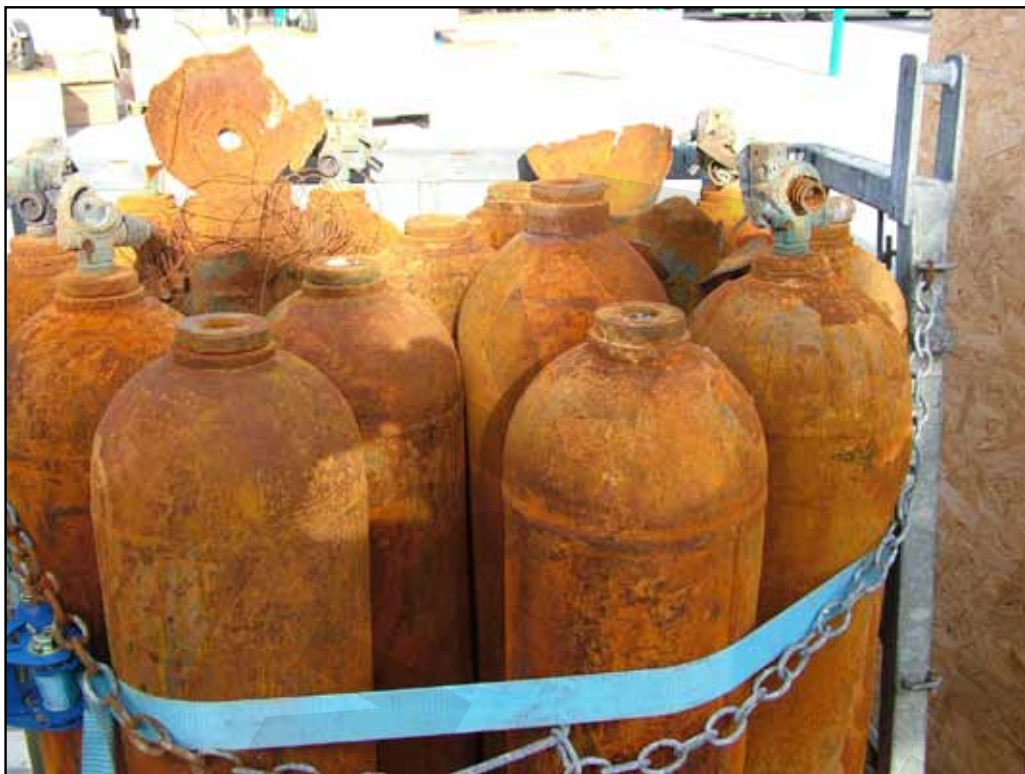
The 15 acetylene and 16 oxygen bottles were damaged beyond use. Two of the acetylene bottles had exploded and many of the others suffered splits and severe distortion (**Figures 19 and 20**). One oxygen bottle had exploded and the rest suffered from severe heat damage (**Figure 21**).

Explosion damaged acetylene bottles

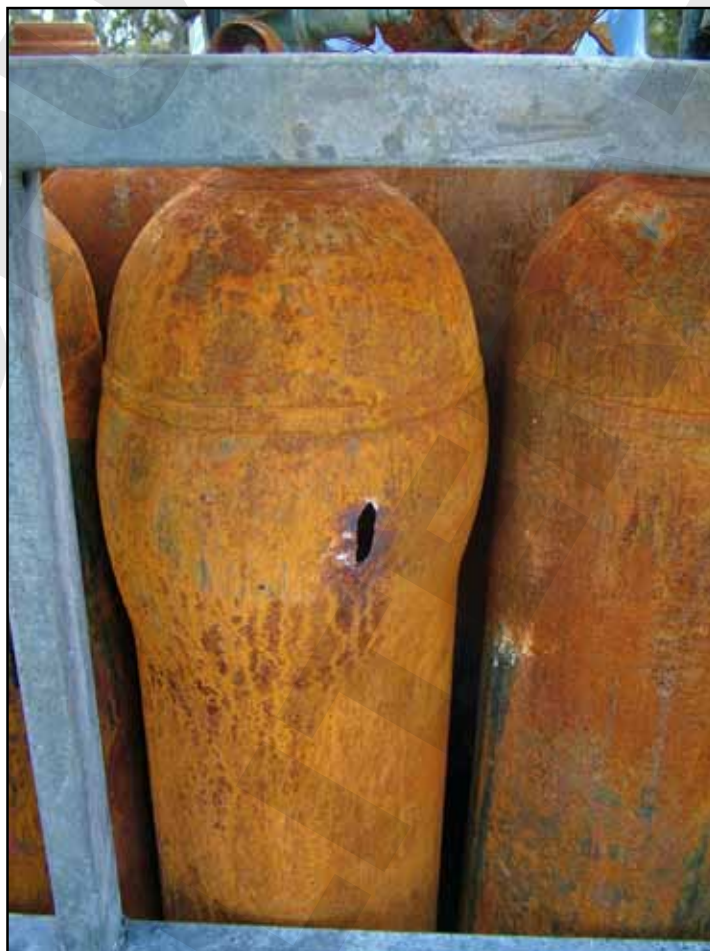
Figure 20

Distorted acetylene bottles

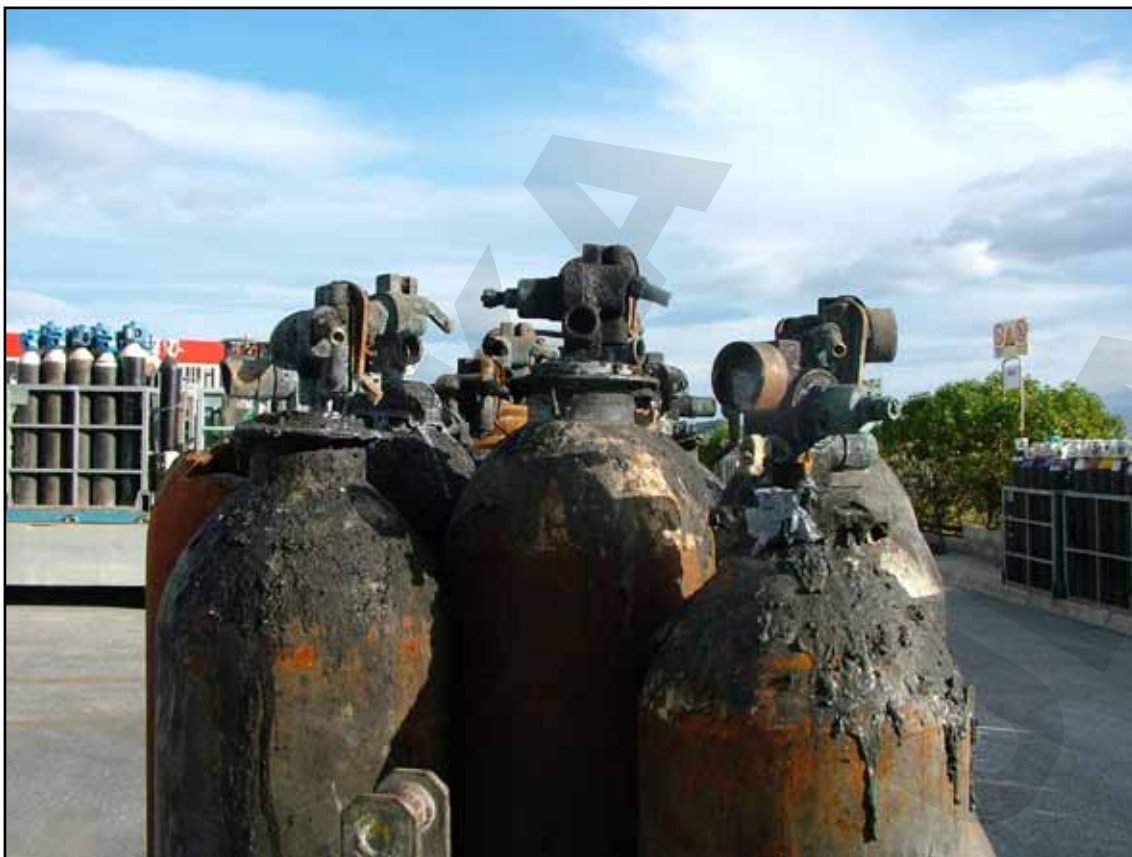
Fire damaged oxygen bottles

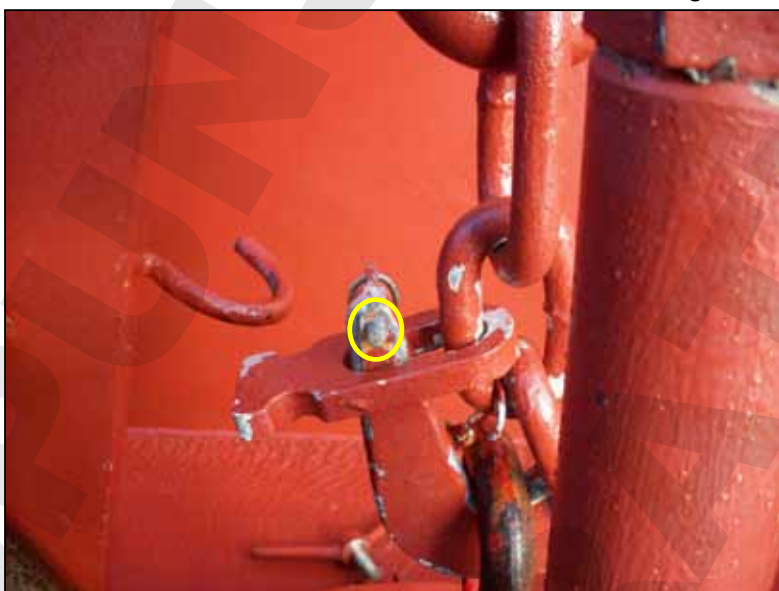
Figure 24

Chain lashing Senhouse slip tapered securing pin

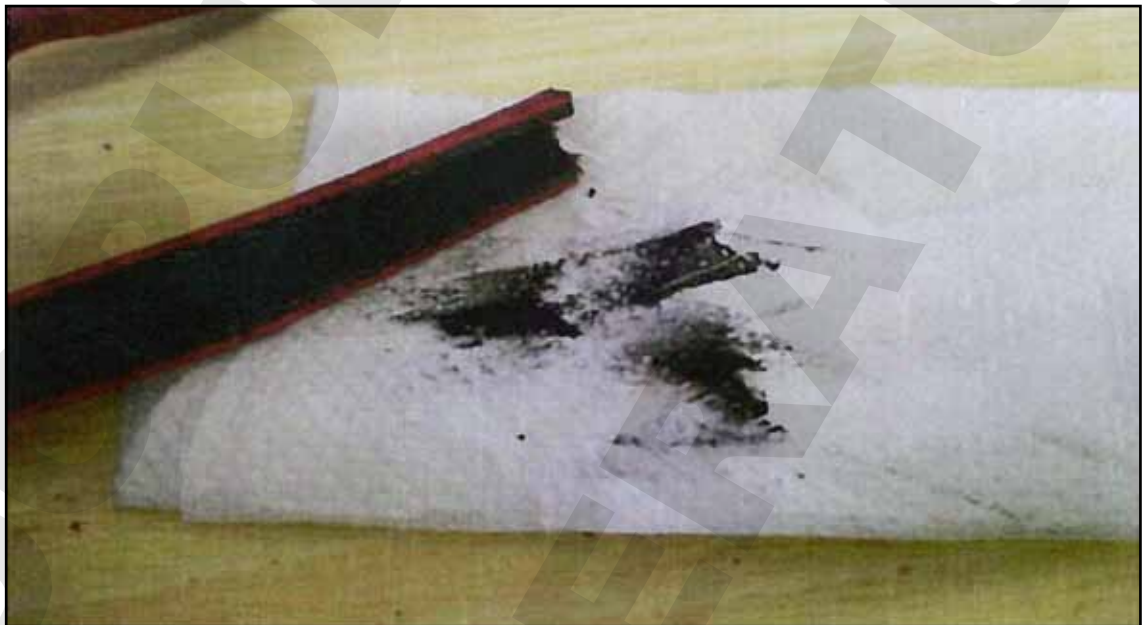
Figure 27

The flame front which precedes the flame can exceed the pressure test of the acetylene hose and cause it to fail, with the result that the flame will become exposed. A flashback is typically evidenced by carbon deposits on the inside of the hose walls – **Figure 27**.

Carbon deposits on the inside of an acetylene hose -
typical indications of a flashback

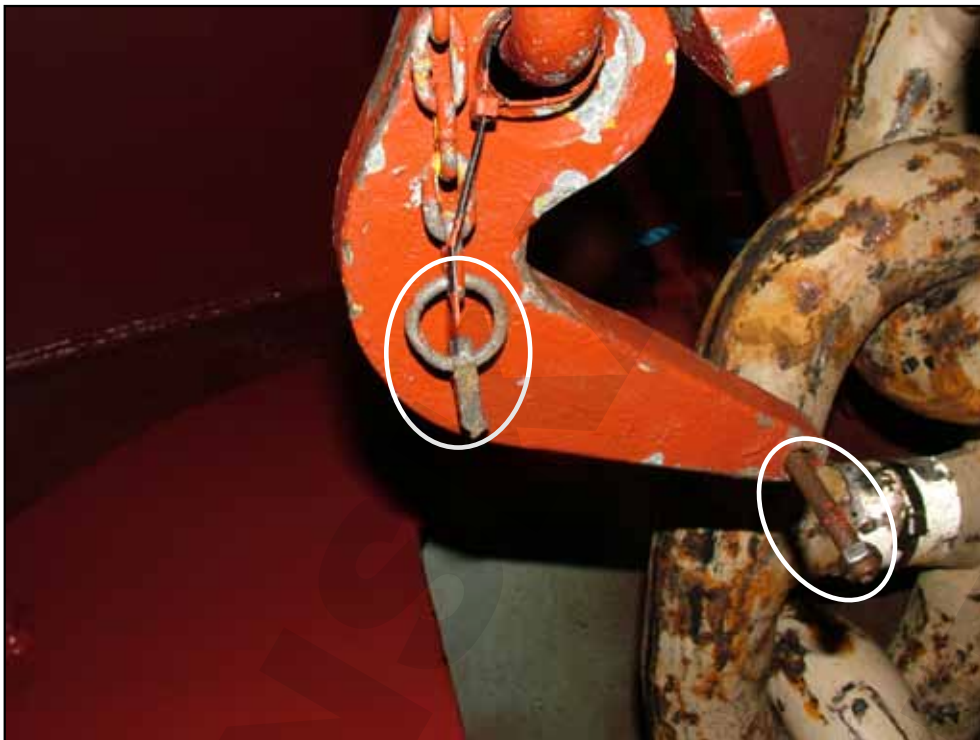
Maersk Newport's starboard anchor Senhouse slip failed tapered securing pin and replaced arrangement

The securing arrangement was subsequently modified by using a bow shackle instead of a Senhouse slip (**Figure 30**), and this was endorsed by the technical management team. However, there is no record of any representation being made to the manufacturer to highlight a possible design shortcoming. Neither was the shortcoming brought to the attention of the rest of A.P. Møller Maersk’s fleet.

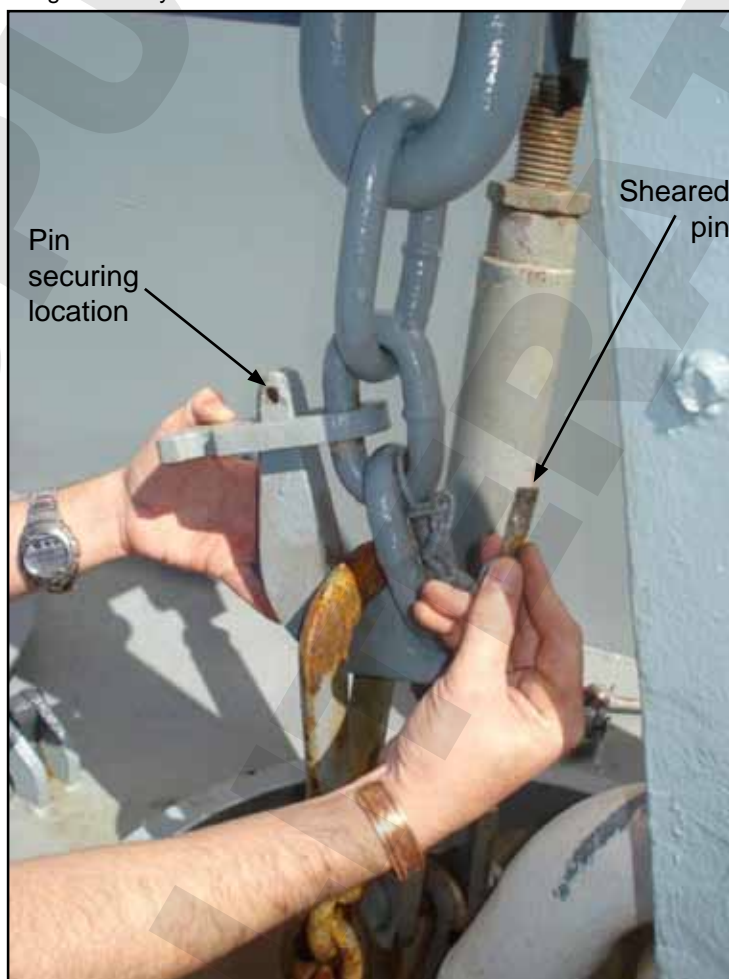
Figure 29

Safmarine Nyassa's starboard anchor Senhouse slip sheared tapered securing pin

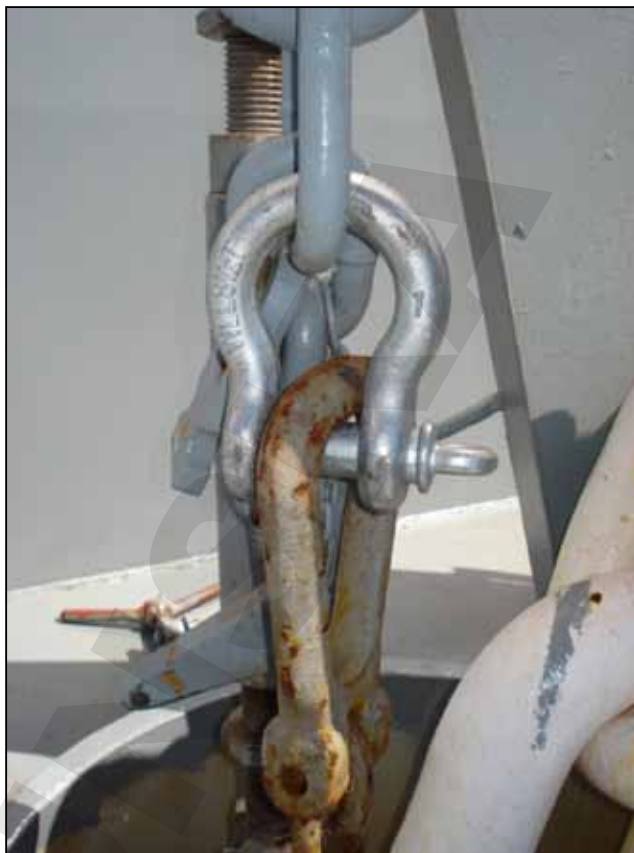
Safmarine Nyassa's starboard anchor Senhouse slip sheared tapered securing pin bow shackle replaced arrangement
