Report on the investigation into
the structural failure and foundering
of the general cargo ship
Swanland

Irish Sea

27 November 2011

with the loss of six crew

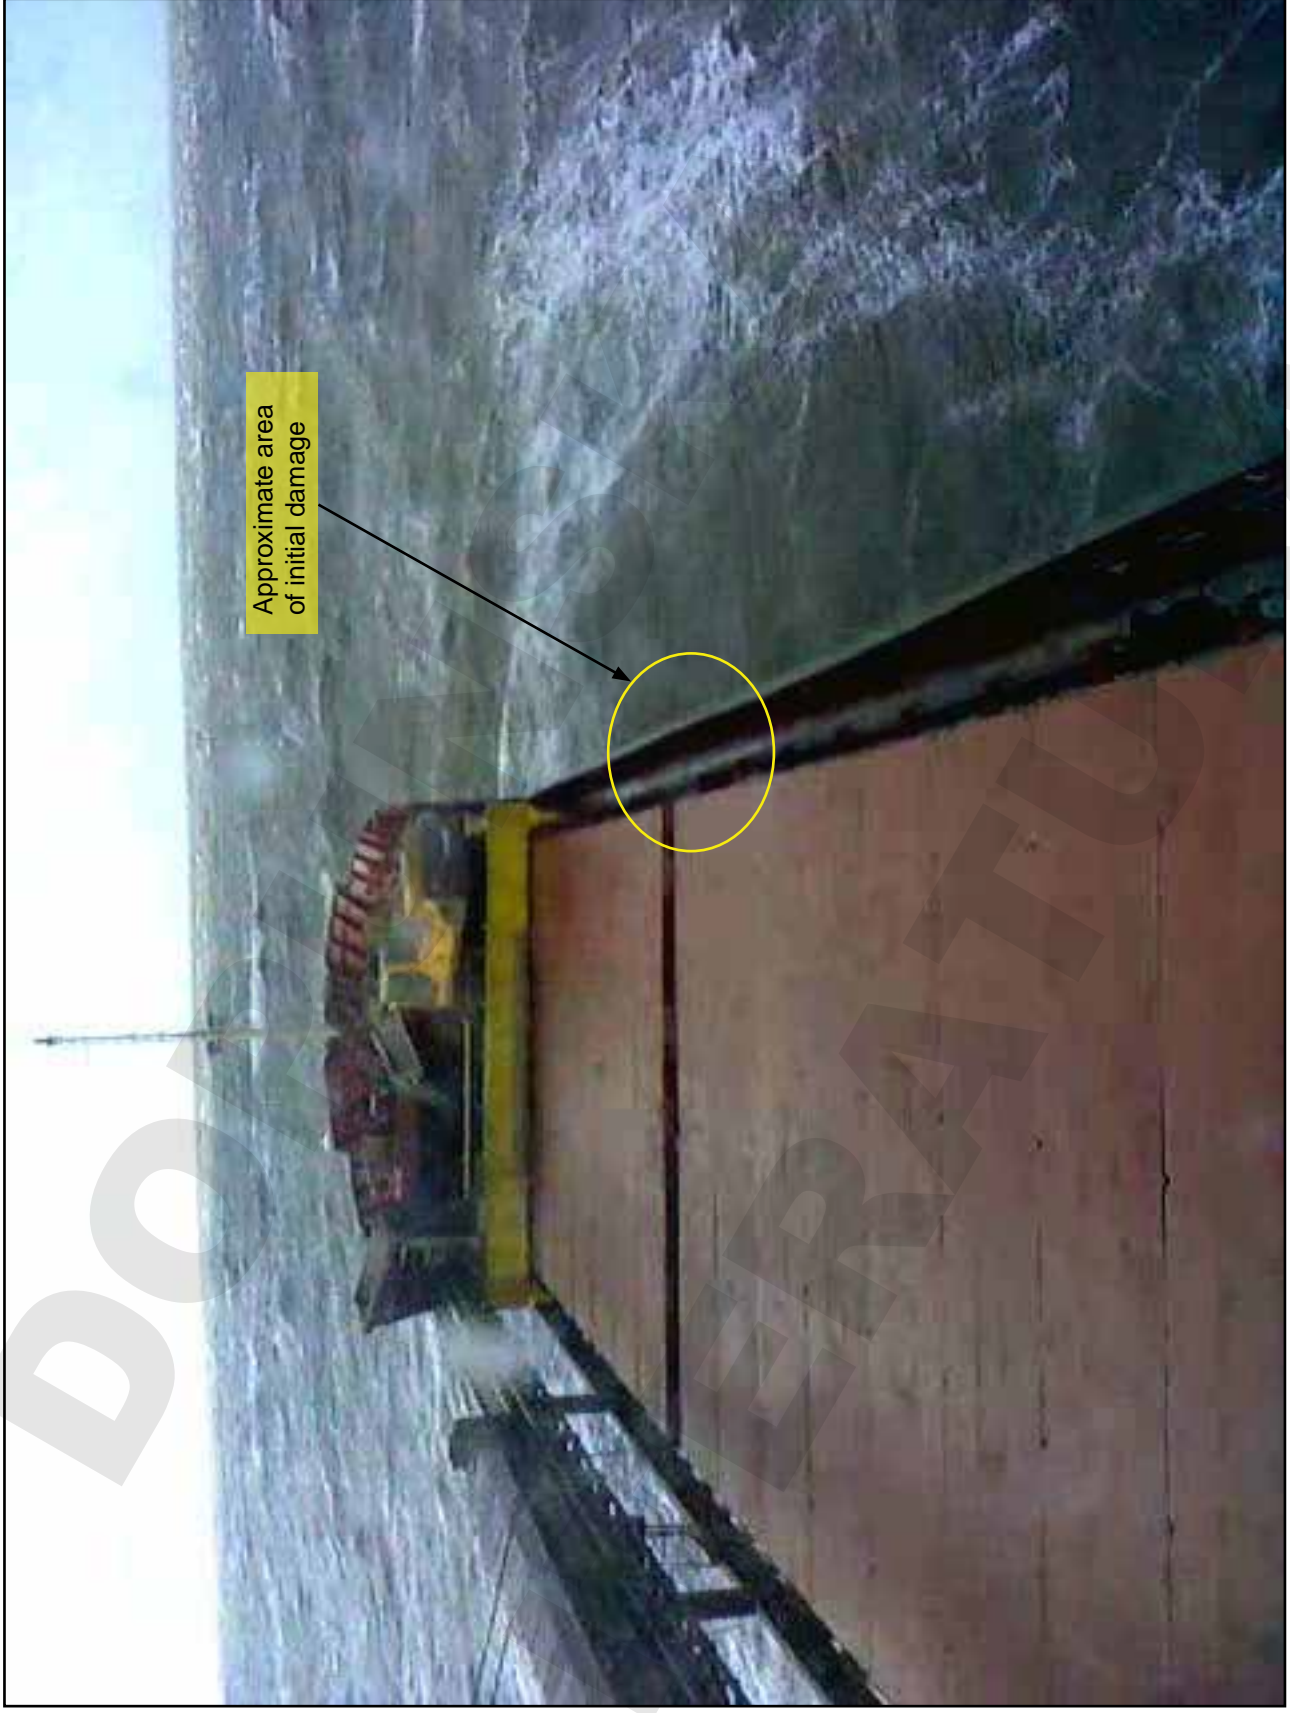
Figure 8: View looking forward from wheelhouse, annotated to show approximate area of initial damage

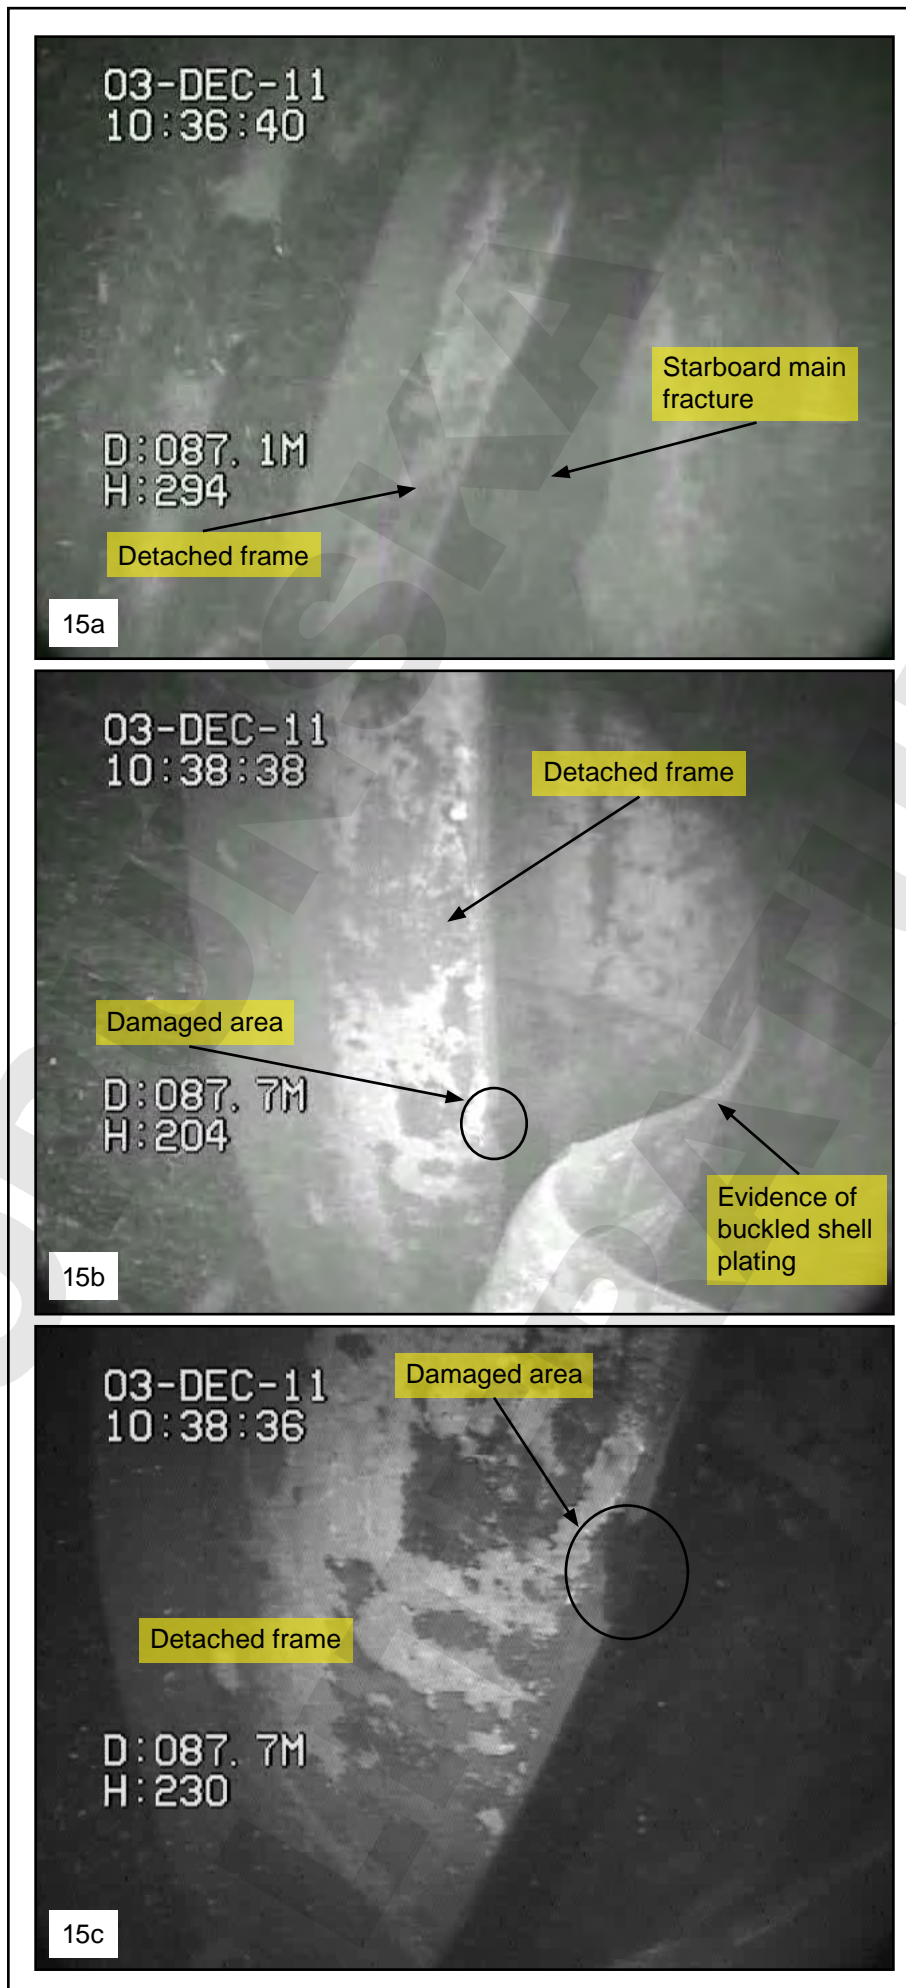
Figures 15a, 15b and 15c: Stills from MiniROV showing the structural failure on starboard side (from inside cargo hold)

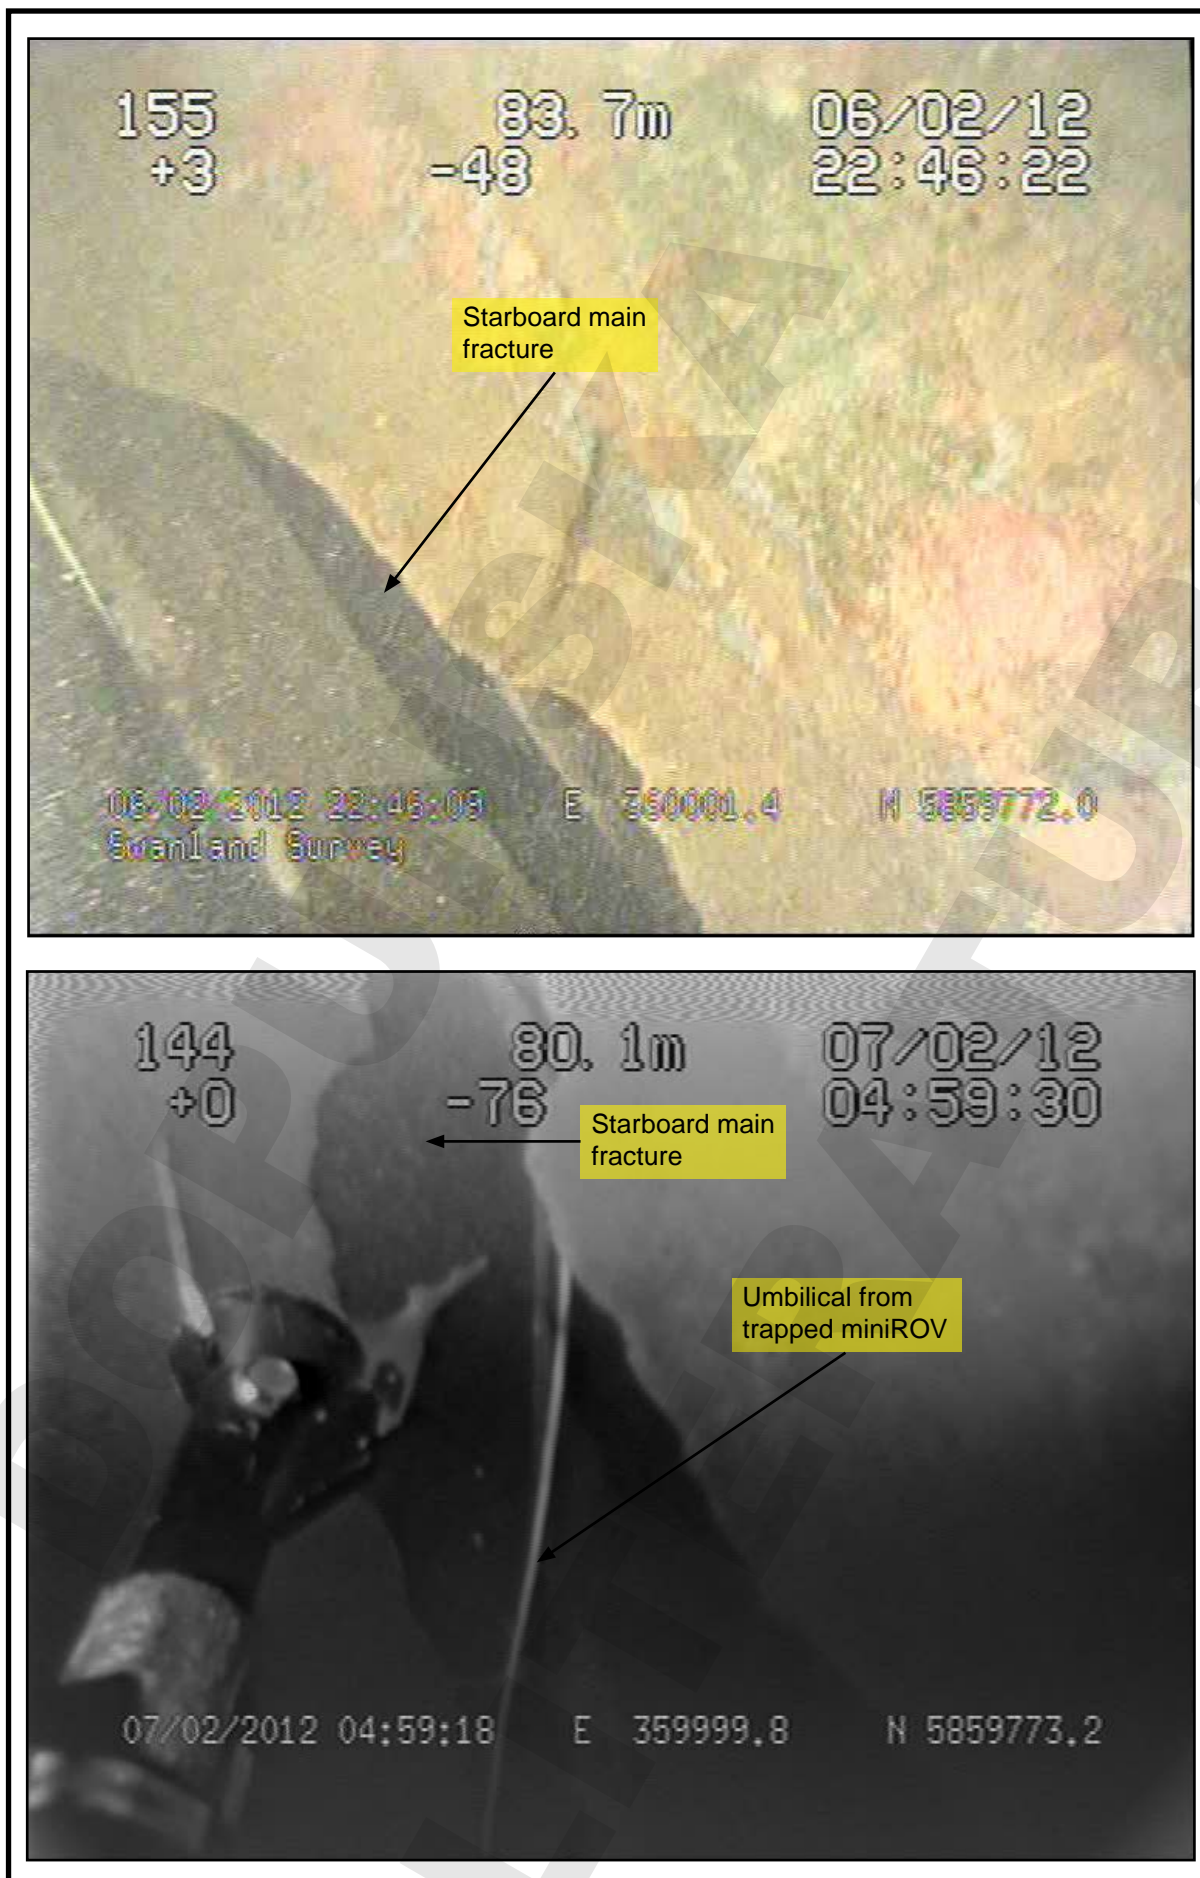
Figures 18a and 18b: Stills from ROV footage showing damage close to the starboard load line mark

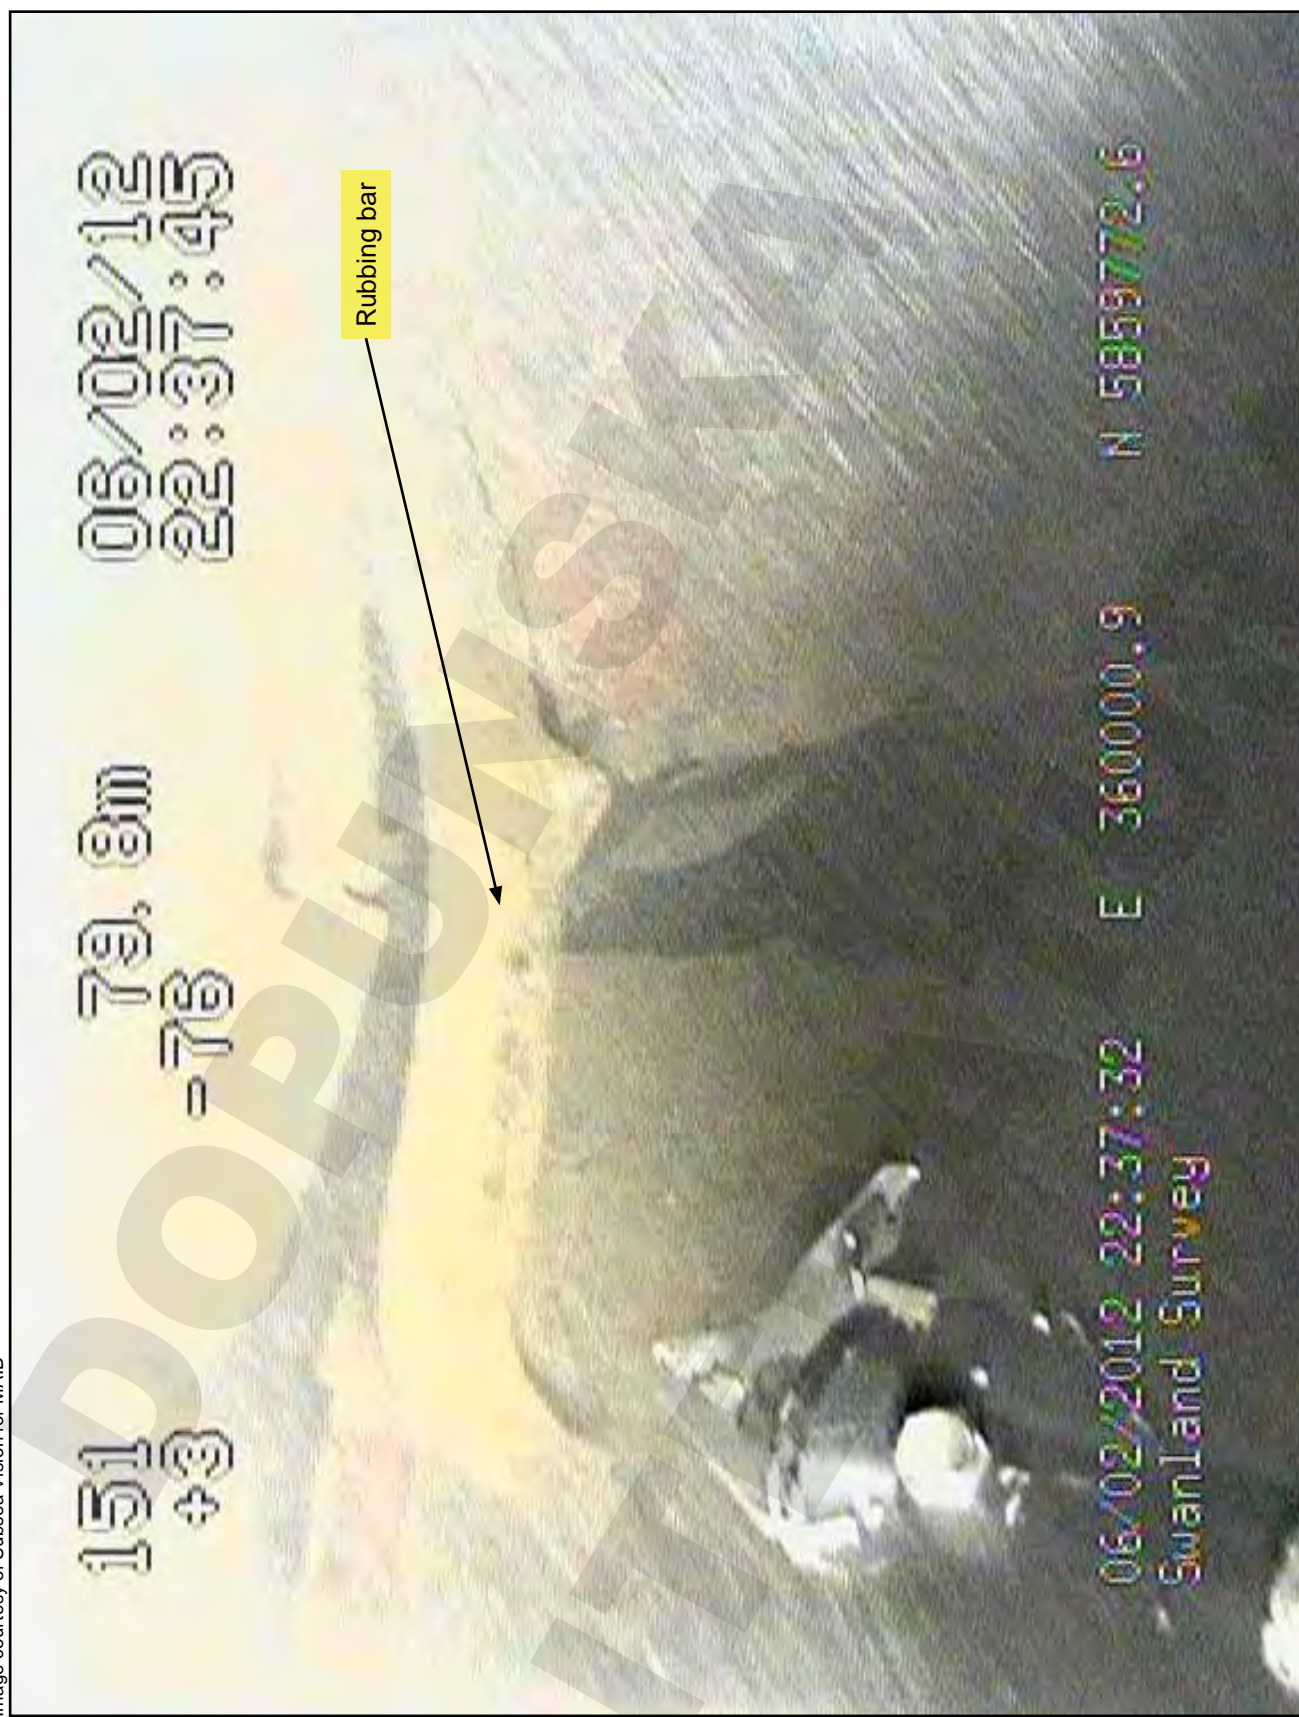
Figure 20: Still from ROV footage showing 'V' shaped fracture in way of the rubbing bar above the starboard bilge keel

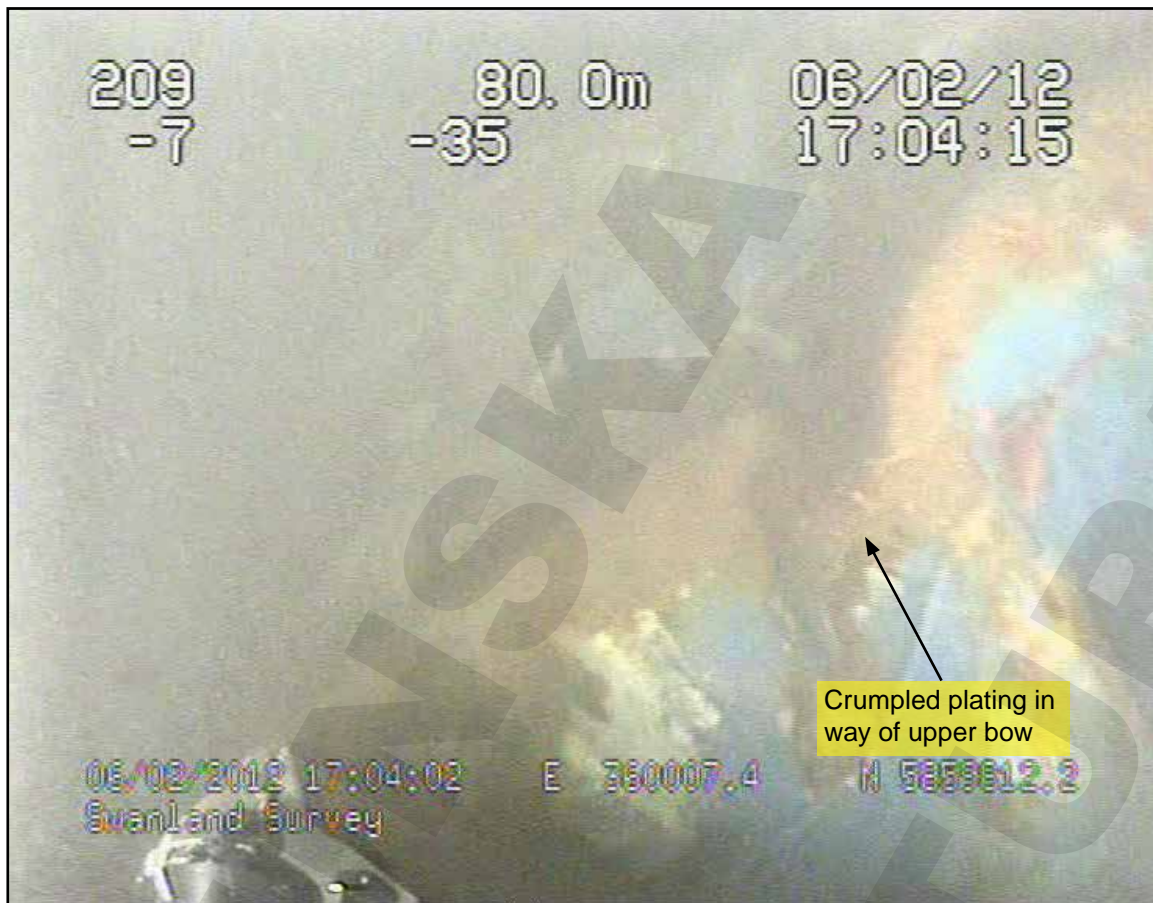
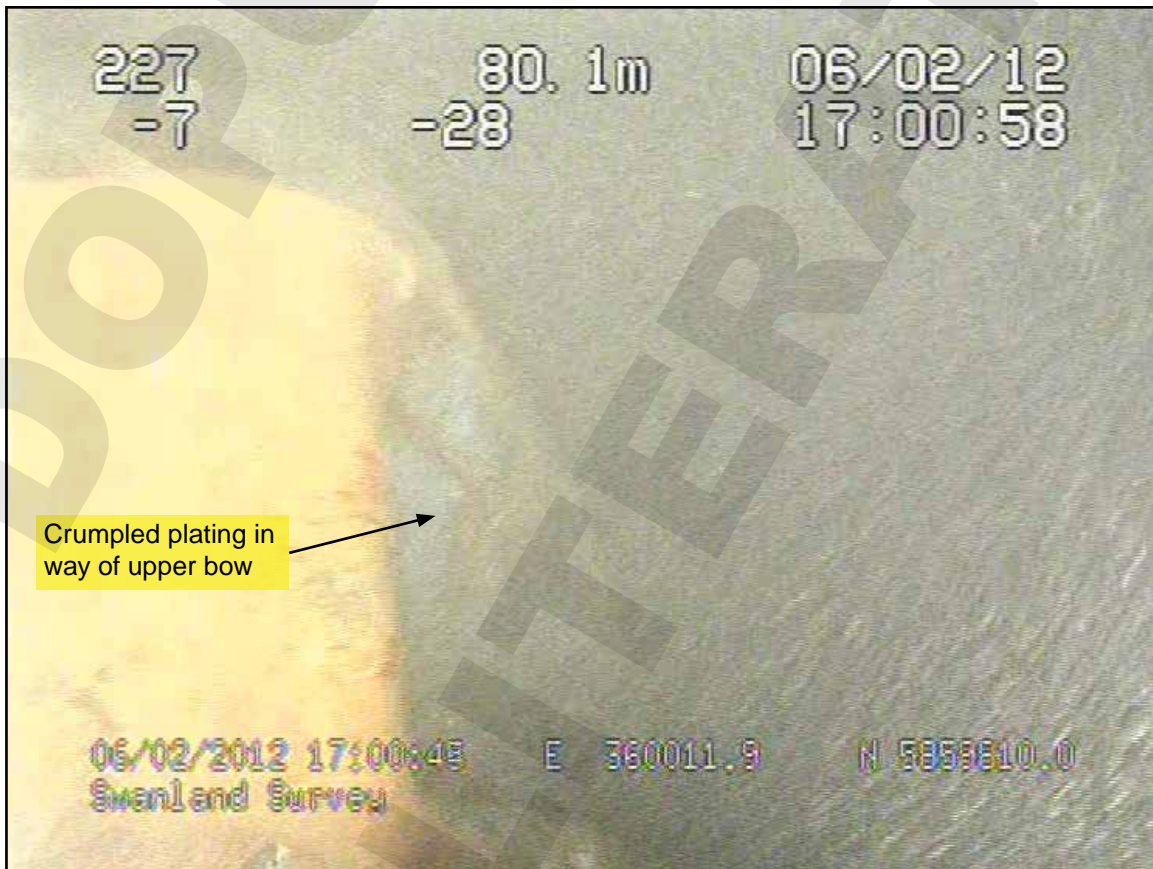
Figures 30a and 30b: Stills from ROV footage showing crumpling of the top of the stem and bulwarks

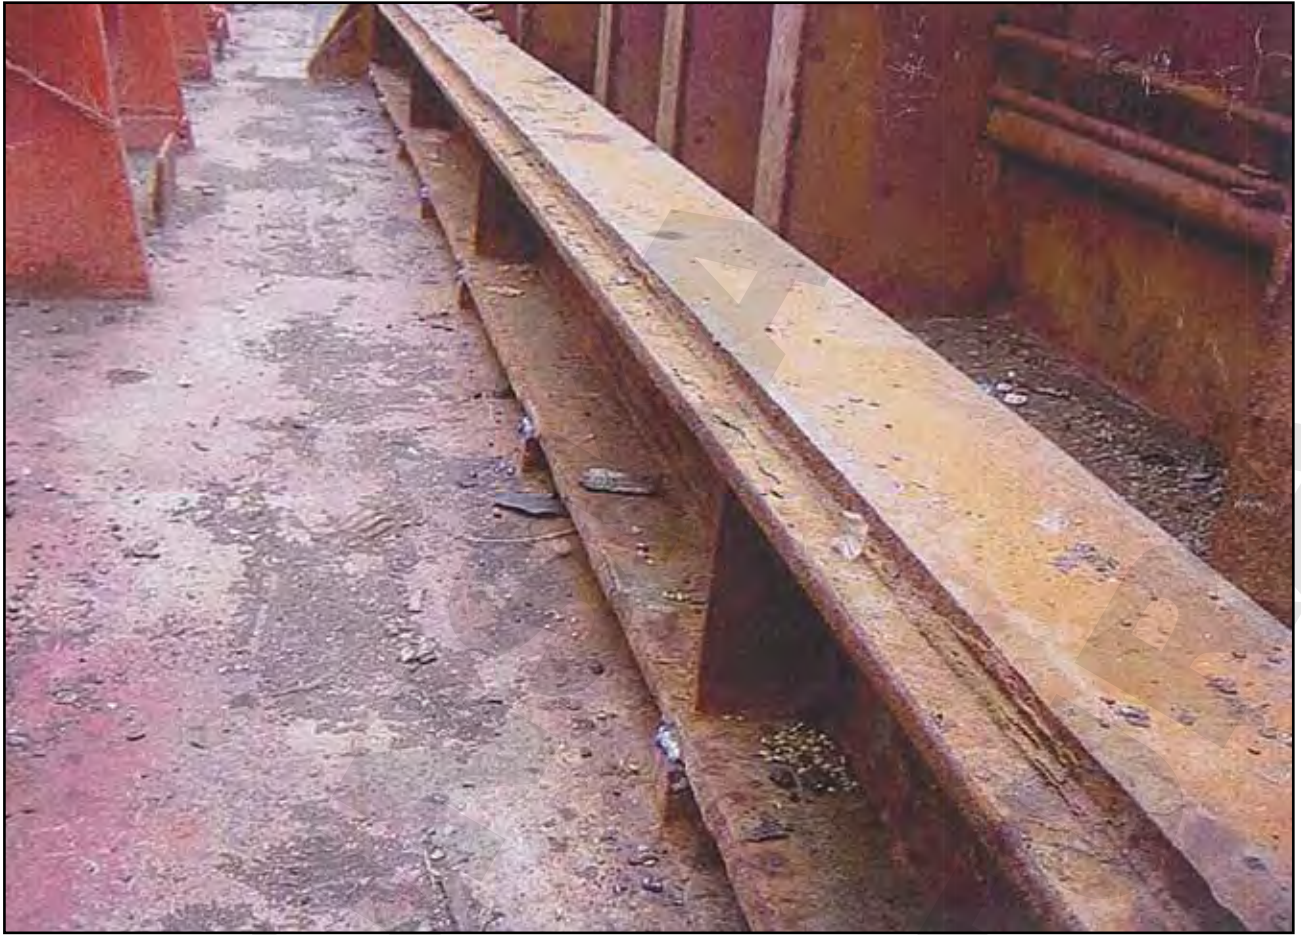
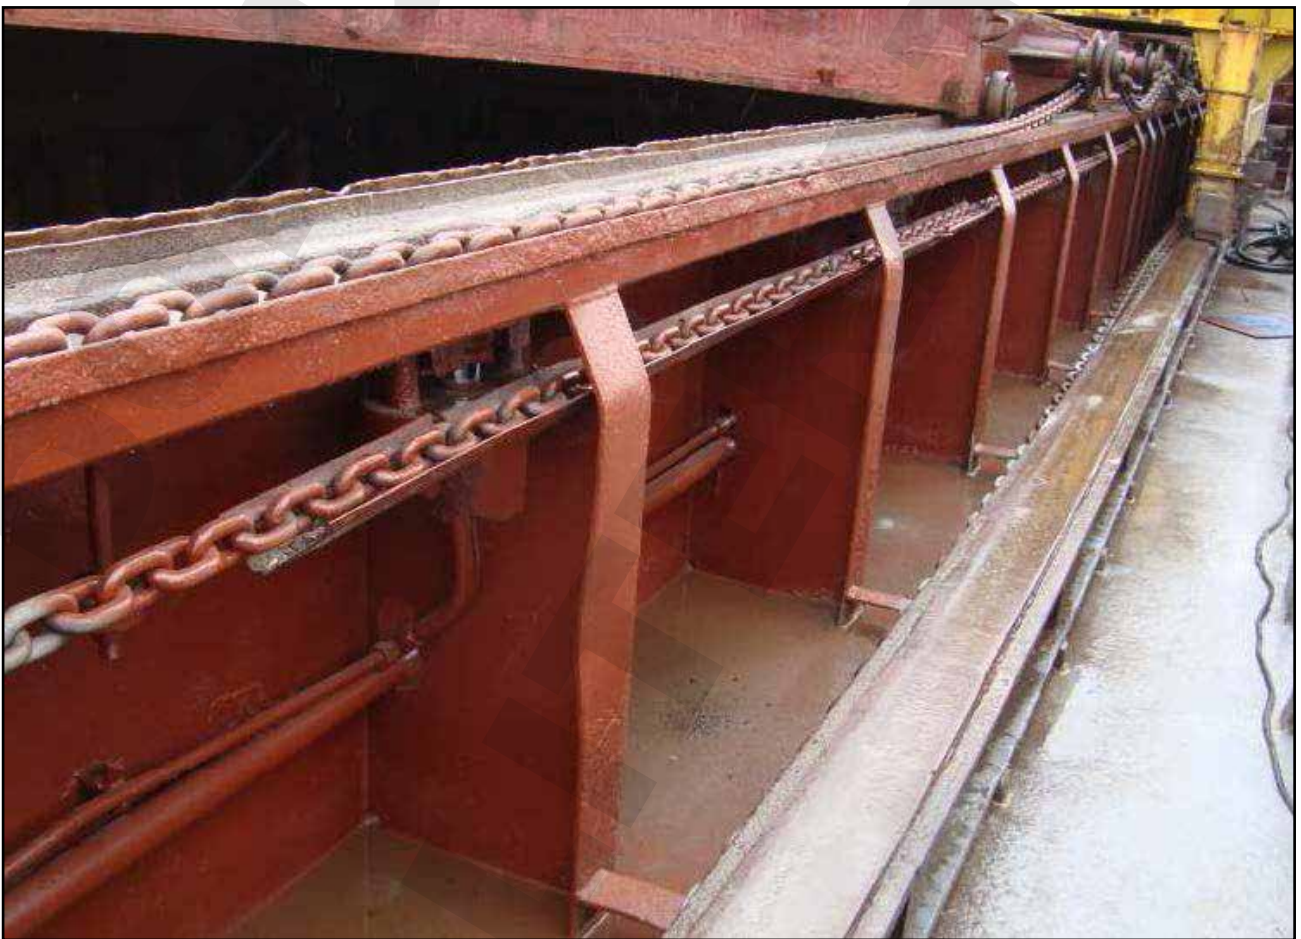
As part of its analysis (**Annex D**), Braemar commented that the addition of the self-discharging equipment would have had an overall beneficial effect on the structural capacity of *Swanland*, given the alterations to the transverse frames. However, Braemar also noted that the installation of the rails either side of the hatch coamings would have created a water 'trap' area where corrosion would have been more likely to develop, as shown at **Figures 39a** and **39b**.

Figures 39a and 39b: Water trap area between excavator carriage rail and cargo hold hatch coaming on *Swanland*

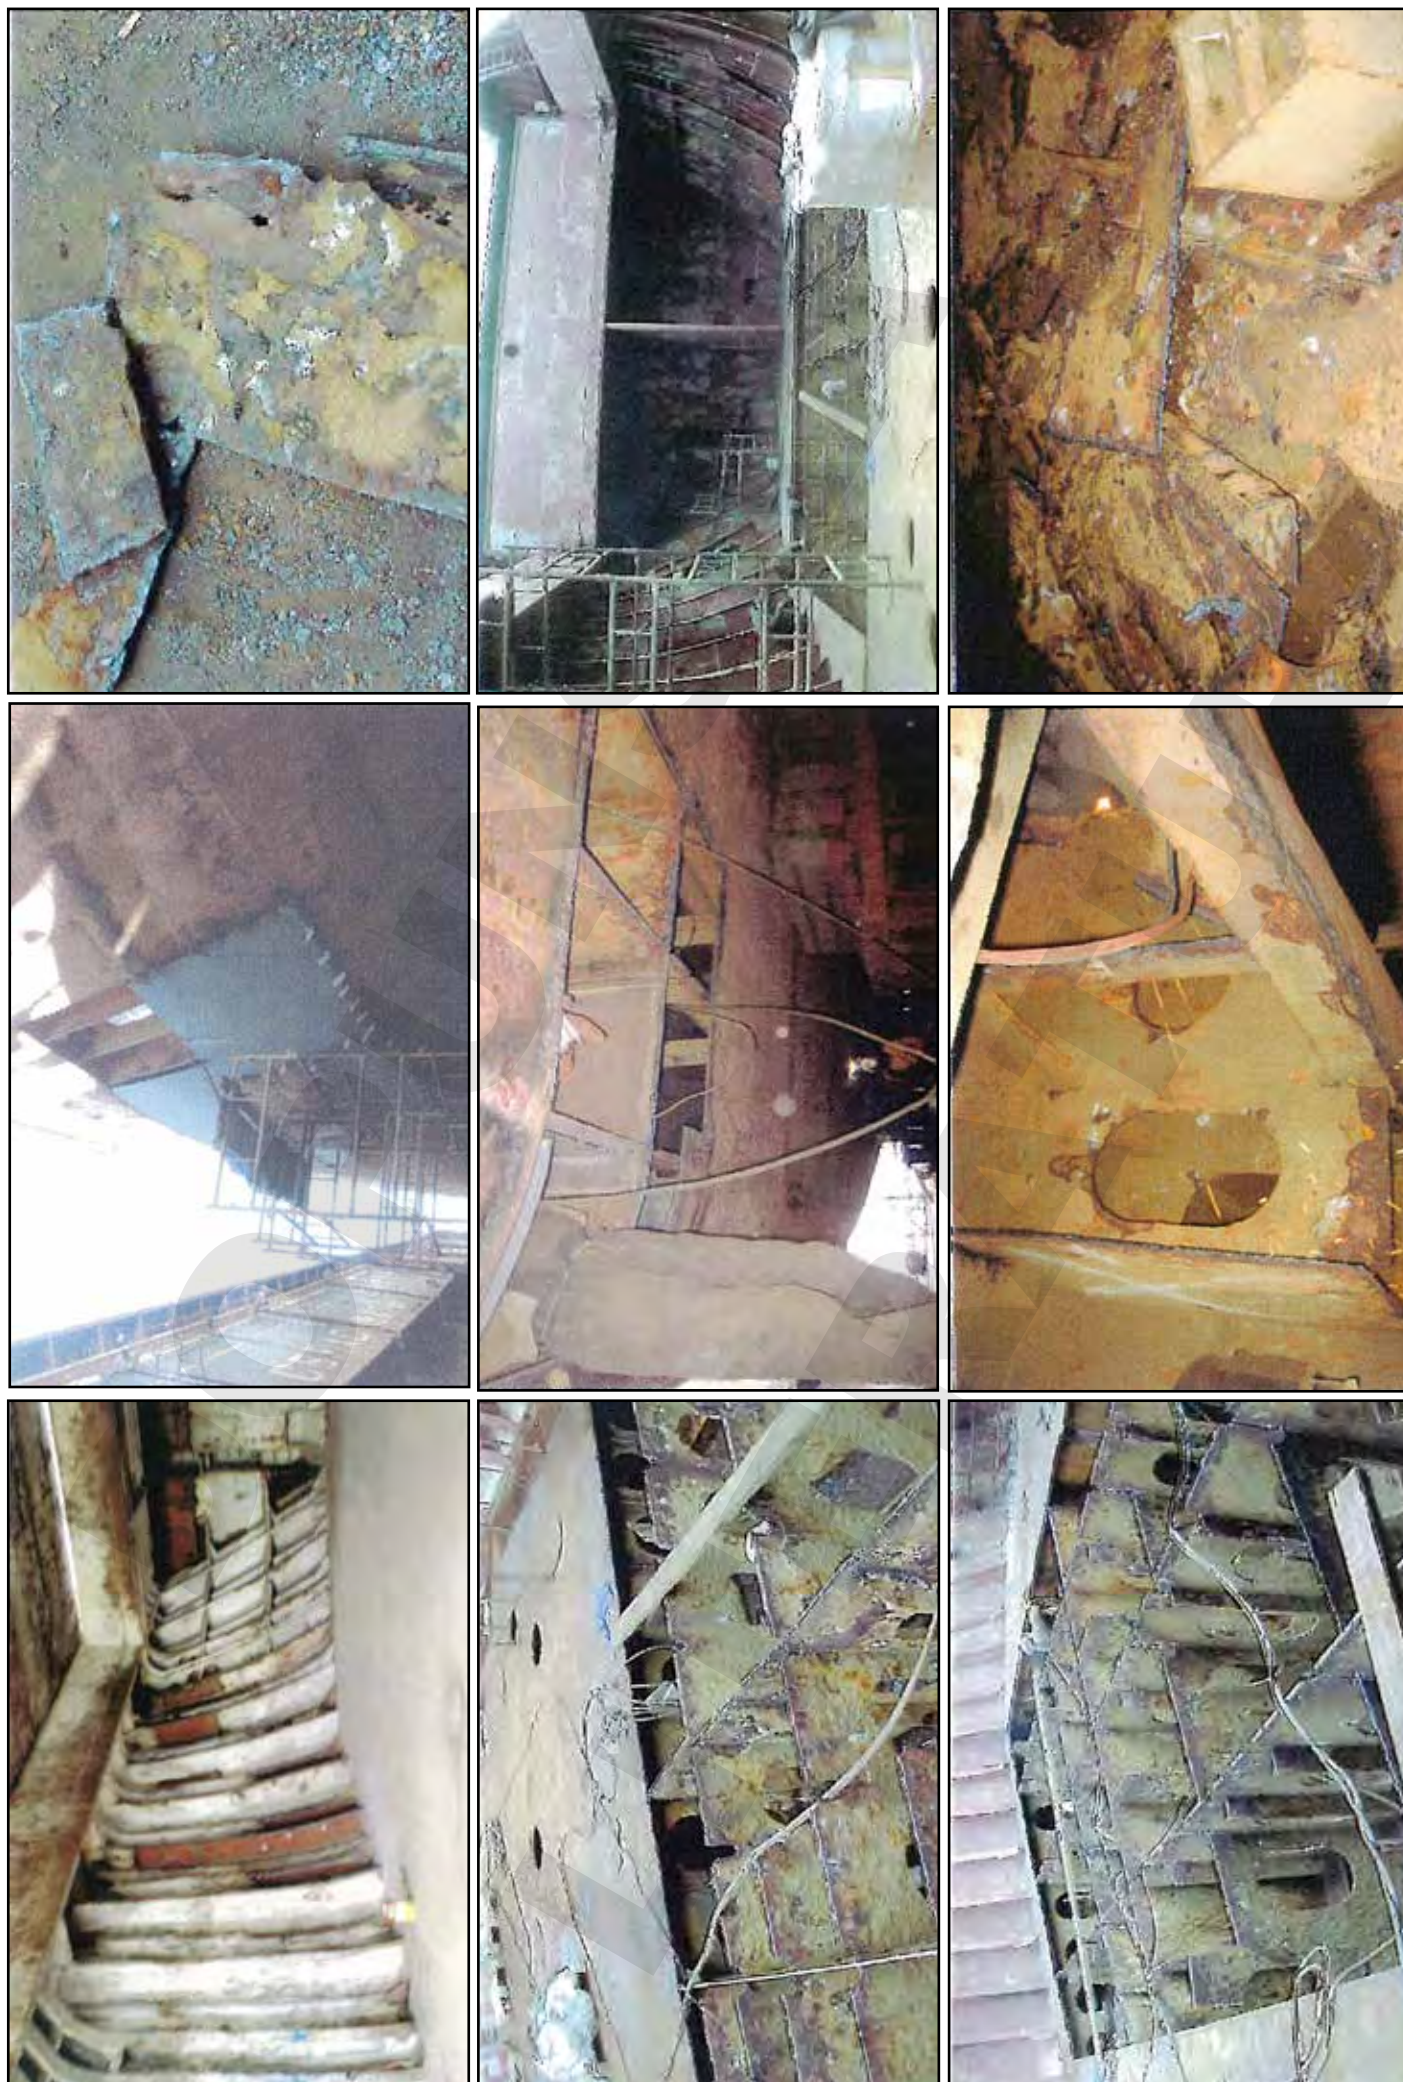
Figure 40: Repair work underway in Liepaja in 2006

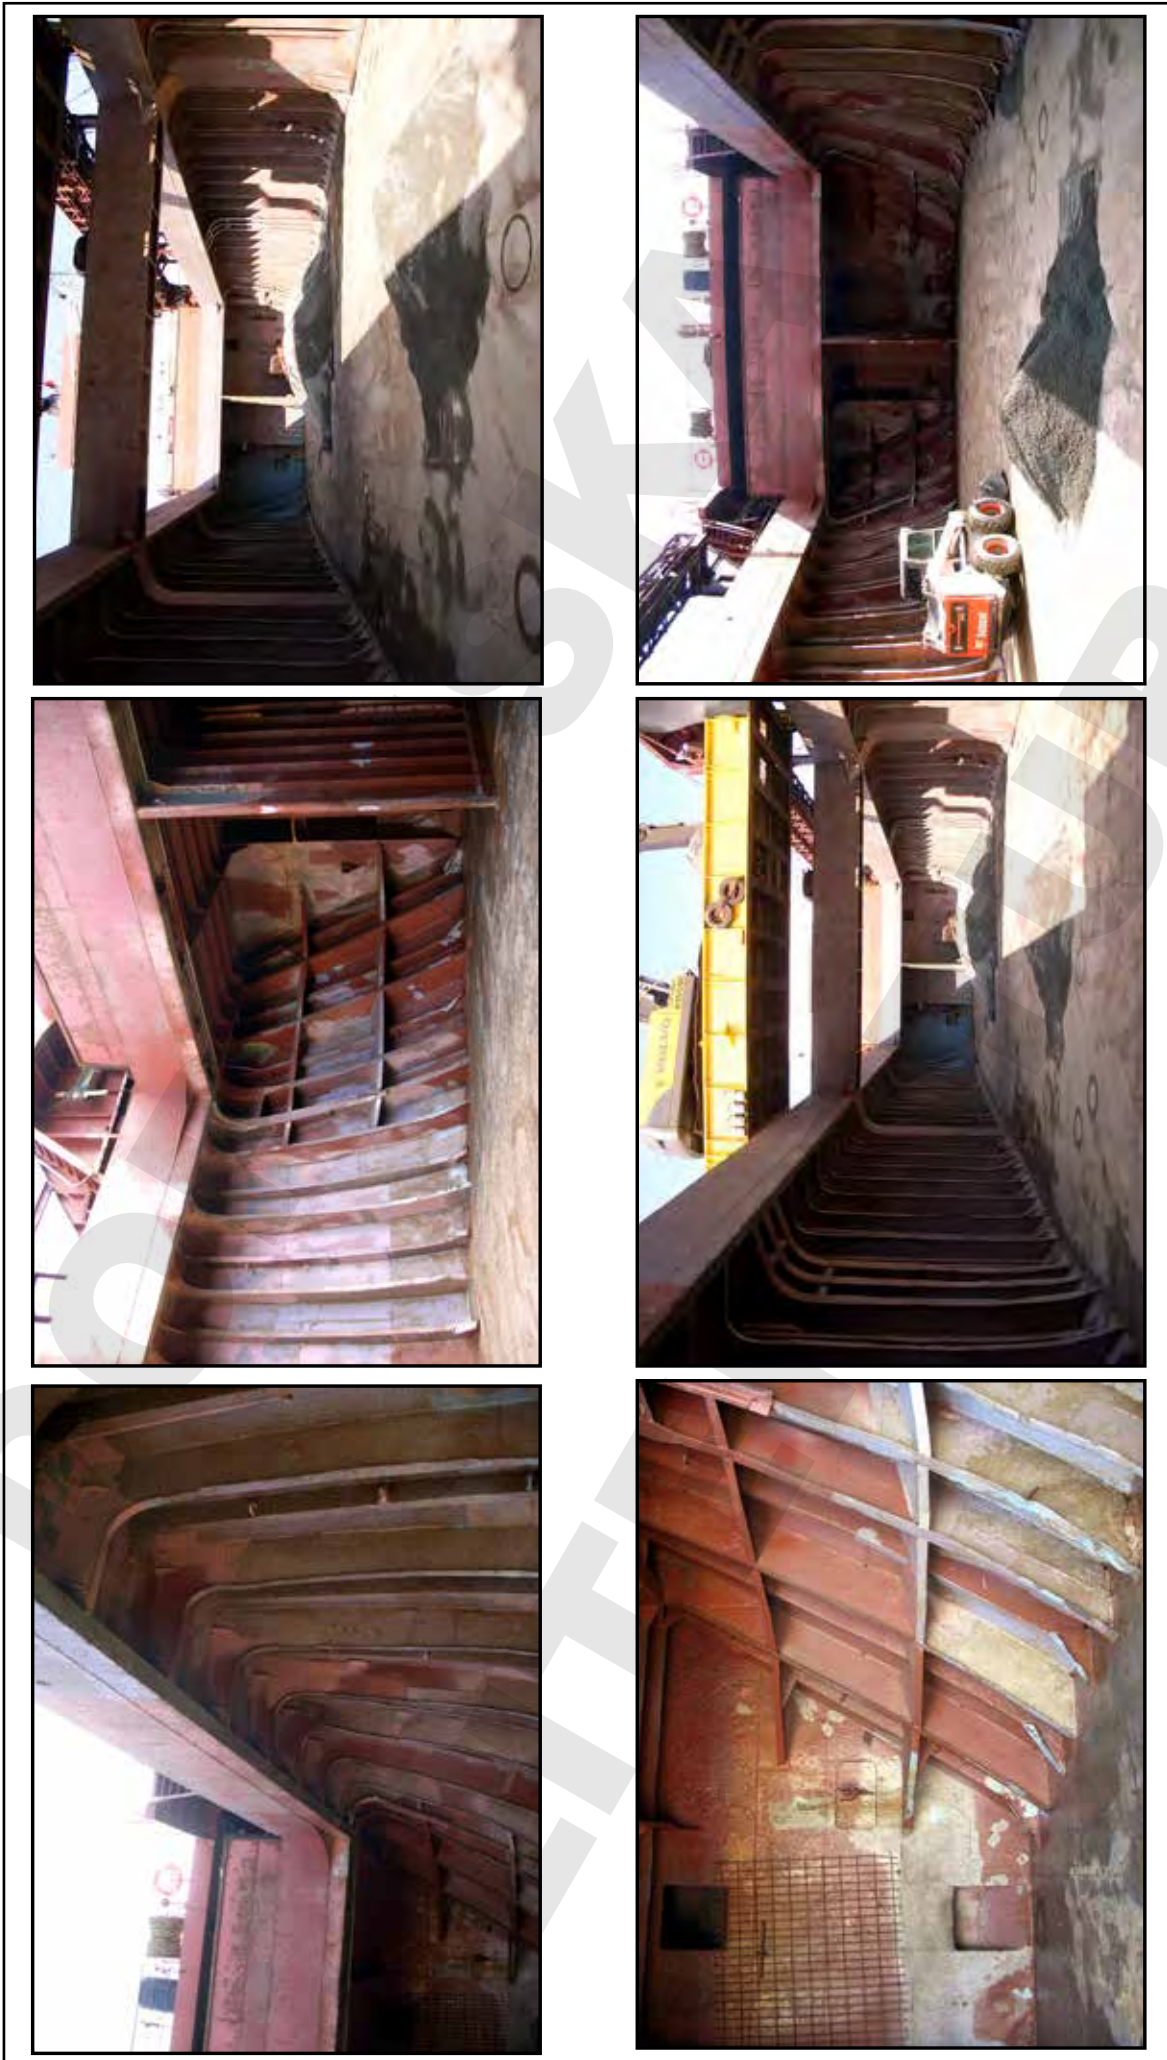
Figure 47: Photographs of *Swanland's* hold in September 2011

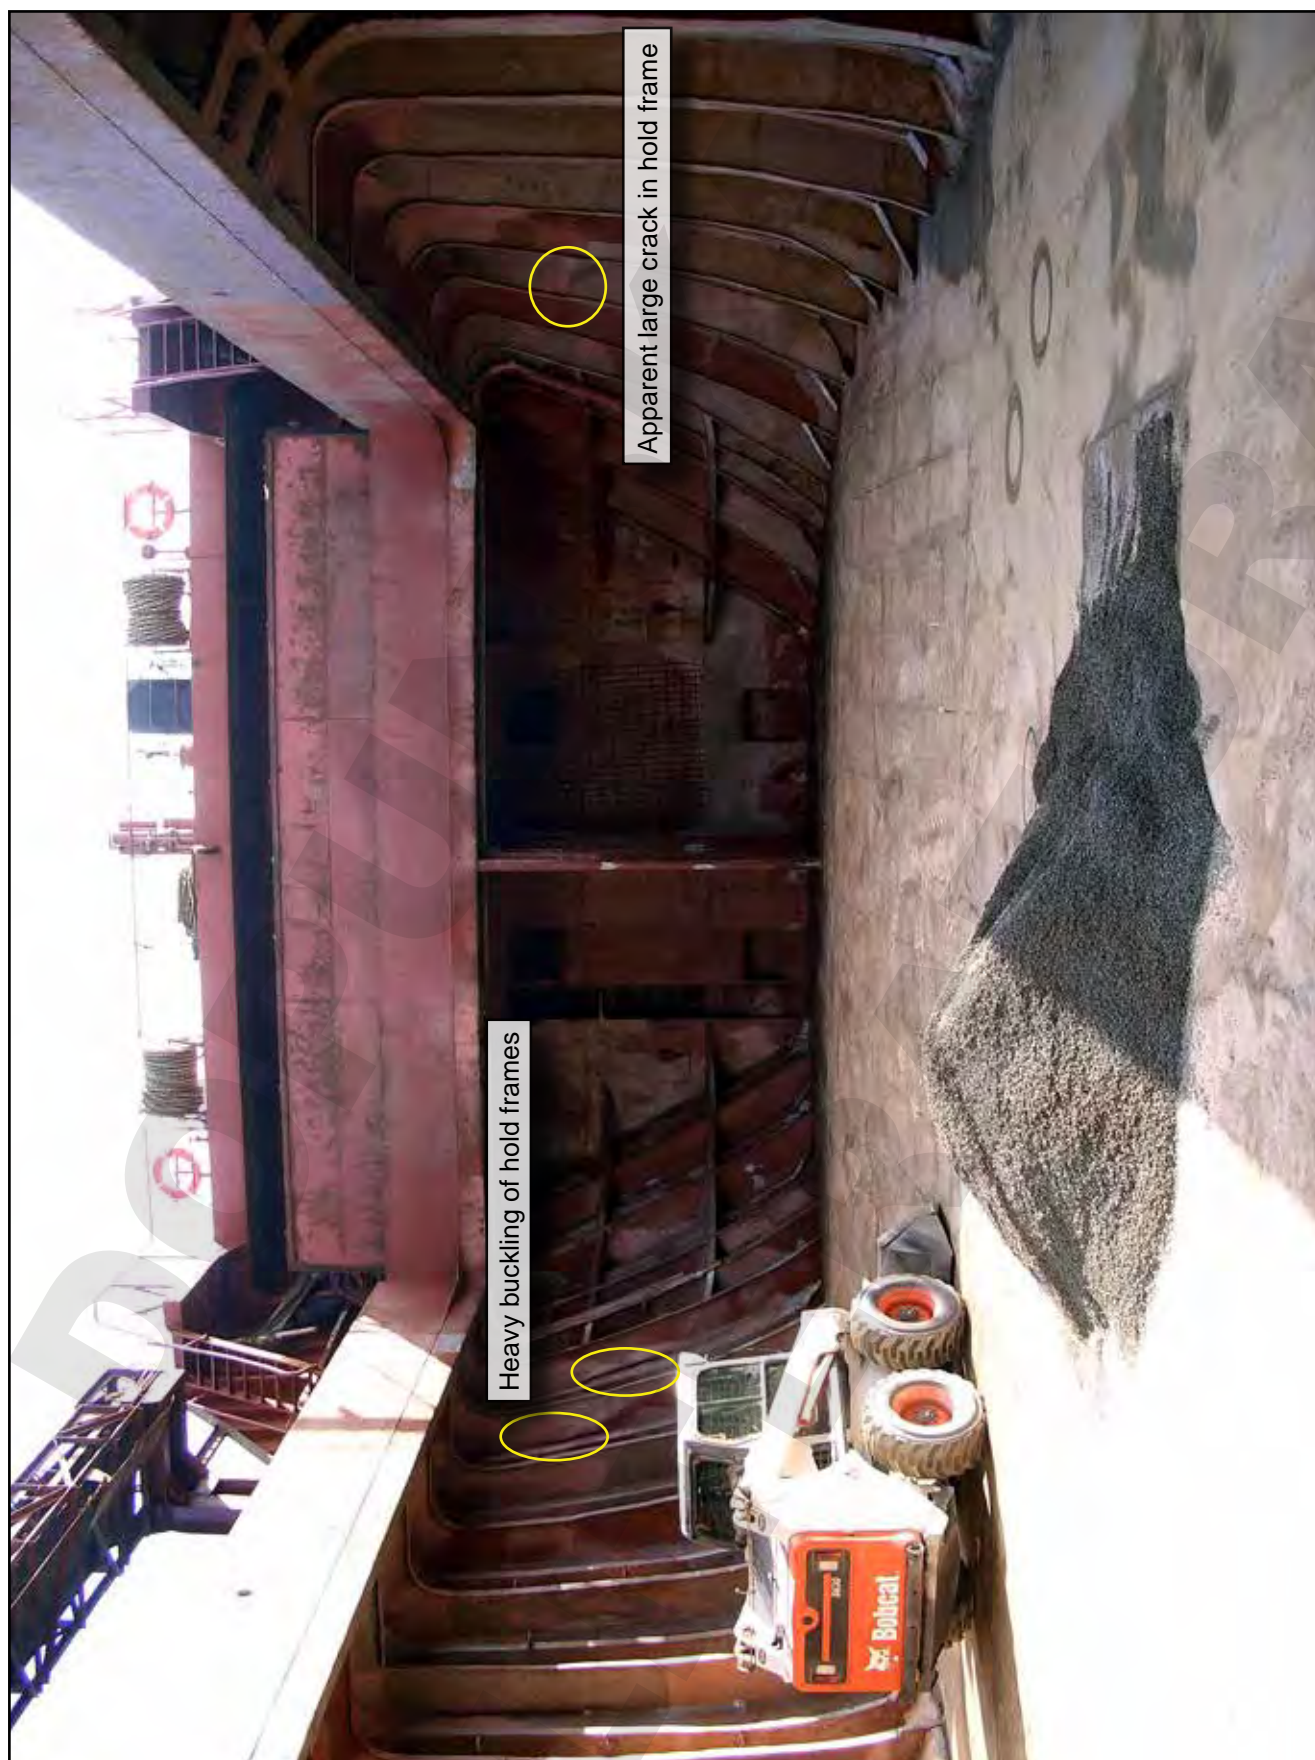
It is apparent that following an intensive period of carrying salt cargoes in late 2010, the condition of the hold necessitated its pressure washing and painting in July 2011. However, as can be seen in **Figures 75a, b, c, d, e and f** the hold coating appeared to be in a poor condition. Closer examination of these photographs appears to show that in addition to mechanical damage, there were areas of coating loss, instances of frame detachment, substantial cracks in some frames, and areas of significant pitting and general corrosion. It also appears that scale (much of it heavy) had simply been painted over.

Figures 75a: Photograph of Swanland's hold in September 2011 showing apparent structural defects
