Report on the investigation into
the structural failure and foundering
of the general cargo ship
Swanland

Irish Sea

27 November 2011

with the loss of six crew

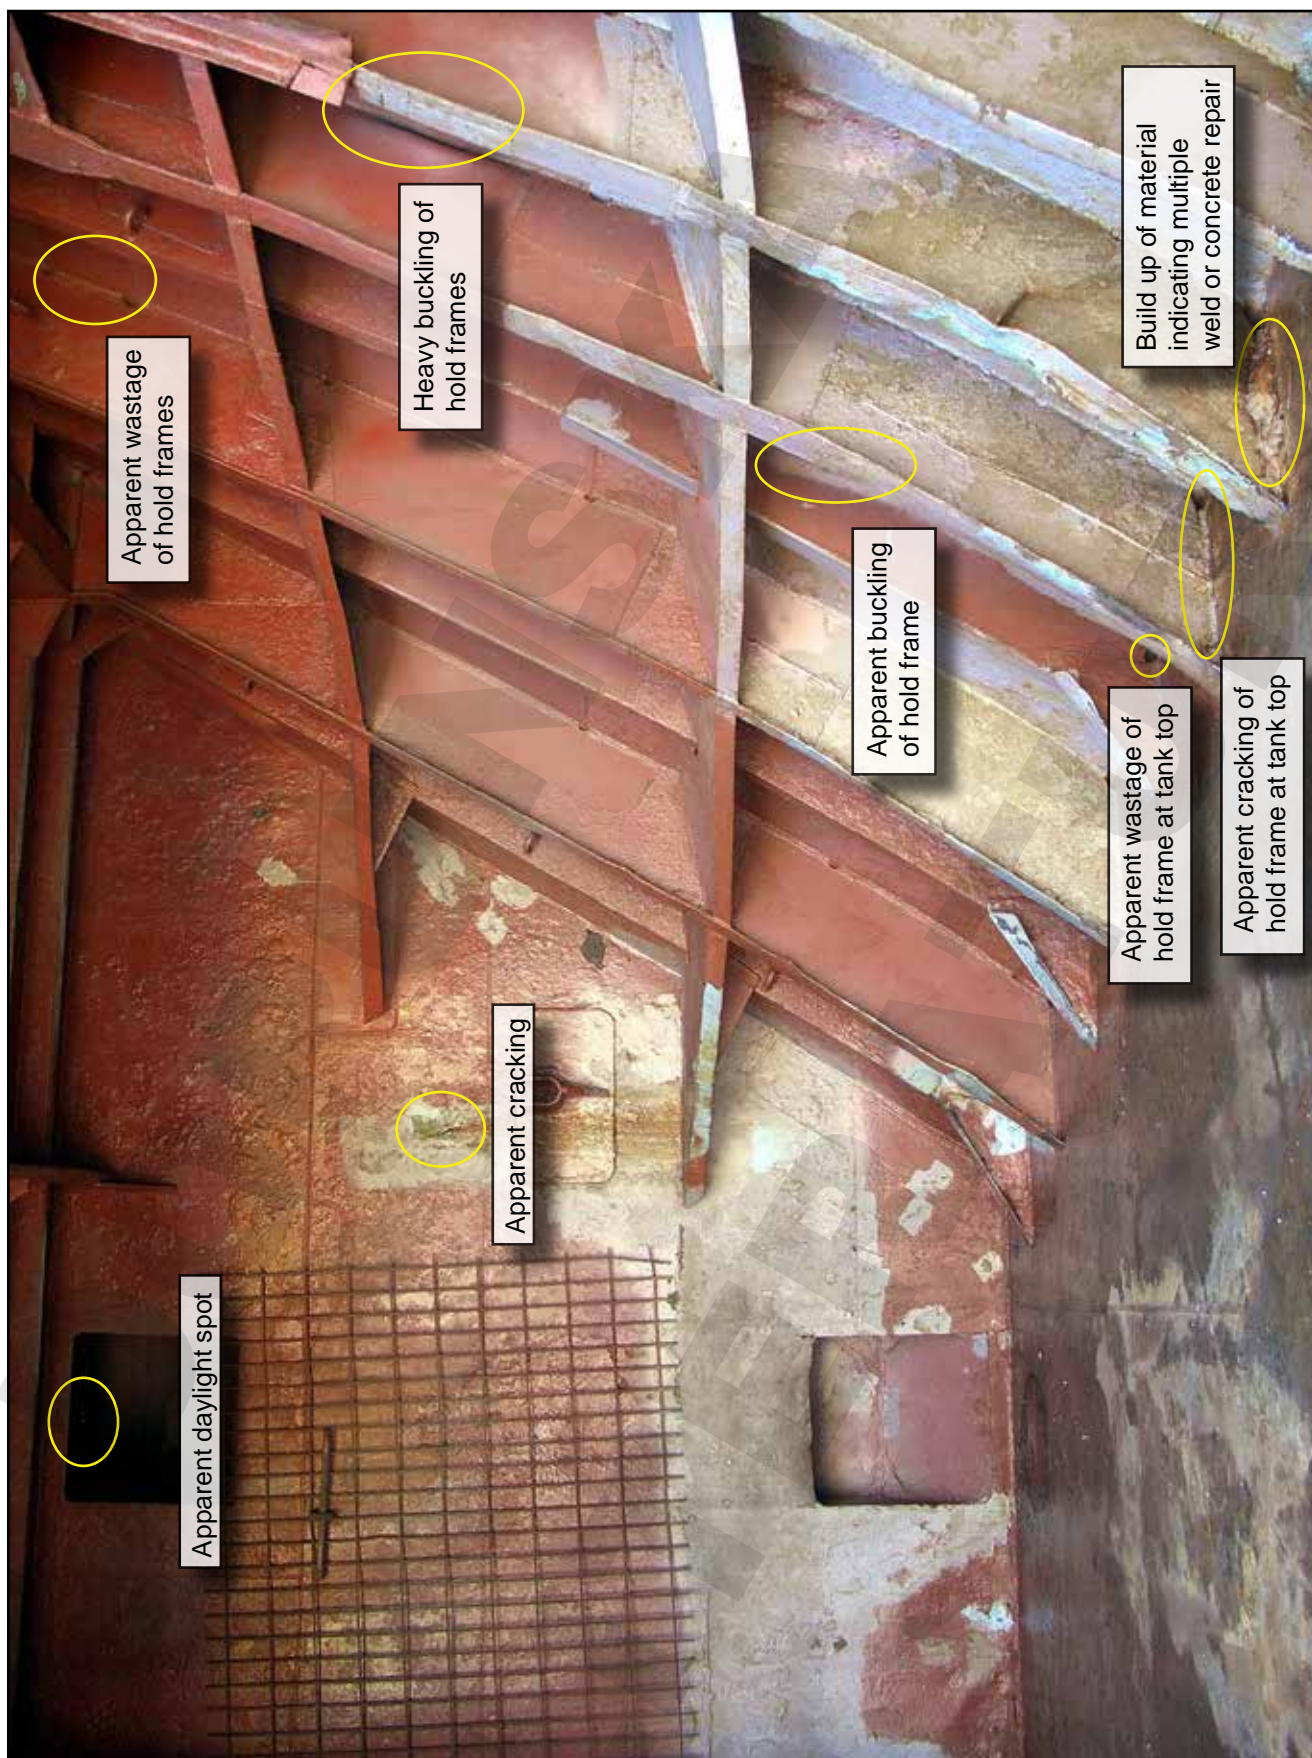
Figures 75c: Photograph of Swanland's hold in September 2011 showing apparent structural defects

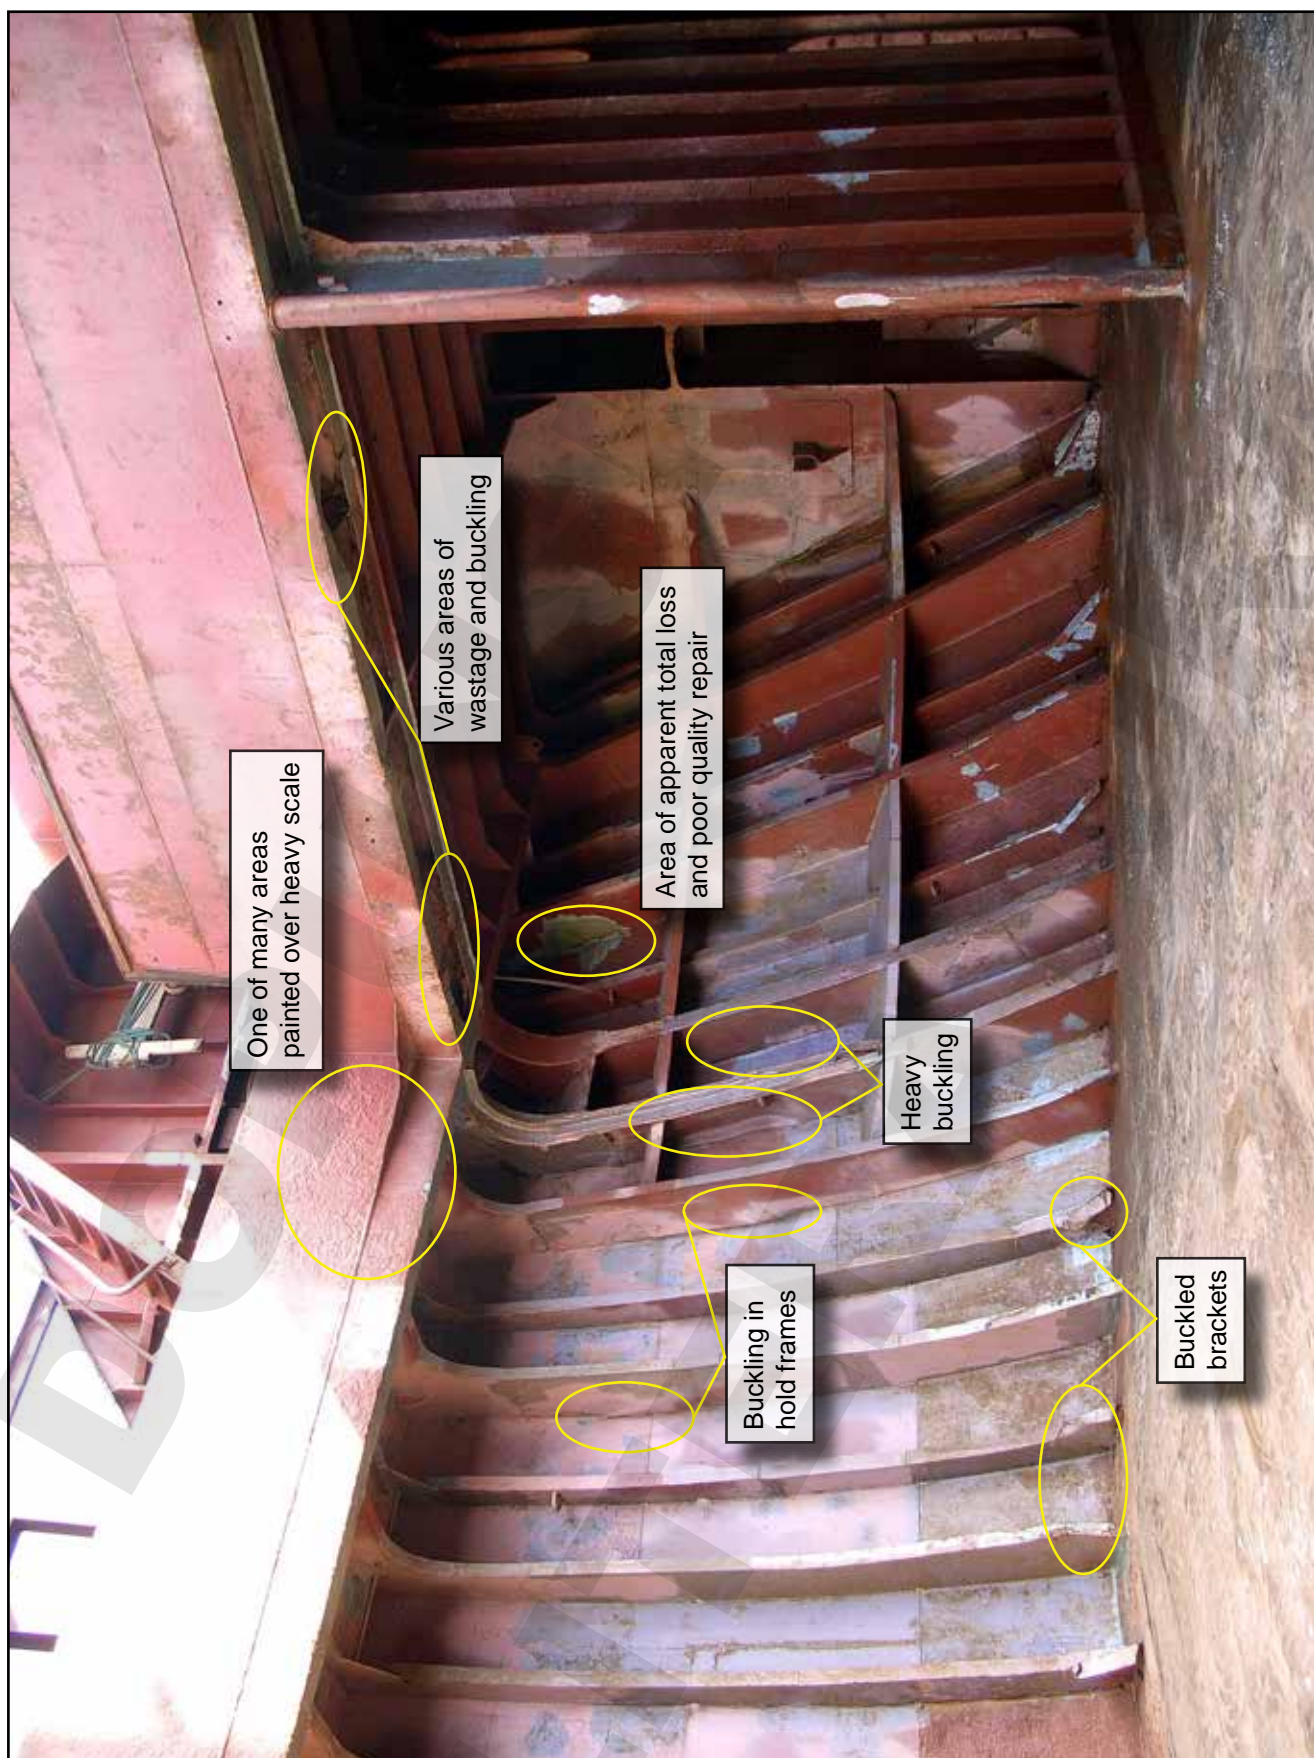
Figures 75e: Photograph of Swanland's hold in September 2011 showing apparent structural defects

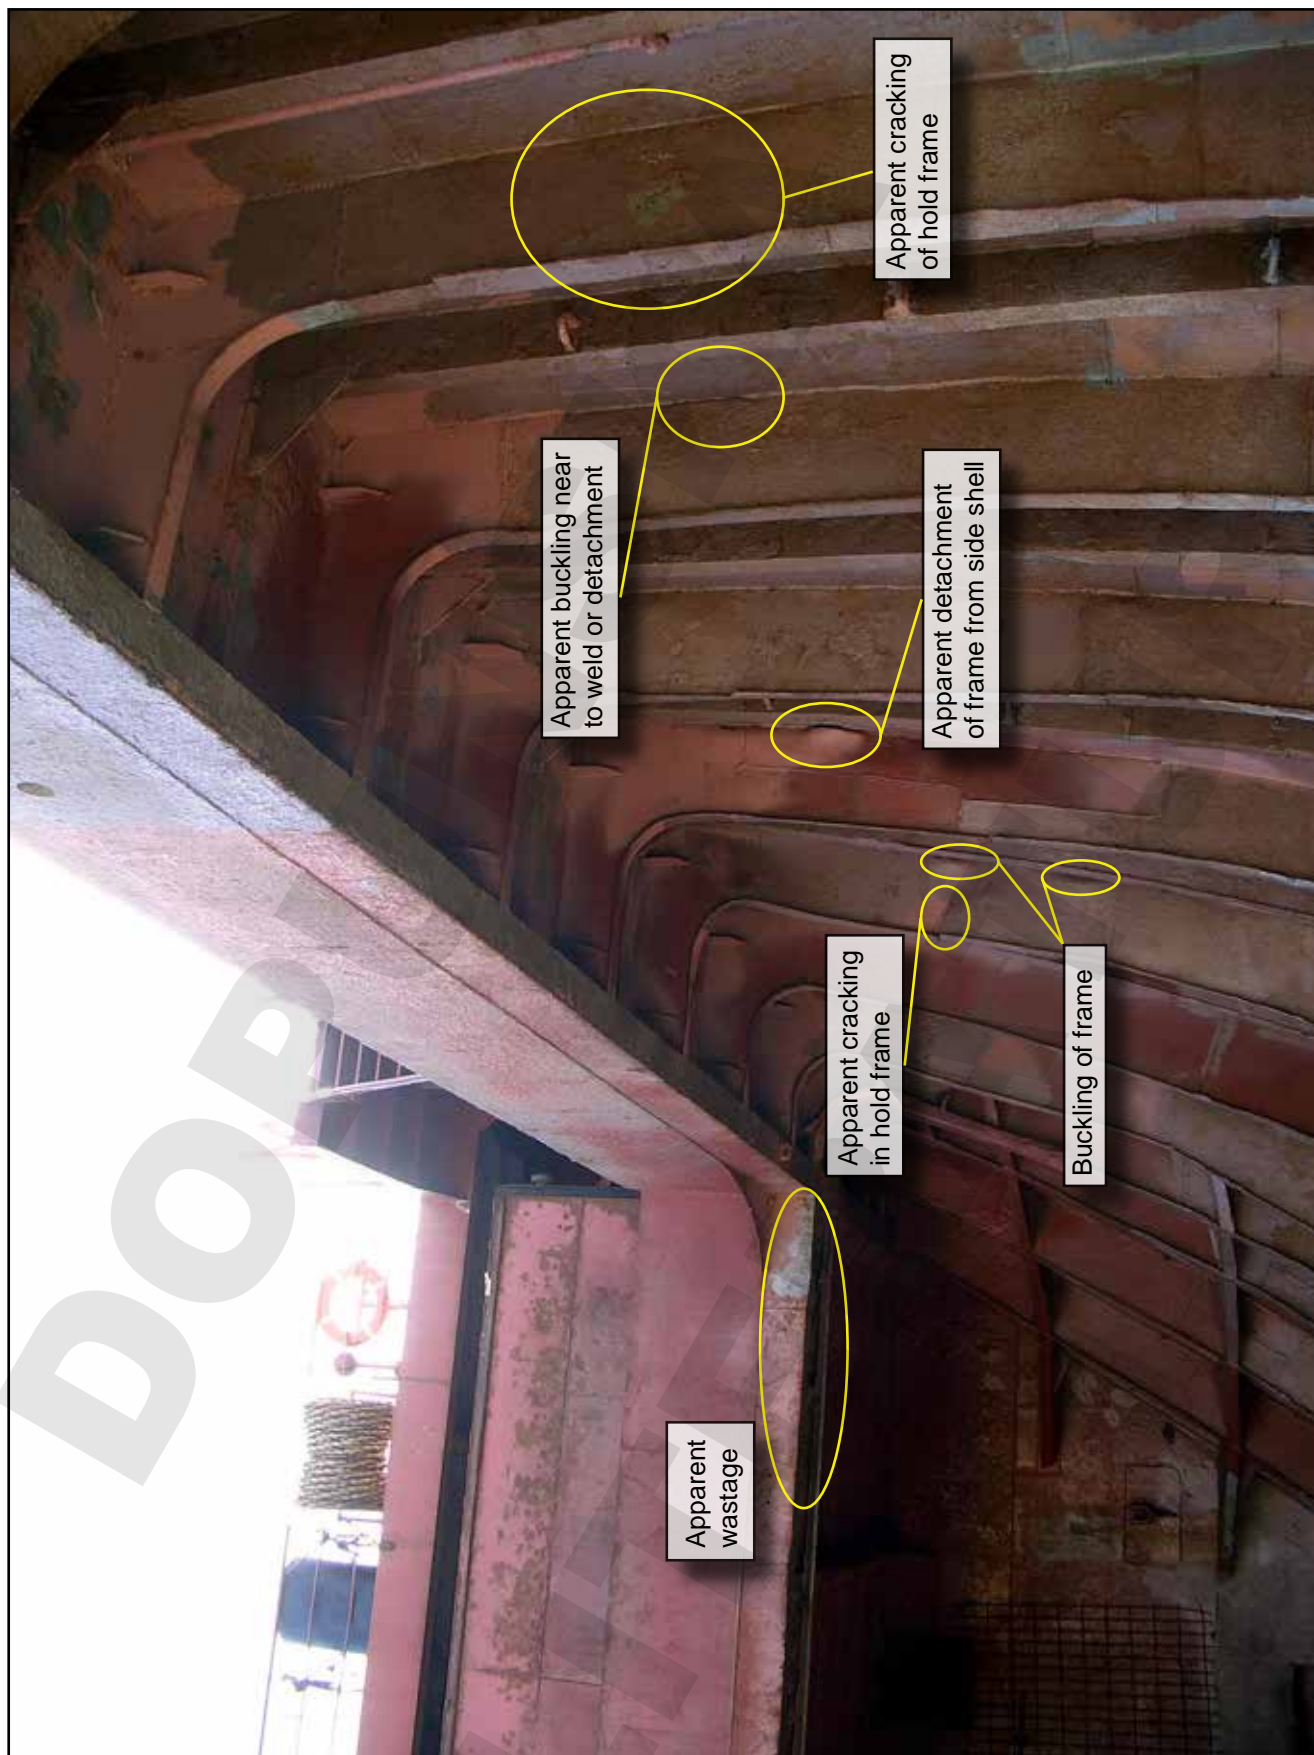
Figures 75f: Photograph of Swanland's hold in September 2011 showing apparent structural defects
