## SUMMARY REPORT ON OCCUPATIONAL ACCIDENT ON HAV STREYM 2 NOVEMBER 2019

*This summary concerns an occupational accident involving an able seaman who suffered severe injuries while opening hatch covers on board HAV STREYM during port stay in Karmøy, Norway, and focuses on the placement of control panels, which provided a restricted overview of the work area.*

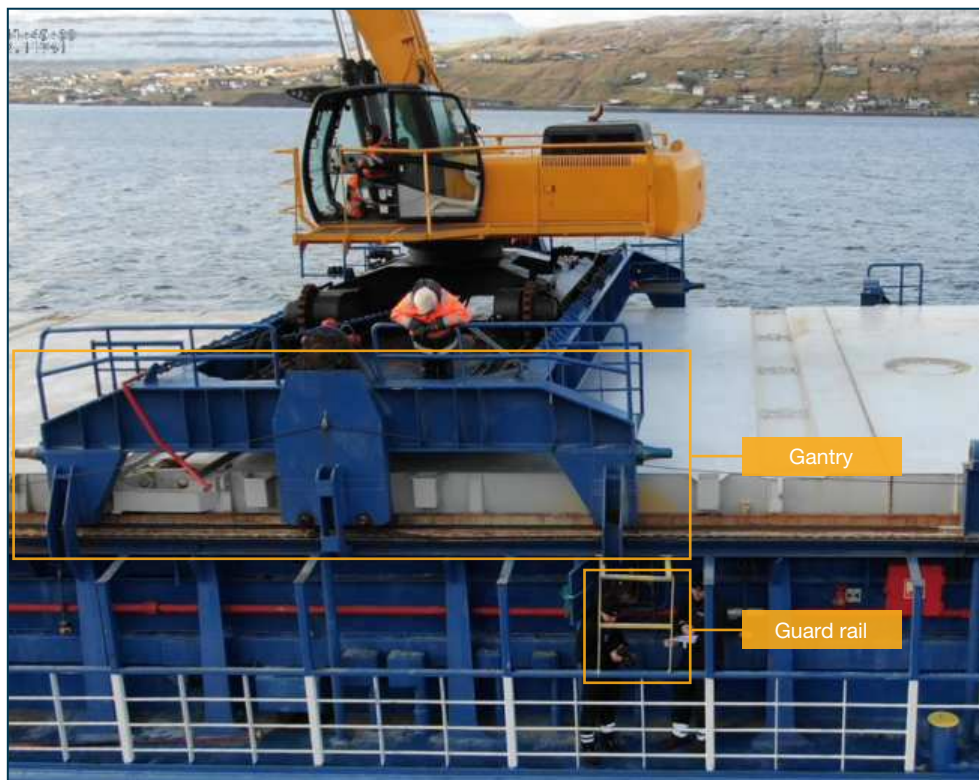
Before opening the hatch cover, the excavator had to be moved aftwards. One AB therefore went to the excavator cab to operate the travelling gantry that carried the excavator. Meanwhile, the other AB stood by on the main deck at the hydraulic control station waiting for the travelling gantry to move aftwards, so he could open the hatch covers. When he heard the travelling gantry stop, he reckoned that the gantry had passed and the space above the hydraulic control station was clear. He climbed the guardrail to check the hatch covers visually to make sure they were clear to open (figure 2). As the AB climbed the railing, the gantry moved aftwards and the AB's upper body was jammed between the guardrail and the gantry (figure 2).

Figure 2: Guard rail and gantry that AB was caught between.  
Source: DMAIB

On the day of the accident, the lighting conditions were such that the AB on deck could only rely on the noise from the gantry to determine its exact position. As the gantry made a short stop, he misjudged its position and climbed the railing before the gantry had passed and was jammed between the guardrail and the gantry.

On HAV STREYM there was no other place to mount the hydraulic control levers, which offered a significantly better overview. Therefore, it would be more expedient to introduce measures, which separately mitigate the risk of falling overboard and the risk of becoming jammed. E.g. having a fixed ladder, warning lights, which indicate that the gantry is moving and where it is, etc.

- A safety light will be fitted on the excavator, which will indicate when the gantry is moving.
- A ladder will be fitted at the control station by the hatch coaming.

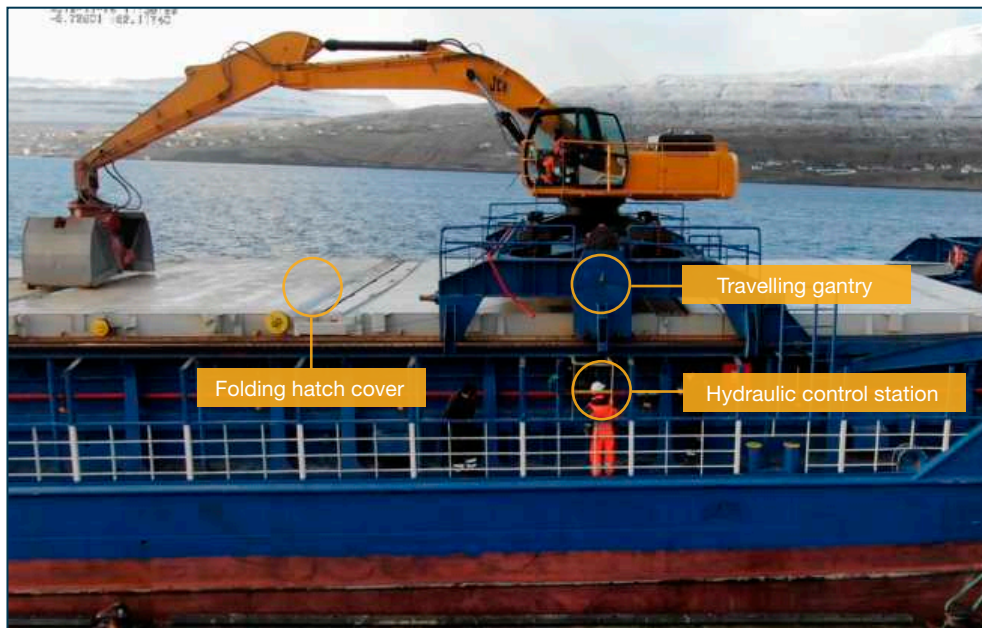
HAV STREYM was equipped with hydraulic folding hatch covers operated by hydraulic control stations forward and aft on the vessel's starboard side. On top of the hatch covers a travelling gantry carried an excavator which was used for loading and discharging the vessel (figure 3, next page).

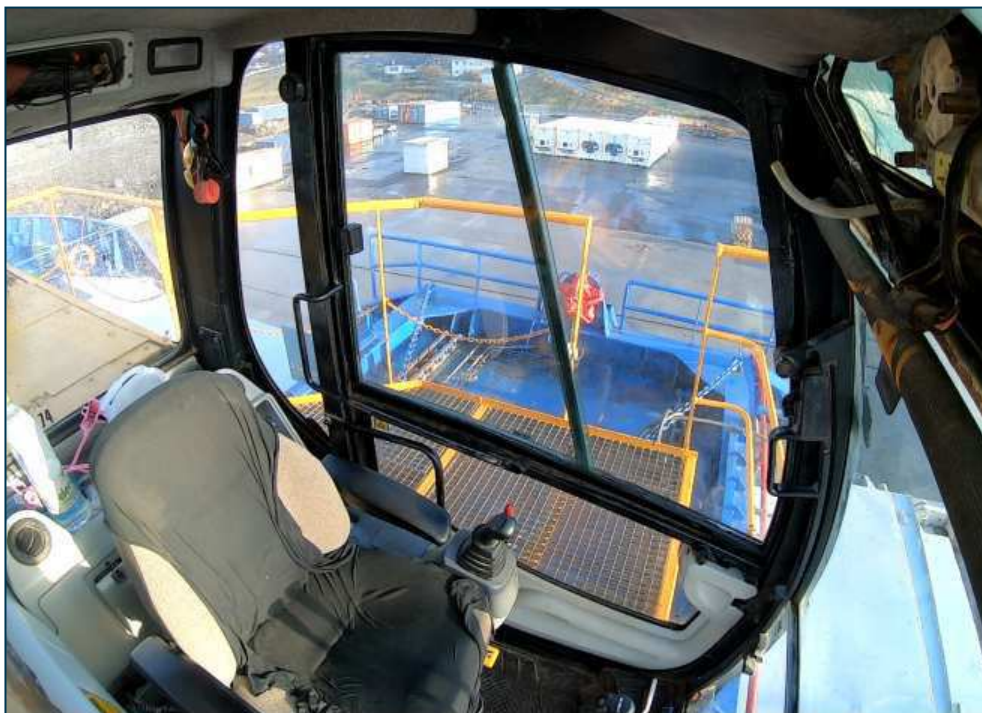
The travelling gantry moved along the top of the hatch covers by use of chains. If the excavator was positioned on top of the hatch covers, it was necessary to move it so the hatch covers could be opened. The travelling gantry was operated from inside the excavator cab. The hatch covers were operated from a hydraulic control station mounted on the hatch coaming below the gantry. Inside the excavator cab, the hatch cover and the hatch coaming restricted the view to the main deck. This meant that the driver was unable to see persons on the main deck (figure 4, next page).

The hydraulic control panel was mounted in a place, which gave a restricted overview of the hatch covers. To gain an overview of the hatch covers, the ABs therefore had to climb the railing. This inexpedient location of the hydraulic control station led to several risk factors. When standing on the railing, the AB was exposed to the risk of falling overboard. This risk was mitigated by installing the guardrail.

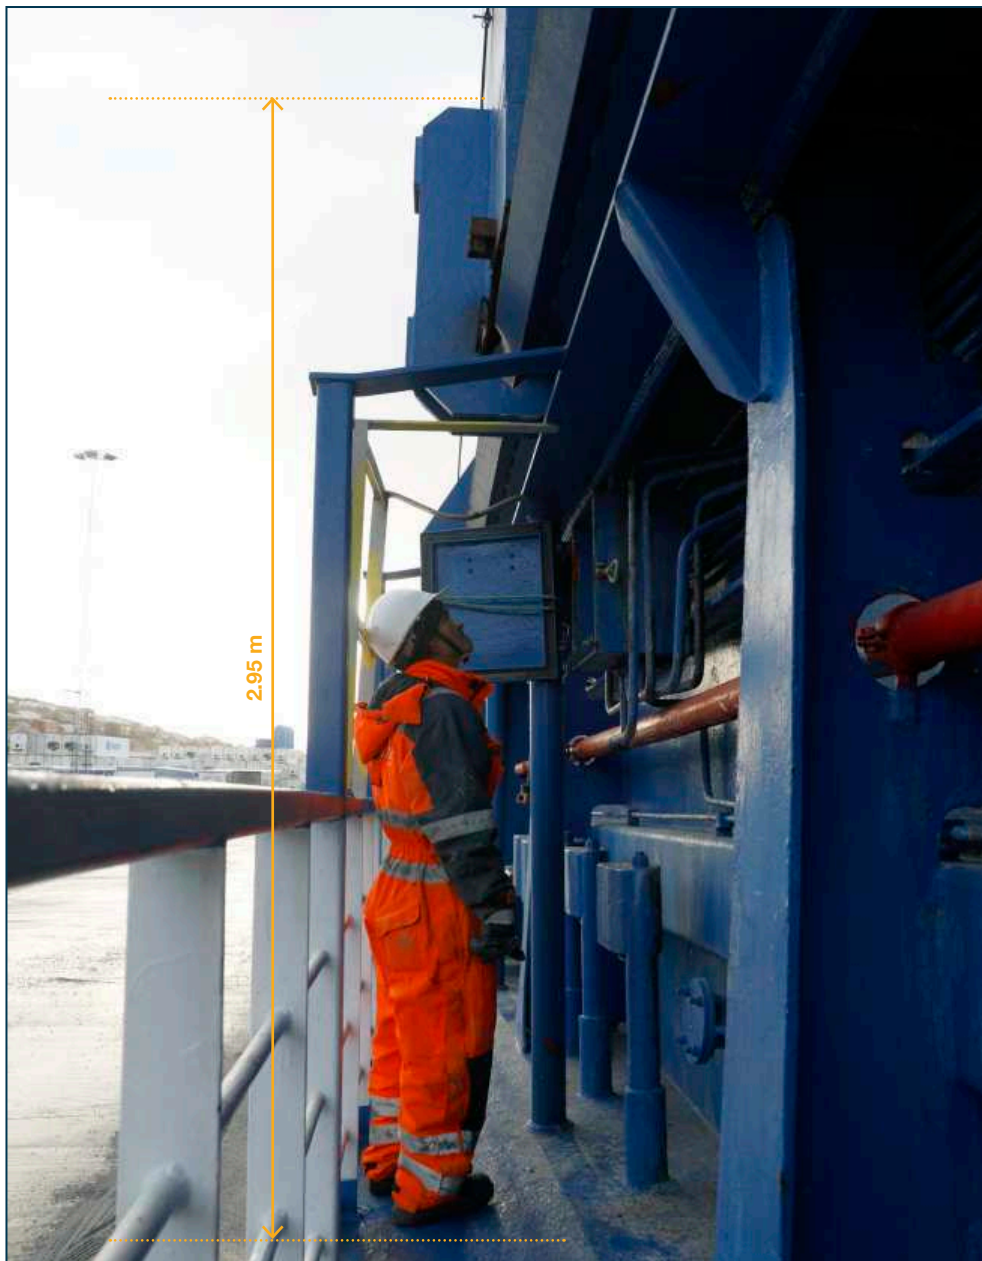
The height from the main deck to the top of the hatch covers was 2.95 meters (figure 5). On the main deck at the hydraulic control station, it was not possible to see the top of the cargo hold. This meant that it was not possible to see the excavator cab or the hatch covers. In order to make sure that no persons were on the hatch covers before opening them, the AB operating the levers had to climb the railing as the operating levers in the control station were 1.25 m below the top of the hatch cover. To protect the ABs from the risk of falling over board when climbing the railing, the ABs had mounted a guardrail on the railing.

Deck lights to illuminate the hydraulic control station were in place, but not functional at the time of the accident. The deck area was only illuminated by lights mounted on the forward part of the accommodation and on the forecastle. During DMAIB's investigation, it was observed that this light had a blinding effect when working at the hydraulic control station, making it difficult to visually identify the position of the travelling gantry. Additionally, the hatch coaming and the gantry had the same colour, making it difficult to identify when the gantry was moving.

Figure 5: View from the main deck to the travelling gantry  
Source: DMAIB
