# National Transportation Safety Board

## Marine Accident Brief

### Collision of *Dixie Vandal* Tow with Moored *Trinity* and Tow

<b>Accident type</b>	Collision	<b>No.</b> DCA19FM026
<b>Vessel names</b>	<i>Dixie Vandal</i> , <i>Trinity</i>	
<b>Location</b>	Houston Ship Channel, mile 44, Kinder Morgan Pasadena Liquids Terminal; Pasadena, Texas 29°44.09' N, 95°12.28' W	
<b>Date</b>	March 15, 2019	
<b>Time</b>	0408 central daylight time (coordinated universal time – 5 hours)	
<b>Injuries</b>	None	
<b>Property damage</b>	\$630,230 (facility: \$519,700; barges: \$110,530)	
<b>Environmental damage</b>	About half-gallon of jet fuel discharged	
<b>Weather</b>	Visibility 10 miles, no precipitation, winds north about 25 mph, air temperature 60°F <sup>1</sup>	
<b>Waterway information</b>	The Kinder Morgan Pasadena Liquids Terminal is located south of Crown Bend in the Houston Ship Channel. The width of the channel is about 300 feet, and the depth is about 40 feet; the depth at the terminal is about 42 feet.

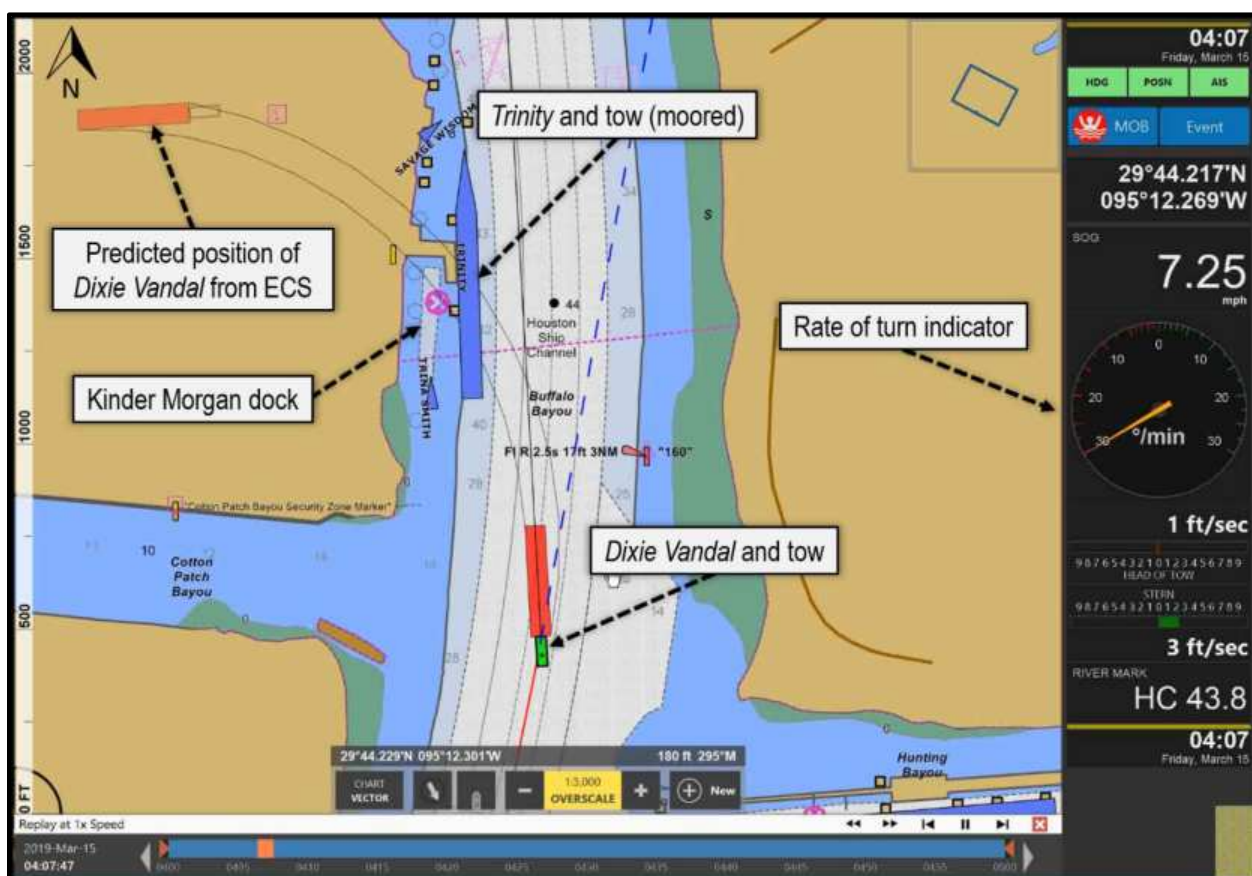
Playback from the *Dixie Vandal*'s electronic charting system (ECS) showed that about 04:07:30, as the *Dixie Vandal* and tow was proceeding around the left-hand turn by the basin, the tow began turning off course to port. At 04:07:47, the rate of turn indicator on the electronic charting system reached its maximum display of 30° to port. At 04:08:31, at a speed of about 6.5 mph, the forward port corner of the lead barge, *Kirby 29751*, contacted the starboard side of the *Trinity* and then struck the forward port corner of the barge *Kirby 29051*.

A screenshot captured at 04:07:47 from playback of the *Dixie Vandal*'s ECS shows the towing vessel as it approached the Kinder Morgan facility. (Source: Rose Point)

The *Dixie Vandal*’s ECS playback displayed a course change to port about 04:07:30, a maximum rate of turn to port at 04:07:47, and a significant drop in speed at 04:08:35, indicating contact occurred between the vessels just over a minute after the course change. The pilot did not recall making this sudden course change nor did he recall hearing the BNWAS alarm on the bridge;

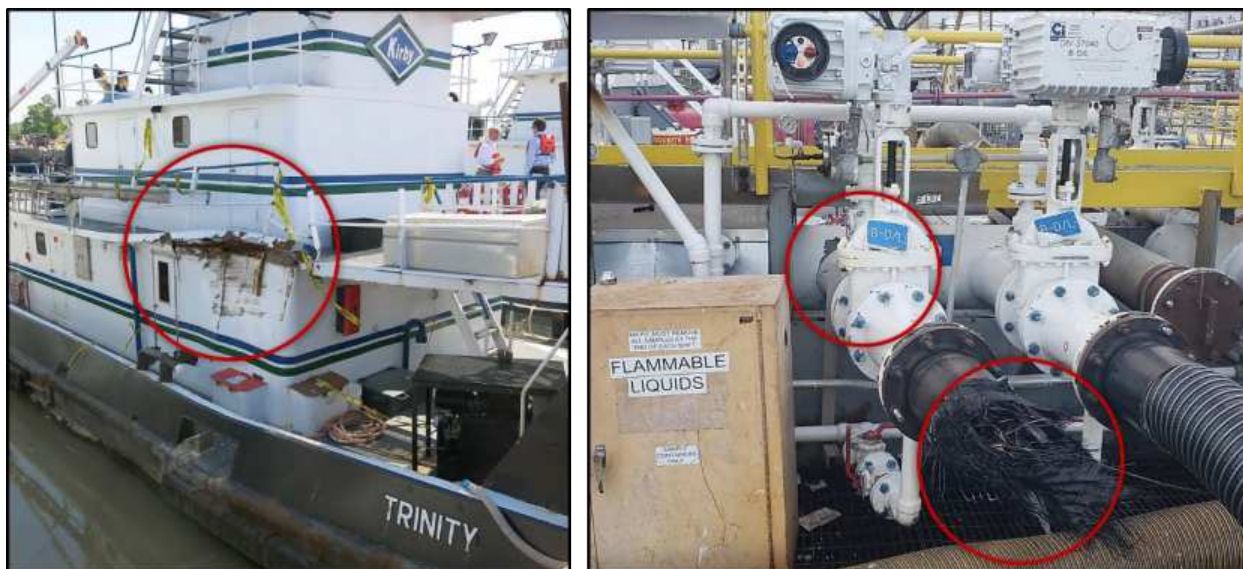
The starboard side of the second deck on the *Trinity* was damaged, including the decking, handrail, and house structure. The vessel was sold "as is" postaccident; therefore, no repairs were made to it. Damage to tank barge *Kirby 29501* included indentation of the deck and hull's upper sheer strake and bow plating. Additionally, a stanchion on the deck was ripped from its weld due to the parted mooring lines. Tank barge *EBL 2997*'s 10-inch-diameter cargo liquid manifold piping was distorted. The facility reported damage to the pipeline, loading systems, dock, and two cranes that were supporting the cargo hoses. The *Dixie Vandal* was not damaged in the incident.

**Left:** Damage to the *Trinity*'s starboard side from the impact of barge *Kirby 29751*. **Right:** Damaged shoreside cargo hose and deformed piping at the manifold at the Kinder Morgan facility. (Source: Kinder Morgan Pasadena Liquids Terminal)
