**REPORT INTO AN INCIDENT  
INVOLVING THE  
'FV DILLON OWEN'  
OFF ARDGLASS HARBOUR  
23rd OCTOBER 2019**

**REPORT NO. MCIB/295  
(No.5 OF 2020)**

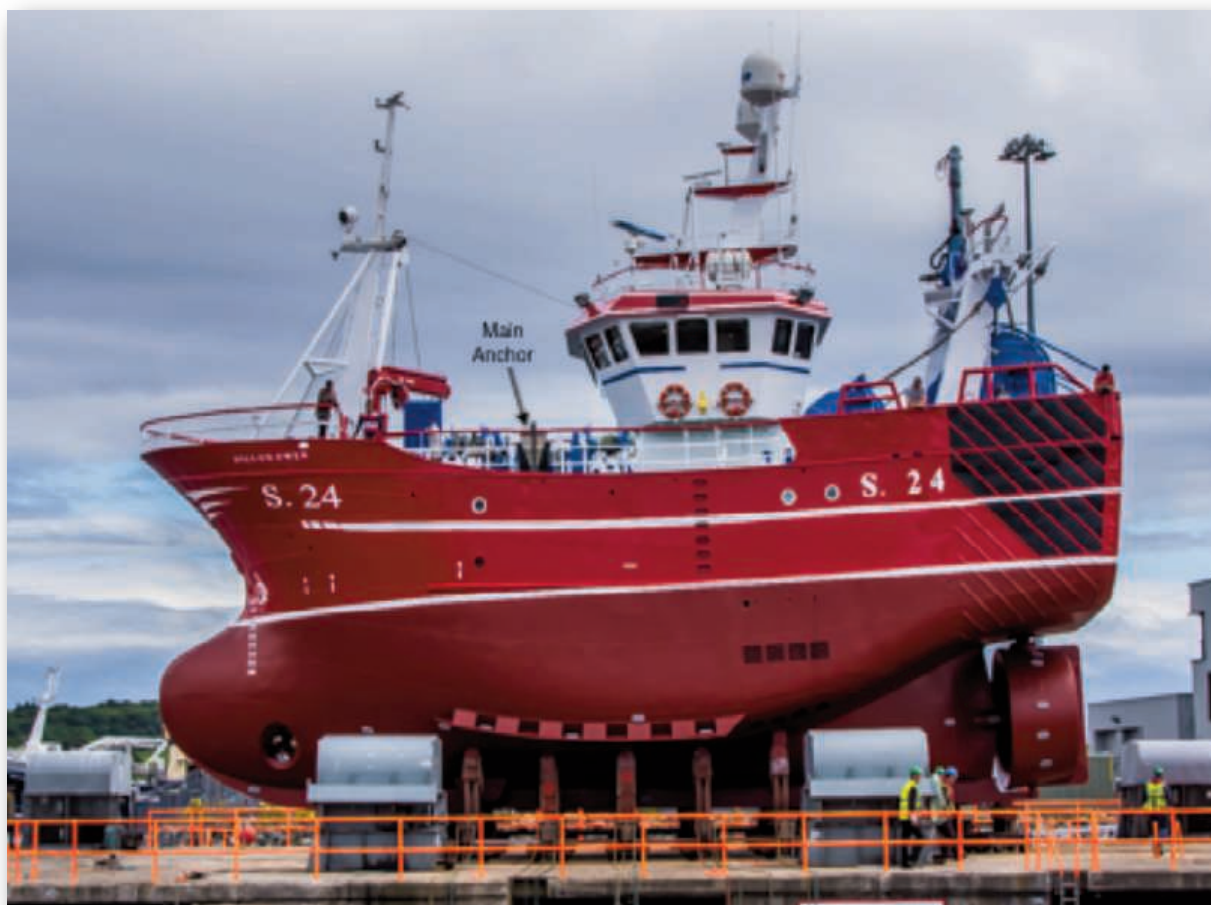
Photograph No.1 - 'FV Dillon Owen'.

The '*FV Dillon Owen*' had on-board two stockless bower anchors reported to be of equal size, approximately 200 kg each. The main or primary anchor was stowed in a housing at the shelter deck guardrail, port side, forward of the wheelhouse. The primary anchor had a length of chain attached which was stowed in a purpose made bin clipped to adjacent guardrails. The anchor was secured from accidental release with a locking device. The primary anchor was rigged for quick release but required a line to be secured to the free end of the anchor chain before deployment as the anchor chains were not normally connected to the vessel with an anchor line or wire.

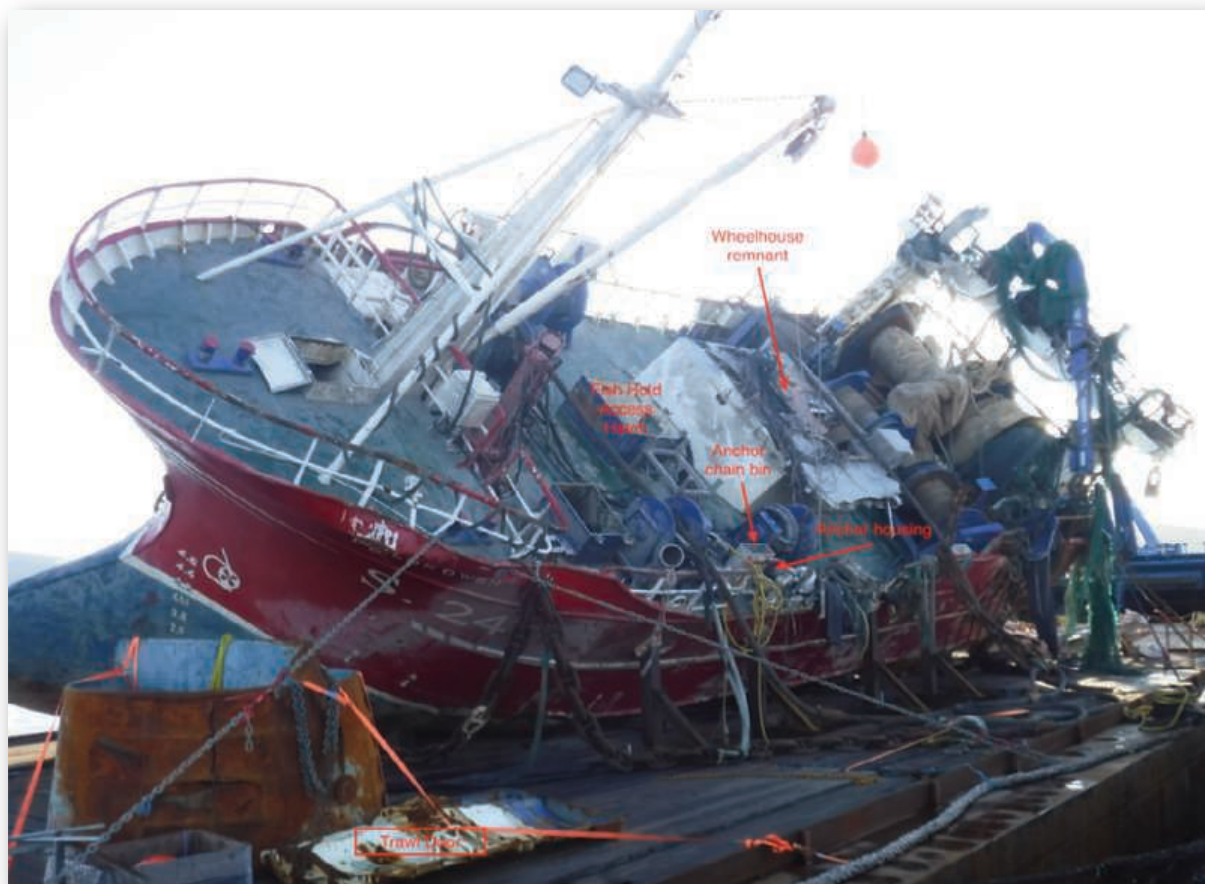
The vessels second anchor was reported to have been stowed port side aft on the shelter deck, of similar size as the primary anchor with a length of chain attached, the chain being stowed in a bin adjacent to the anchor. Deployment of the second anchor required mechanical means to lift and release the anchor equipment. A line was required to be secured to the free end of the anchor chain before deployment. The '*FV Dillon Owen*' was not fitted out with an anchor hawse pipe or dedicated anchor windlass.

Photograph No.2 - 'FV Dillon Owen' wreck as lifted off the seabed.

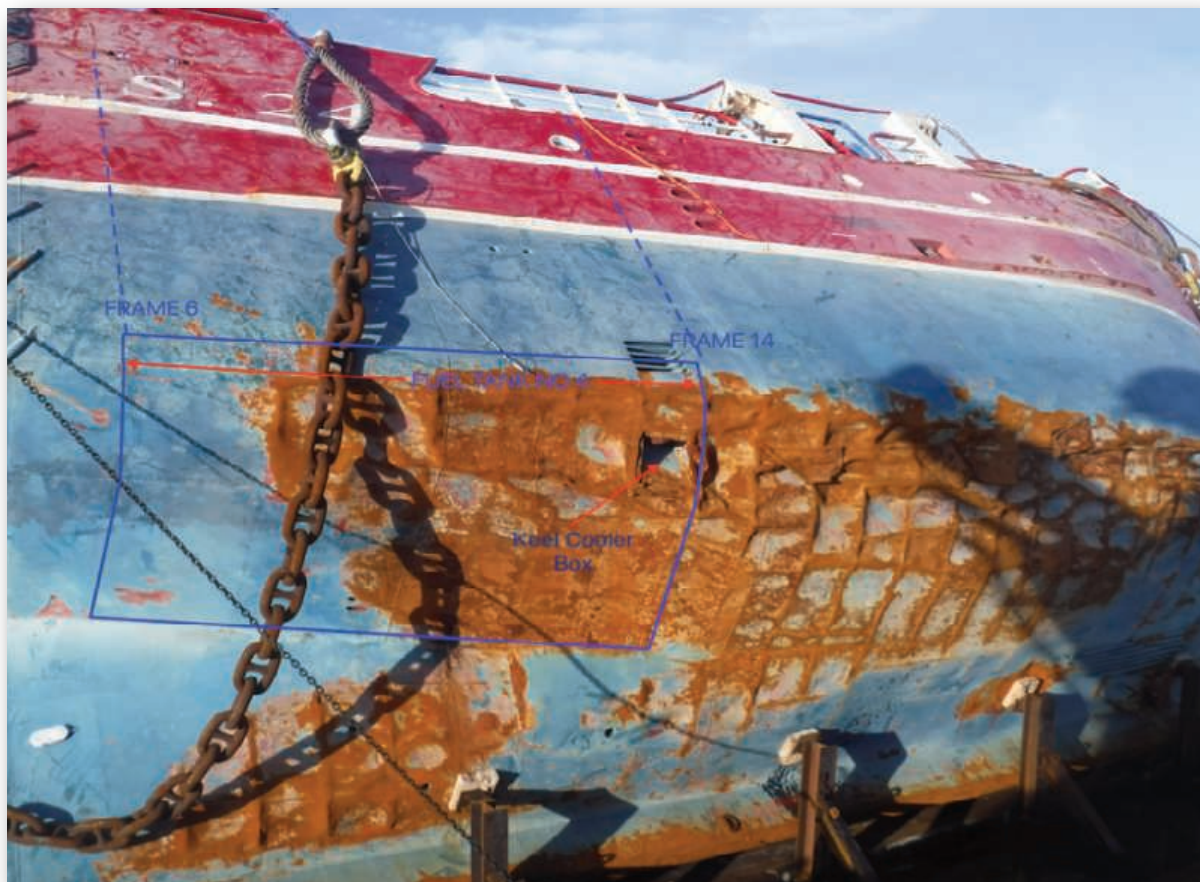
Photographic evidence shows significant damage in the vicinity of the bilge keel, keel cooler and No.4 fuel tank.

Photograph No.3 - Position of No.4 fuel bunker tank located between frames 6 to 14.

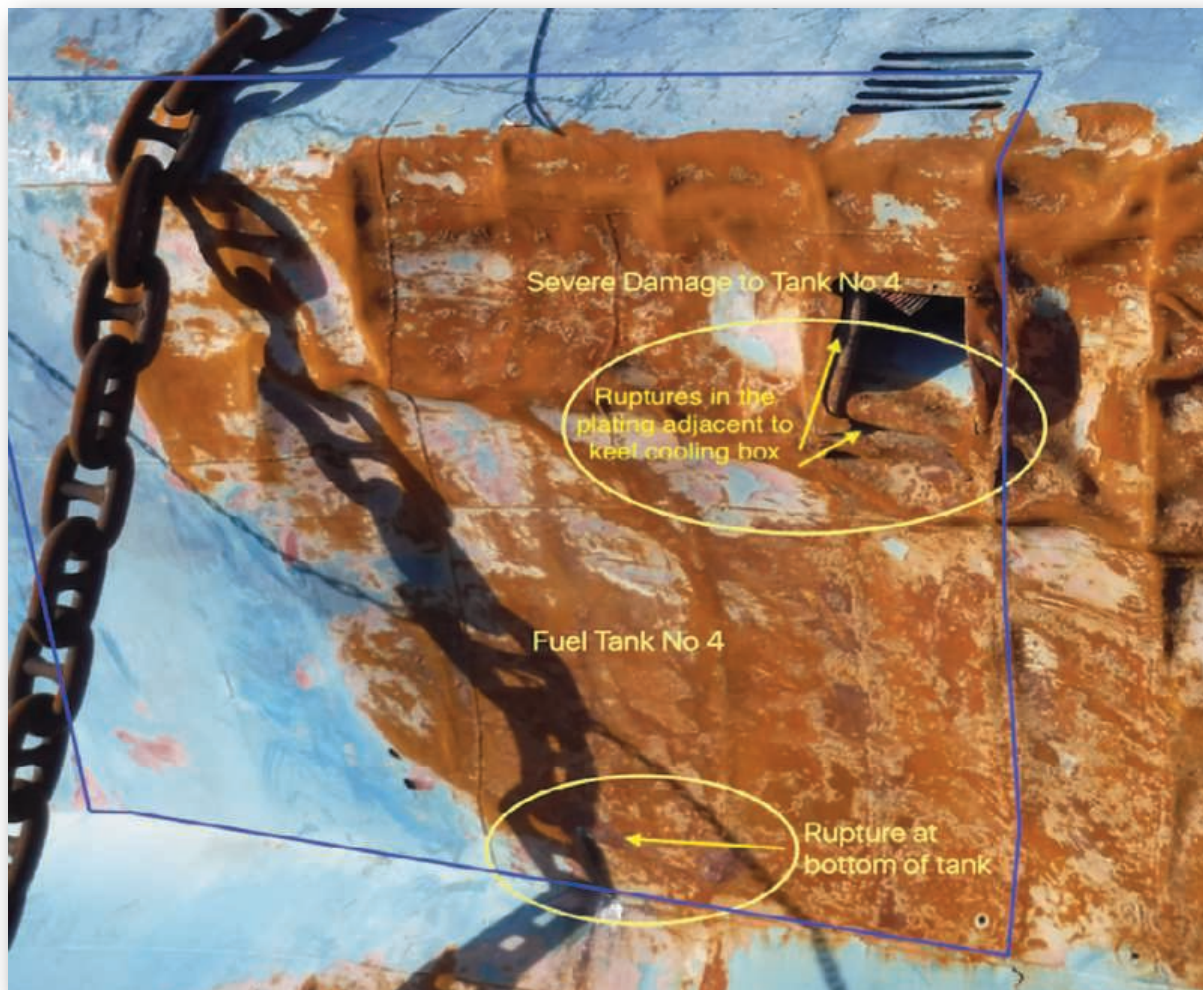
The hull plating along the vessel’s starboard bilge keel at the round of the bilge, extending from approximately frame 6 forward to frame 25, was significantly

damaged and the plating ruptured in way of fuel tank No.4 adjacent to the keel cooler box. The keel cooler box bottom grid was missing and the keel cooler box bottom aperture through the hull significantly deformed. No.4 fuel tank was open to the sea through the ruptured plating.

- 4.5 Photographs of the vessel's starboard side shows hull plating damage below the waterline in line with the bilge keel extending lengthways (approximately 12 m long) between frames 6 to frame 25. The damaged plating between frames 8 to

frame 14 are integral to No.4 fuel bunker tank and frames 14 to frame 25 are integral to the starboard fish hold. No.4 fuel tank opened to the sea when the tanks hull plating adjacent to the bilge cooler inlets was ruptured at frame 13 to frame 14.

Photograph No.4 - Damage to No.4 fuel tank showing hull plating rupture adjacent to the keel cooler box and at the bottom of the fuel tank.

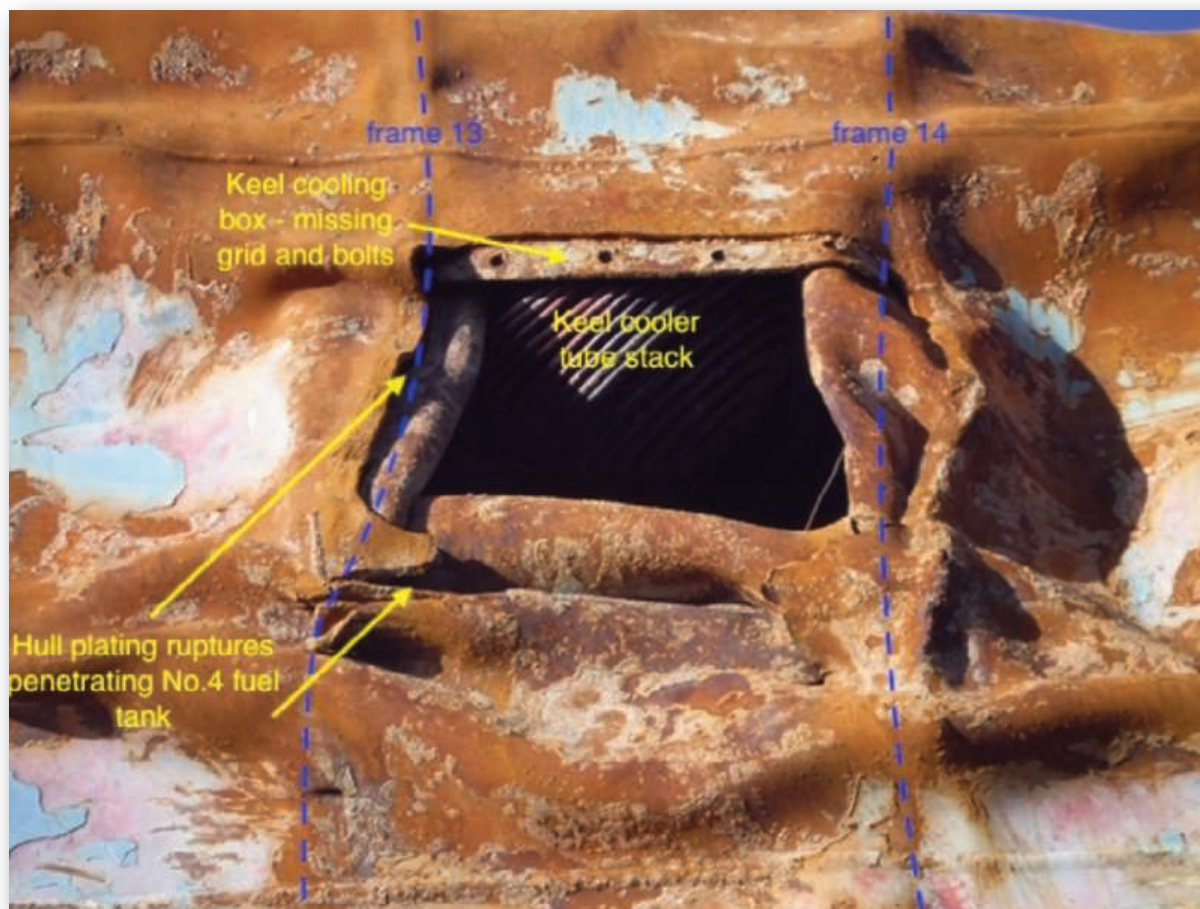
- 5.3 The rupture of No.4 fuel tank immediately filled the tank with seawater and the practice of continually circulating fuel oil through the CJC filter in turn contaminated the daily service tank supplying fuel to the main engine and the generators, causing the vessel to lose electrical and propulsion power. If the transfer and recirculation of fuel from the bunker tank through the CJC unit into the Day Tank had been stopped as the vessel approached shallow waters and restricted navigation, or if a procedure was in place to stop this pump should a suspected grounding event occur, then the Day Tank fuel contents would not have been contaminated and the vessel would not have lost power after the first grounding.

Photograph No.5 - Hull plating rupture in way of No.4 fuel tank adjacent to the Keel.

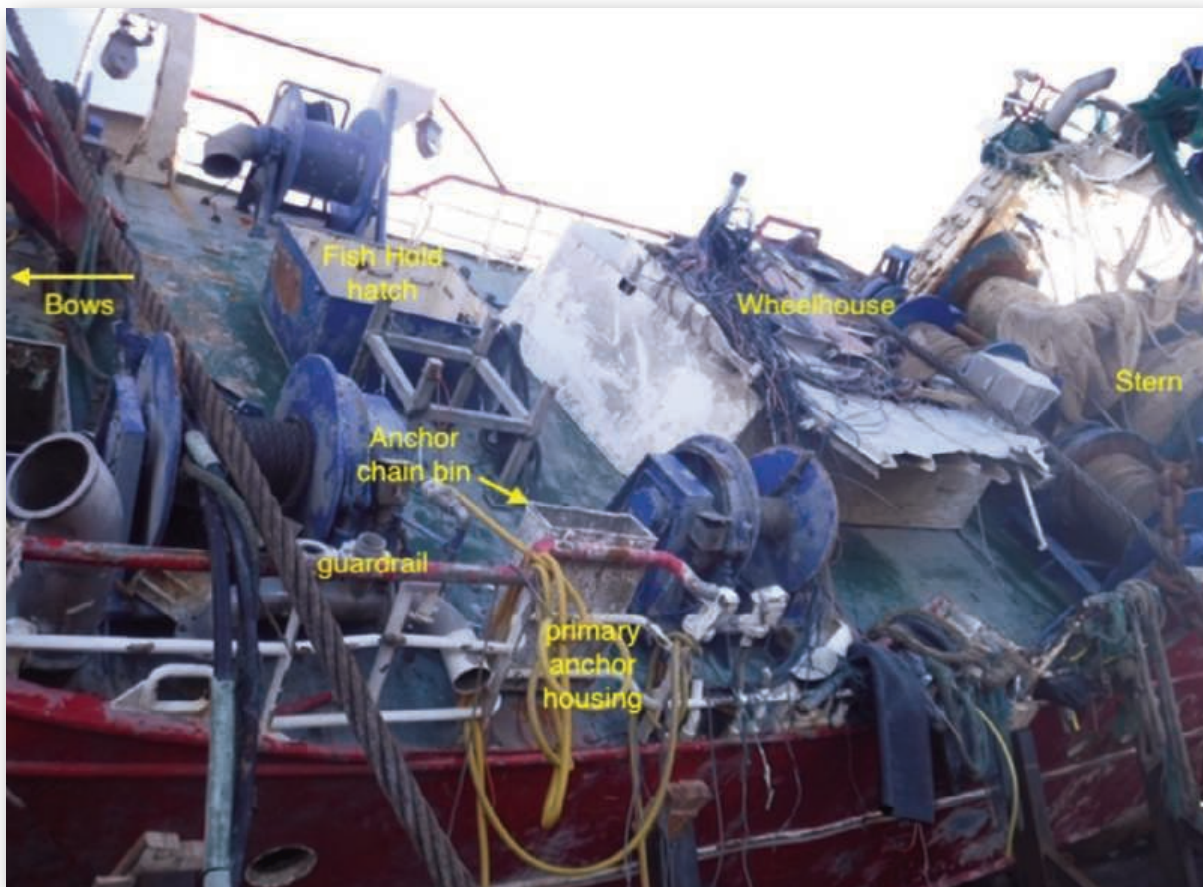
- 5.4 The causal factor leading to the vessel's second grounding on Phennick Point was the failure of the crew to deploy the primary anchor as the prevailing wind sea direction drove the powerless vessel towards the north shoreline and Phennick Point. The depth of water here was shallow enough to drop an anchor in order to stop the vessel's drift. By first focusing on attempts to release the trawl doors the crew lost valuable time and indicates they did not understand the recommendation contained within S.I. No. 640 of 2007 Merchant Shipping (Safety of Fishing Vessels)(15 - 24 metres) Regulations 2007, Schedule 2 'Recommended Practice for Anchor and Mooring Equipment'. Paragraph 17, which states that 'the use of otter boards/trawl doors should only be used if the vessel has lost its anchors'. The *'FV Dillon Owen'* had not lost its anchors and timely release by the crew of the vessel's primary anchor at this time would likely have averted the vessel's second grounding at Phennick Point.

Photograph No.6 - Main (Primary) anchor arrangement.

- 6.1 The Minister for Transport, Tourism & Sport should issue a Marine Notice to remind vessel owners and operators to ensure all navigation is planned in adequate detail and with contingency plans where appropriate.
- 6.2 The Minister for Transport, Tourism & Sport should issue a Marine Notice stating that fishing vessel owners and operators develop contingency plans and procedures and conduct emergency exercise drills to prepare for a grounding event or collision incident.
- 6.3 Where owners and operators of fishing vessels have an anchoring arrangement whereby chain cables are replaced by trawl warps, that crews ready anchors for deployment when entering or leaving port by connecting the trawl warp to the free end of the primary anchor chain.

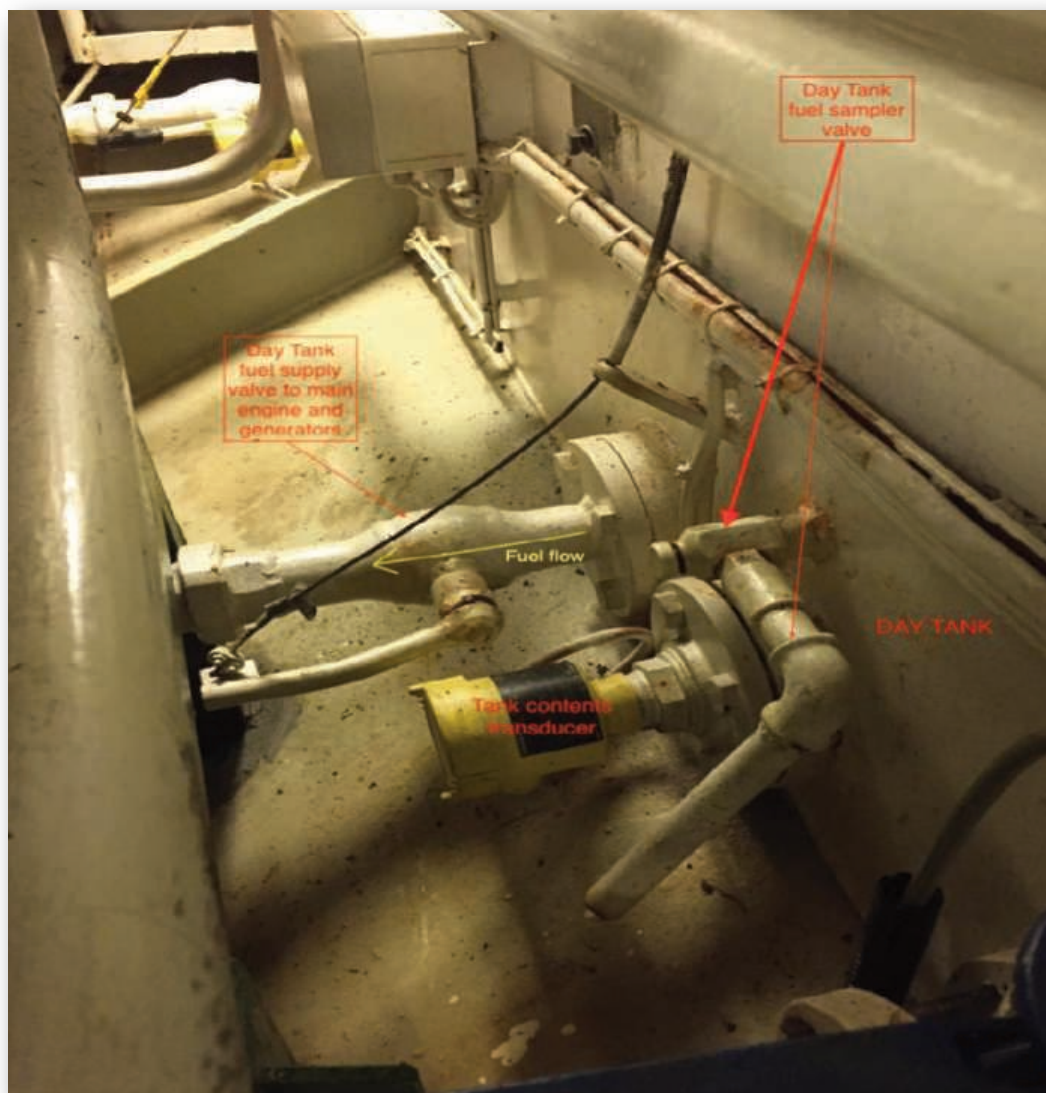
ensured the Day Tank was at its maximum level at all times and also ensured that the generators and main engines were continuously supplied with clean uncontaminated fuel. The fuel suction from the Day Tank to the main engine and generators was connected through a dedicated valve at the bottom of the tank situated immediately adjacent to the Day Tank fuel sampling/drain valve.

Photograph No.7 - Fuel Day Tank bottom valves ('FV Ardent') Cooler Box.

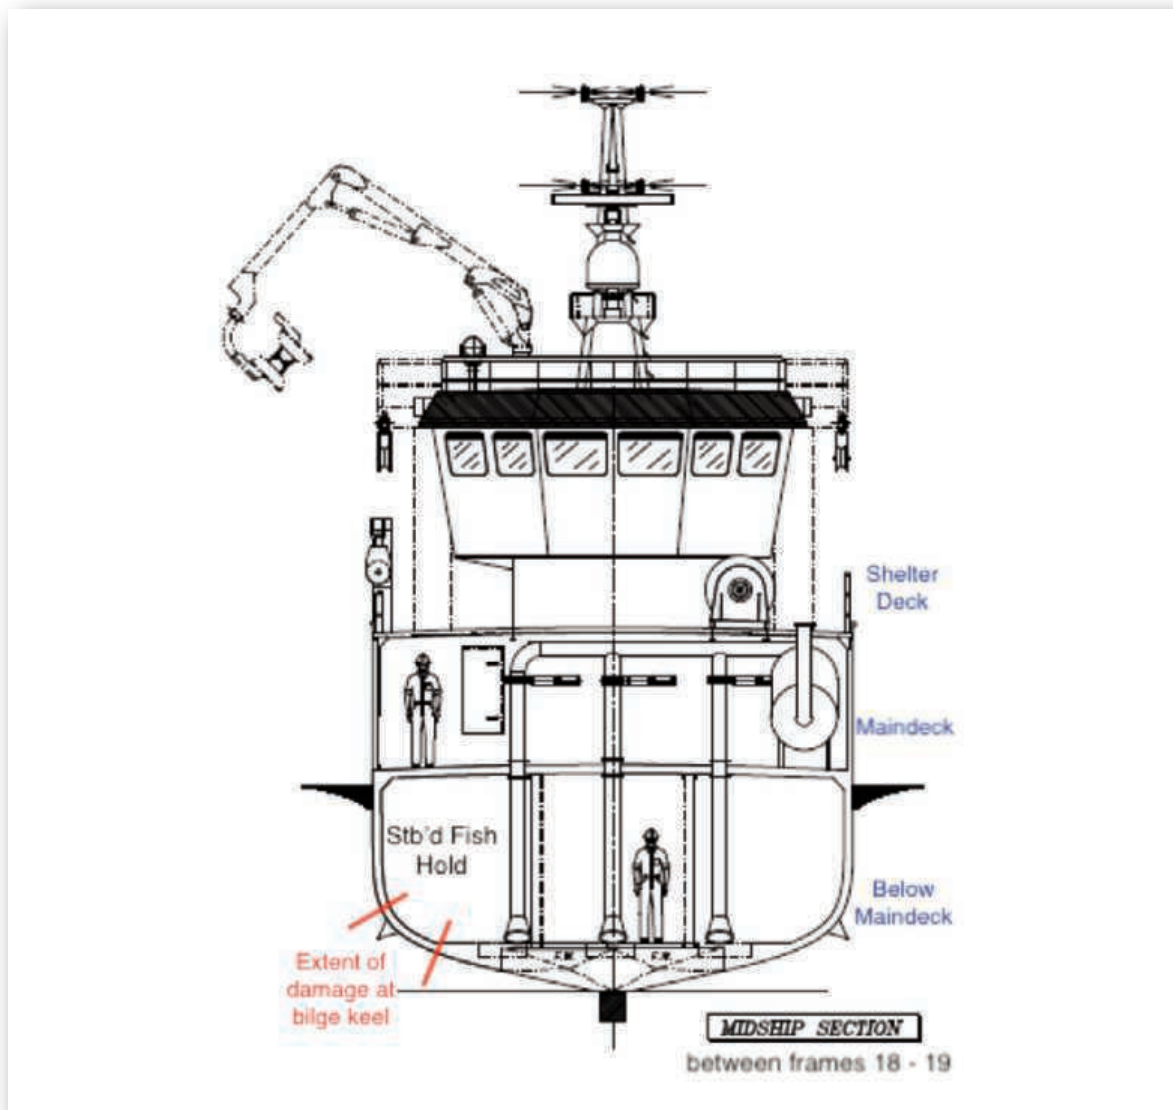
The evidence that no water was found in the ships spaces at this time indicates that seawater ingress from the first grounding event was contained to No.4 fuel bunker tank and starboard fish hold only.

Fig.2. Orientation of hull damage to the vessels compartment(s) (Elevation).

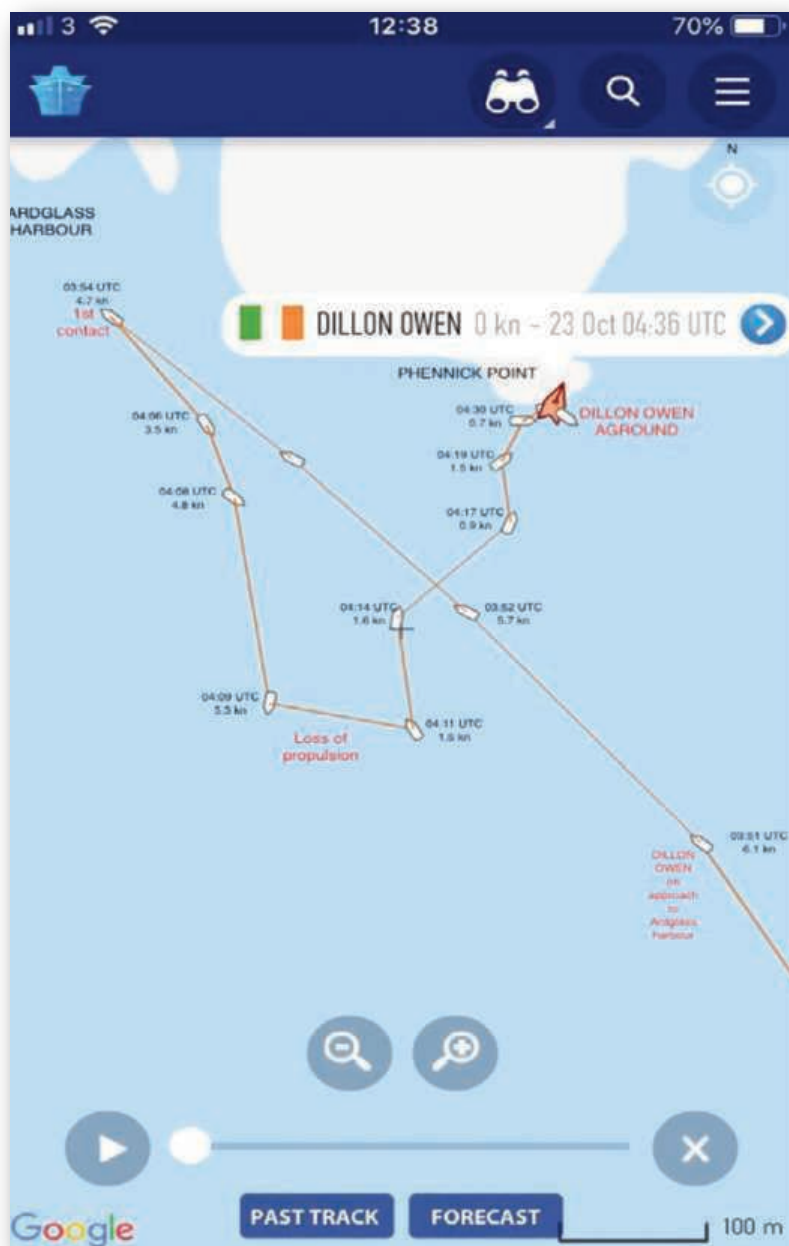
- 4.3 The draft of the '*FV Dillon Owen*' was approximately 4.8 m (Forward) to 5.2 m (Aft) in the loaded condition. If the vessel's draft was in this loaded condition it would have been safe practice to ensure the vessel's approach to Ardglass Harbour was close to the centre of the entrance channel while taking cognizance of the isophase (sector) North Pier light. The AIS track at 03.54 hrs (UTC) shows the vessel's approach was from the south east at 4.7 kn. The Skipper stated that the vessel was to starboard of the entrance channel. He was not observing the sector light from the North Pier and he was of the opinion the depth was sufficient to enter the harbour. If the '*FV Dillon Owen*' was indeed to starboard side of the entrance channel the vessel would be at risk of crossing the shallow water shelf south of Ardtole Beacon and grounding.

Fig.5. 'FV Dillon Owen' - AIS Track.

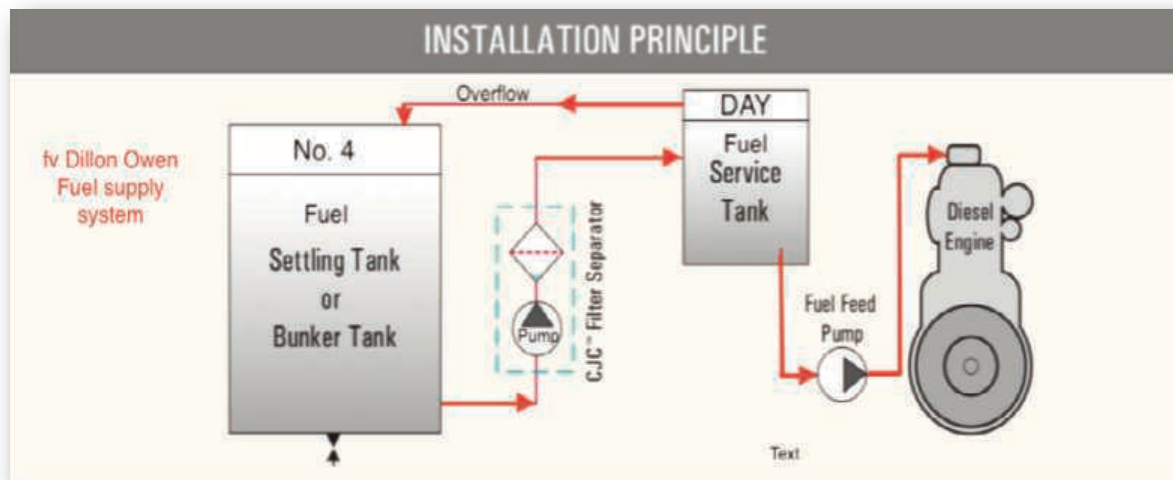
- 4.6.3 At 400 litre/hour pumping rate the CJC filter would pass approximately 100 ltr of seawater from the flooded No.4 fuel bunker tank into the Day Tank in the 15 minutes between the initial grounding and the vessel's electrical failure and dead ship condition. Having regard to the proximity of the fuel suction pipe supplying the generator and main engine diesel engines to the lowest level of the Day Tank the water contamination of the fuel supply system would follow shortly after water entered the bunker tank. A small quantity of water into the Day Tank would be sufficient to significantly contaminate the fuel supply lines and quickly stop the generator and main engine.

Fig.6. Fuel Supply and CJC Filter system.

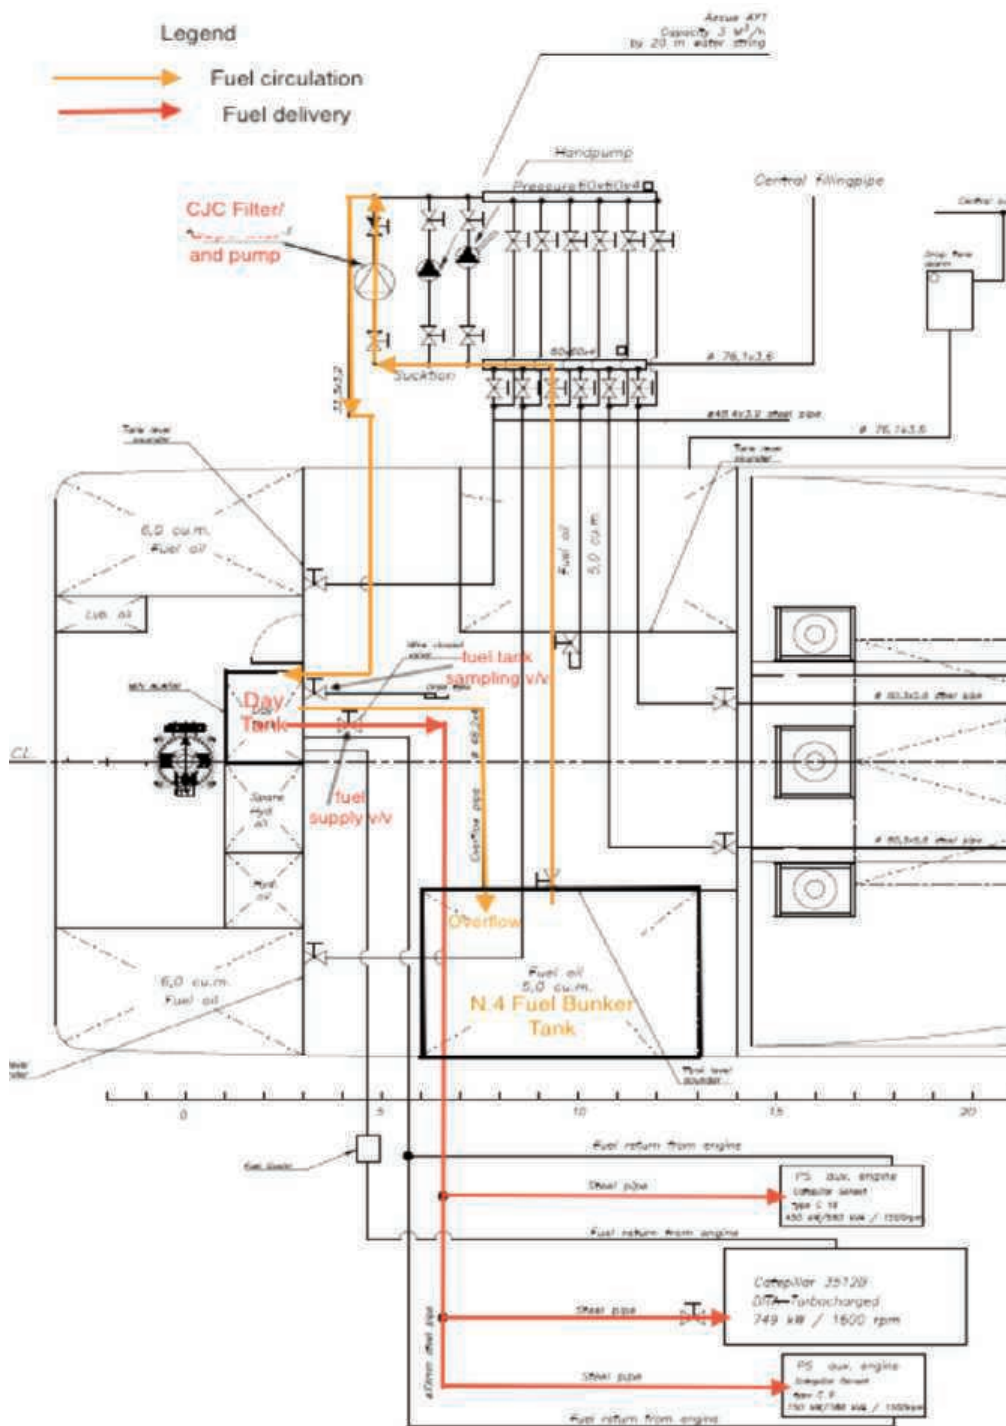
- 4.6.2 The second electrical power failure and the subsequent loss of propulsion power event suggest that the seawater flooding into No.4 fuel bunker tank and the practice of continuous recirculation of fuel from No.4 fuel tank to the Day Tank quickly resulted with inundation of seawater into the fuel pipes supplying fuel to the diesel generators and main engine. This hypothesis is supported by Crewmember No.1 who reported that there appeared to be significantly more pressure than normal in the fuel Day Tank when he opened the sampling valve to test the tank contents and he saw an amount of water issuing out of the sample valve and from the CJC filter drain valve at that time. The hydrostatic pressure of the sea quickly filled and pressurised the ruptured No.4 fuel tank while the CJC filter pump continued to operate, pumping sea water into the Day Tank (until the time of the electrical blackout). The normal overflow of diesel from the Day Tank into No.4 tank would be stopped by the hydrostatic back pressure from No.4 fuel tank. The head of pressure within the Day Tank would thereby increase to a higher head of pressure than when normally overflowing into No.4 fuel tank. Seawater entering the Day Tank would displace the diesel fuel from the lower level of the tank bottom (diesel fuel having a lower specific gravity and therefore lighter than seawater).

Fig.7. Fuel Circulation and Supply System (schematic).
