Report on the investigation of the collision between

ACX Hibiscus

Hyundai Discovery

at 0756 local time on 11 December 2011

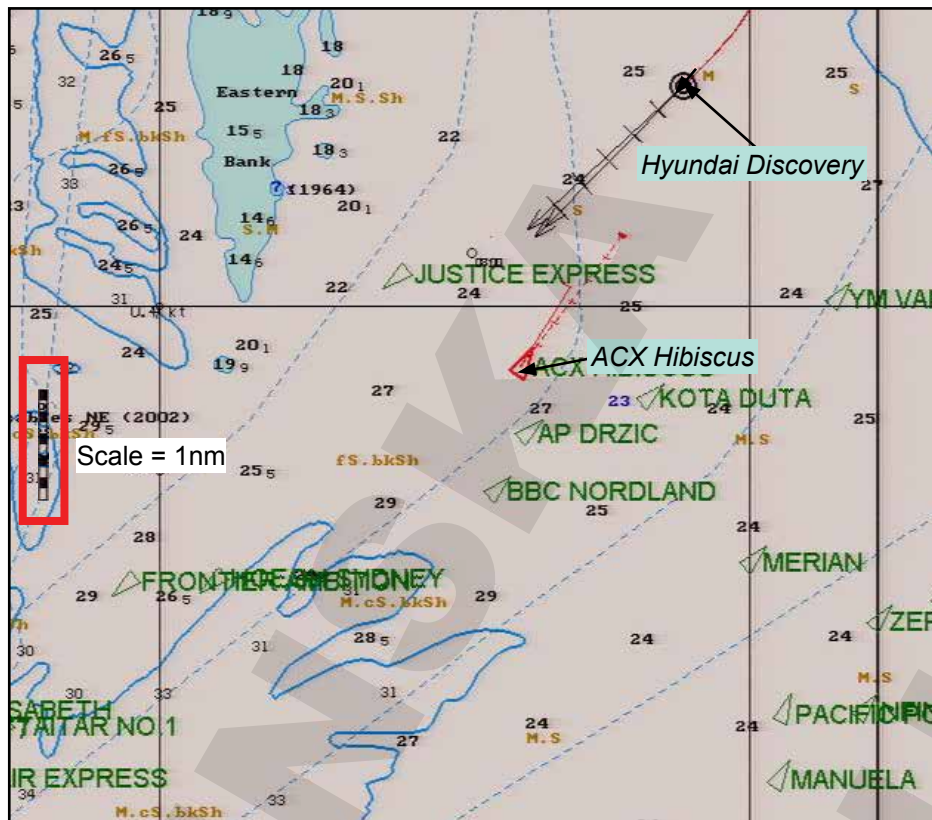
Figure 5: Position of ACX Hibiscus and Hyundai Discovery at 0751:30

ACX Hibiscus's third officer arrived on the bridge at around 0750 ready to take over the watch at 0800. At 0751:30, *ACX Hibiscus*'s chief officer started to alter his vessel's course to port by adjusting the desired heading on the autopilot to turn the ship incrementally onto the next planned track of 350° (**Figure 5**). It was reported that the third officer looked at the radar display and found that radar targets were not seen due to clutter, and that he informed the chief officer about the situation.

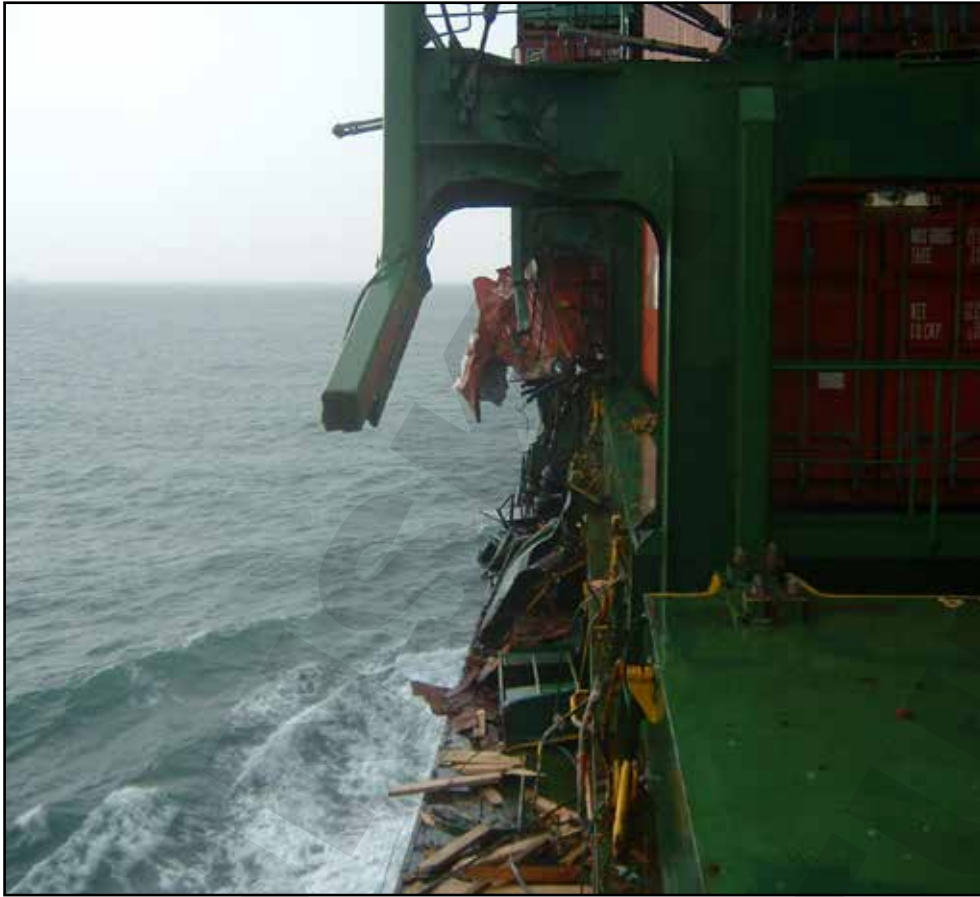
Figure 9: Environmental condition shortly after the collision

A picture taken soon after the collision shows the typical conditions at the time (**Figure 9**).

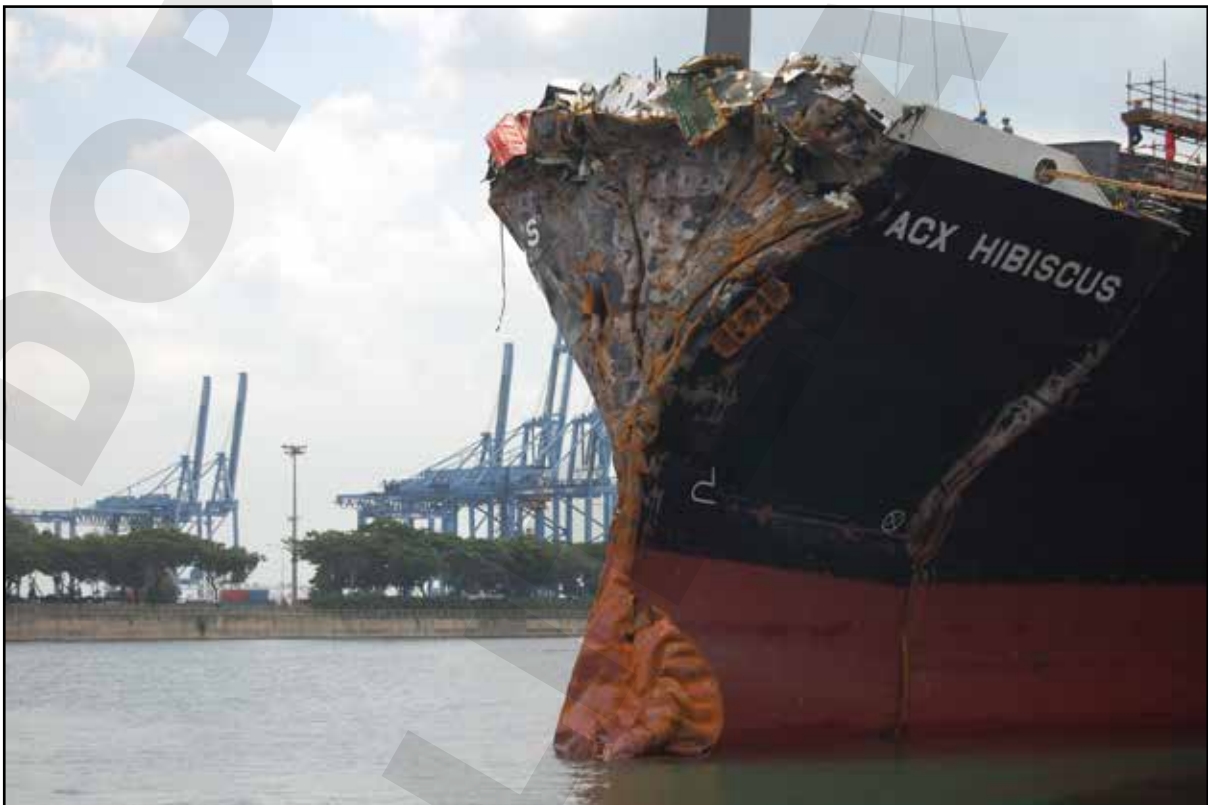
Figure 10: Damage to ACX Hibiscus's bow

ACX Hibiscus sustained significant damage to its bow section (**Figure 10**). The forward mooring deck, chain locker, fore peak tank and bow thrust room were very heavily damaged. Both anchors were unusable. The collision bulkhead was breached and damage extended into the forward hold.

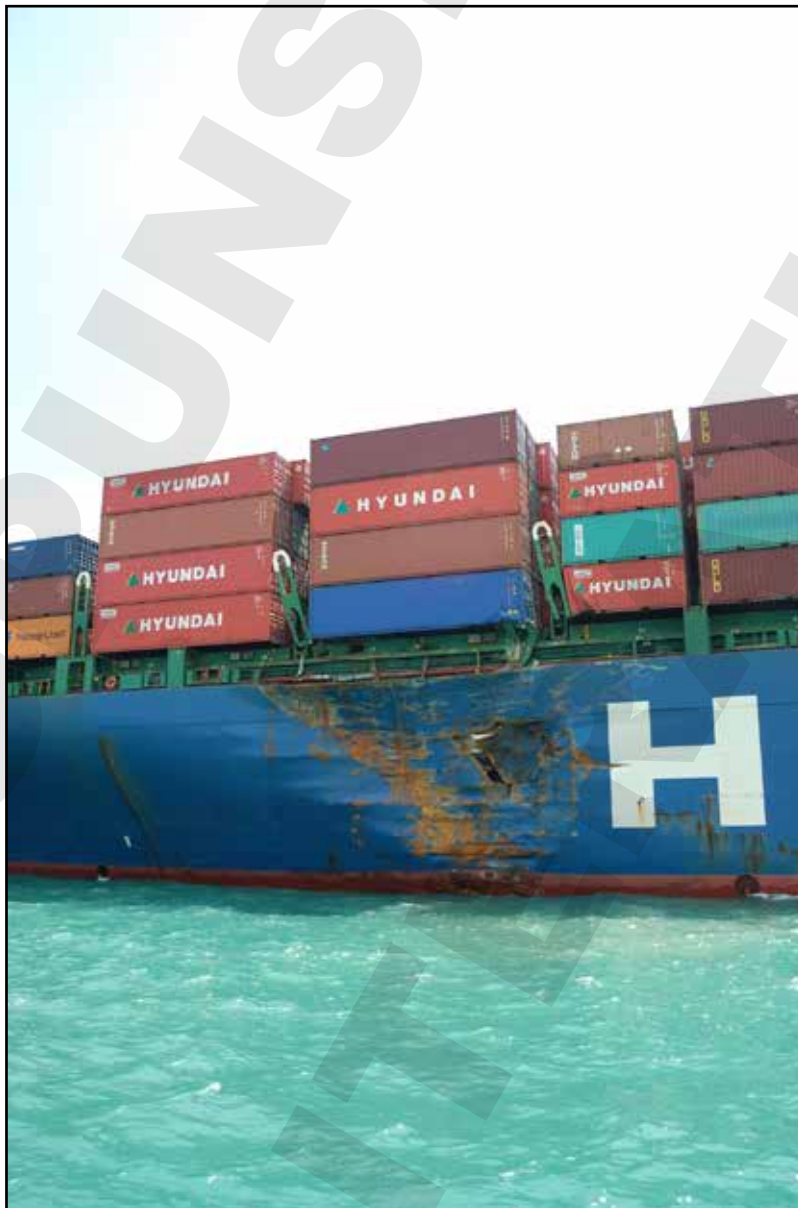
Figure 11: Damage to *Hyundai Discovery*'s port side No. 2 water ballast tank

Hyundai Discovery's hull was holed in No.2 water ballast wing tank, both above and below the waterline (**Figure 11**). No.2 hold port bulkhead was indented but remained watertight. Five, 40-foot long containers were lost overboard and several other 20 and 40-foot long containers and their securing arrangements were damaged. The port side of the vessel was indented along the length of the hull from No. 2 hold, aft to the accommodation where the port accommodation ladder and surrounding structure was heavily deformed (**Figure 12**).

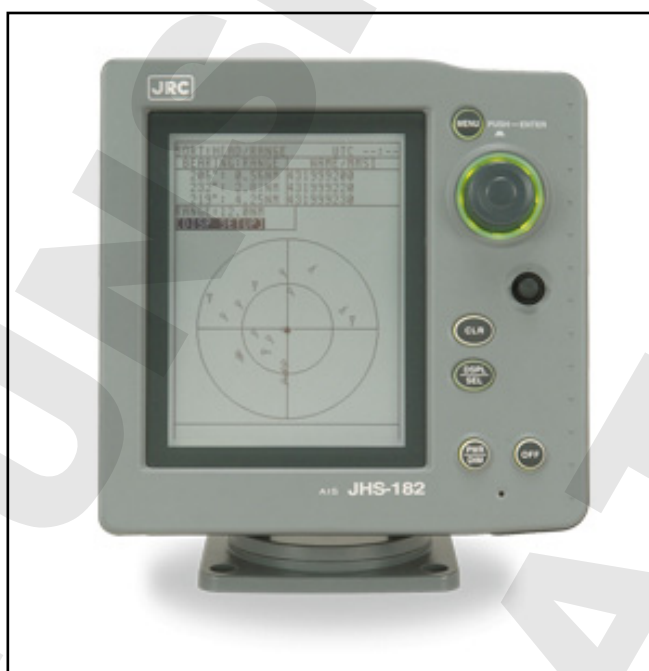
Figure 14: ACX Hibiscus's AIS unit

The AIS unit's display screen was small and showed only nearby vessels' ranges, bearings, and names, either in text form, or in a radar-style format. The unit was located next to the steering console (**Figure 14**).

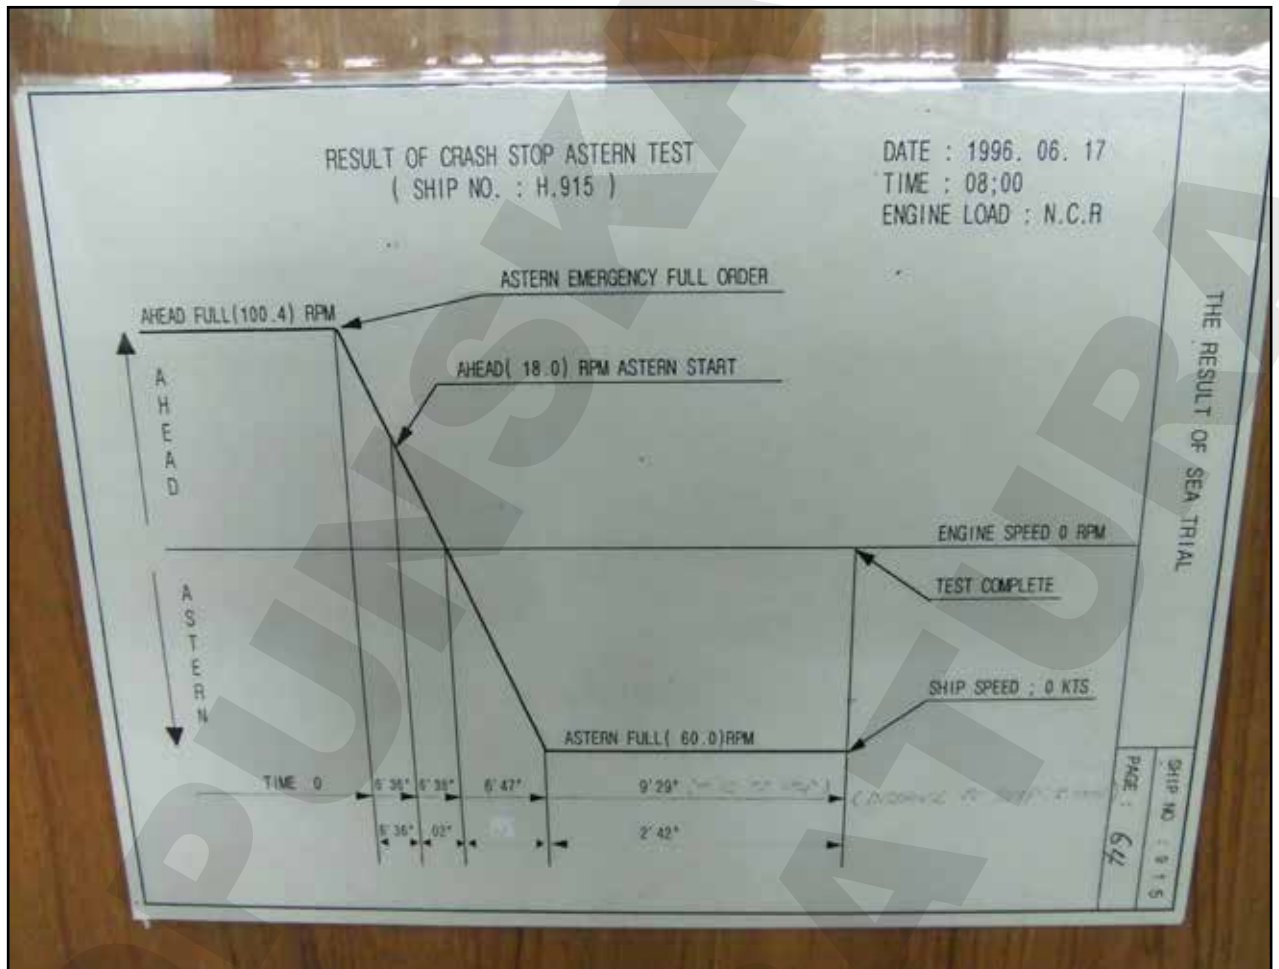
Figure 20: Hyundai Discovery's crash stop test results

The results of a crash stop test were also posted on the bridge (**Figure 20**). The diagram showed that from full speed (100 RPM), astern propulsion would be started in 6 minutes and 38 seconds. Full astern propulsion would be achieved after 6 minutes and 47 seconds with the vessel brought to a stop after 9 minutes and 29 seconds.
