Fatality in the elevator trunk on board *OOCL Kuala Lumpur*

8.5 nautical miles south-east of Port Botany on 3 June 2018

ATSB Transport Safety Report

345-MO-2018-009

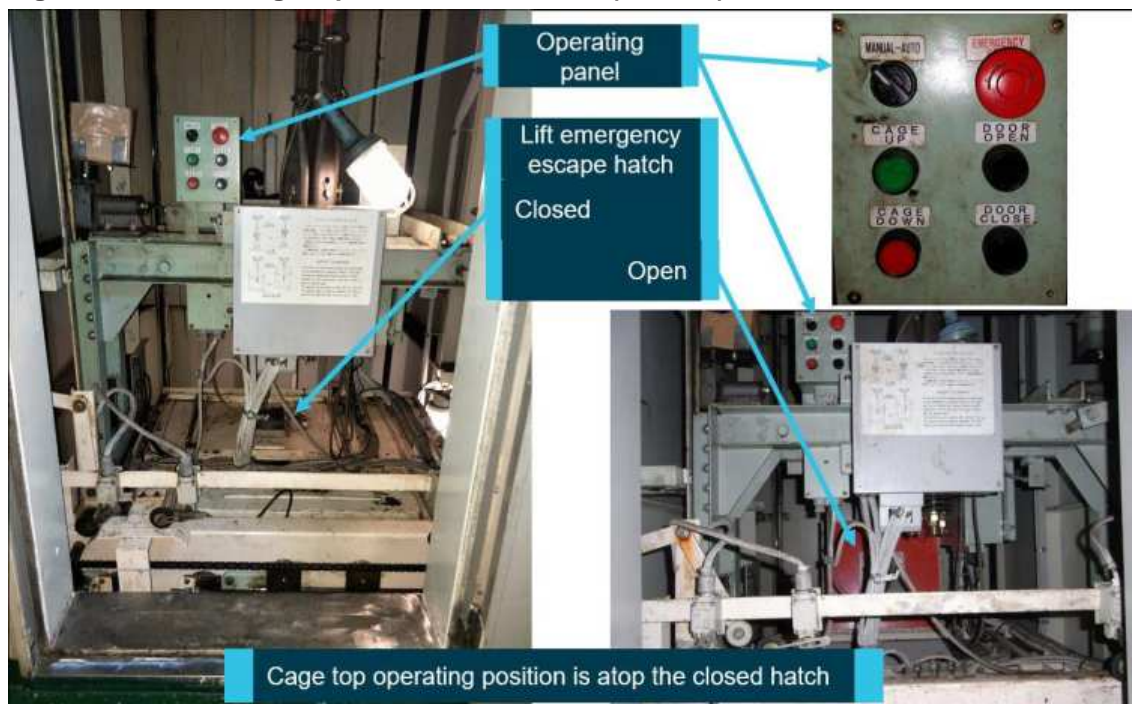
Figure 2: Elevator cage top from entrance door (forward)

The chief engineer authorised the EWP at 0820. The requirements of the task were discussed and the ETO showed the chief engineer the chain drive sprocket and explained the repair. They discussed how the work was to be completed, agreeing that the ETO would isolate the elevator and access the elevator cage top (Figure 2) through the engine room second deck elevator entrance door, and the fitter would complete the repair. The ETO undertook to notify the chief engineer when the repair work was complete and testing would proceed. The ETO and fitter went to do the work and the chief engineer turned his attention to the imminent main engine movements.

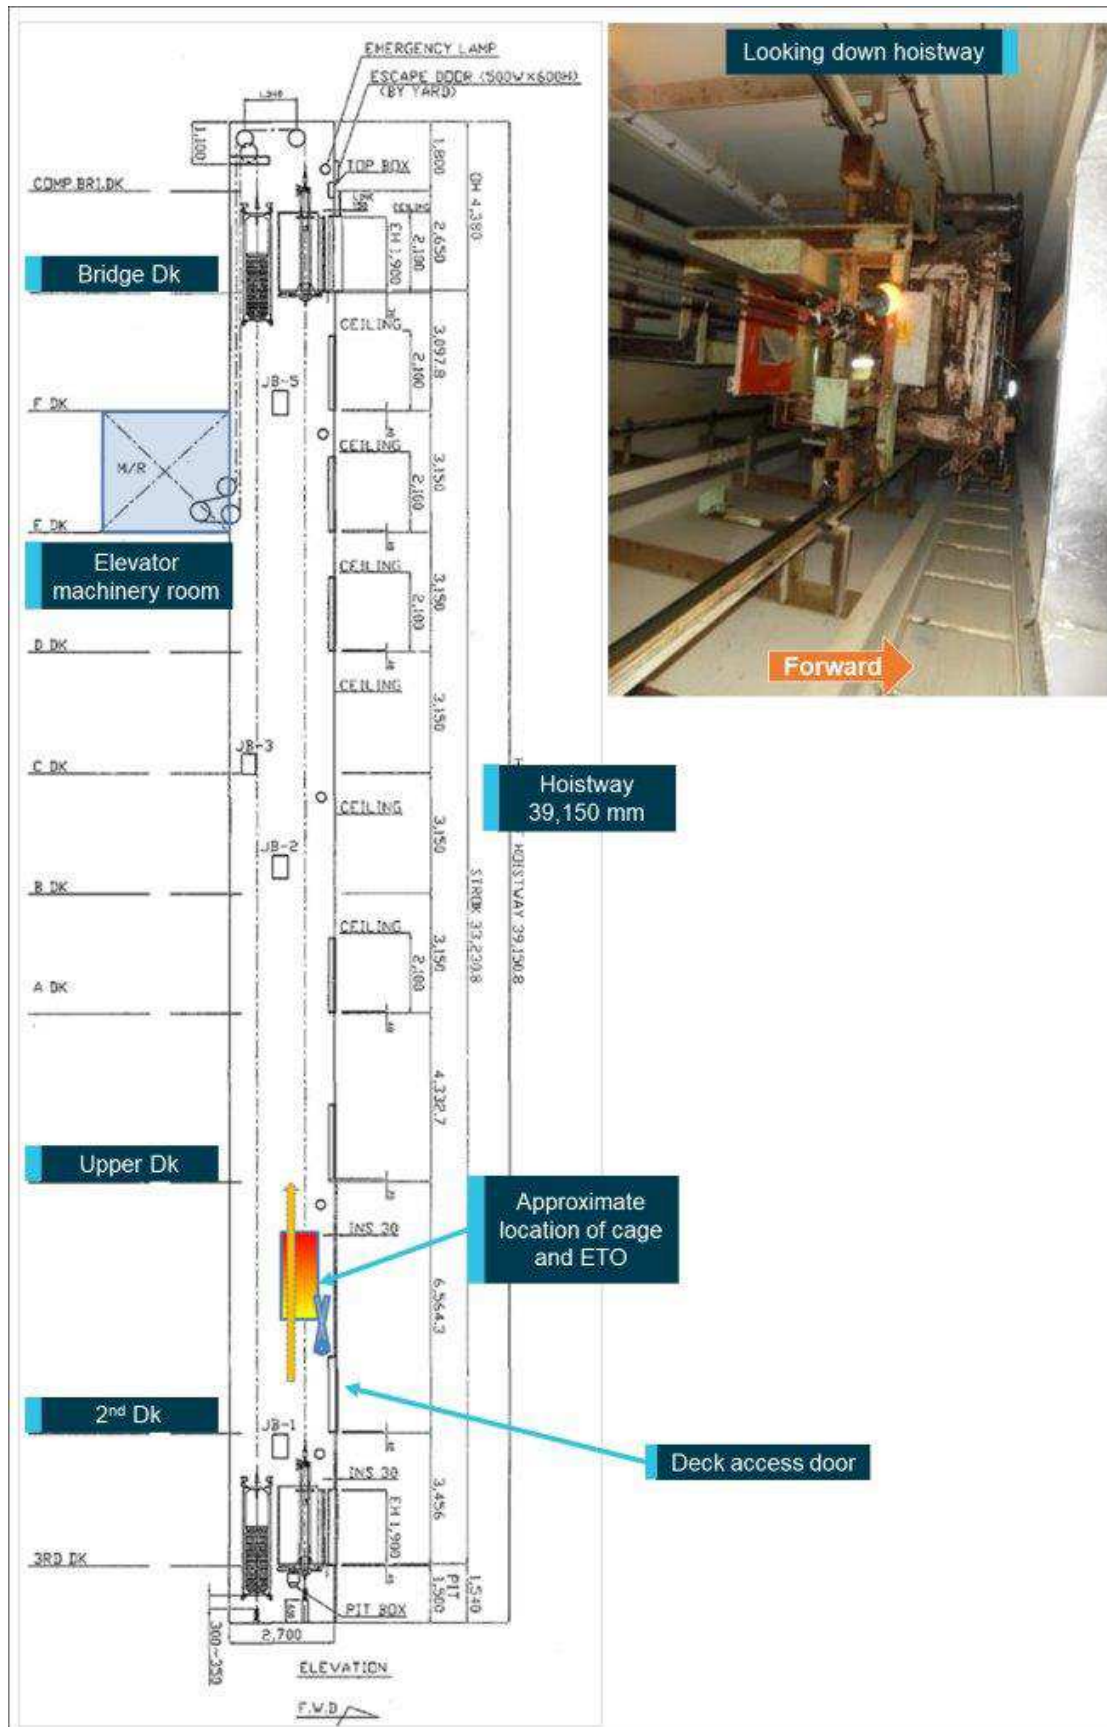
Figure 3: Elevator hoistway arrangement and location of accident

The elevator machinery and control unit are located in the elevator machinery room located on E deck, 2 decks below the navigation bridge and about 25 m above the third deck level. When there is no electrical power supply to the elevator, the elevator cage can be raised or lowered by fitting a provided hand-wheel to the electric drive motor. When the traction machine brake is released, the hand-wheel can be turned in either direction to move the elevator car up or down.

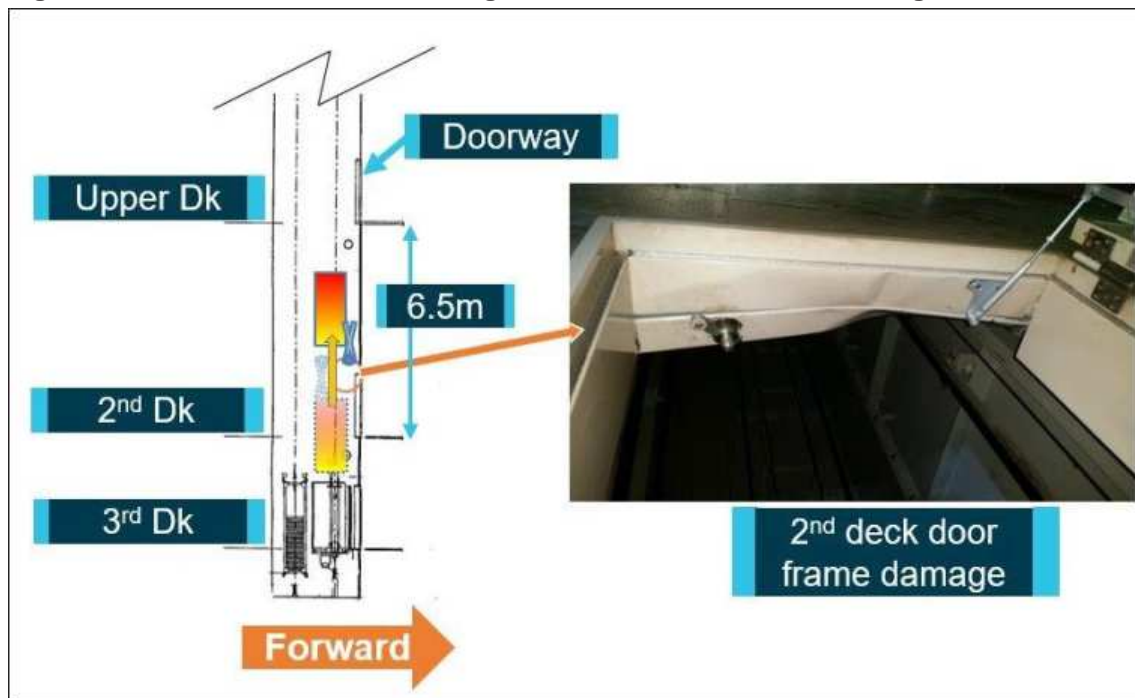
Figure 4: Accident location and damage to second deck elevator landing door frame

After the accident, the ETO was found on the forward side of the elevator, toward the port side, in an inverted position. The top plate of the second deck landing door frame was found damaged and bent upwards with the door position micro-switch dislocated and the door closer damaged (Figure 4). This indicated, that, at some stage after the second deck elevator access door was closed, the ETO moved away from the cage top safe zone to a position that exposed him to a crush hazard beyond the side of the cage. It was not possible to determine the reason for this re-positioning.

The elevator travelled several metres vertically from its original location until the cage bottom was about 0.5 m above the second deck doorway top plate. The push-and-hold design of the manual control buttons meant that if the ETO had been driving the cage manually, it should have stopped once he was struck and his finger was removed from the button.
