Report on the investigation of  
a fatal accident on

***Wellservicer***

3 miles SE of Aberdeen, Scotland

1 April 2009

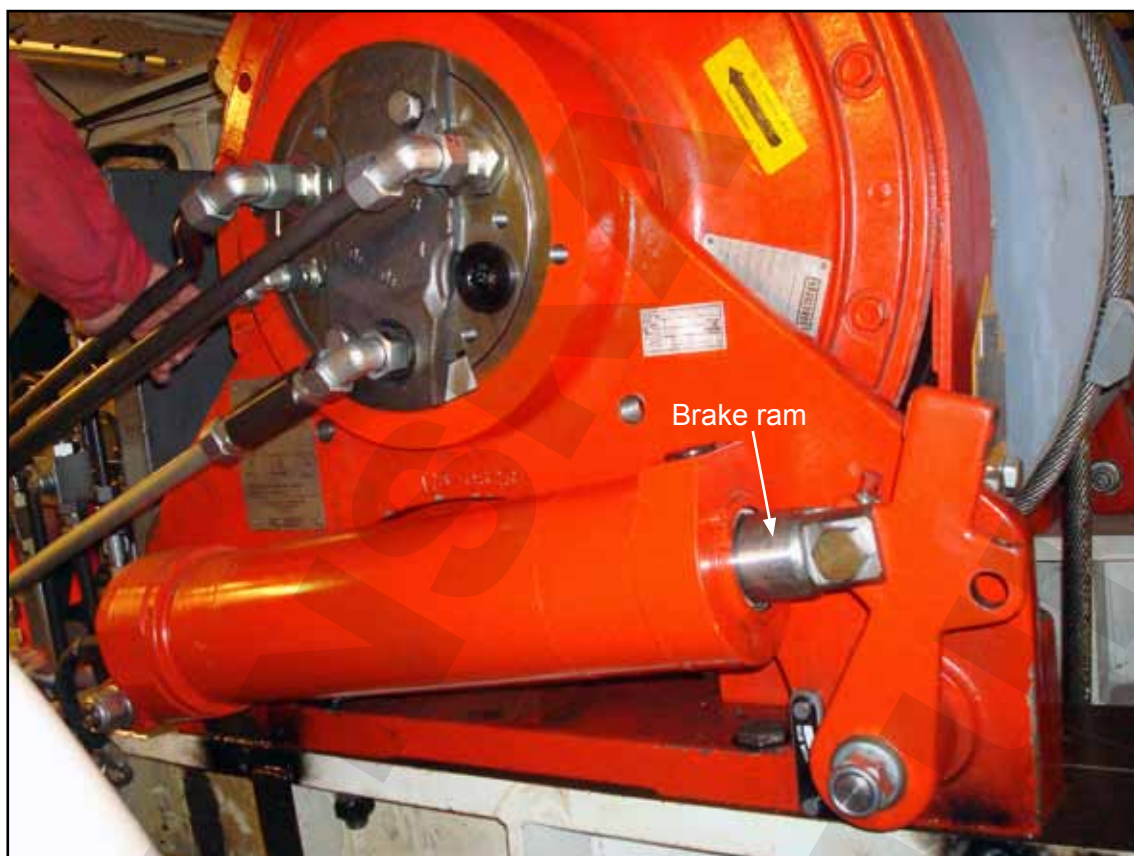
On 31 March, with the bell in the moonpool suspended from its normal winch wires and the cursor suspended by stops from the trolley, modification work continued, including the spooling of wire onto the new cursor winch sited on top of the bell trolley. The wire was then attached to the 4t cursor, enabling it to be independently supported by its own dedicated winch and wire. During the spooling of the winch wire, one of the Modification installation team noticed that, on one occasion, the winch brake ram (**Figure 8**) did not properly apply when

Cursor winch forward brake ram

the local winch control handle was released (**Figure 9**). This was remedied by the winch operator wiggling the control lever, and highlighted to him that the brakes would need some adjustment as part of the system's commissioning.

At one point during installation, a member of the installation team observed that the brakes did not fully apply. This was corrected by wiggling the control handle, and a mental note was made at the time to adjust the brakes later on. This was, in all probability, an early indication that the pilot valve was faulty and the “wiggle” was simply enough to release pressure from the system allowing the brakes to apply.

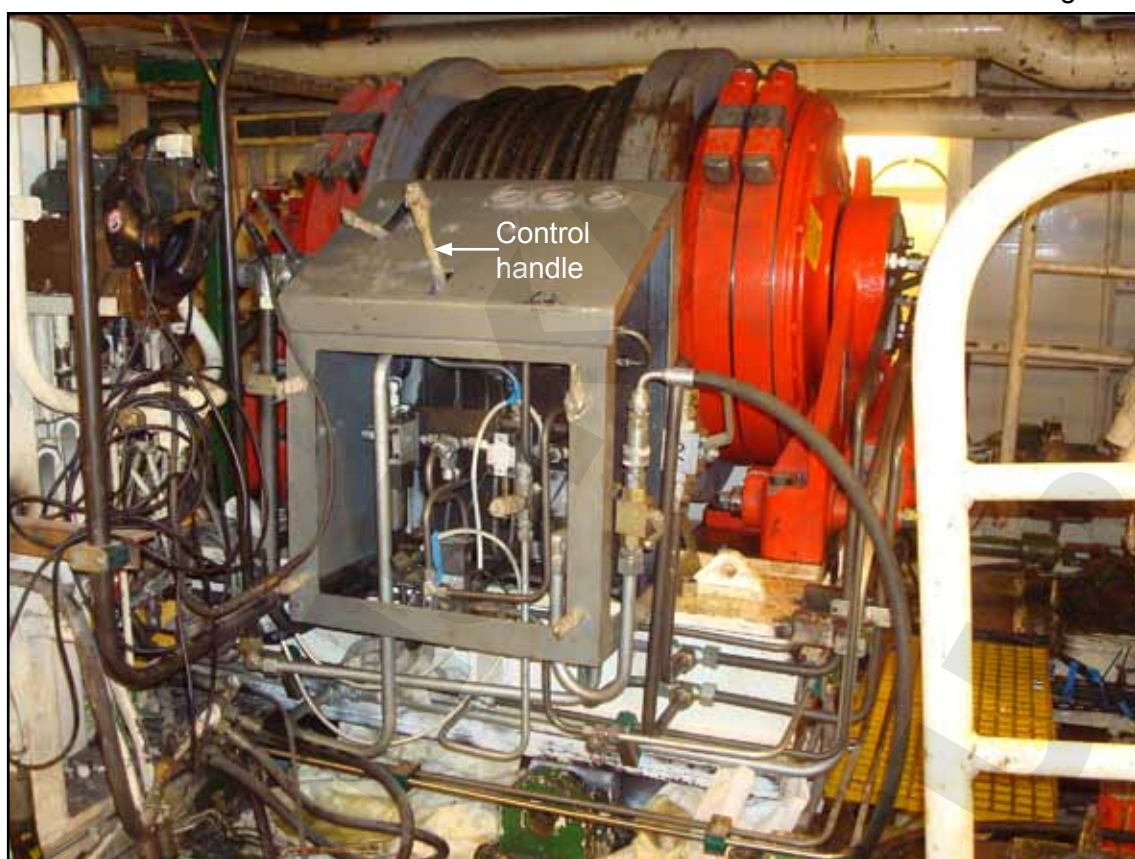
Figure 9

Cursor winch local control panel

Similarly, Technip commissioned an independent external expert, Thomson Engineering Consultants, to carry out an intrusive investigation into the hydraulic circuit. This investigation, observed by Aberdeen Hydraulics on behalf of the MAIB, identified a malfunction within the local control panel for the winch.

In view of the function required to be carried out by the winch, i.e. emergency lifting or constant tension of the cursor wire in normal operations, the hydraulic lock, often found in winches to prevent them from veering, was not incorporated in the Hagglunds winch. This would have been acceptable provided the brakes were independently controlled. However, the design of the hydraulic circuit was such that the brakes were controlled through a single source (the defective pilot valve) and the independence of the brake operation was compromised. Consequently, on this occasion, when the control lever was released and the

power to the winch switched off, neither brake applied as hydraulic pressure was retained in circuits to both the brakes by the defective valve. The weight of the suspended cursor then caused the winch drum to creep back and go into freefall.

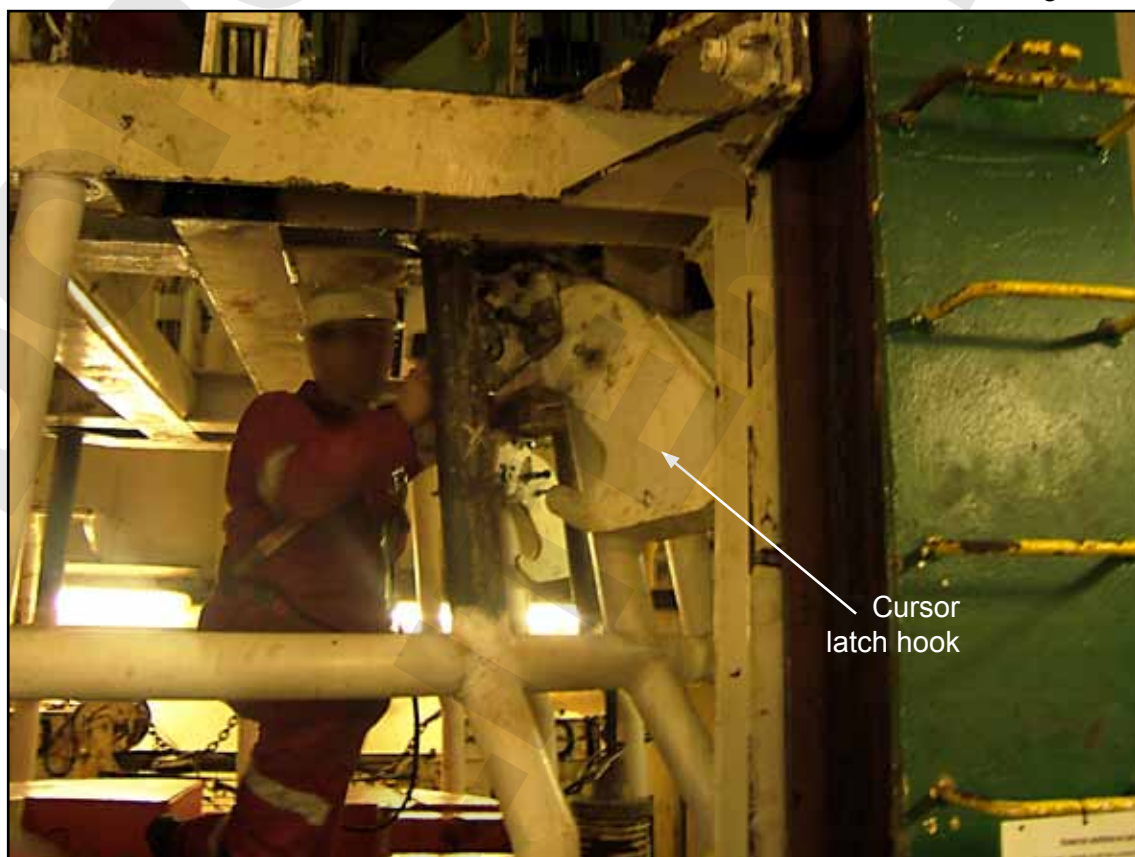
Figure 10

Rigger working on cursor latch hooks under suspended cursor

The Modification installation team did not exercise a reasonable duty of care by failing to apply the most basic of safety principles while working under a suspended load.

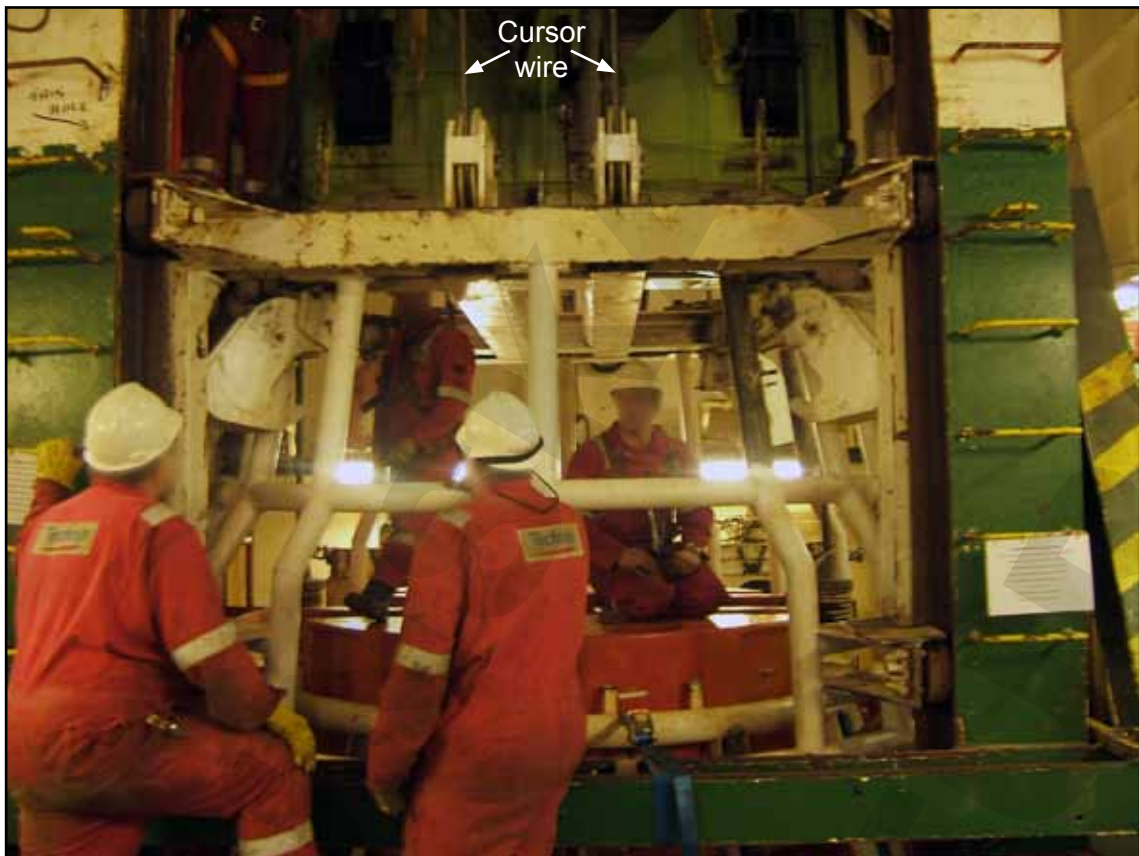
Figure 11

Riggers on top of the bell, under suspended cursor

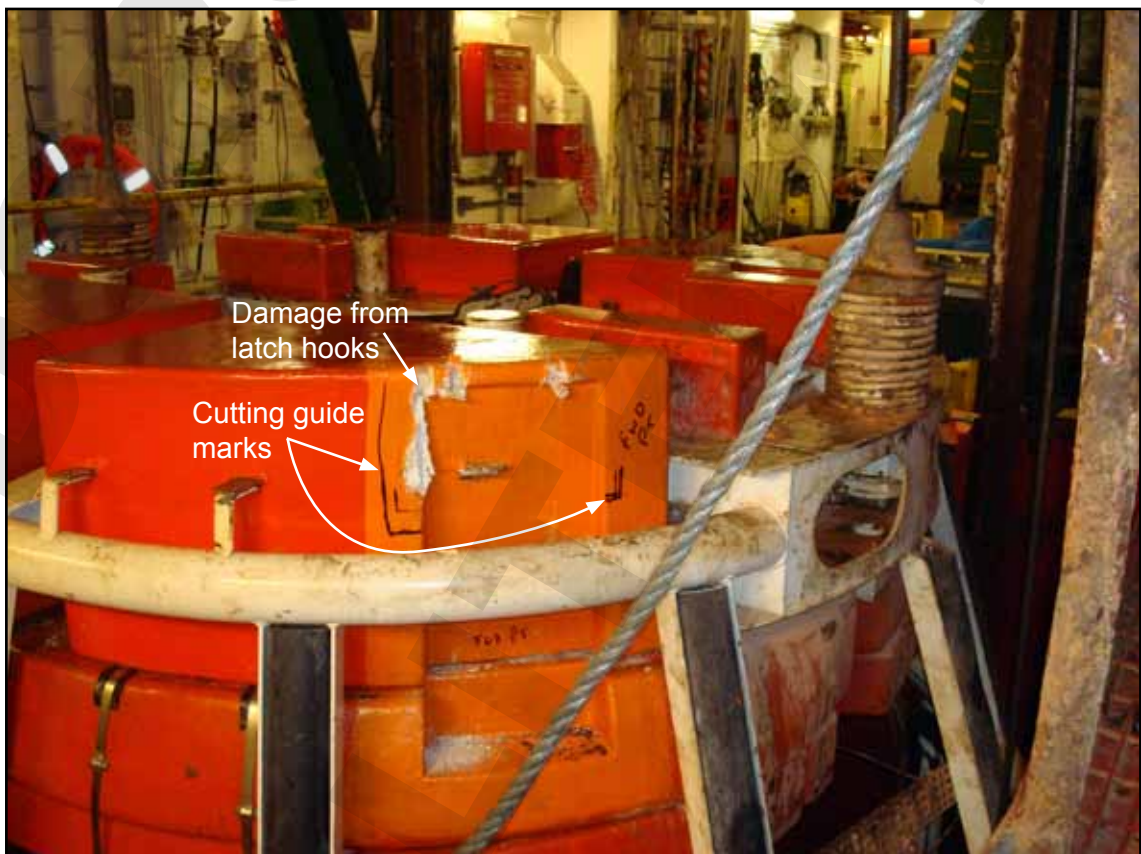
Figure 12

Damaged buoyancy blocks

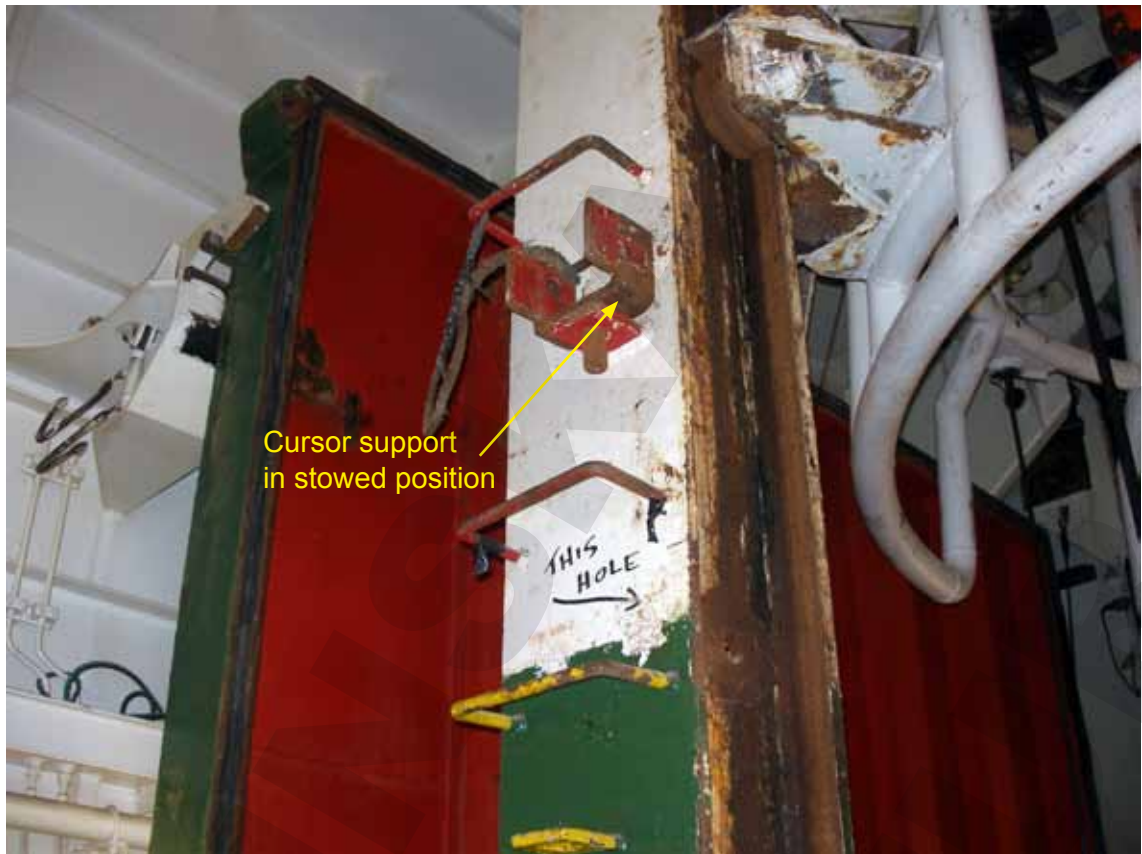
Figure 15a

The dive technician supervisor left the control room to go down to the hanger deck after shutting down hydraulic power, and the hydraulic engineer left the local winch control to return to his cabin. A rigger, David Stephenson, better known as “Luey”, was already on top of the bell, with his inertia reel fall arrester attached to his safety harness preparing for buoyancy block removal as the cursor was raised. A few seconds later the winch rendered and the cursor fell uncontrollably. This was seen and heard by colleagues, who shouted to Luey to get off the bell. He attempted to get clear of the falling cursor but, as he did so, his inertia reel fall arrester locked in place, preventing any chance of escape. The cursor continued to fall, trapping Luey between it and the diving bell.

Cursor support position at the time of accident

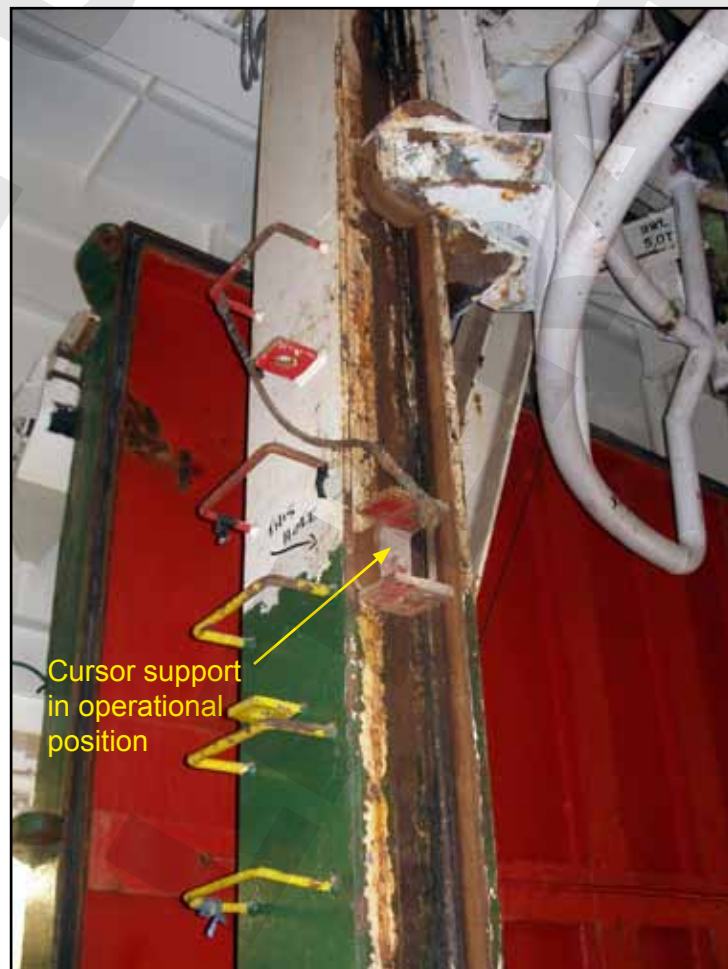
Figure 15b

Cursor support shown in operational position
