Marine Accident Report

**Allision of Hong Kong-Registered Containership M/V *Cosco Busan*
with the Delta Tower of the San Francisco–Oakland Bay Bridge
San Francisco, California
November 7, 2007**

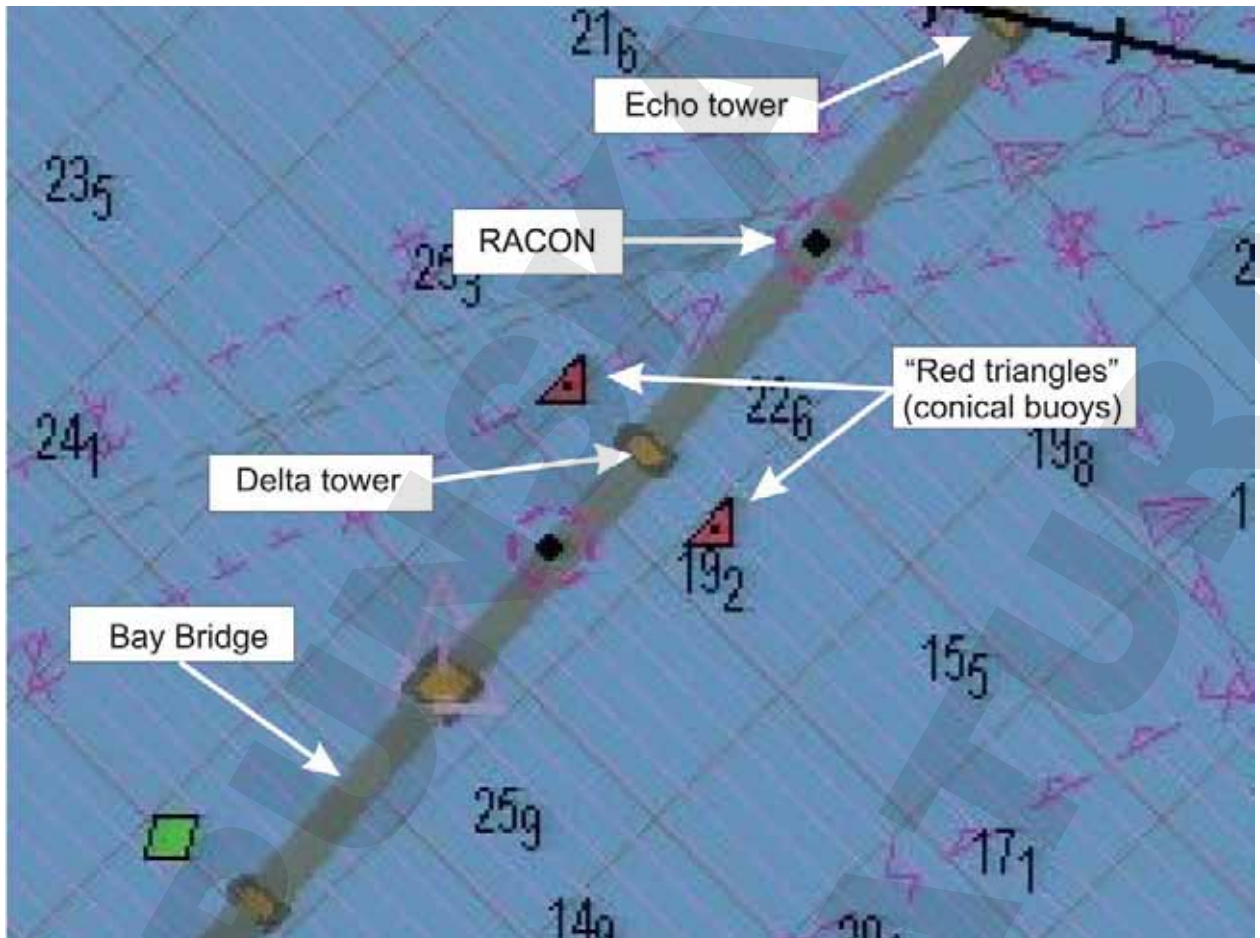
Figure 2. An enlarged section of the electronic chart on board the *Cosco Busan*. Two conical buoys, positioned on either side of the Delta tower, are displayed as red triangles on the electronic chart.

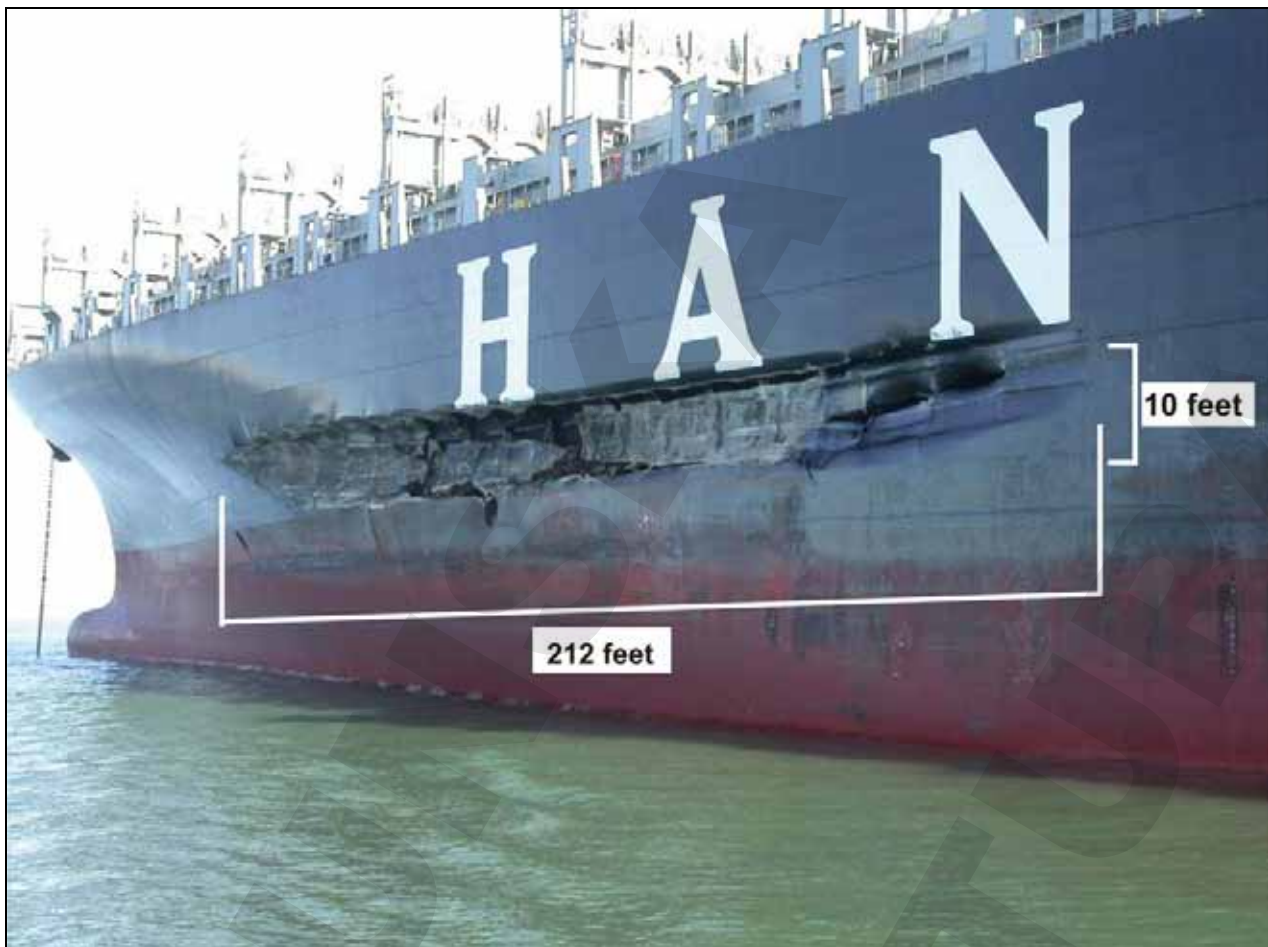
Damage to the *Cosco Busan* from its allision with the Bay Bridge was confined to the port side of the vessel, forward of the superstructure, above the waterline (figure 4) The Nos. 3 and 4 port fuel tanks were breached, as was the No. 2 port water ballast tank.

The *Cosco Busan*'s classification society, Germanischer Lloyd,³⁶ surveyed the vessel's damage on November 13, 2007. The forward-most point of the damage was about 237 feet aft of the ship's bow and extended along the port side of the vessel for about 212 feet. This damage area extended about 10 feet vertically up the hull side. The hull's shell plating³⁷ was torn open along the entire length of the damaged area. All the internal web frames in the damage area were deformed to some extent. Pipes, ladders, handrails, and gratings associated with all three of the damaged tanks were damaged or destroyed. Internal damage to the vessel did not extend past the inboard boundaries of the three breached tanks.

At the time of the allision, according to sounding tables from the day before the accident, the No. 3 port fuel tank was about 10 percent full. This placed the fuel level below the breach in the hull, and none of the fuel was released in the accident. Conversely, from the same day's soundings tables, the No. 4 port fuel tank was at 87 percent capacity, a level above that of the hull's postaccident portside damage.

Figure 4. Damage to the forward port side of the *Cosco Busan* after the allision with the bridge tower.

The *Cosco Busan* remained in the San Francisco Bay area for 30 days after the allision while temporary repairs were made to the vessel hull. The repairs consisted of fitting a plate over the shell opening. According to a Fleet Management official, the cost of the temporary repairs

totaled \$1,239,792. After completion of the temporary repairs, the vessel transited to China for permanent repairs. The damaged tanks were not used to carry fuel on that voyage. The vessel's temporary repairs were made to the outside shell plating, not the actual inner bunker fuel tank boundaries. The final repairs were completed in 13 days and cost an additional \$812,000. On January 11, 2008, the vessel was renamed *Hanjin Venezia*.

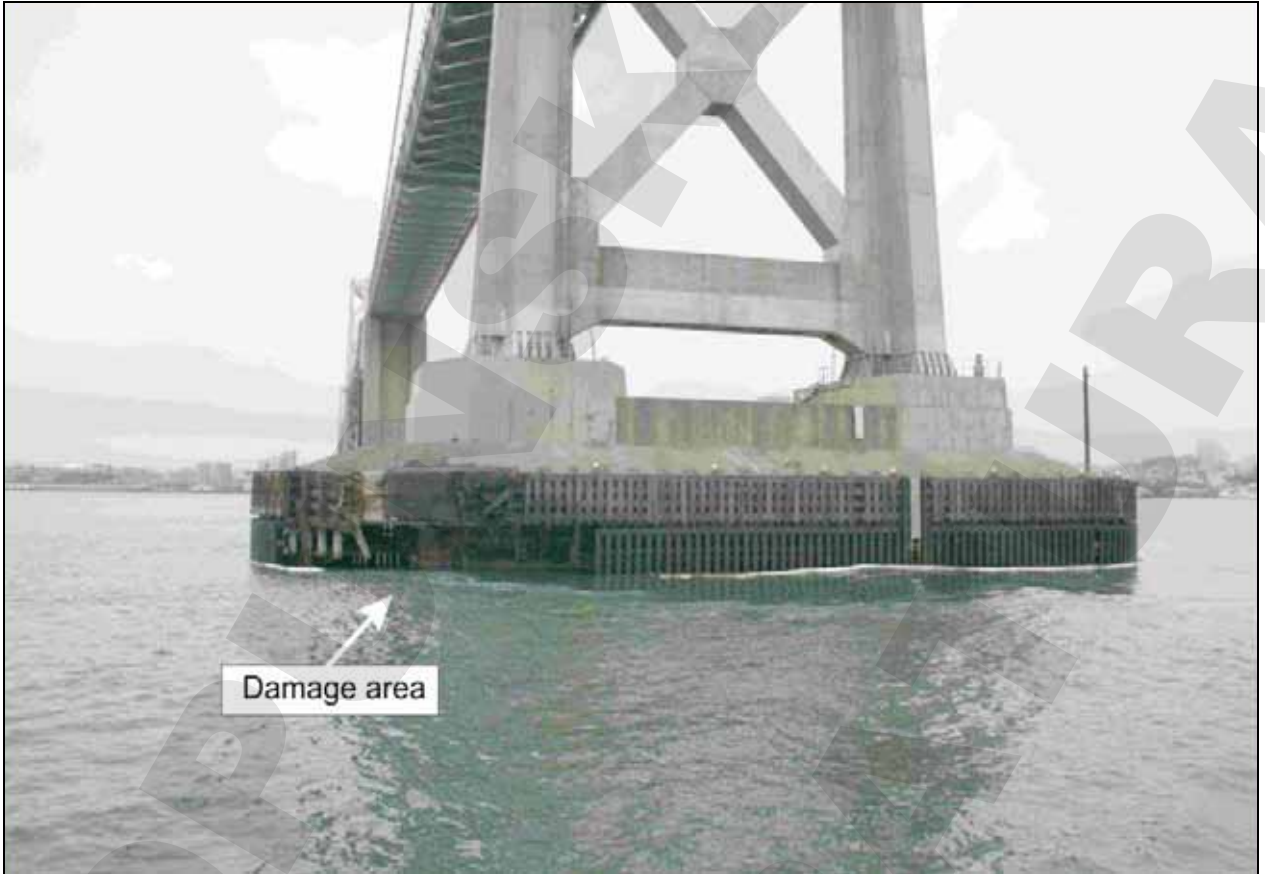
engineer, and a state transportation engineer inspected the pier. They found that about 100 feet of the fendering and skirt at the southeast corner of the Delta pier had been damaged (see figures 5 and 6), but they found no damage to the pier itself or to any other part of the bridge structure.

Cost to repair the damage was \$1.5 million. By 0950, Caltrans engineers had completed their inspection and found no damage that would compromise the structural integrity of the bridge.

Figure 5. Damaged fendering system at the base of the Bay Bridge Delta tower.

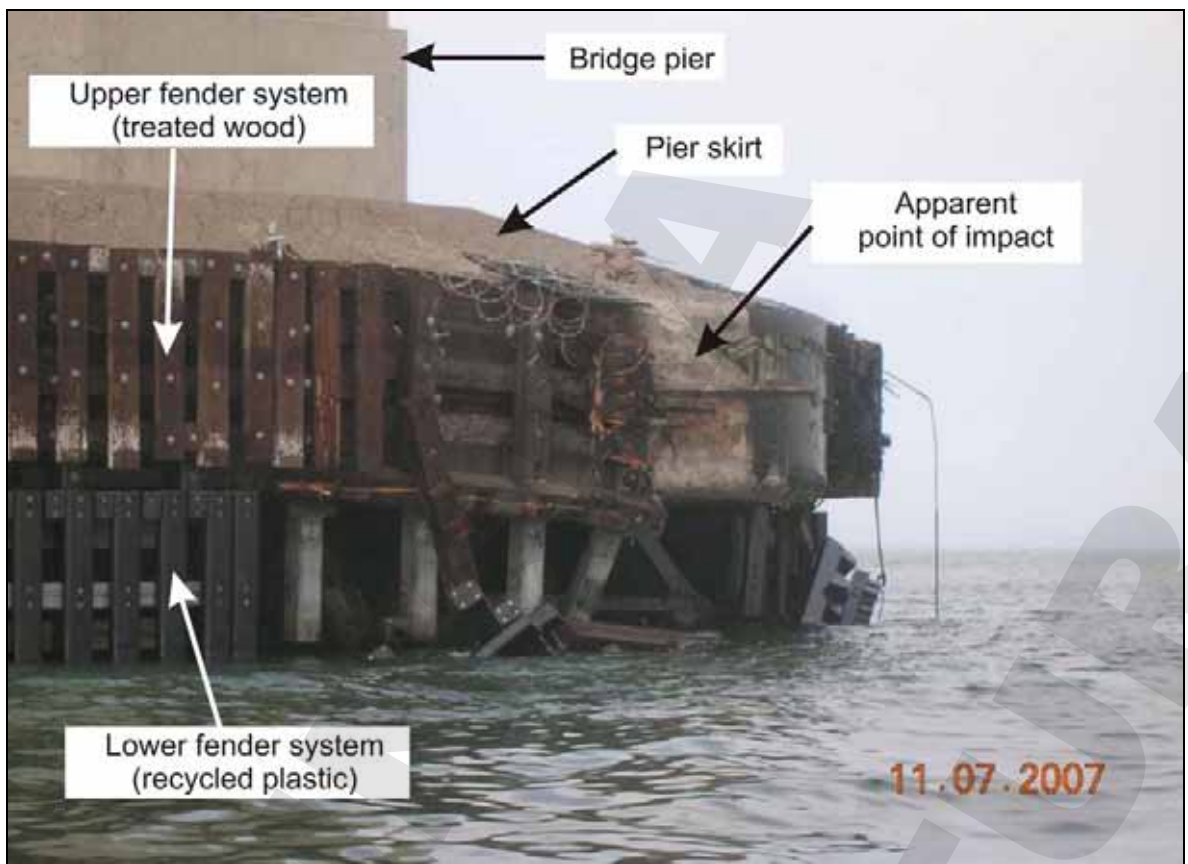
Figure 6. Close-up view of the fendering system at the base of the Delta tower showing the likely point of impact and a portion of the 100-foot-long damage area.

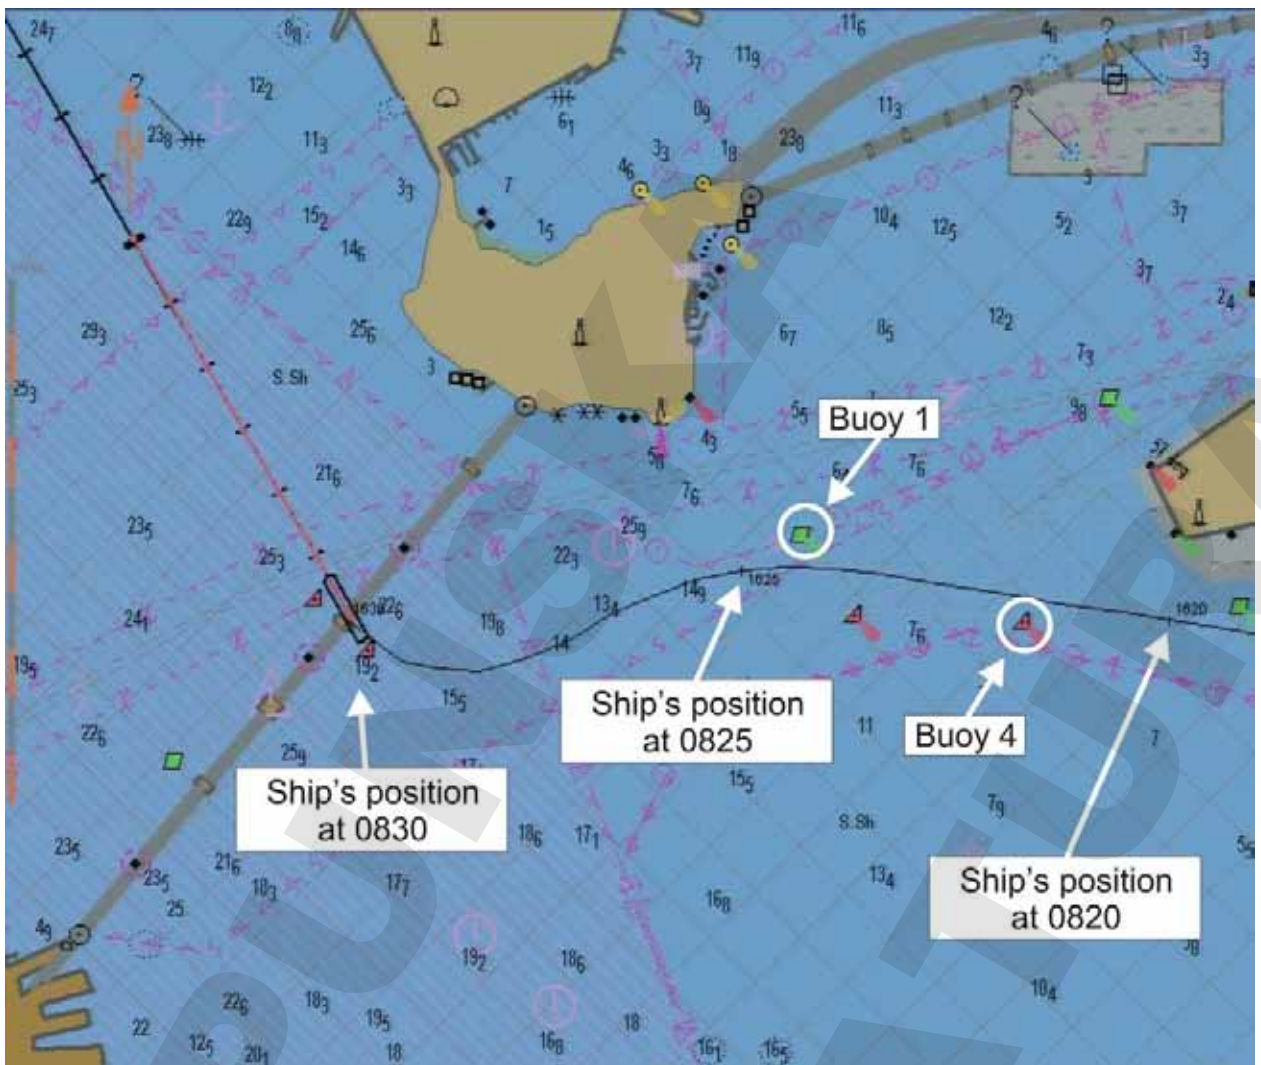
Figure 9. Electronic chart from the *Cosco Busan* showing the vessel's track from the entrance channel to the bridge during the accident voyage. The ship's position was marked on the chart at 5-minute intervals.

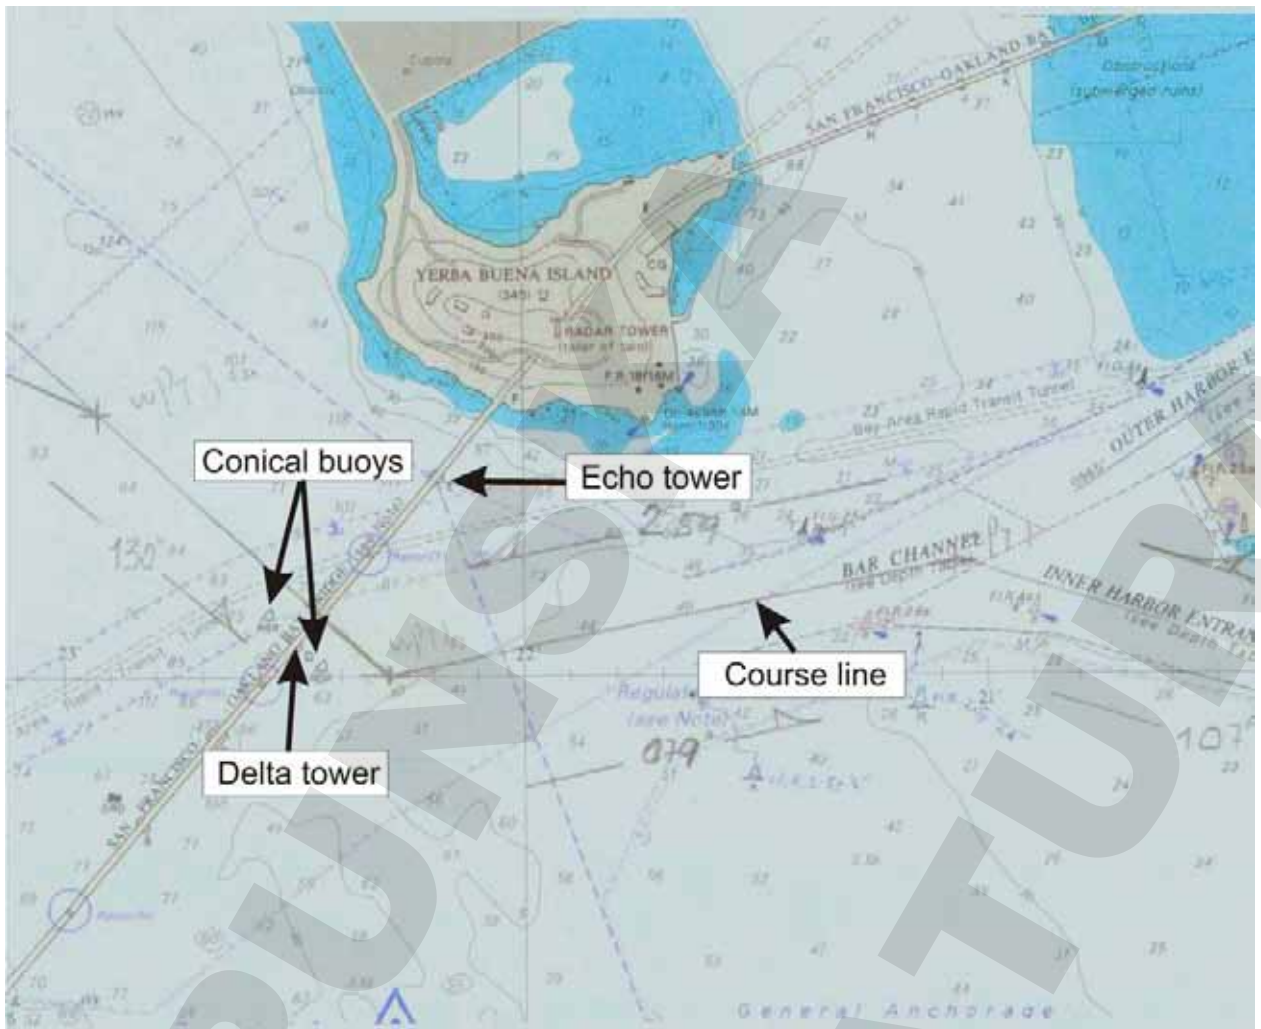
Paper Chart. The paper chart on the chart table on the morning of the allision was British Admiralty chart No. 588, Edition 5, dated November 29, 2001 (corrected through Notice to Mariners No. 38/07). A crewmember had drawn a single course line on the chart indicating the planned route through the Delta–Echo span of the Bay Bridge to and from berth 56 (figure 10).

Figure 10. A portion of the paper chart that was on the chart table on the bridge of the *Cosco Busan* at the time of the allision. The course line, with in- and outbound headings, had been plotted and added to the chart by the ship's crew.

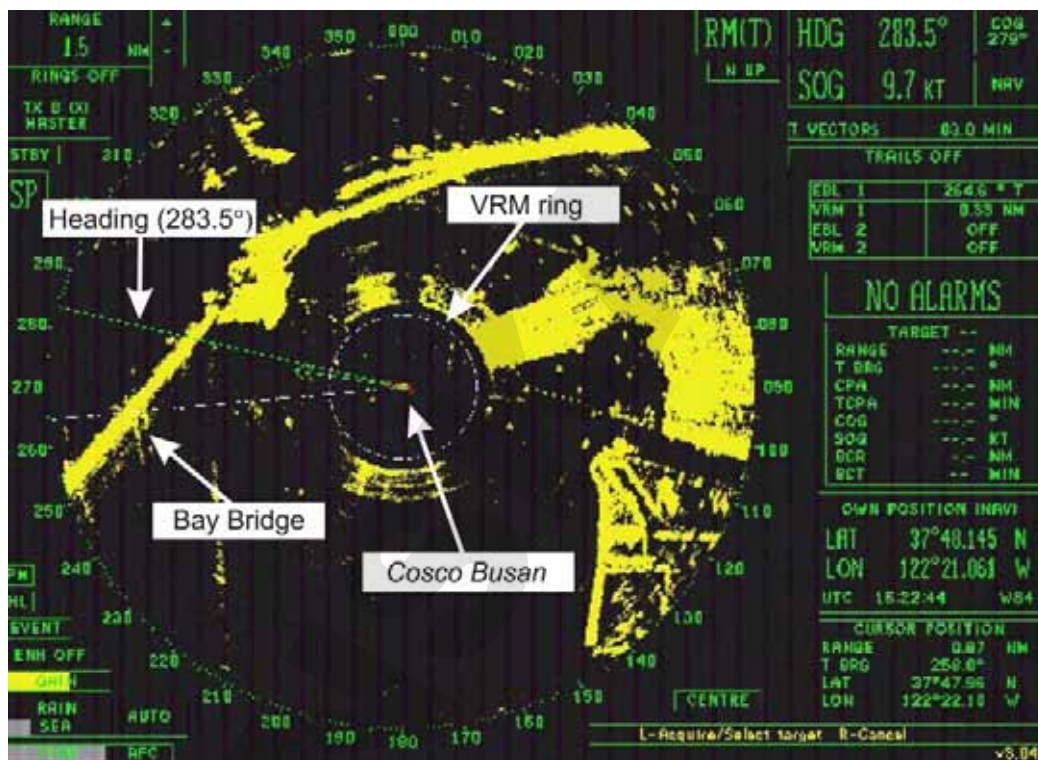
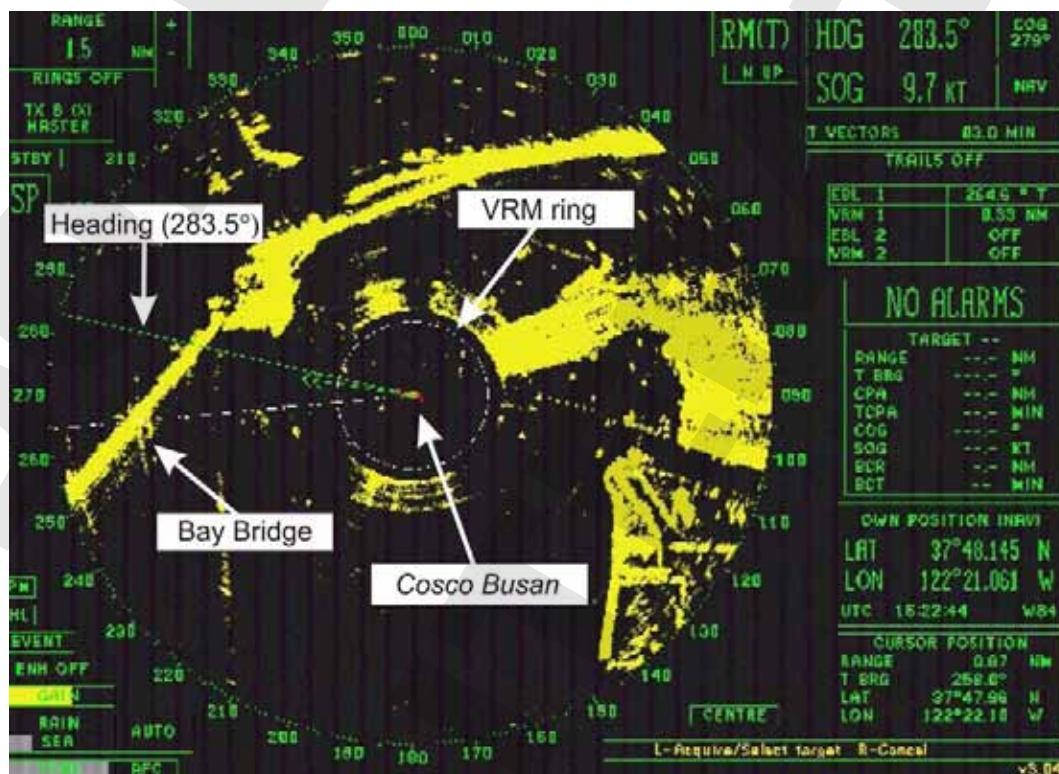
The *Cosco Busan* pilot told investigators that about the time the vessel began its initial turn to port (about 0823), “the radar picture of the bridge got distorted. It got wider. The bridge got wider. The RACON never appeared.” Investigators reviewed the radar images captured by the VDR and assessed the quality and consistency of the images that were displayed during the accident voyage (figure 13). This review revealed that the radar returns from the Bay Bridge did not change significantly from the time the bridge first became visible on the display about 0819 until about 0826 when the upper end of the bridge appeared to widen. The upper portion of the bridge appeared to widen on the radar image for about 1 minute before beginning to return to normal.

During the public hearing on this accident, the Sperry manager of product support and training reviewed the image and attributed the change in the bridge’s appearance to the *Cosco Busan* being almost abeam of the bridge at that point, with the top section of the bridge providing a much stronger radar return because the radar was “shooting . . . [radiofrequency] energy directly into the girders . . .” Figure 14 shows the radar image that was being displayed on the *Cosco Busan* at the time the radar image of the Bay Bridge became, in the words of the pilot, “distorted.” After about 2 minutes, the entire bridge began to appear thinner on the radar screen as the ship approached the bridge and more of its radar waves passed beneath the bridge instead of being reflected back. The signature of the RACON transponder at the midpoint of the Delta–Echo span also appeared on the radar screen at regular intervals throughout the voyage.

Figure 13. (Top) Radar image displayed on the bridge of the *Cosco Busan* at 0822:44, just before the vessel turned to port, and (bottom) the radar image at 0826:14, just after the vessel made the turn to port. In the bottom image, note the identifier for the RACON at the center of the Delta–Echo span of the bridge.

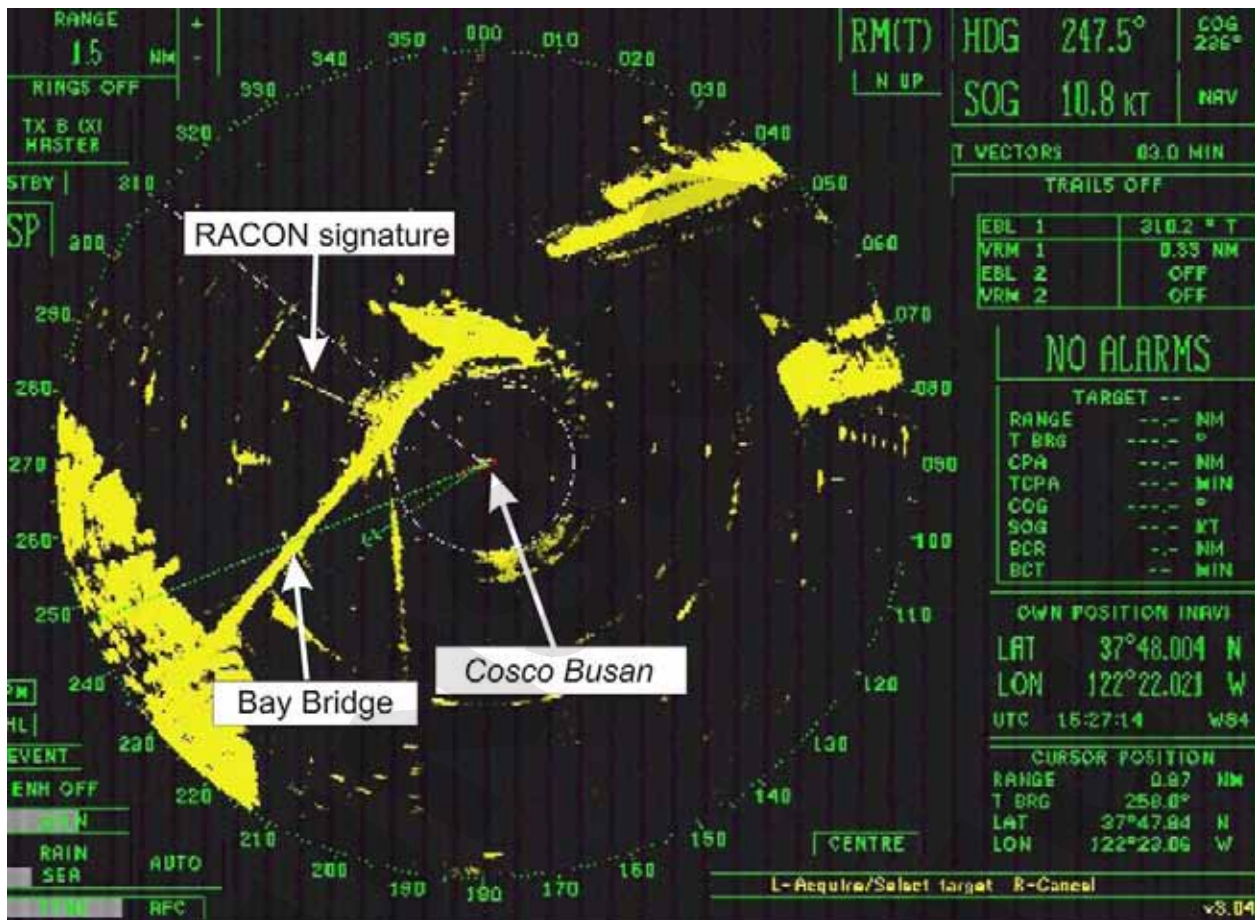
Figure 14. Radar image on board the *Cosco Busan* at 0827:14. According to investigators, 0827:14 was the time at which the upper portion of the bridge appeared the most enlarged on the radar image before returning to normal.
