Report on the investigation of
The machinery space fire on board

Oscar Wilde

In Falmouth Bay

Report No 3/2011
March 2011

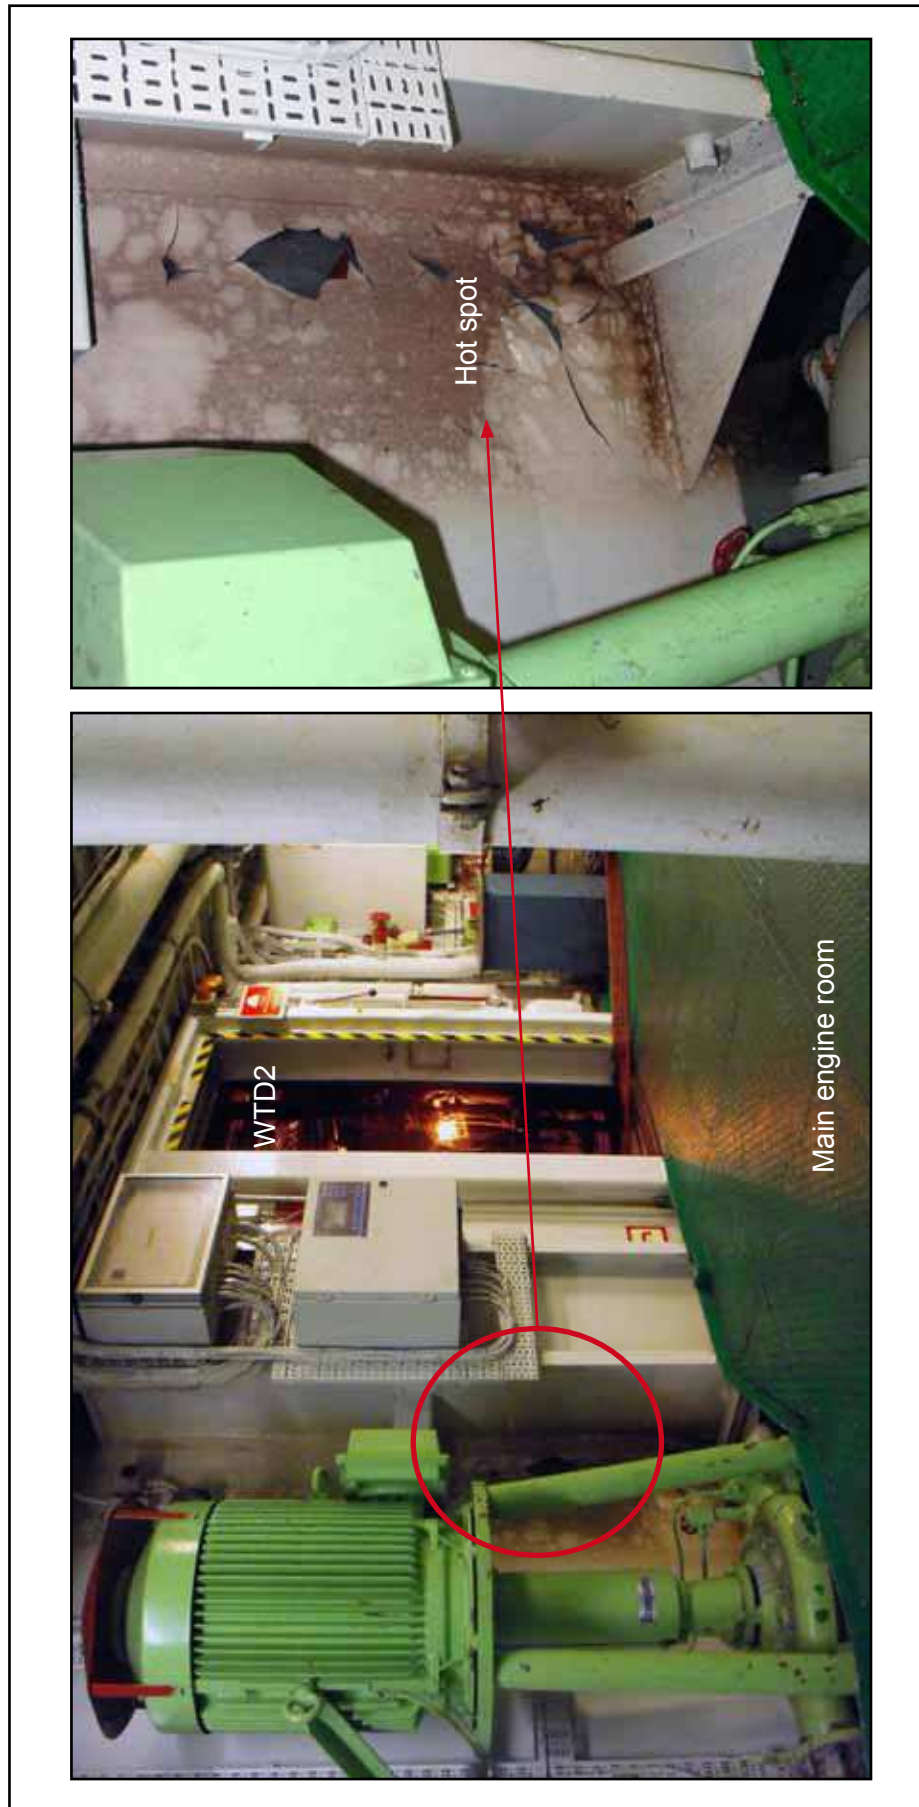
Figure 6

At 1927, the chief engineer reported hot spots on the deck of the lobby area outside the ECR. Two minutes later, the 2/E reported hot spots on the forward main engine room bulkhead next to WTD2 (**Figure 6**). The C/O interpreted this message to mean hot spots had been reported in the fire control station. This caused some confusion on the bridge as the control station was 2 decks above the AER (**Figure 7**).

Hot spots on main engine room bulkhead

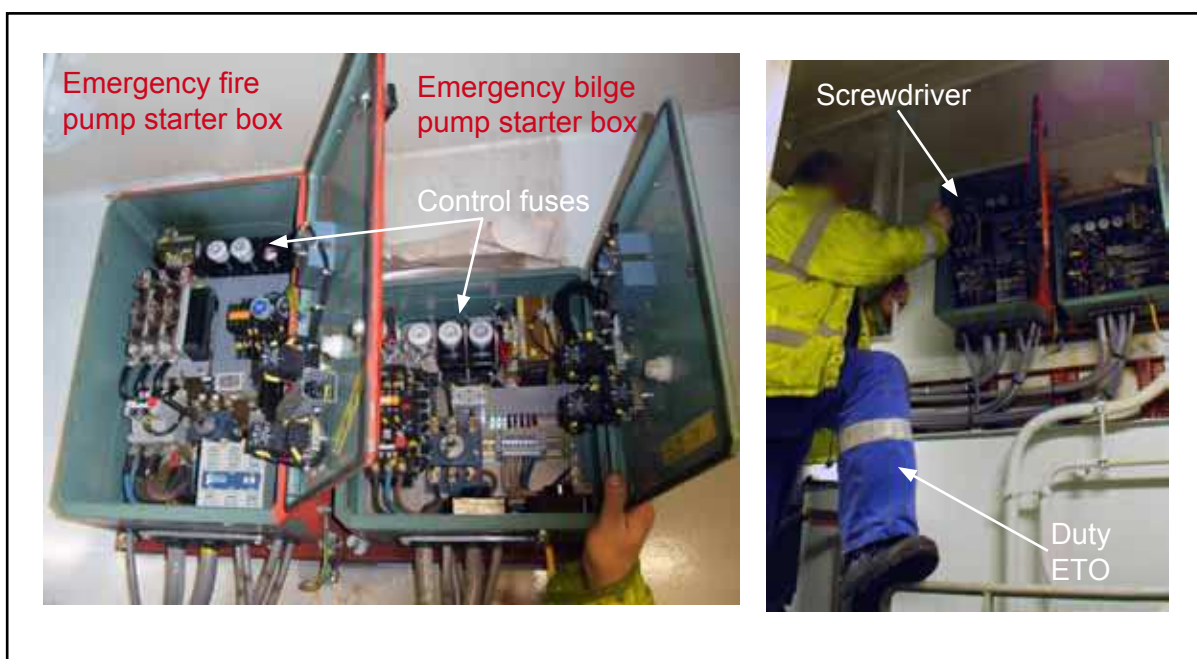
Figure 8

The emergency fire pump was not running. The 2/E opened its starter box and replaced a blown control fuse with a fuse taken from the adjacent emergency bilge pump starter box. This also blew when he attempted to restart the fire pump. The duty ETO climbed onto a set of guardrails next to the starter box, and used his screwdriver to push in the start control contactor (**Figure 8**). The pump started and fire main pressure was re-established. The EOOW was sent to close the engine room fire main isolation valve while the chief engineer went to the *Hotfoam* room, and the 2/E checked the *Hi-fog* system. The extra 2/E and the duty ETO remained in the bow thruster space.

Emergency fire pump starter box and actions of the duty ETO

In the bow thruster space, the duty ETO continued to hold in the emergency fire pump contactor which was sparking and generating smoke within the starter box. The extra 2/E advised the C/O that the pump might only last a further 5 minutes. A second ETO was dispatched to the bow thruster space with an emergency repair bag to assist his colleague.

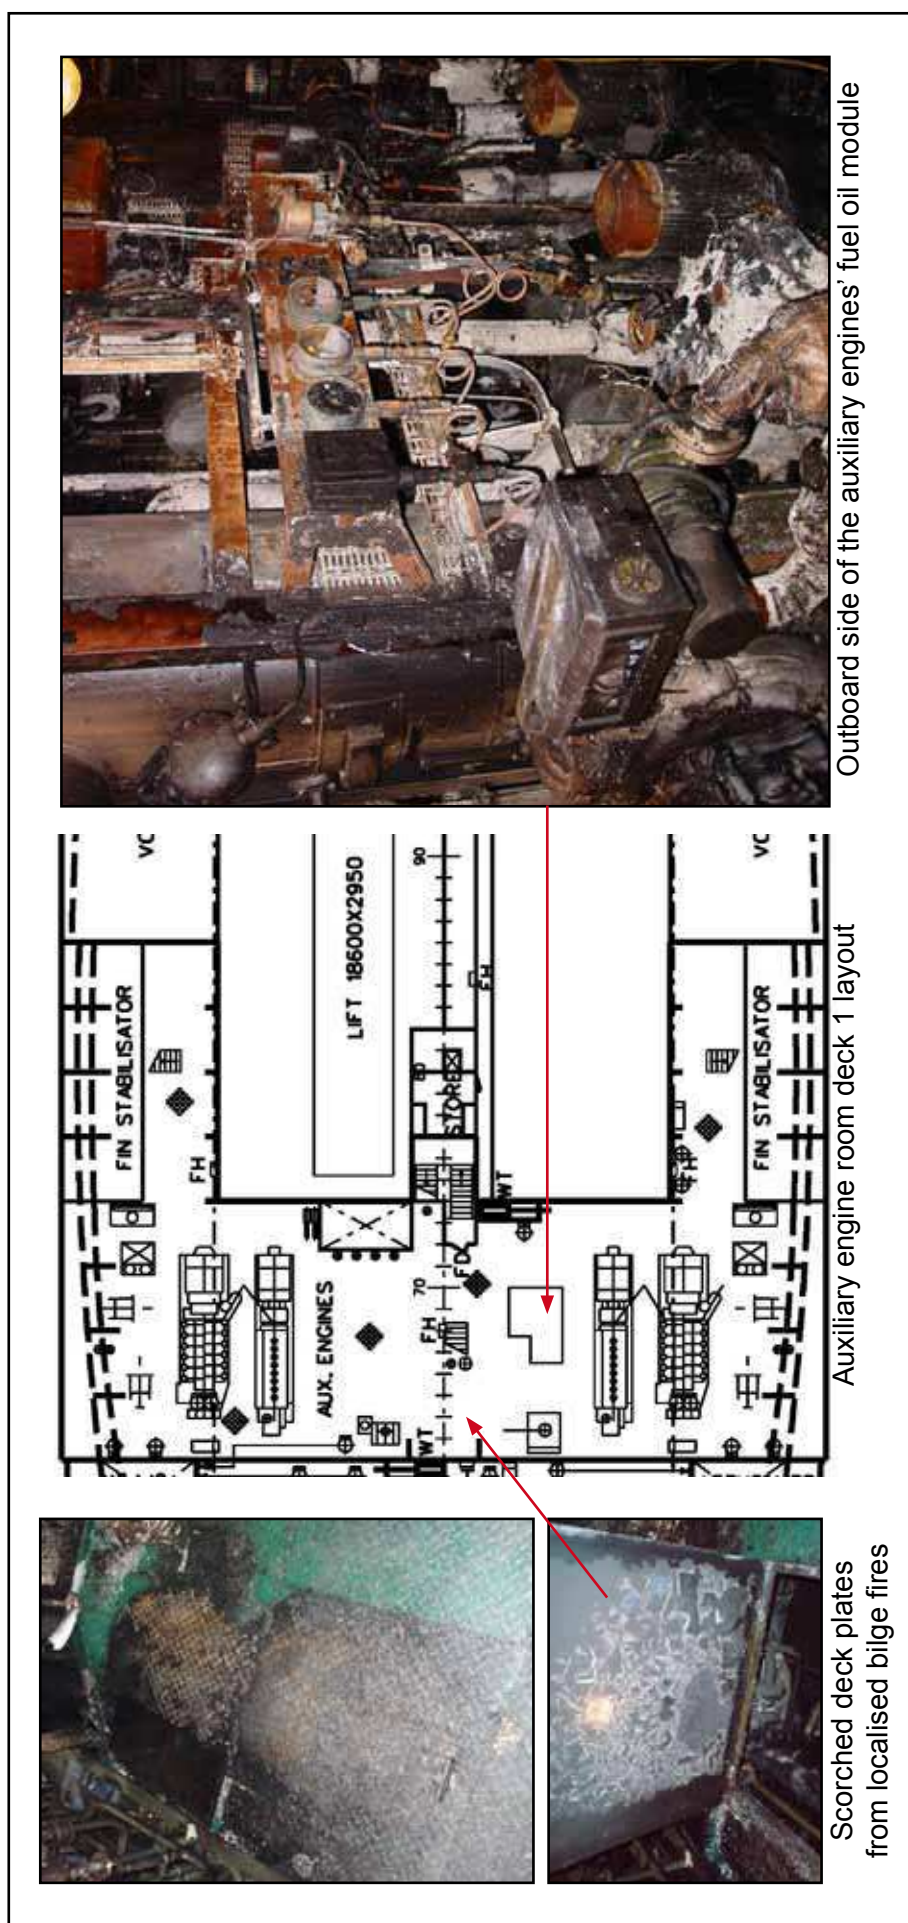
Figure 10

The heat damage and burn patterns on the outboard side of the fuel module indicated that the seat of the fire was low down but had spread to the electrical cables above. Damaged cables included the start/stop control cables for the emergency fire pump. No.3 auxiliary engine was not significantly affected by the heat radiated from the fuel module fire. The greatest damage at deckhead level was evident between the fuel module and the AER ventilation duct openings and starboard forward casing uptake area (**Figure 12**).

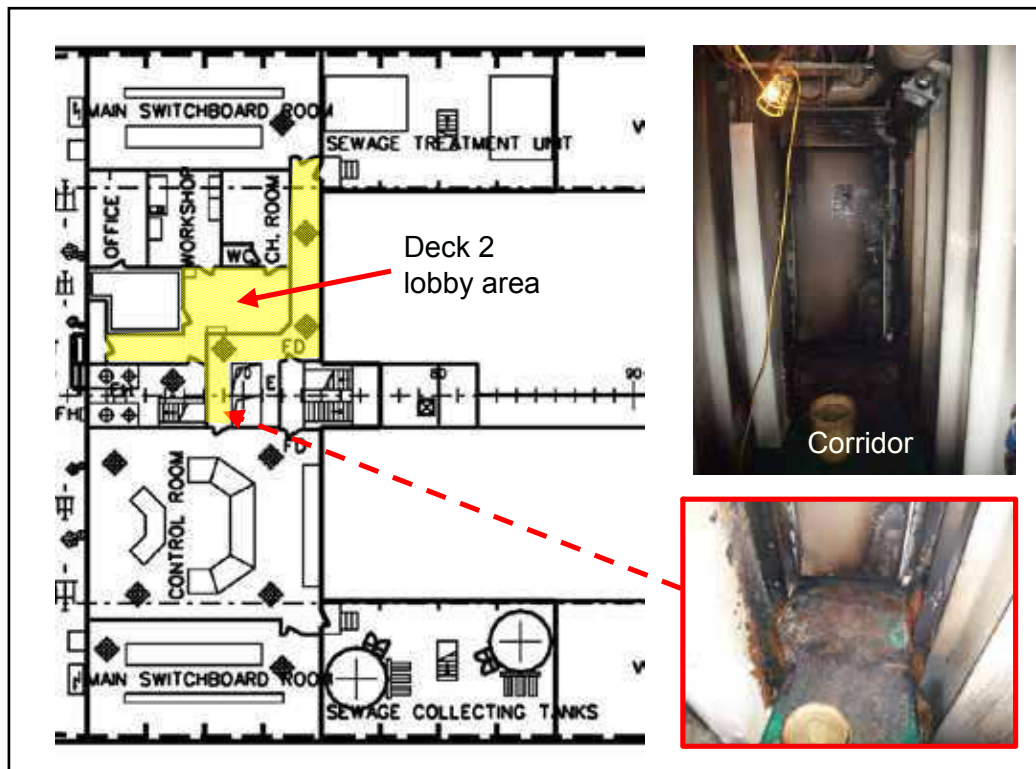
Figure 11

Seat of fire in corridor leading to the engine control room

The seat of the fire in the corridor outside the ECR was located at deck level on a cable tray that ran under a section of raised floor plates. The heat from the flames burnt paint on the bulkhead and ECR door, melted a light fitting and burst a sprinkler head bulb (**Figure 14**).

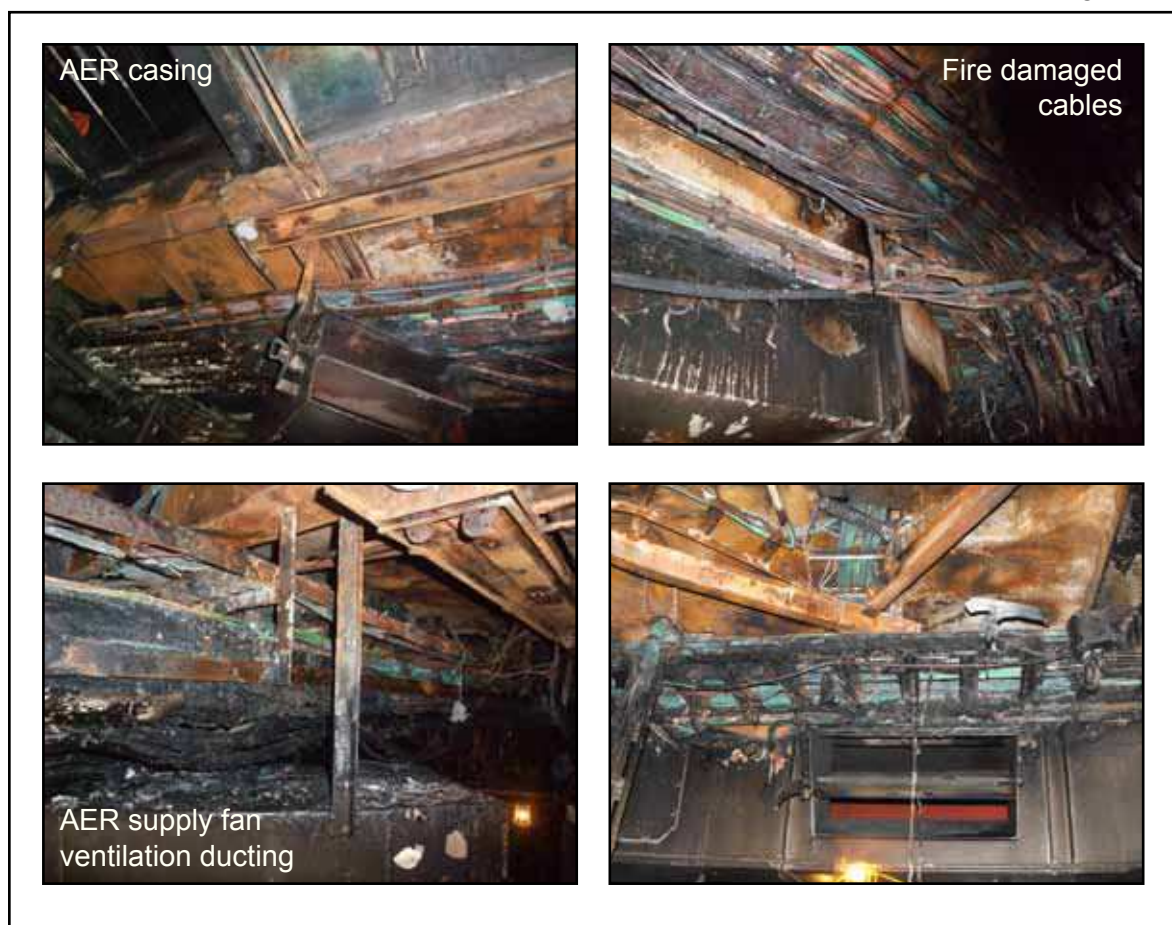
Figure 12

Fire damage to deckhead cables in the auxiliary engine room

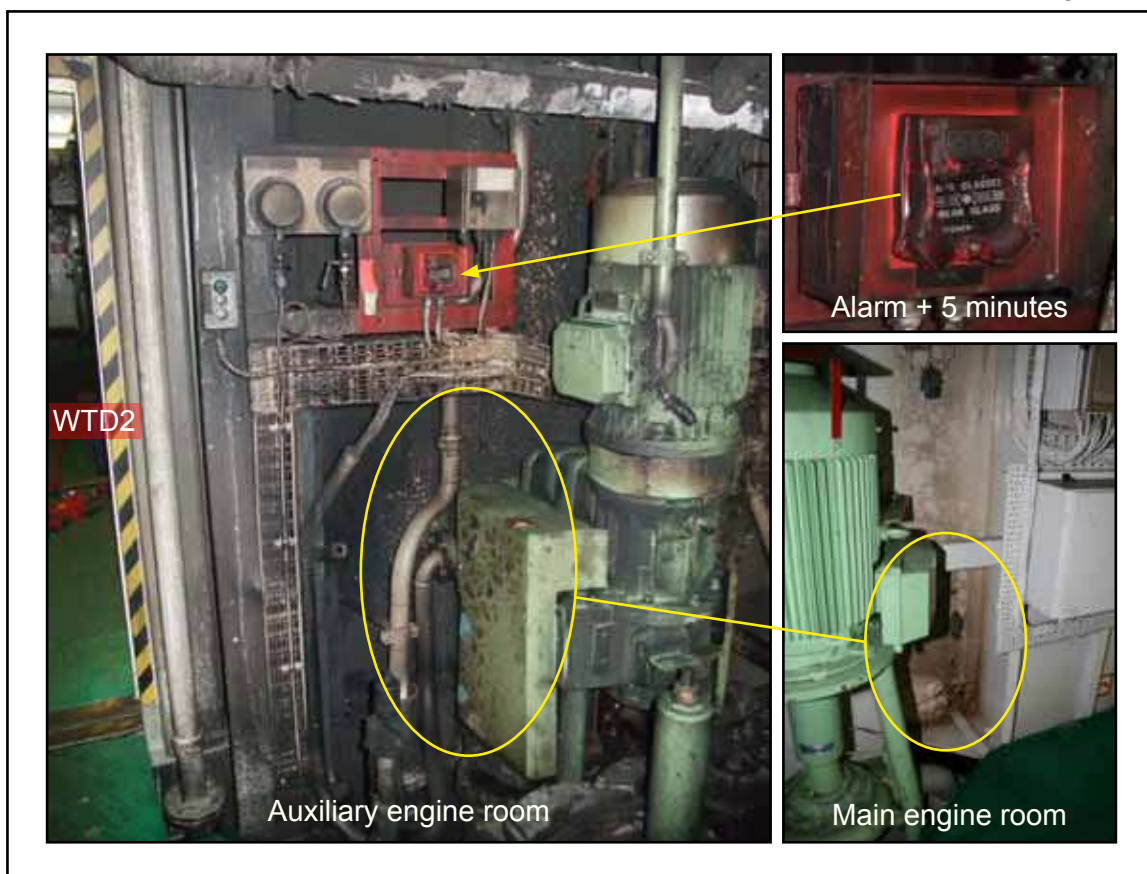
The heat from the bilge fires close to the aft AER bulkhead caused the casing of the manual break-glass fire alarm call point next to WTD2 to melt and the paint on the bulkhead in the main engine room to blister (**Figure 13**). The manual call point alarmed about 5 minutes after the initial flame sensor had activated.

Damage caused by bilge fire

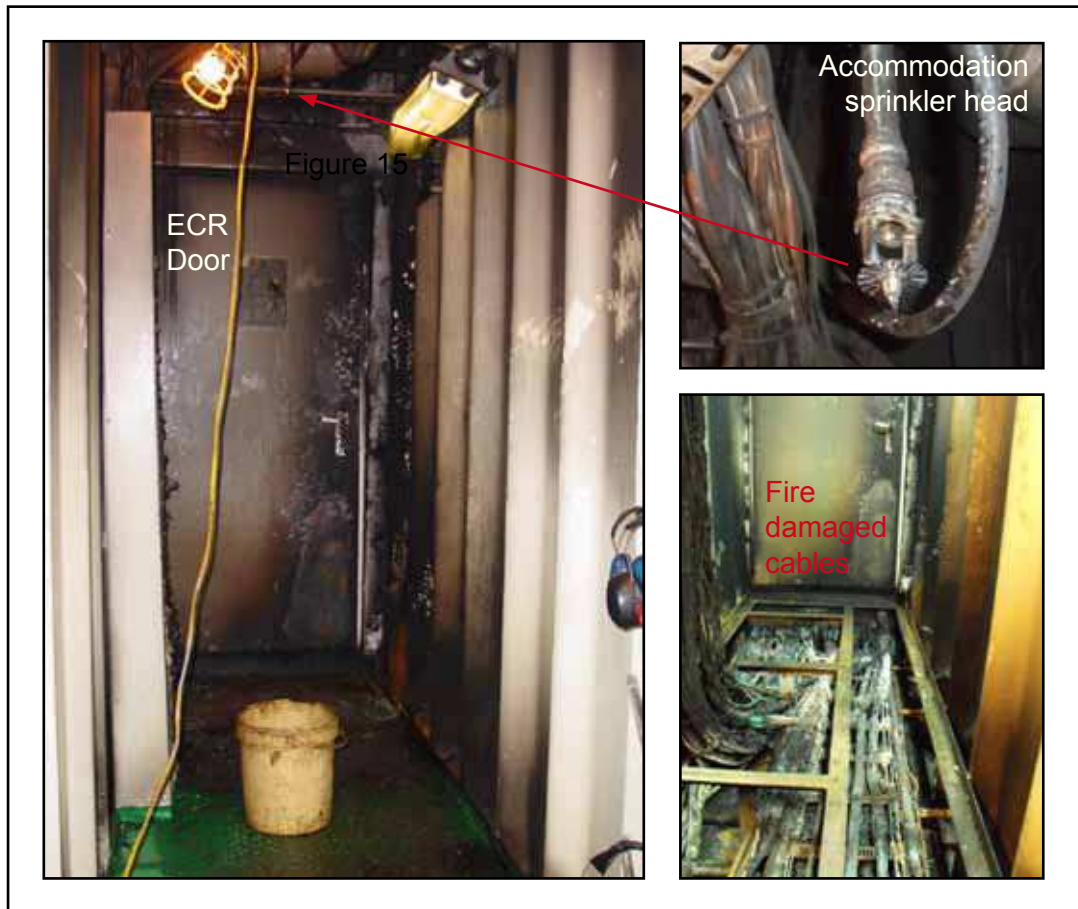
Fire damage on deck 2 outside the engine control room

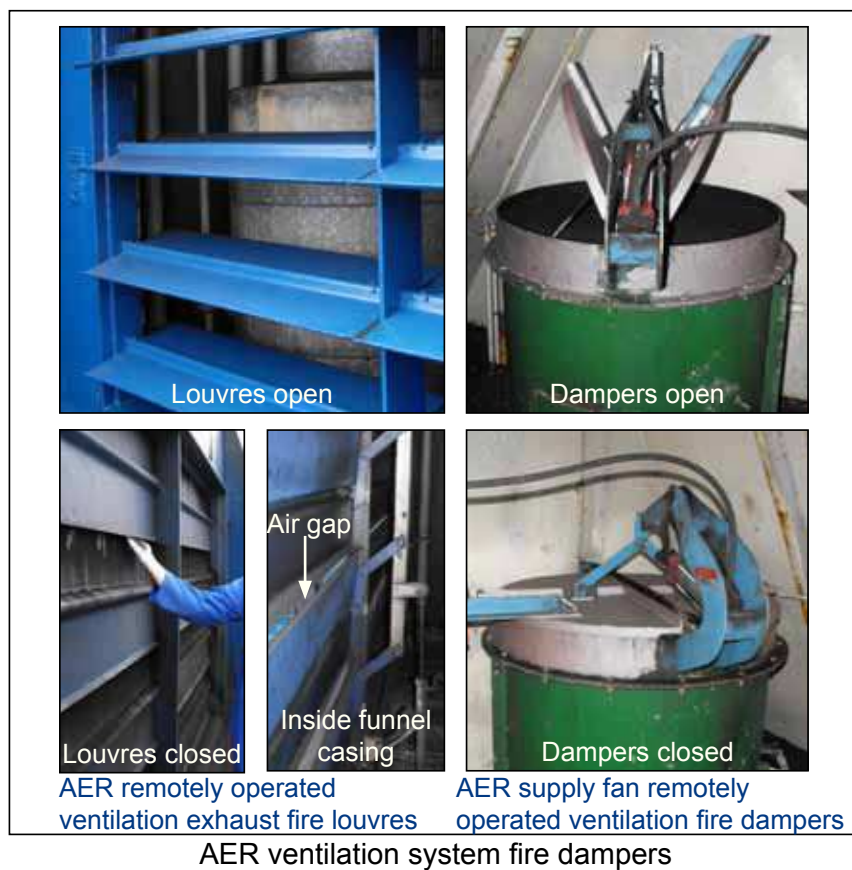
Figure 15

The AER ventilation dampers were found to be in the closed position (**Figure 15**). However, the exhaust louvres on the back of the funnel did not form a gas-tight seal when closed.

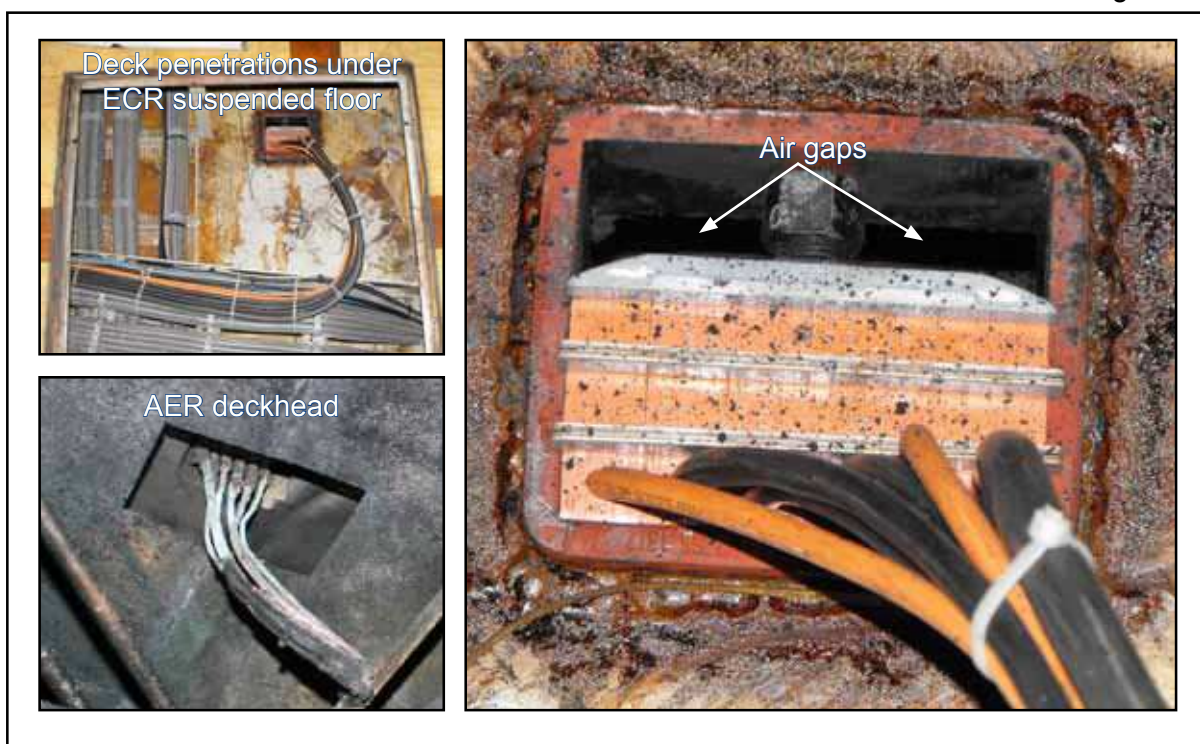
Several deck penetrations between the AER and ECR had not been properly packed and did not provide a gas-tight seal (**Figure 16**). The ventilation supply and exhaust system for the ECR and adjacent compartments was common to the zone 2 passenger accommodation spaces on deck 8. The crew was unfamiliar with the ventilation system, and the vent trunk fire dampers between these areas had not been closed. The doors to the switchboard rooms and other compartments on deck 2 were secured in the open position.

Engine control room deck penetrations

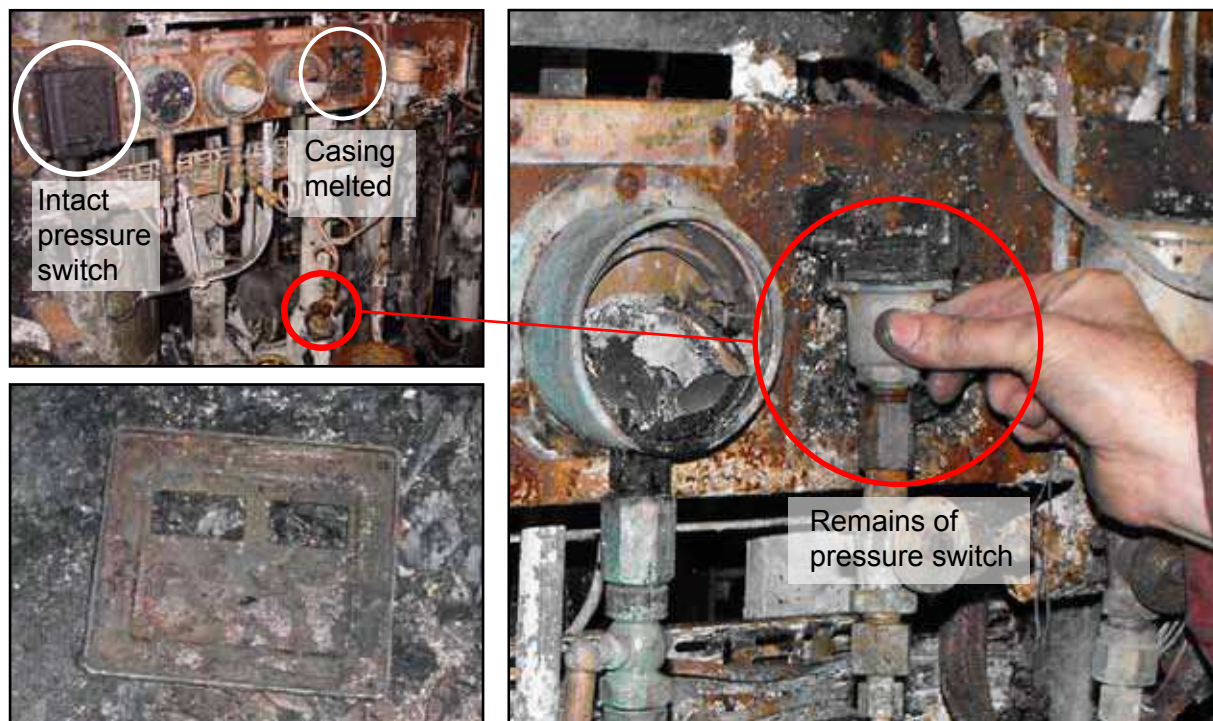
One of the module's pressure switches had been exposed to intense localised heat. Its metal alloy casing had completely melted and its steel casing cover was found on the deck plates close to No.3 auxiliary engine (**Figure 19**). The remains of the pressure switch were removed and closer examination revealed its pressure bellows to be intact.

Pressure switch casing cover found on deck plates

Fire damaged pressure switch

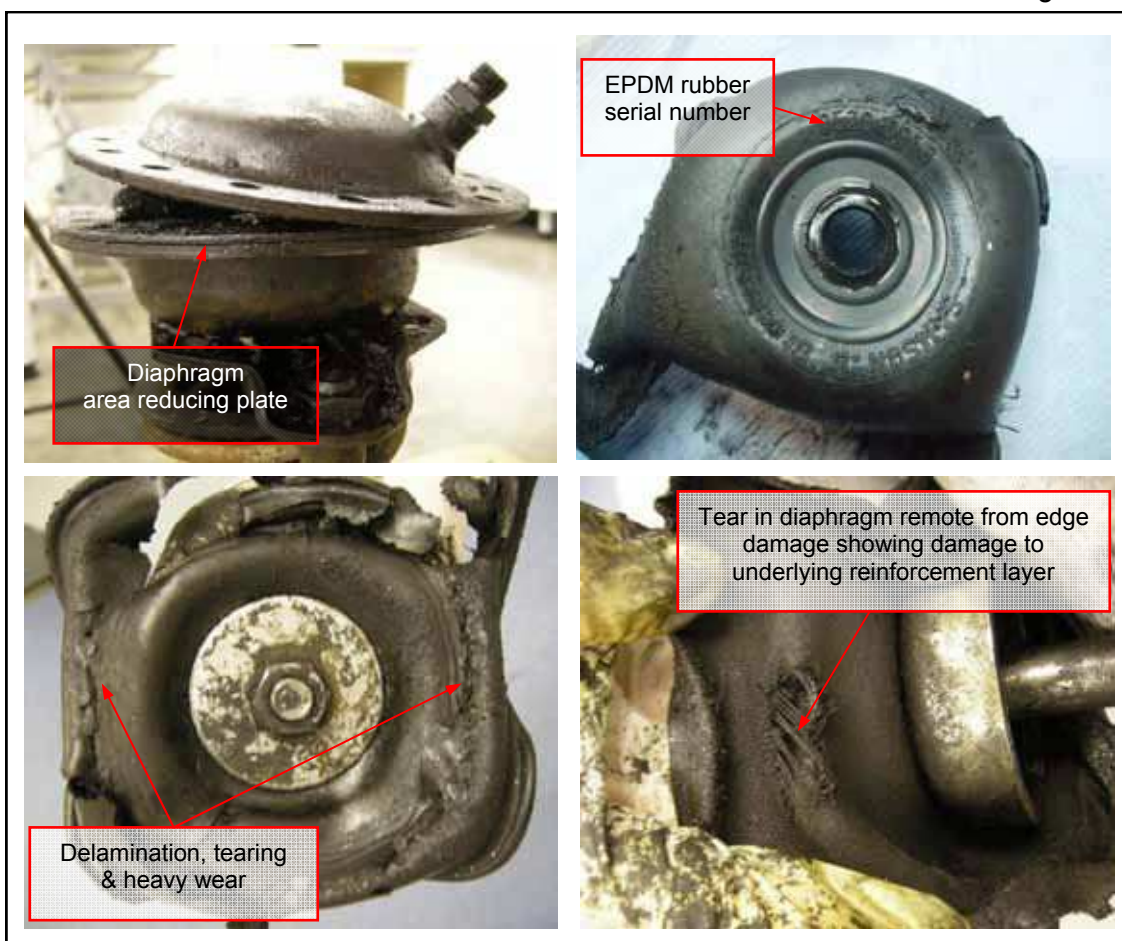
Figure 23

The test report on the diaphragm removed from the valve actuator identified deterioration of the rubber and a tear in its main flex region (**Annex B**). This damage was remote from the fire damage evident at its outer edge. The diaphragm was made from EPDM rubber and was therefore not suitable for use in fuel oil systems. The actuator had a diaphragm area reducing plate which increased the valves' operating pressure range to 4.5 to 10bar (**Figure 23**). The actuators fitted to the fuel modules on board *Oscar Wilde* were not fitted with any optional safety features.

Condition of the auxiliary engines' excess fuel pressure regulating valve diaphragm

Following the examination of damage to the diaphragm from the excess pressure regulating valve, similar valves fitted to the vessel's two main engine fuel modules were replaced. The diaphragms in the main engine valves were also made from EPDM rubber and found to be severely degraded in the main flex area (**Figure 24**). The replacement valves were fitted with FPM diaphragms, diaphragm leakage glands and rupture indicators.

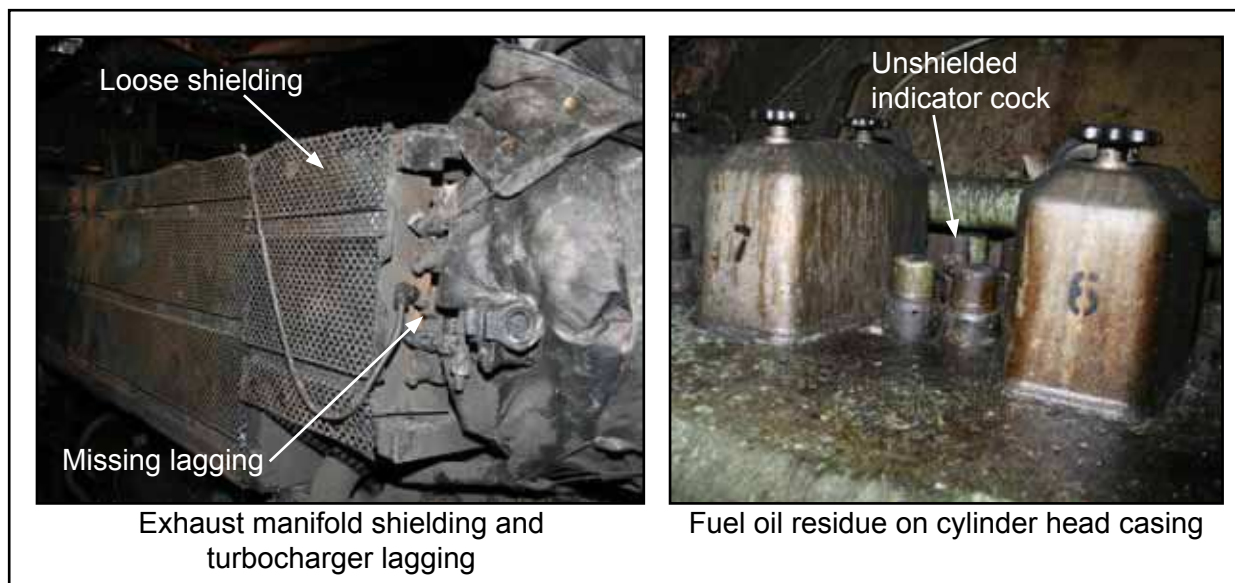
Fuel oil residue on number three auxiliary engine

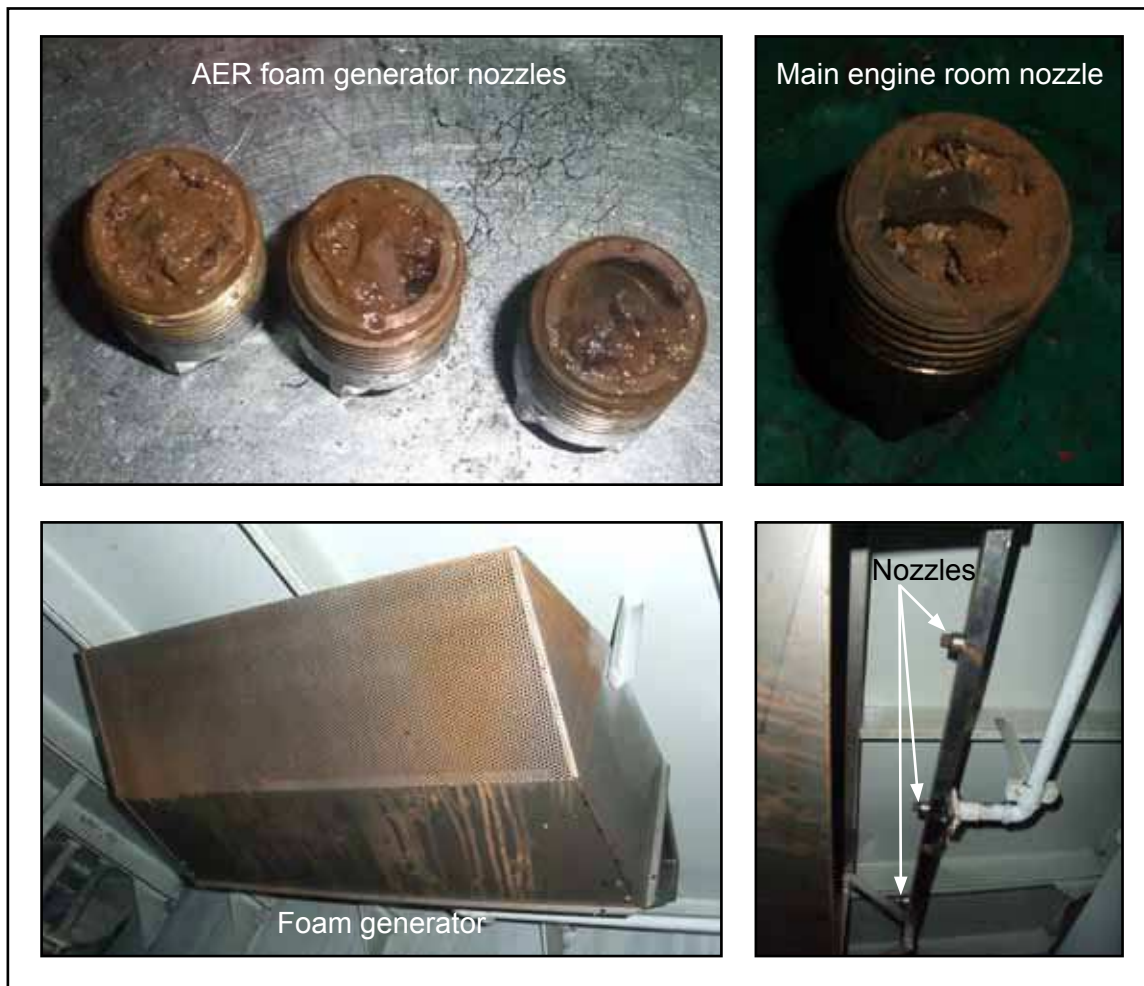
Figure 36

On 5 March 2010, manufacturer's representatives conducted a thorough examination of the system. The foam concentrate pump was found to be fully operational and the sea water strainer was clear. The foam proportioner was in good condition, set at the required 2%, and was functioning correctly. Thirty-one of the 39 AER foam generator nozzles were found to be completely blocked with rust and scale (**Figure 36**). The nozzles from the other protected spaces were removed for inspection, and approximately 50% were found to be blocked.

Blocked *Hotfoam* generator nozzles

The distribution pipework was chemically cleaned and was proved clear of debris before being tested to the satisfaction of the class and flag surveyor. The manufacturer's investigation report included the following recommendations:
