# Marine Accident Report

Fire Aboard Small Passenger Vessel *Conception*  
Platts Harbor, Channel Islands National Park, Santa Cruz Island,  
21.5 miles South-Southwest of Santa Barbara, California  
September 2, 2019

**National Transportation Safety Board. 2020. *Fire Aboard Small Passenger Vessel Conception Platts Harbor, Channel Islands National Park, Santa Cruz Island, 21.5 miles South-Southwest of Santa Barbara, California, September 2, 2019. Marine Accident Report NTSB/MAR-20/03.* Washington, DC.**

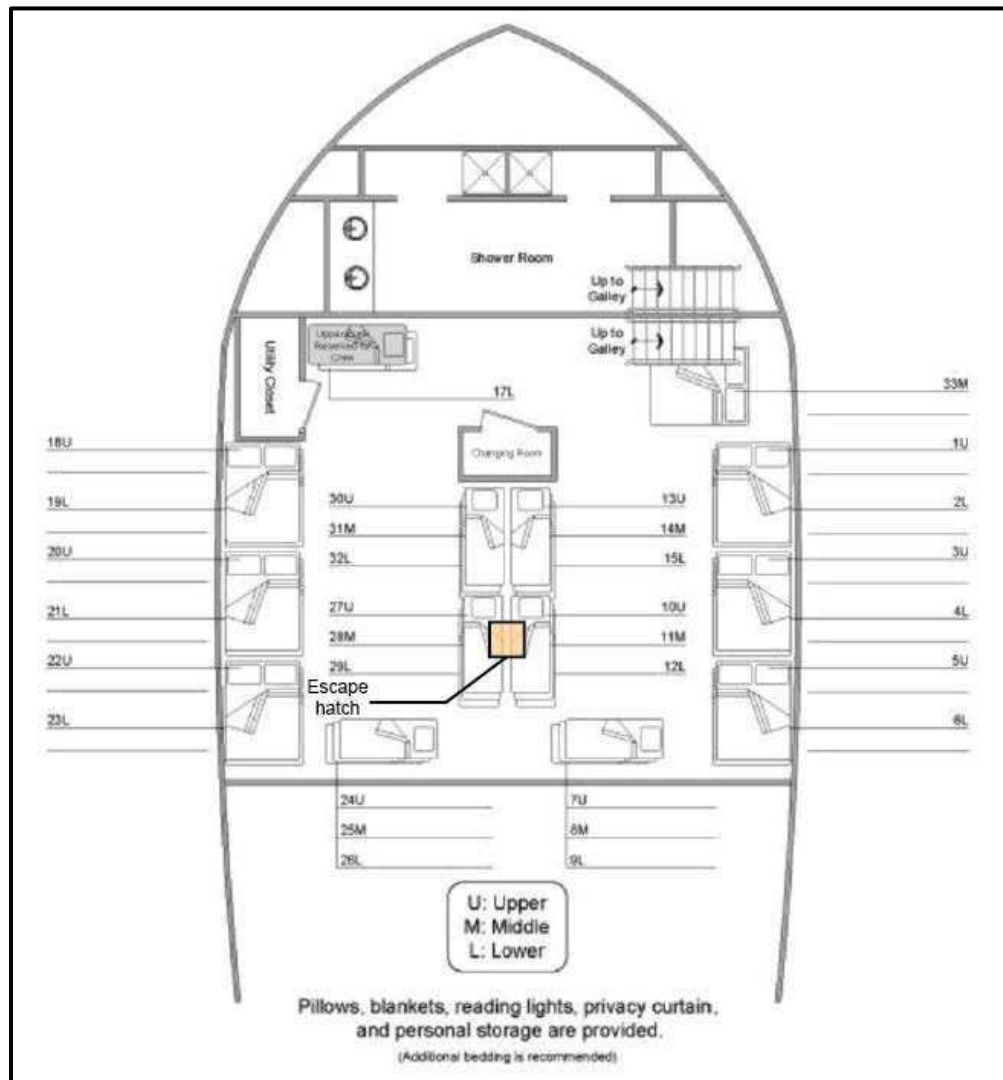
**Figure 5.** *Conception* bunkroom arrangement, with escape hatch location added by NTSB. (Source: Truth Aquatics; annotated by NTSB)

salon, and thus both escape routes from the bunkroom exited into the salon. The upper bunks nearest the emergency escape hatch had passengers assigned to them during the accident voyage.

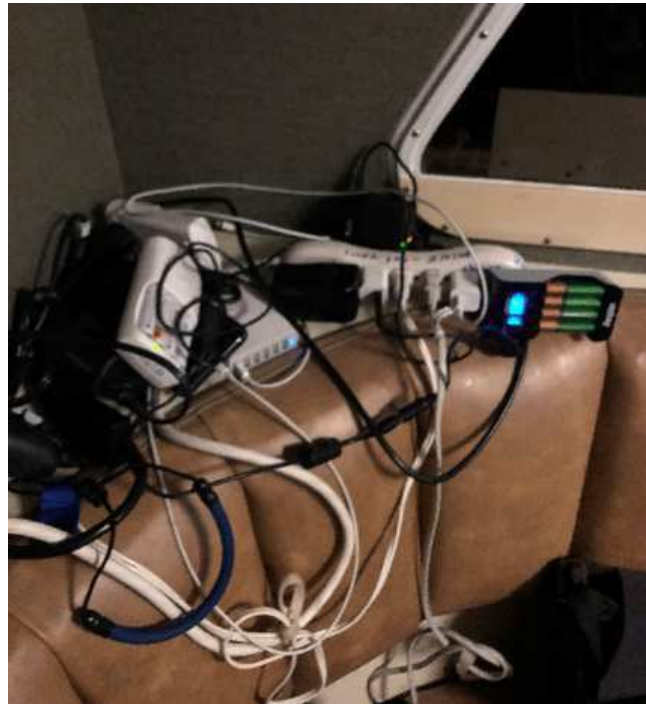
**Figure 8.** Photo taken during accident voyage (August 31, 2019) of devices plugged in to charge at the port side aft corner of the salon on the *Conception*. (Source: J. Dignam).

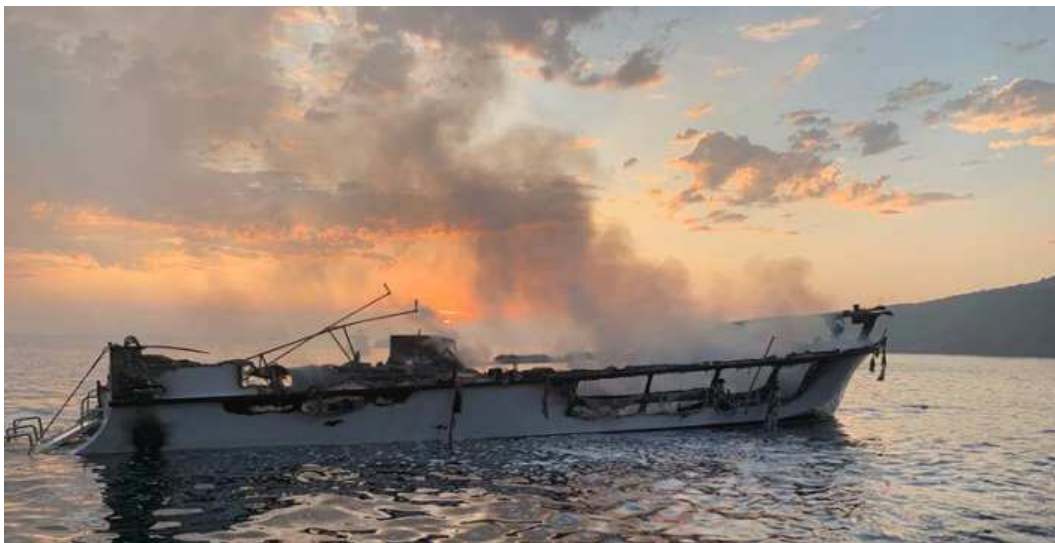
The fire was first reported extinguished at 0508 but re-flashed several times in the area of the fuel tanks and on the bow. Burned-out through-hull penetrations—where the main engine exhausts had been—eventually submerged, and the vessel sank stern first at 0654, approximately 20 yards from shore, in 61 feet of water. First responders were not able to safely board the vessel before it sank. Underwater recovery divers later found the wreckage lying on the seafloor in an upside-down position.

**Figure 12.** Small passenger vessel *Conception* at sunrise prior to sinking. (Source: VCFD)

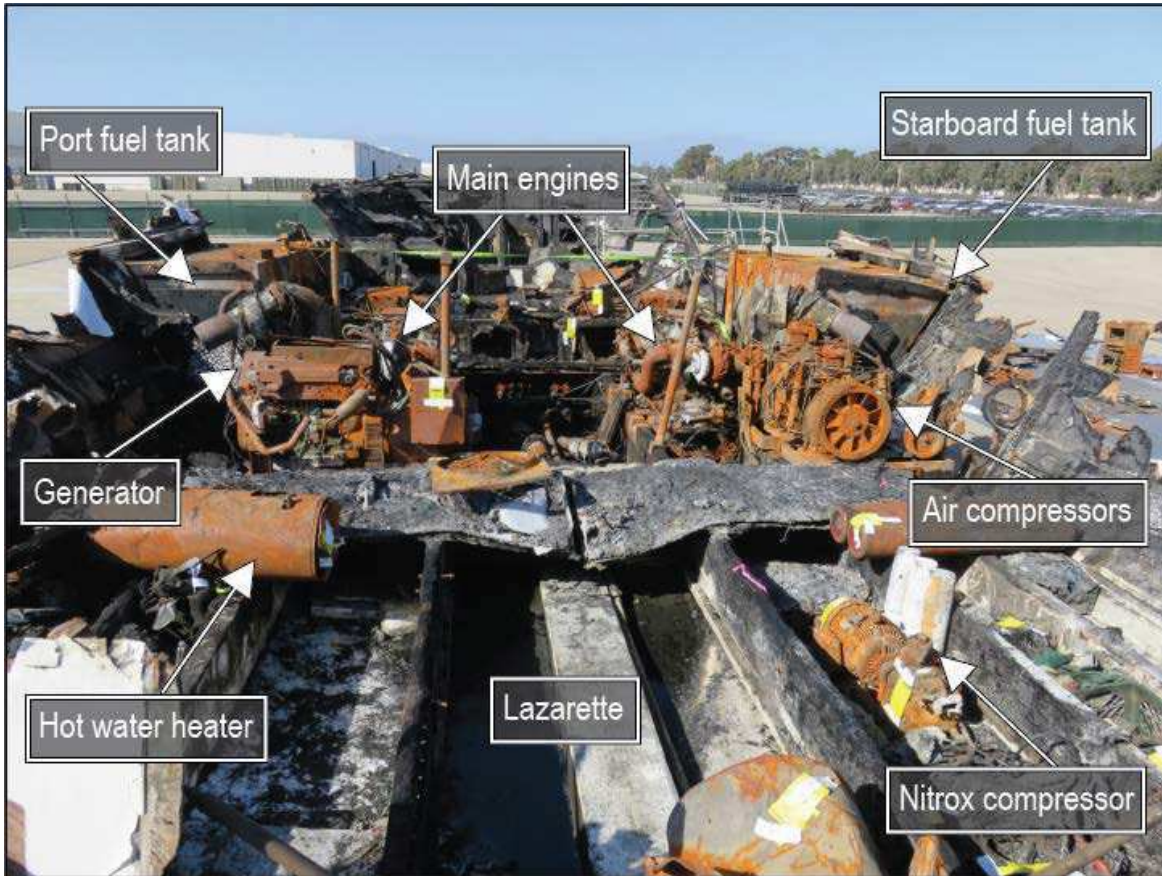
**Figure 13.** The salvaged hull of the *Conception*, looking from aft to forward, with recovered engine room and lazarette equipment placed in their original installed location (with the exception of the water heater, which was located on the starboard side).

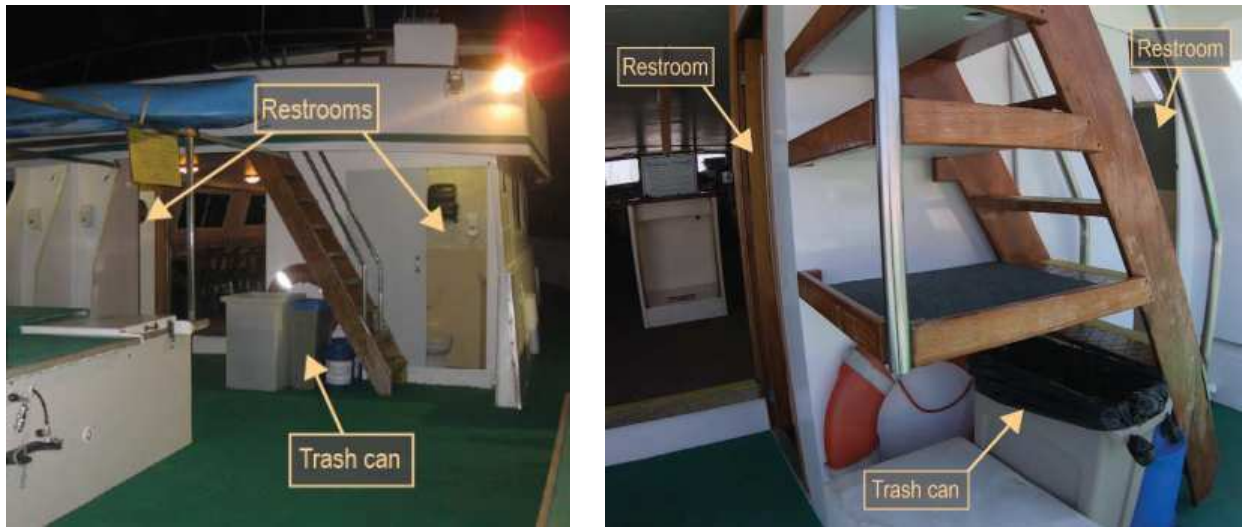
In eyewitness photos and videos of the *Conception*, large polyethylene trash cans can be seen throughout the interior and exterior areas of the vessel, including the bunkroom. The trash cans were manufactured by Rubbermaid from 2016 onward. Neither the Old T nor the New T regulations allow for these types of trash cans to be used in passenger bunkrooms and instead require that trash cans be constructed of non-combustible materials. New T regulations extend the prohibition on combustible trash cans to all compartments, but only apply to existing (Old T) vessels when the trash cans are replaced. Throughout the inspection history of the *Conception*, there were no remarks or deficiencies related to the waste receptacles on board.

**Figure 18.** Left: Photo from a previous voyage of stairway to the upper deck and restrooms of the *Conception*. Note the regular stowage of a polyethylene trash can under the stairway aft of the salon. Right: Still image from a 2019 video taken of the stairway on board the *Conception* with shelving installed. (Source: M. Ryan [left], R. Clevenger [right])

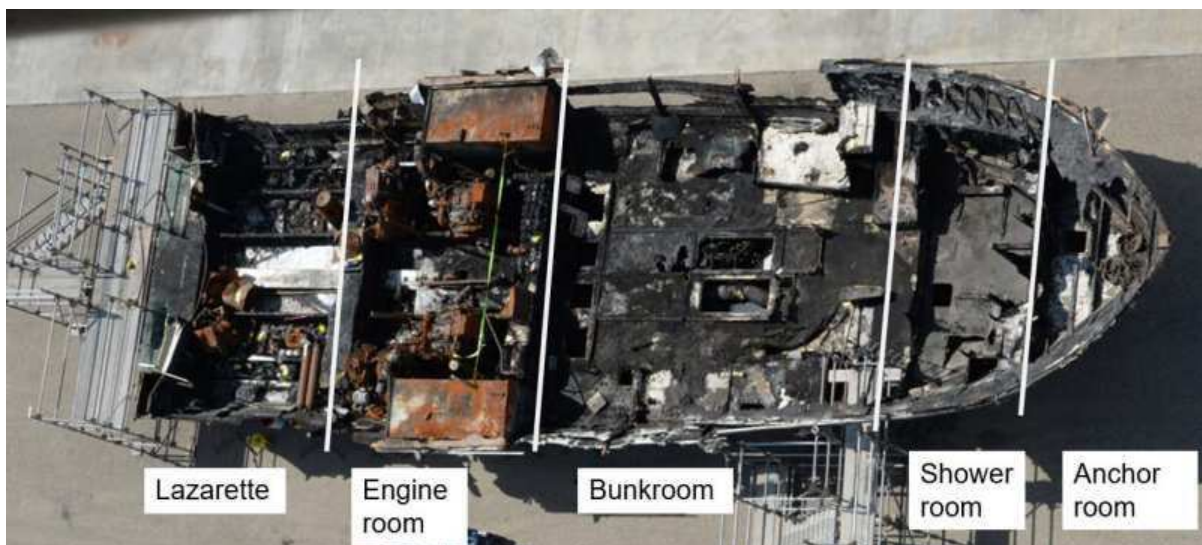
The hull of the *Conception*, where the below-deck compartments had been located, represented the bulk of the remaining structure. The transverse bulkheads were severely fire damaged, eliminating the separation of the below-deck compartments between the anchor room, shower room, bunkroom, engine room, and lazarette from forward to aft. The entire interior of the below-deck space was charred. Overall, the interior of the below-deck compartments had burned all the way down to the floor in the bunkroom and shower room and had consumed the floor, exposing the longitudinal frames, in both the engine room and lazarette ([figure 20](#)).

**Figure 20.** Below-deck areas of the *Conception*. The solid white lines mark the approximate boundaries of each compartment. (Source: FBI Evidence Response Team)

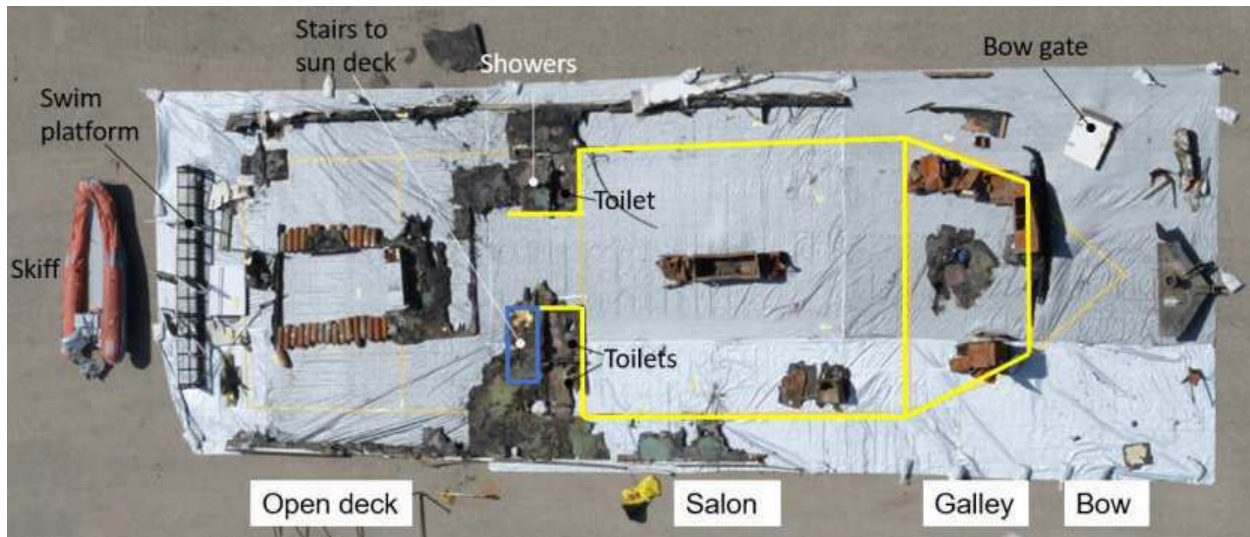
**Figure 21.** Wreckage belonging to the main deck of the *Conception*. Solid yellow lines indicate the enclosed spaces on the deck. The blue box marks the location of the stairway to the sun deck. (Source: FBI Evidence Response Team)

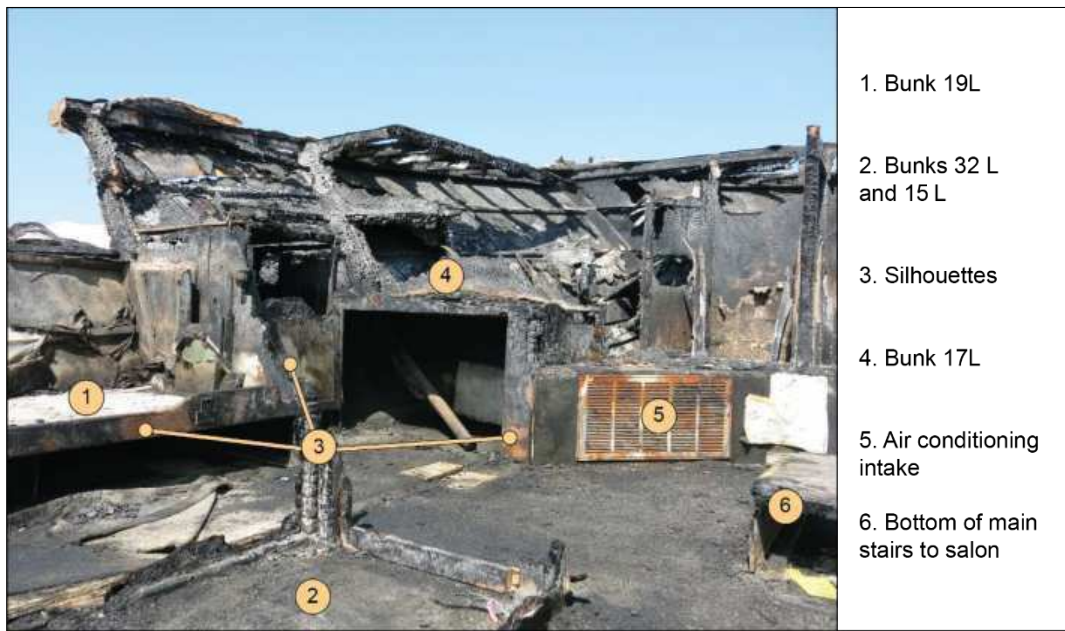
**Figure 22.** Postaccident photo of the bunkroom looking from the starboard aisle forward and to port.

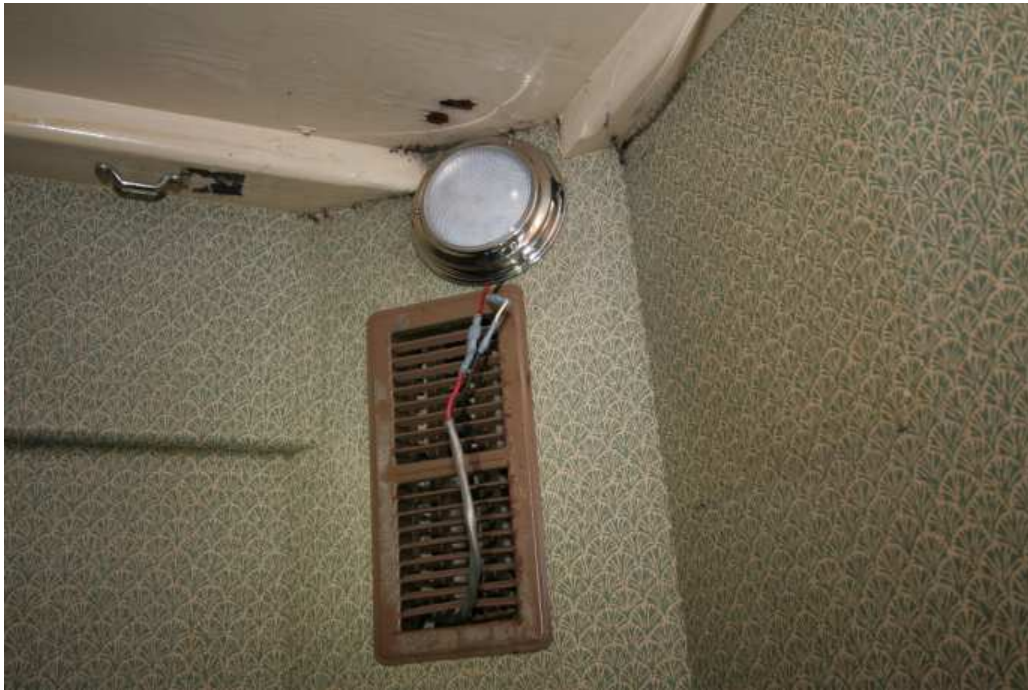
Investigators examined the *Vision*'s salon for potential ignition sources. There were cable runs located behind the seatback of the bench-type seating and receptacle drops just under the seatbacks. The electrical cable runs were not enclosed in protective conduit, were often not supported, and did not have the appearance of a professional installation. Similar installations were also observed in the bunkroom ([figure 23](#)).

**Figure 23.** Power cable for lighting routed through ventilation grille in the *Vision*'s bunkroom.

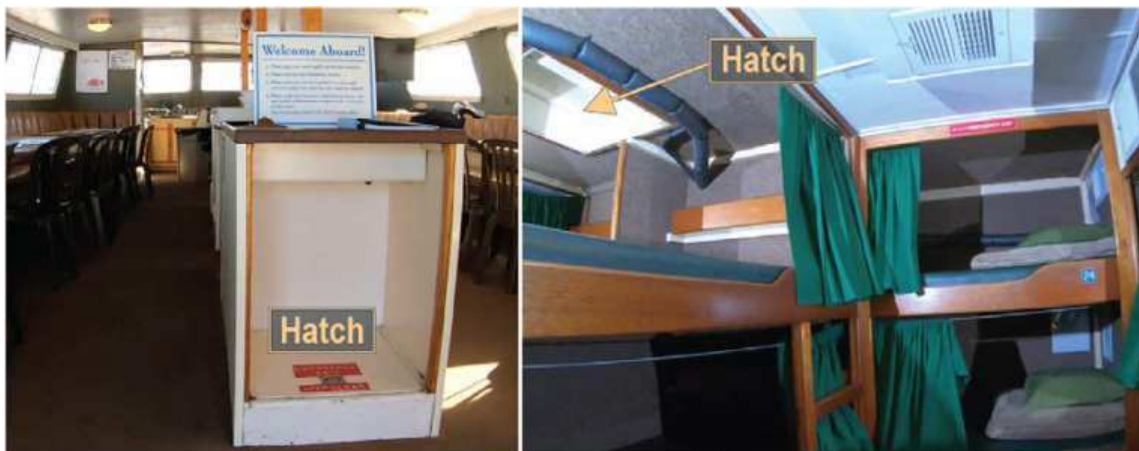
From the *Conception*’s bunkroom, there were two means of escape, both leading to the salon above: (1) the spiral stairs forward in the bunkroom ([figure 28](#)), and (2) the escape hatch installed centerline at the aft end of the bunkroom ([figure 29](#)). The hatch, marked with a two-inch plastic sign, was accessible from either aisle by climbing a wooden ladder, located in the corner where the aftermost middle and aft athwartship tiers of bunks were, onto the upper bunk; crawling to the centerline; and then pushing the plywood escape hatch up and out of the way. The hatch opened below the centerline countertop in the salon. Investigators measured the *Vision*’s escape hatch, which, according to the owner, was similar to the *Conception*’s escape hatch. The opening dimensions were approximately 22 inches by 22 inches through the main deck, with the aft-facing vertical opening having a clearance of about 35 inches from the main deck to the countertop above, or 28 inches from the top of the 7-inch main deck coaming. The two means of escape were at opposite ends of the bunkroom (so as to minimize the possibility of one incident blocking both escapes) and did not pass through a watertight door, thereby fulfilling the regulations applicable to the *Conception*. In the available documentation and inspection history of the vessel, no deficiencies or modifications were found related to the emergency escape hatch or the bunk ladders to the hatch.

**Figure 29.** The *Conception* bunkroom escape hatch from above in the salon (left) and in the bunkroom from the port side (right). (Source: R. Clevenger [left]; Truth Aquatics [right], annotated by NTSB)

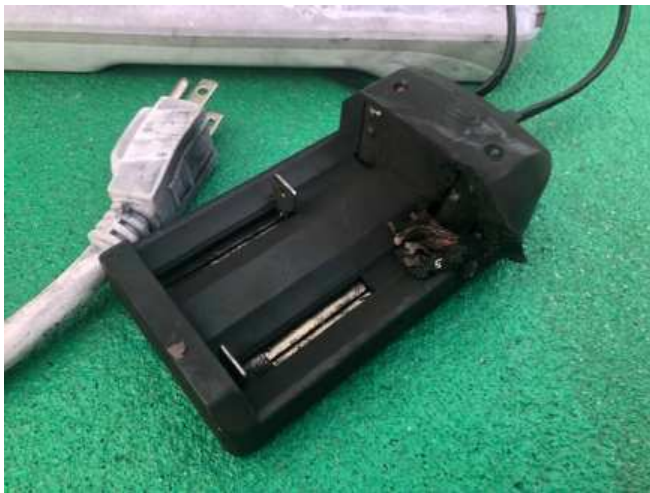
A small fire involving the charging of a lithium-ion battery took place on board the Truth Aquatics small passenger vessel *Vision* about a year before the fire aboard the *Conception*. On October 8, 2018, between 0415 and 0430 in the morning, a passenger, who was awake and in the galley, heard a “hissing” noise and then a loud “bang” that came from the bookshelf located at the aft starboard side of the salon (the *Conception* did not have a bookshelf in the same area). Another passenger, who was returning to the bunkroom after using the restroom on the aft deck, also heard the noise, which drew his attention to a fire on the bookshelf. He stated that the fire looked like a “torch” flame, and a battery charger (which was charging two lithium-ion batteries) was emitting smoke. The passenger in the galley grabbed a dry chemical extinguisher from the galley, and both passengers went to the battery charger. The passenger without the fire extinguisher unplugged the charger, grabbed the unburnt end of the charger, brought it out to the main deck, and threw it in to the rinse bin located under the stairs to the sun deck. The passenger with the fire extinguisher stated he discharged one “shot” on the bookshelf after the battery charger had been removed to extinguish the smoldering paper books on the shelf. He then grabbed a sponge and wetted the bookshelf and items on it to prevent reignition.

**Figure 33.** Photograph taken of the battery charger that caught fire on the *Vision* (with the batteries removed).
