National Transportation Safety Board

Marine Accident Brief

Engine Room Fire aboard Bulk Carrier *St. Clair*

Accident type	Fire/Explosion	No. DCA19FM020
Vessel name	<i>St. Clair</i>	
Location	CSX TORCO Iron Ore Terminal, Maumee River; Toledo, Ohio 41°41.54' N, 083°27.05' W	
Date	February 16, 2019	
Time	2010 eastern standard time (coordinated universal time – 5 hours)	
Injuries	None reported	
Property damage	>\$150 million	
Environmental damage	None	
Weather	Mostly cloudy, visibility 10 miles, winds east 12 mph, air temperature 28°F, water temperature 34°F ¹	
Waterway information	Maumee River flows from northeast Indiana, into northwest Ohio, and then into Lake Erie. The city of Toledo borders the river where it enters Lake Erie.

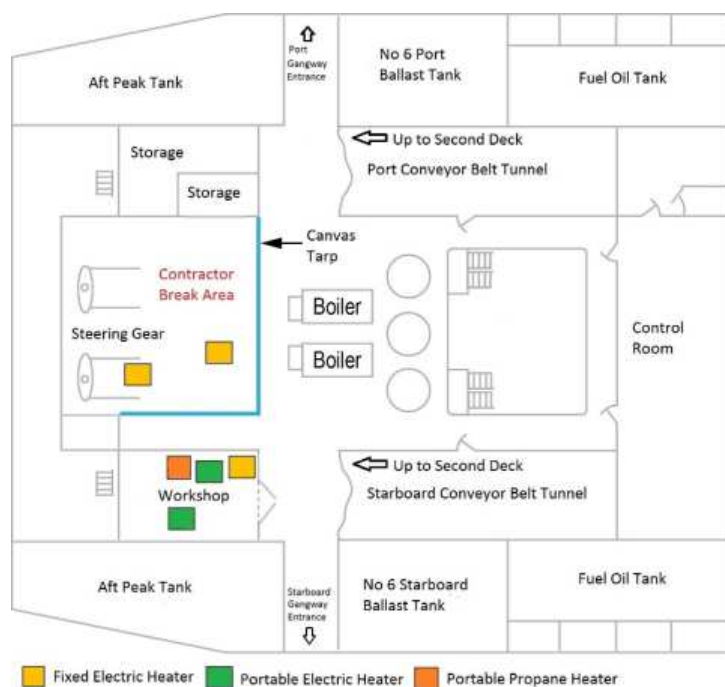
Drawing (not to scale) of third deck, showing location of heaters and tarp in the engine room.

There was a total of six heaters, five electronic and one propane, located in the area of the workshop and the steering gear. A red canvas tarp was hung around the steering gear to help keep the area heated while the workers were taking their breaks. The electronic heaters were routinely left on after the contractors departed the vessel at the end of the day to keep the space warm.

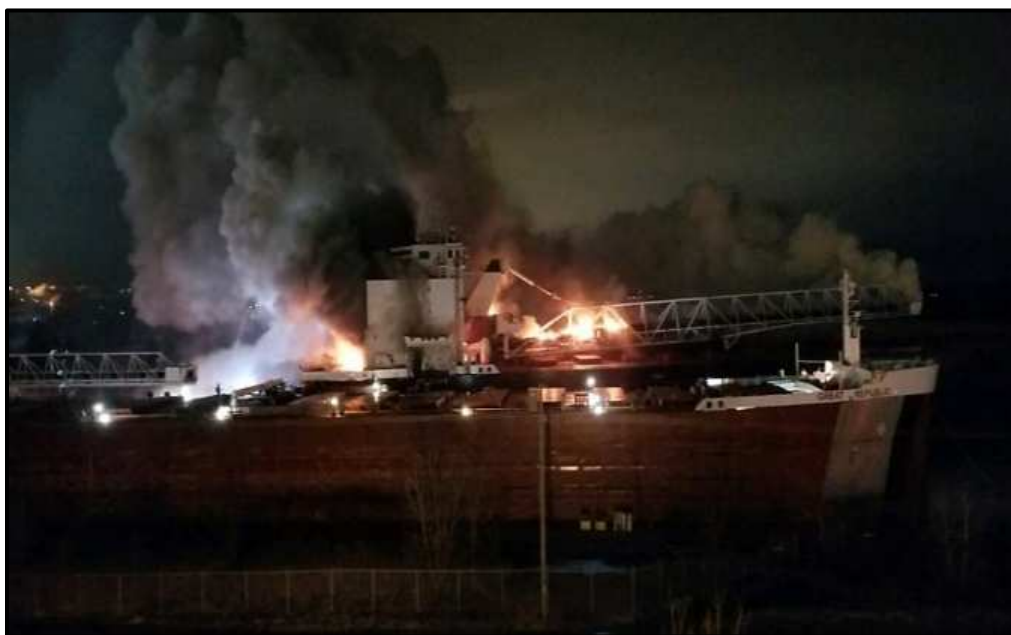
Vessel fire at 2209. Billowing smoke pours from the vessel as fire in the aft part of the deckhouse spreads up the conveyor belt on the boom. (Source: *Great Lakes Trader* Chief Engineer)

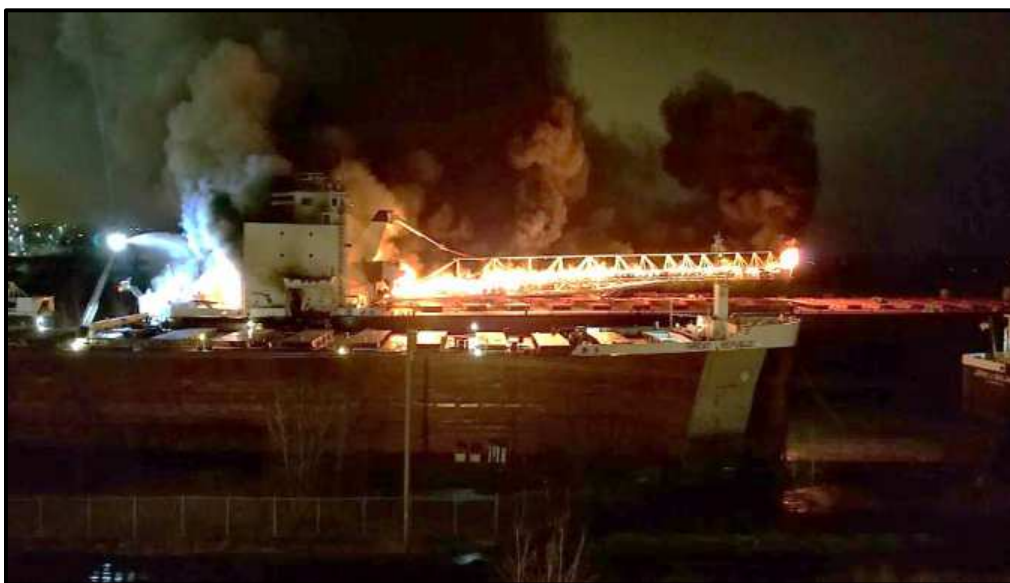
Vessel fire about 10 minutes later, at 2220. The cargo conveyor boom is completely engulfed in flames (Source: *Great Lakes Trader* chief engineer)

The fire burned within the engine room spaces, the entire superstructure, and the self-unloading belt throughout the port- and starboard-side conveyor tunnels to the bow, as well as onto the cargo conveyor boom belt above the main deck.

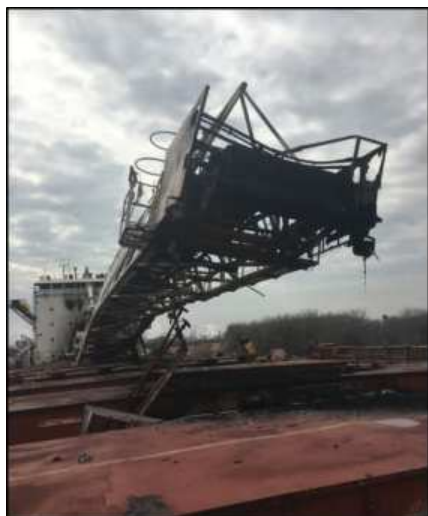
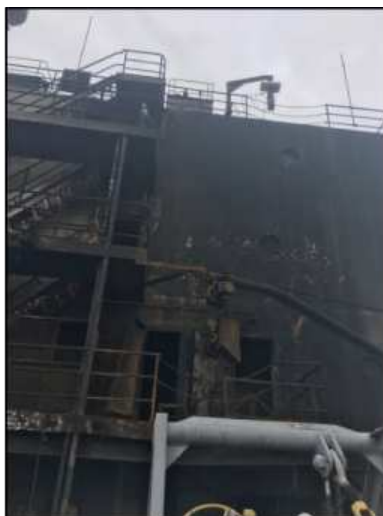
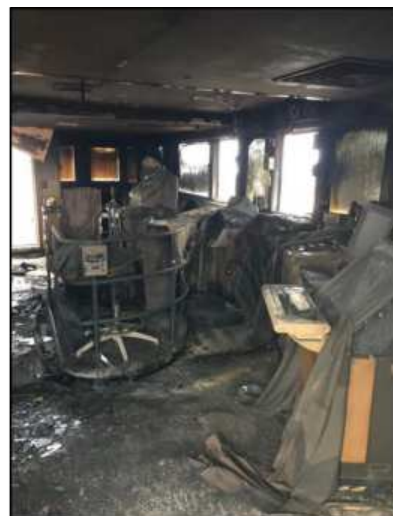
Fire damage to the vessel: (left) cargo conveyor boom, (center) stern of the deckhouse, and (right) the bridge.

Fire Damage. The investigation into the fire identified a significant amount of damage within the vessel. The engine room, the second deck (where the port- and starboard-side tunnel conveyor belts, port- and starboard-side cross belts, and incline conveyor belt were located), and the entire deckhouse were severely damaged by fire. All the conveyor belts within the vessel were completely burned. Investigators noted that the smoke and fire damage was also located with the forward ladder trunk and all the cargo holds. The most extensive fire damage discovered were fractures in the overhead of the third deck, which was the second deck. These fractures were located just outside and above the workshop.

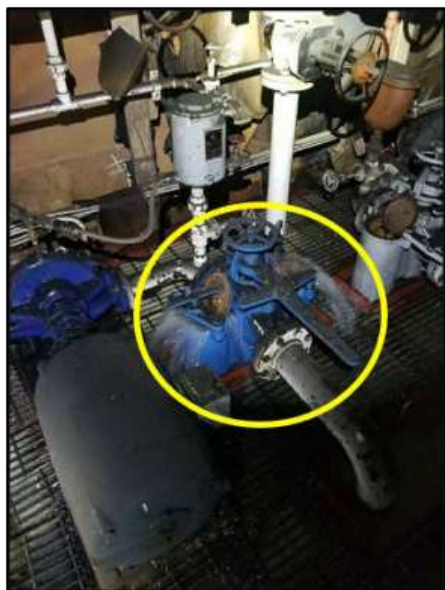
After the fire was extinguished, the vessel's engine room was found flooding from the emergency fire pump's strainers and sea chests, which were open for layup. The pump's sea valve was electrically controlled and designed to fail open during a loss of power. During the fire, the vessel lost shore power, which actuated the opening of the valve and thereby allowed a steady ingress of water through open strainers and sea chests. Eleven days passed before divers were able to temporarily plug the main sea chest and close internal valves to stop the flooding. The water that entered the vessel was removed with portable pumps.

As encircled, the seawater duplex strainer to the emergency fire pump in the lower level of the engine room leaking water. (Source: Coast Guard)

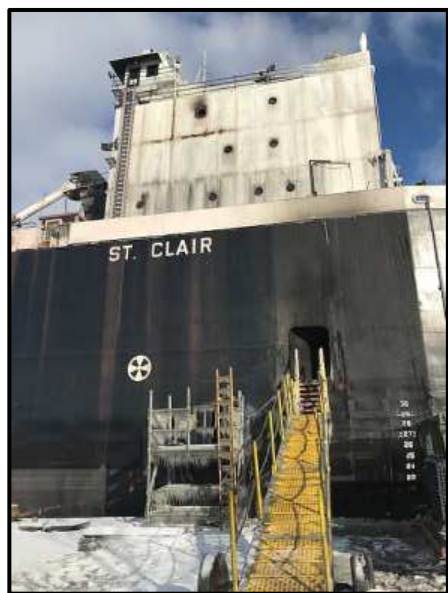
Since the only access to the interior of the vessel—the portside gangway door—was blocked by the fire, the responding firefighters focused on cooling the exterior of the *St. Clair* and of the other vessels docked nearby. Initial efforts to put water on the vessel were hindered by frozen fire hydrants. Due to the ice, suction could not be taken from the lake water.

Portside gangway entrance following the extinguishing of the fire.

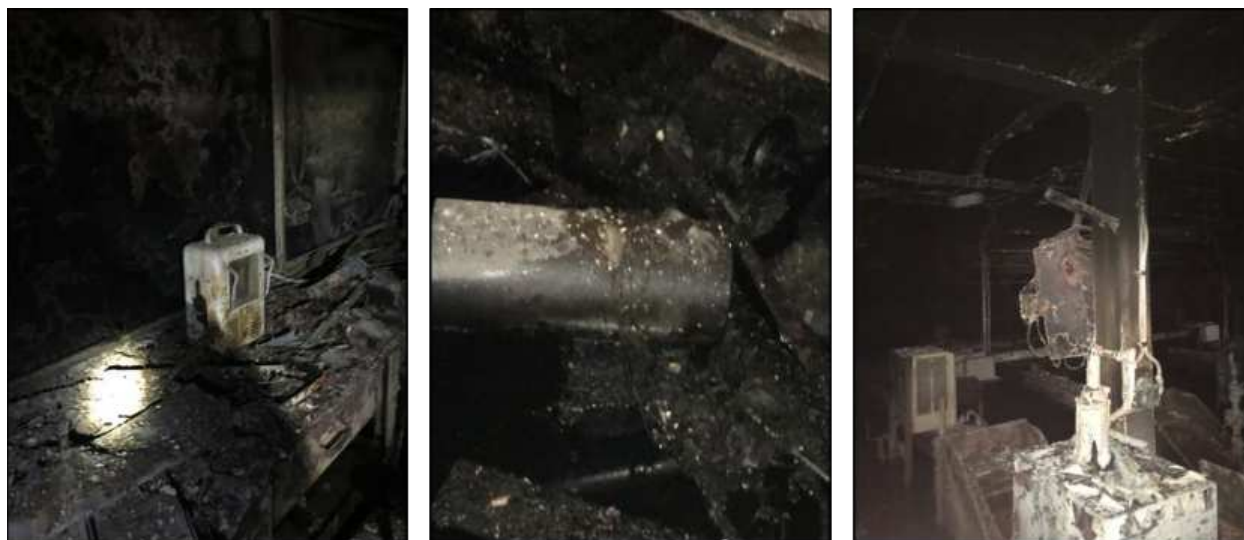
Space heaters located in the engine room break area following the fire: (left) an electric heater on the workshop bench, (center) a propane heater on the deck of the workshop, and (right) a fixed electric heater located forward of the steering gear.

The National Transportation Safety Board determines that the probable cause of the fire aboard the bulk carrier *St. Clair* was the ignition of combustible material in the vicinity of an engine room workshop likely due to the use of portable space heaters or smoldering smoking materials, which spread to other areas of the vessel. Contributing to the extent of the fire damage was the lack of operating procedures for continuous active monitoring of the vessel while in layup status.

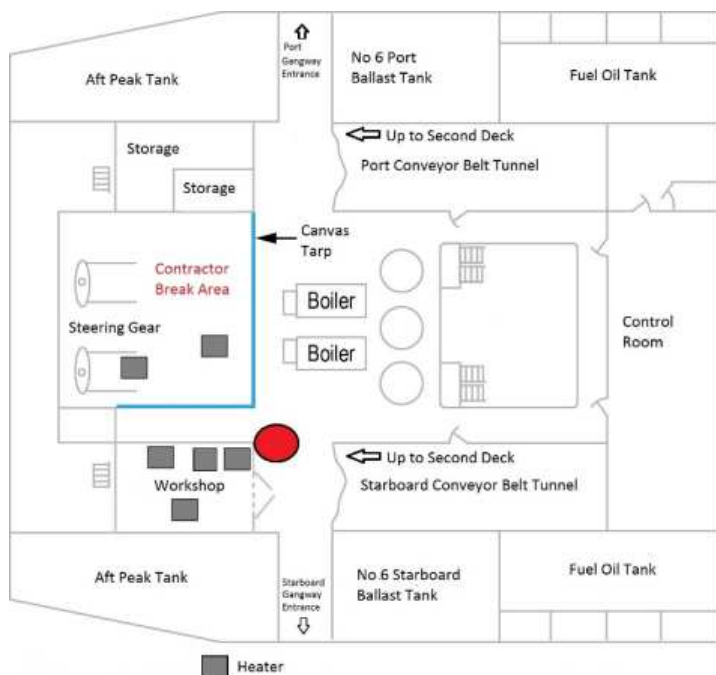
A red circle identifies the structural fire damage on the third deck (not drawn to scale).

Given the location of the hot work and based on the structural damage found during the investigation, the fire appeared to have originated just outside the workshop on the third deck on the starboard side of the engine room where the contractors regularly took their breaks. While numerous possible sources of ignition were identified in this area—including the propane heater, permanent (hardwired) and portable electric heaters, and heat lamps, as well as cigarette smoking in the break area—the exact source could not be determined. However, there was a lot of combustible material in this area, including wood and the lubricants used in the engine room. As the fire grew and became stronger, heat was transferred through the steel deck above and into the spaces on the second deck. At some point as the fire grew, the conveyor belt on the second deck was ignited. After the conveyor belt caught fire, it provided a path for the fire to expand forward to the bow and up into the deckhouse and onto the cargo boom.
