DS WISCONSIN CASUALTY INVESTIGATION REPORT

Fatal Fall Overboard

Visakhapatnam, Republic of India | 8 August 2019

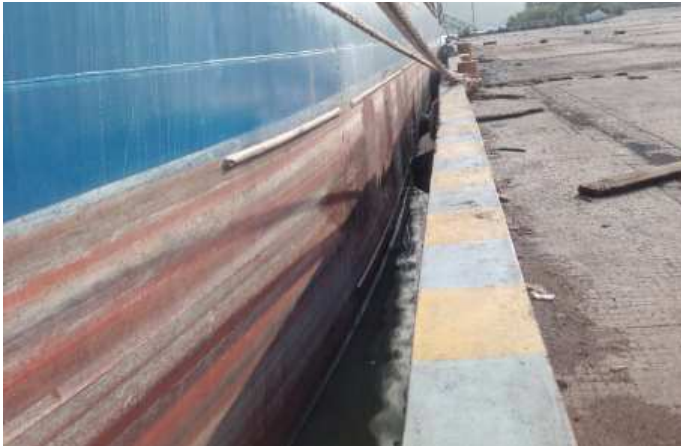
3. On 1 July 2019, DS WISCONSIN was moored at Visakhapatnam, Republic of India and discharging bags of ammonium nitrate from all holds. During the discharge, panels 2-3 and 2-4 of the Cargo Hold No. 2 aft hatch cover were damaged. It was reported this damage occurred during frequent opening and closing of the hatch covers to protect the cargo from the periodic rainfall that was occurring at the time.²
4. On 19 July 2019, DNV GL issued a Condition of Class requiring that the damaged hatch cover panels be repaired and water tightness be verified prior to departure from Visakhapatnam. DS WISCONSIN shifted to a lay berth, where shore-based workers started to repair the damage.
5. DS WISCONSIN was moored port side alongside the lay berth. Fixed fendering was holding the ship about 1.5 meters (m) off the quay (*see* Figure 2).

Figure 2: DS WISCONSIN (looking aft) moored port side to the quay at Visakhapatnam lay berth. This shows the approximate distance of the ship off the quay.

The postmortem examination determined that the ASD1's cause of death was asphyxia due to drowning following a head injury. DS WISCONSIN was only about 1.5 m off the quay when moored at the lay berth. It is likely that the ASD1's fall trajectory caused his head to hit the guard rail and/or concrete quay as he was falling. This would have rendered him unconscious and unable to keep his head above water.

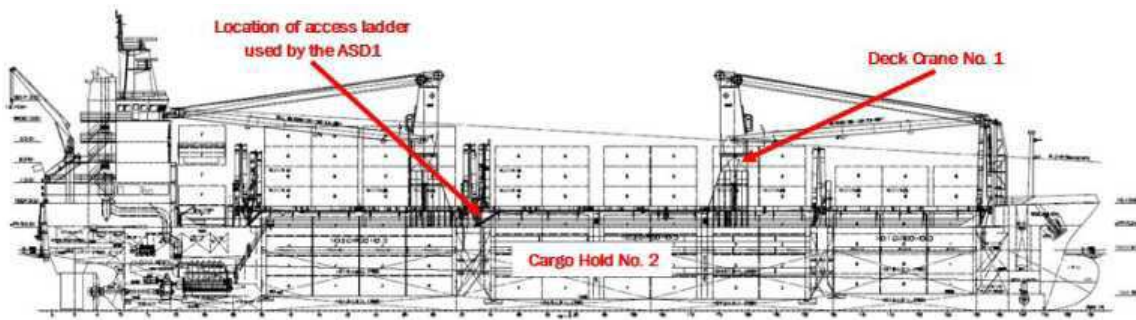
17. The vertical access ladder used by the ASD1 is on the port side, aft end of the Cargo Hold No. 2 hatch coaming. The ladder for Deck Crane No. 1 is accessed from the main deck, forward of Cargo Hold No. 2 (see Figures 1, 3, and 4).

Figure 3: Location of the access ladder that the ASD1 fell from and Deck Crane No. 1. The locations of these are the same on the port side of DS WISCONSIN.

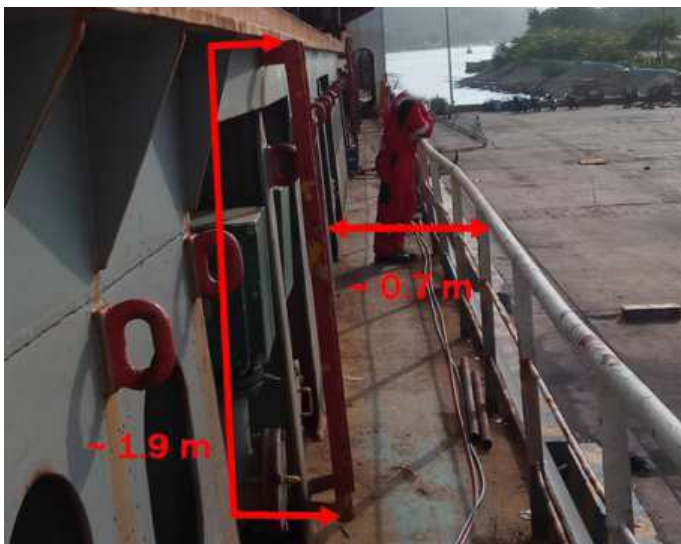
Figure 4: Dimensions of the access ladder.

18. The access ladder is about 1.9 m in height and located about 0.7 m from the guard rail (see Figure 5).
19. The top of the guard rail was about 5.4 m above the water. The access ladder ends below the top of the hatch cover and there are no handrails on the hatch cover top (see Figures 4 and 5).

Additionally, the access ladder terminates below the top of the hatch cover and there are no handrails on the hatch cover top. It is possible that the ASD1 lost his balance while attempting to transition from the hatch cover to the access ladder.

The distance between the access ladder and the guard rail is about 0.7 m, increasing the risk of going overboard if a crewmember falls from the ladder. This is especially true when transferring from the hatch cover onto the ladder, which is well above the height of the guard rail.

1. It is recommended that the Company review the design and placement of hatch cover access ladders on ships in their managed fleet to assess the risk of going overboard in the event of a fall from the ladder.

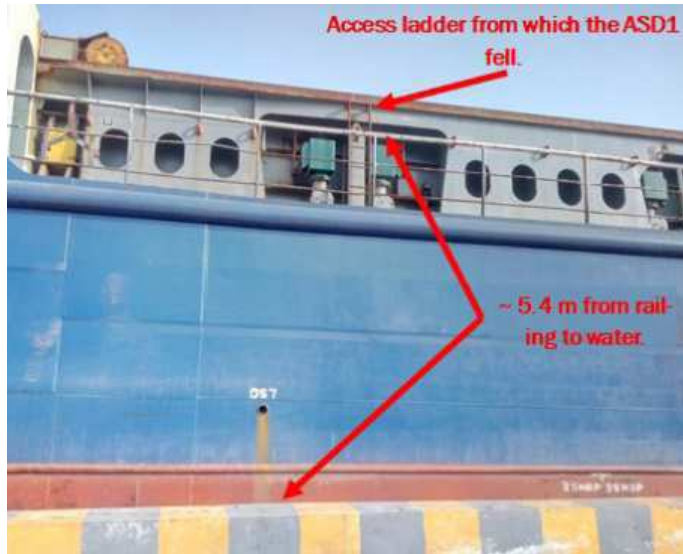
Figure 5: Port side of DS WISCONSIN while moored at the Visakhapatnam lay berth.

The Bosun saw the ASD1 begin to climb down the access ladder and a few moments later saw when he was falling. However, the Bosun did not see the start or cause of the ASD1's fall. Based on the information available to the Administrator, the cause of the ASD1's fall could not be definitively determined. It is possible that he lost his grip or slipped from a rung while on the upper half of the access ladder and fell backwards over the guard rail. Only about 0.7 m separates the rail from the access ladder.
