MA2020-5

MARINE ACCIDENT INVESTIGATION REPORT

Accident type	Fatality of a worker
Date and time	Around 03:39 on January 17, 2019
Location	Quay adjacent to Sumitomo Chemical Co., Ltd., Niihama Port, Niihama City, Ehime Prefecture Vicinity of T.B'g 059°/668 m from Niihama Port East Breakwater Lighthouse (Approximately 33°59.0' N 133°16.3' E)
Summary of the accident	While the cargo ship "ISHIZUCHI" was unloading cargo at Niihama Port, a worker was hit by a bulldozer in the hold and died at around 03:39 on January 17, 2019.
Process and progress of the investigation	<p>(1) Set up of investigation</p> <p>The Japan Transport Safety Board appointed a chief investigator-in charge and two other investigators to investigate this accident on February 5, 2019.</p> <p>(2) Collection of evidence</p> <p>February 24, 2019: On-site investigation; February 5, 6, 12, 20, 22, 23 and July 30, 2019: Interview; February 13, 21, March 6, 7, 2019, and January 20, 2020: Collection of questionnaire</p> <p>(3) Comments from parties relevant to the cause</p> <p>Comments on the draft report were invited from parties relevant to the cause of accident.</p> <p>(4) Comments from the Flag State</p> <p>Comments on th

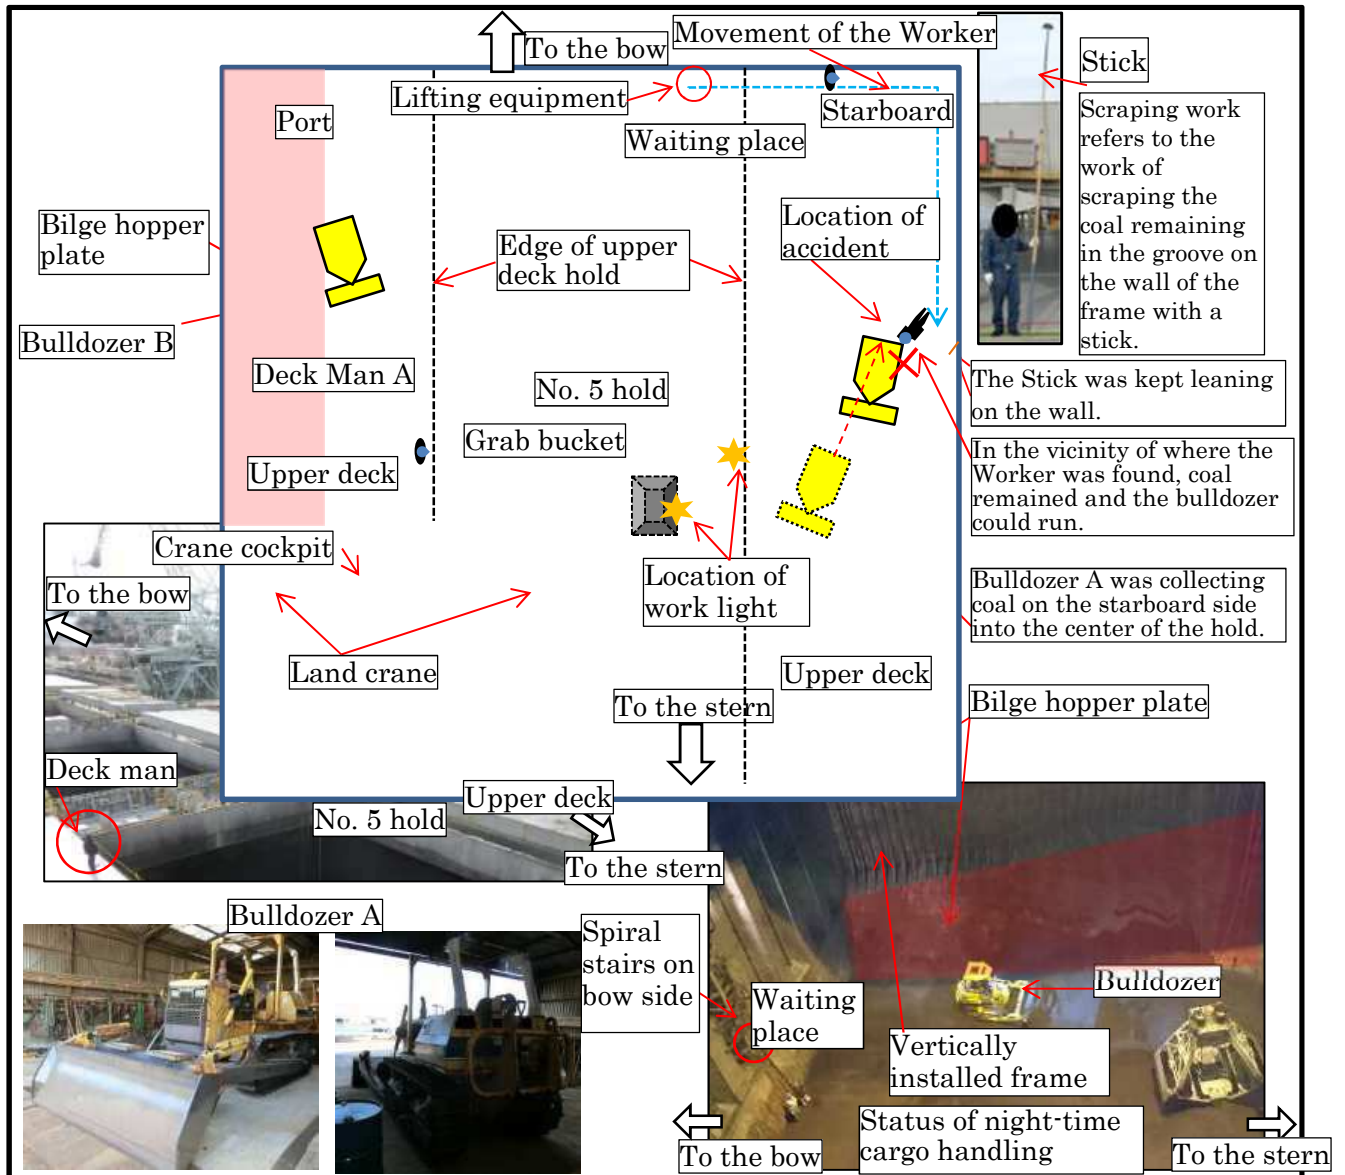
Figure 3 Situation of the accident occurrence (image)

<p>with a bulldozer in the hold.</p> <p>(2) Situation of the accident occurrence, etc.</p> <p>No one witnessed this accident.</p> <p>The Worker was wearing work clothes, a helmet, safety shoes, a dust-proof mask and a reflective vest as designated by Company A.</p> <p>With regard to the cargo-hold-work, Deck Man A heard from other workers about a contact accident occurring during work between a bulldozer and a grab bucket in another company, and so he was paying attention to contact between Bulldozer A and the grab bucket when this accident occurred.</p> <p>In Operator A's experience, when performing the cargo-hold-work with this Worker, he never failed to appear in a position which was easily visible from the bulldozer and he always gave a signal. Never did he work in dangerous situations, such as moving within the operating range of a bulldozer.</p> <p>While Operator A was working near the side wall, he never expected the Worker to move nearer to the wall concerned. He did not even notice that the Worker had been hit by Bulldozer A.</p> <p>After this accident occurred, there remained traces of being run over by the caterpillar of Bulldozer A upon the body of the Worker having fallen into the coal, ranging from his helmet to the lower part of his body, and the coal was also left on the bilge hopper plate.</p> <p>Inside the hold, brightness was sufficient for performing the cargo-hold-work with the work lights of the Vessel and the land crane.</p> <p>(Figure 1: Map of location of the accident, Figure 2: General arrangement, Figure 3: Situation of the accident occurrence (image), Figure 4: State of the land crane, Figure 5: State of the cargo-hold-work)</p>

<p>The Worker died immediately due to multiple traumas.</p> <p>(2) Status of occurrence</p> <p>It is highly probable that the Worker of Company A, while unloading coal in No. 5 hold at Niihama Port where the Vessel moored, was run over by Bulldozer A to death, when it was moving backward.</p> <p>(3) Actions of the Worker</p> <p>Although the Worker was instructed by Company A to keep out of the moving range of the bulldozer, it is highly probable that he moved from the waiting place to the center of the wall on the starboard side with a stick and was staying in the backward moving range of Bulldozer A.</p> <p>When this accident occurred, the Worker was found with his head facing the interior of the hold and there remained the traces of him being run over, ranging from his helmet to the lower part of his body. Therefore, it is somewhat likely that he fell down and was hit during his work. However, since there were no witnesses, the situation could not be determined.</p> <p>(4) Actions of Operator A</p> <p>It is probable that Operator A thought that the Worker would not approach the vicinity of the wall while the bulldozer was working near the side wall, based on his own experience of performing scraping work by himself and the cargo-hold-work together with the Worker.</p> <p>Although Operator A was instructed to carry out the work while checking the position of the Scraper, he did not acknowledge the signals from the Worker and Deck Man A at the time of this accident. And under the circumstances, it was probable that only the Scraper and two bulldozers were working in the hold, as a result of which he thought that the Worker was still in the waiting place and nobody was behind Bulldozer A, and the operator continued to move the Bulldozer backward in the vicinity of the wall on the starboard side without turning his face backward.</p> <p>It is probable that Operator A did not notice the Worker in the rear.</p> <p>(5) Actions of Deck Man A</p> <p>Although Deck Man A, being the chief of cargo handling officer on board, was in a position to issue a command to the cargo-hold-worker directly, but his attention was focused on the</p>

<p>Probable causes</p>	<p>It is probable that this accident occurred as follows: The Worker of Company A was unloading coal behind Bulldozer A in No. 5 hold in Niihama Port where the Vessel moored during nighttime, Operator A thought there was nobody behind the Bulldozer A and thus moved it backward, causing the Worker to be run over by Bulldozer A.</p> <p>It is probable that Operator A thought that there was nobody behind and moved Bulldozer A backward because there had been no signal given by either the Worker or Deck Man A.</p> <p>Deck Man A, who was paying attention to the contact between Bulldozer A and the grab bucket, did not notice the positional relationship between the Worker and Bulldozer A, and there was no system established for the cargo-hold-work that enables the bulldozer to stop immediately in response to the position and actions of the Scraper, as a result of which it is probable that this accident occurred.</p>

<p>Safety actions</p>	<p>1. Measures taken by Company A after this fatal accident</p> <p>Company A has put together safety work procedures for the cargo-hold-work and has made the signals and actions of the Scraper and heavy equipment operators in the hold thoroughly well-known as well as it has taken measures for keeping the Scraper out of places where a danger of contact may arise between the Scraper and vehicle-type construction machinery in operation.</p> <p>(1) The Scraper must carry a whistle, and when moving in the hold, he must give a signal to the operator of bulldozer with the whistle to stop the bulldozer and thereafter move to the required position.</p> <p>(2) The operator of bulldozer, when acknowledging the signal of the Scraper, must stop the bulldozer and confirm the position of the Scraper.</p> <p>(3) While a bulldozer works in an area where two bulldozers can stay side by side (about 2.7 m x 2), the Scraper must not enter the space between the side wall and heavy equipment in operation.</p> <p>(4) The Scraper must wear a light-emitting vest so that the deck man and bulldozer operator can find his whereabouts easily.</p> <p>2. Accordingly, the implementation of the following measures would help to prevent recurrence of a similar accident, etc.:</p> <ul style="list-style-type: none"> • The deck man, as the chief of cargo handling officer onboard, must grasp the positional relationship between the Scraper and the bulldozer, and determine the method of work for preventing the Scraper from entering the moving range of the bulldozer, and make a command of the work directly. • Company A is required to conduct internal safety education on a regular basis, and make it well known that the Scraper must not enter the moving range of the bulldozer. • Every time the bulldozer moves backward, its operator is required to point at the position of the Scraper, and the bulldozer must not move backward before the position of the Scraper is confirmed. • If Company A finds it difficult for one deck man to monitor the cargo-hold-work, it is desirable to deploy another person in charge of monitoring the work or guiding the bulldozer. • It is desirable for Company A to have each worker carry a radio so that the deck man can quickly and easily contact the

<p>Scraper and the operator of bulldozer.</p> <ul style="list-style-type: none"> • It is desirable for Company A to repair the defective part of bulldozer, and to equip the bulldozer with the facilities for checking the surroundings and for issuing an alarm when the Scraper approaches the bulldozer.
--	---
