Transport Accident  
Investigation  
Commission

# Final Report

**Marine inquiry MO-2019-203**

**Bulk log carrier *Coresky OL***

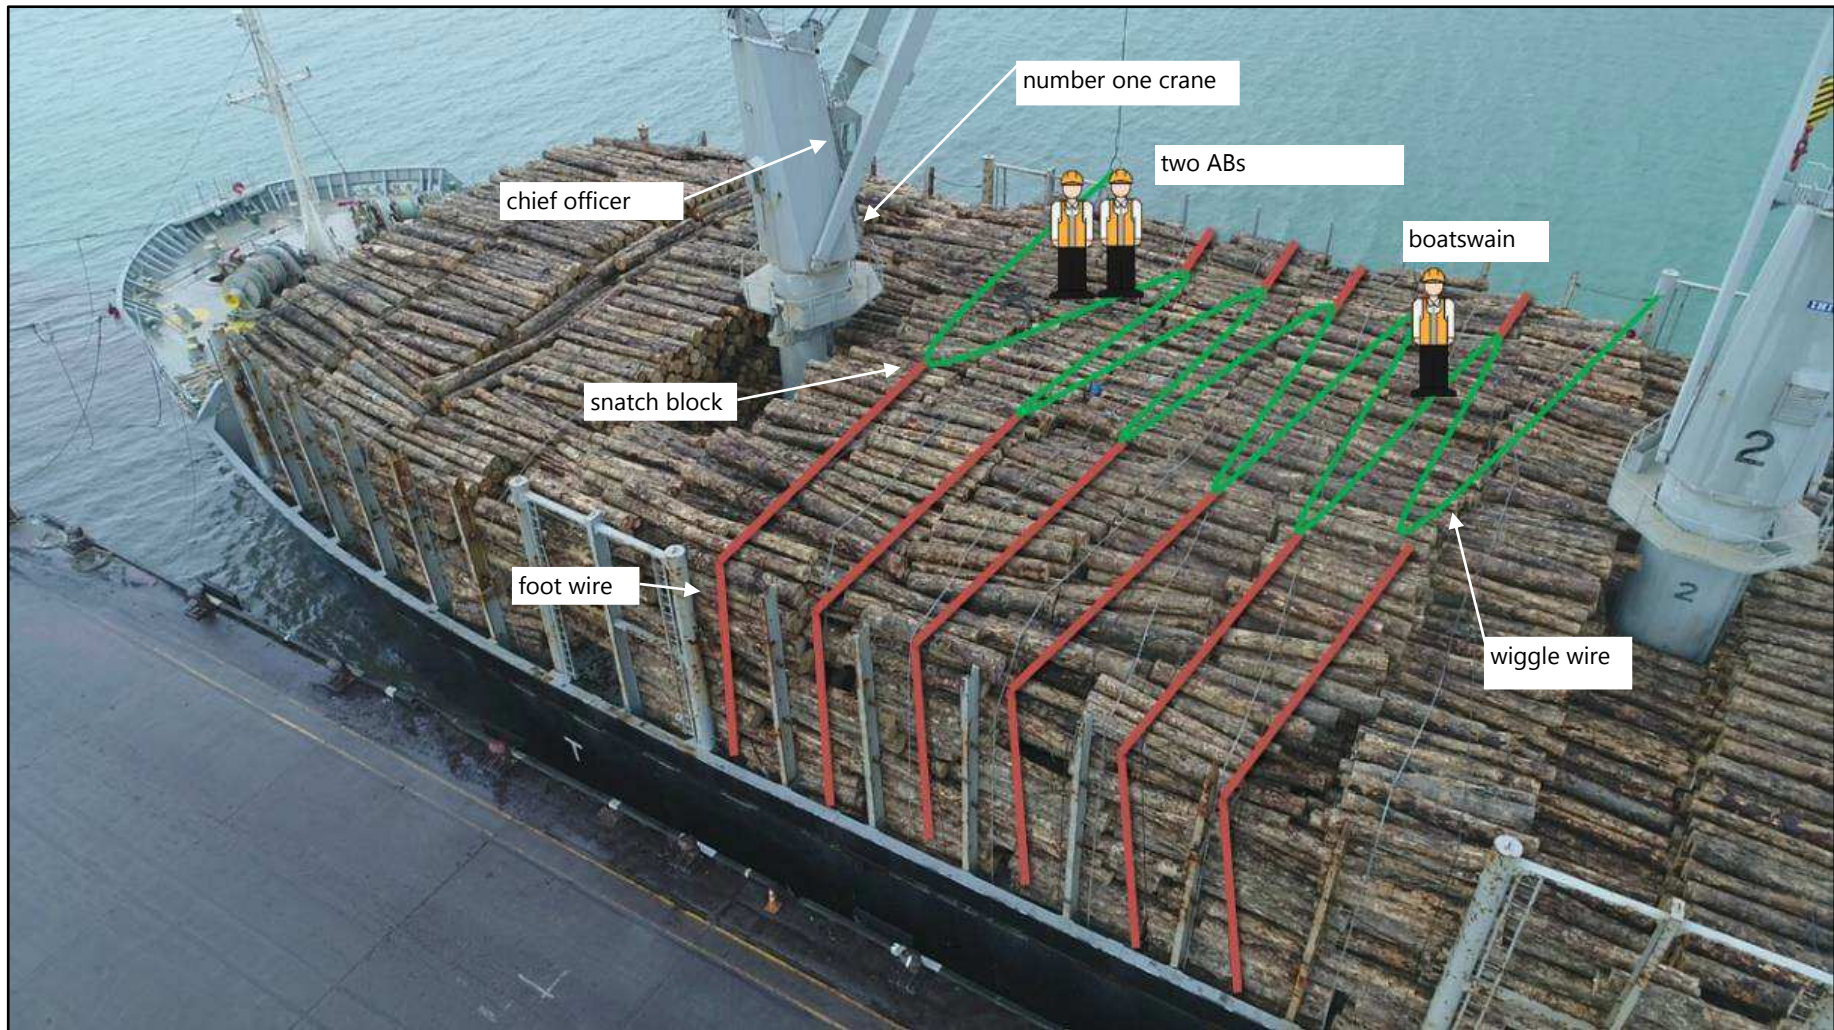
**Figure 3: Diagram of the accident site**  
(Credit: Eastland Port)

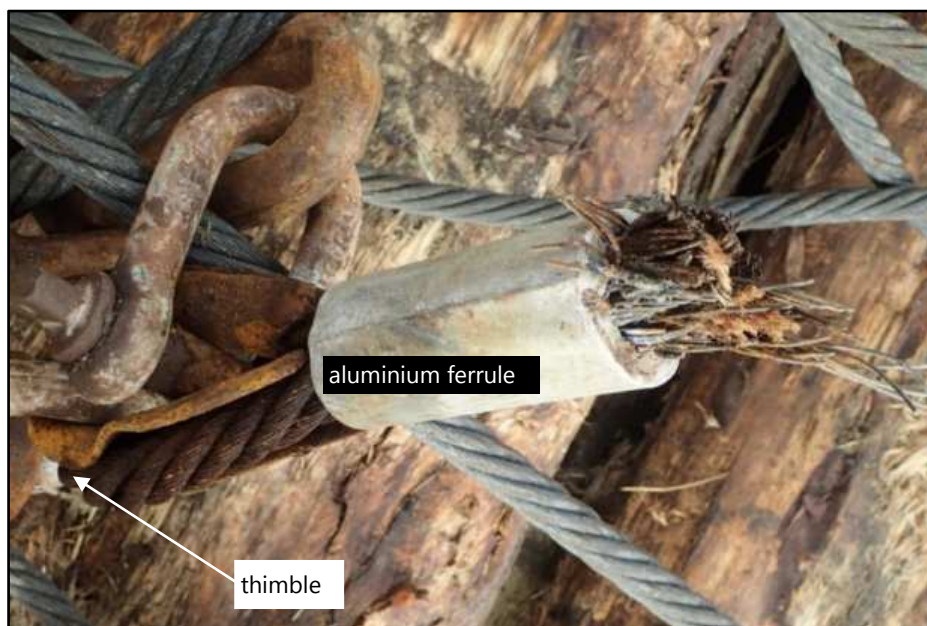
The failure of the rope most likely occurred as a result of overload. The failed wires exhibited necking and a cup and cone fracture face that is typical of this type of failure.

Although some corrosion had occurred it is considered unlikely that corrosion of the rope was the primary cause of the failure.
- 3.8 The elements of the failure mechanism described by the engineer can be seen in Figure 7, and the relevant section of the report is contained in Appendix 1.

**Figure 6: Photograph of the parted wire rope after the accident**

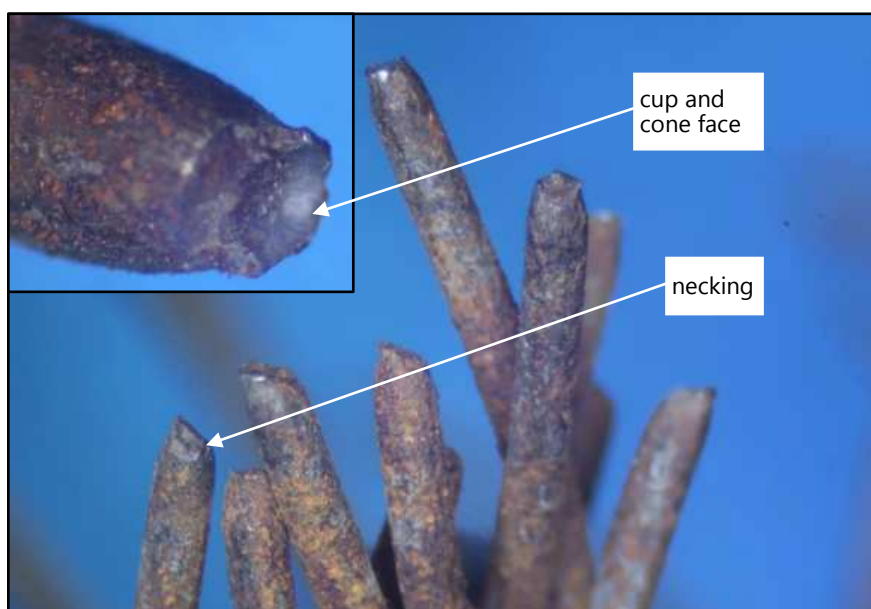
**Figure 7: Macro photograph of the failed foot wire showing reduction (necking) and cup and cone failure face**

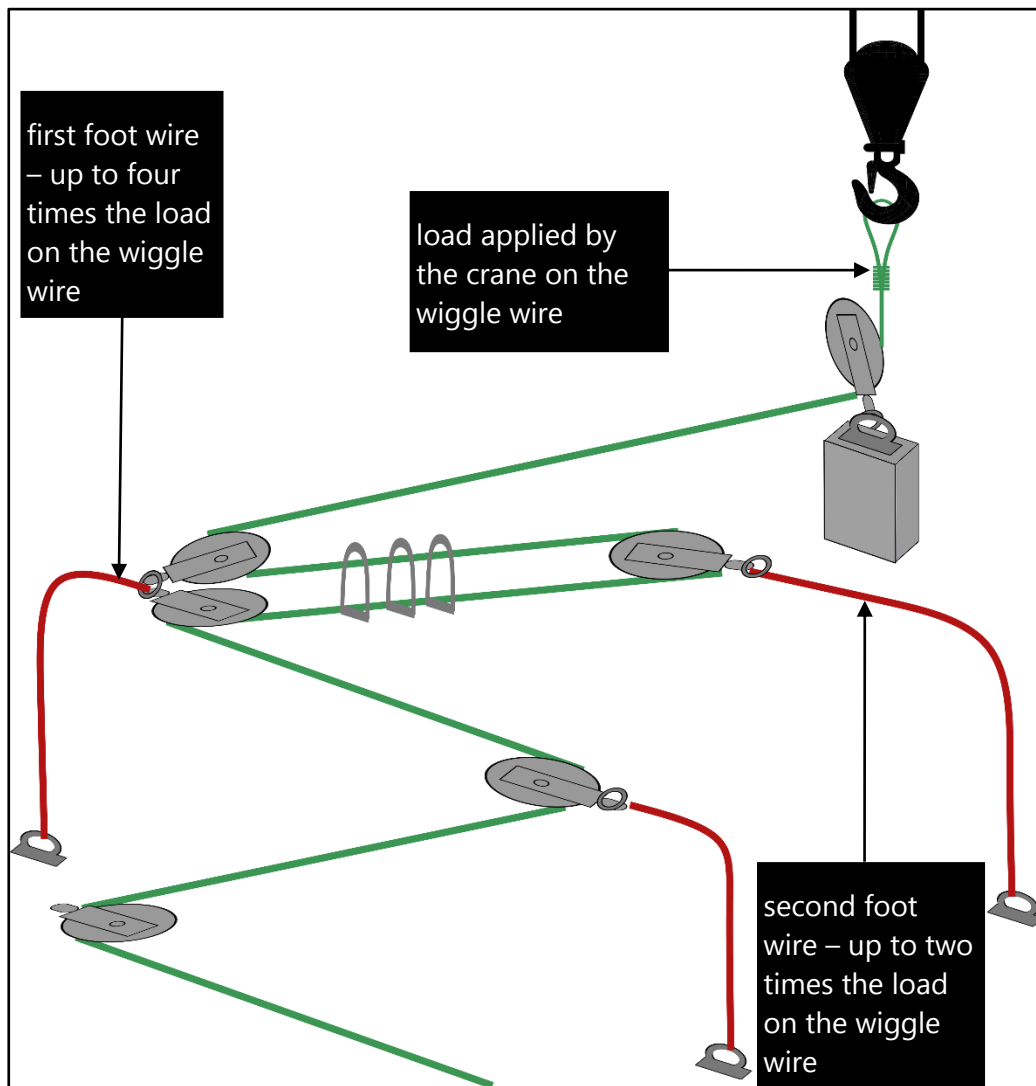
- 3.11 In the absence of any defect being identified in the foot wire, it was likely that the crane was applying a load that resulted in the foot wire being overloaded and parting.

**Figure 8: Diagram showing the configuration of the blocks on the day of the accident**
