MARINE SAFETY INVESTIGATION REPORT

Safety investigation into the engine-room fire on board the
Maltese registered ro-ro cargo vessel

EUROCARGO TRIESTE

MARINE SAFETY INVESTIGATION REPORT NO. 21/2020

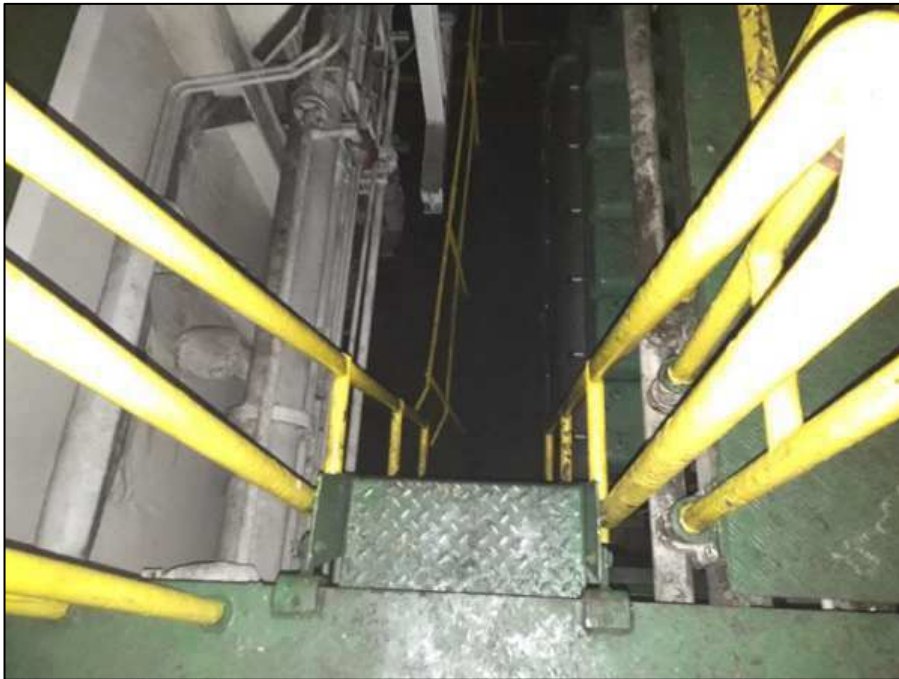
Due to thick smoke in the generator room and a sharp angle of descent (Figure 6) into the engine-room from the main deck, the fire-fighting team found it very difficult to

Figure 6: Stairs leading to the generator room from the engine-room entrance on the main deck

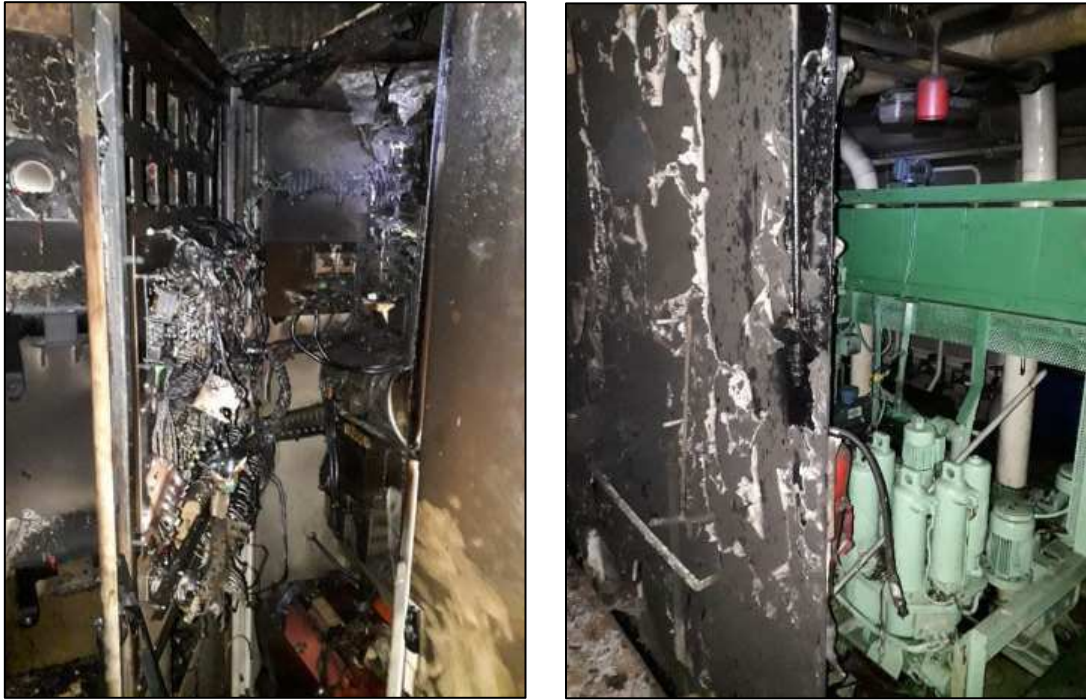
The starboard propulsion system's damage could only be determined by a complete overhaul of its units and the turbocharger. The port propulsion engine appeared to have been unaffected. An electrical control sub-station unit, located immediately forward of the ECR's windows, was completely destroyed (Figure 7).

Figure 7: Burnt out electrical / control panel forward of the ECR and modules room bulkhead

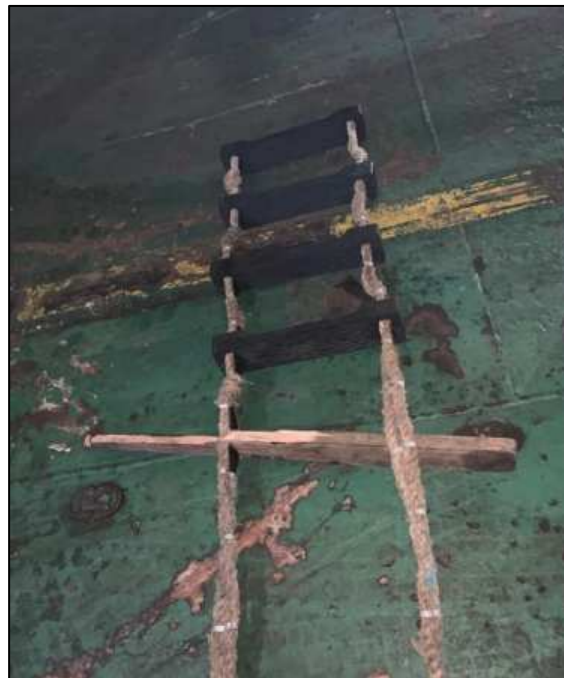
The port side pilot ladder was found damaged, namely: its lowermost spreader was broken (Figure 8).

Figure 8: Damaged port side pilot ladder

The paint scratches on the port side shell plating of the vessel, in the vicinity of the area where the port side pilot ladder was rigged up, seemed to indicate that the damages to the pilot ladder and the paint scratches were caused by the fire-fighting tugs, whilst they were engaged in boundary cooling, and/or the boats used to transfer the pilots. It should be noted that the pilot ladder was reported as damaged when the

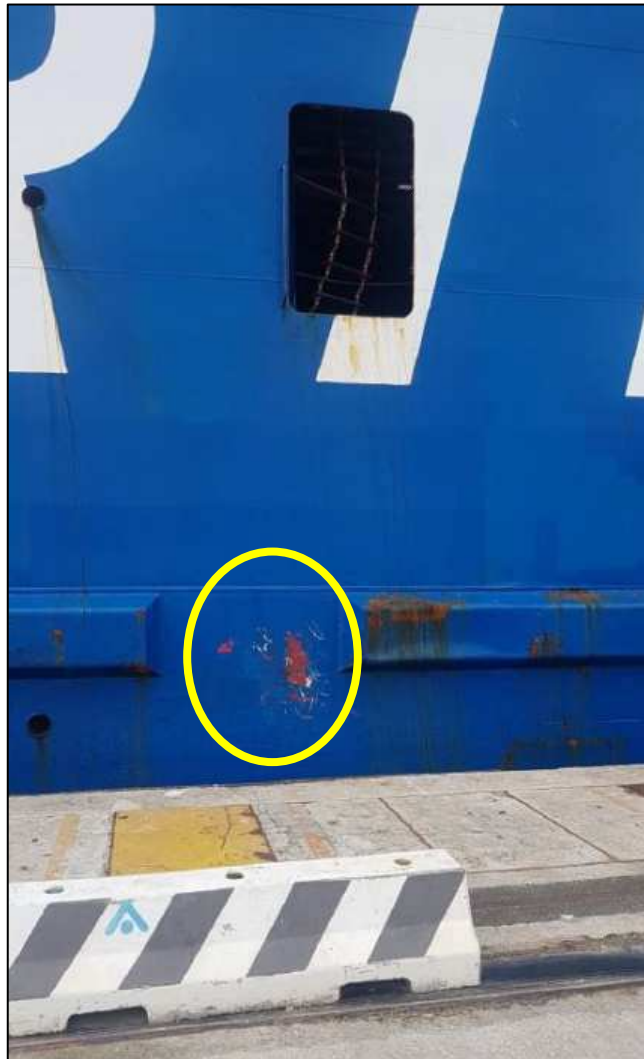
Furthermore, paint scratches were observed on the port shell plating of the vessel, around the area where the pilot ladder was rigged up (Figure 9).

Figure 9: Paint scratches on the vessel's hull (circled in yellow)

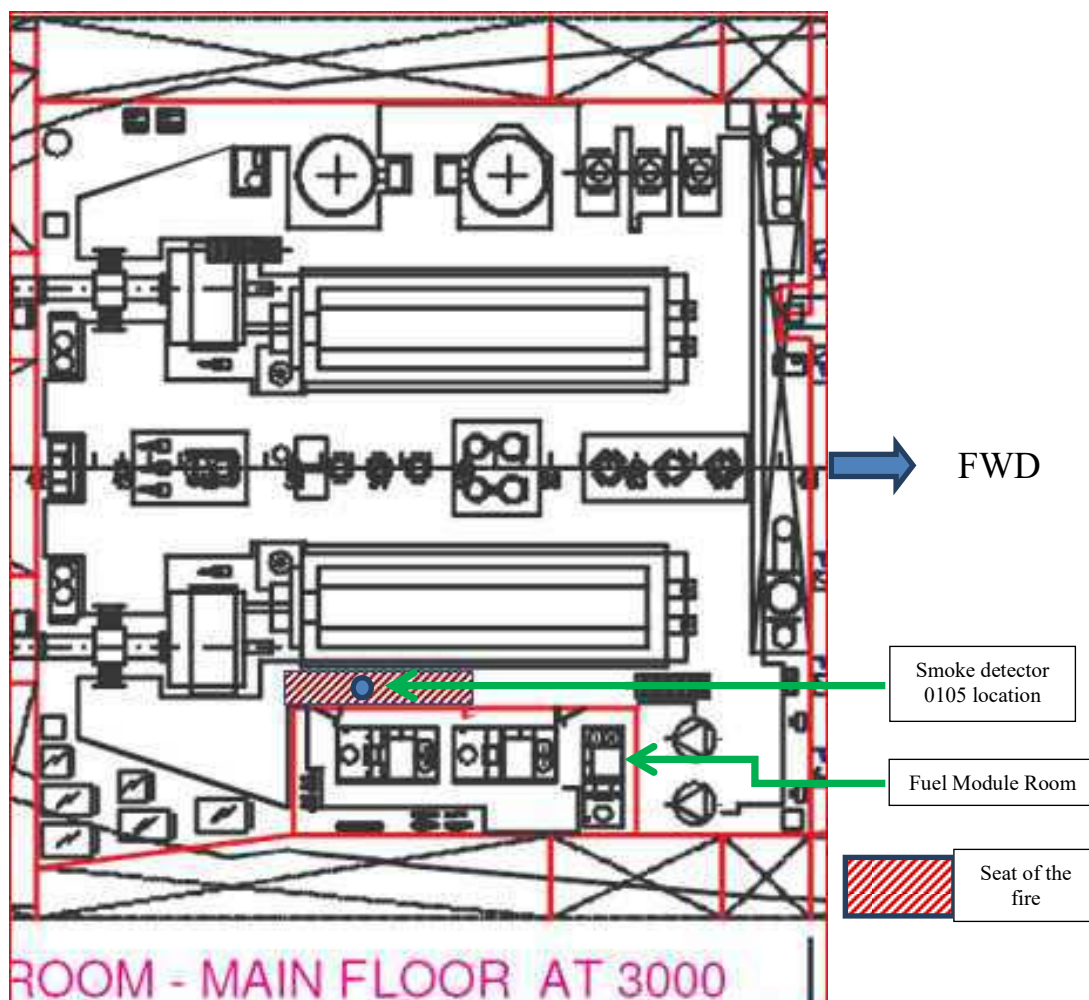
According to the fire alarm system's printer data, smoke detector 0105 (Figure 10) located on the starboard side of the starboard engine, above the main deck level, was the first smoke detector in the machinery space that was activated by the fire.

Figure 10: Seat of the fire on the main floor

The location of the seat of the fire⁷ was just outside the fuel oil modules room, on the main floor, in front of its aft access door (Figures 10 and 11). All fuel supply equipment to the engines such as pumps, heaters, fuel filters and gauges are in the modules room. Signs of heat and smoke damages were observed in the modules room, as well as in the separator room, indicating that these rooms were partly affected by flames, even though the seat of the fire was not within any of these rooms. This led the safety investigation to believe that at least one of the access doors to each of these rooms were open during the fire.

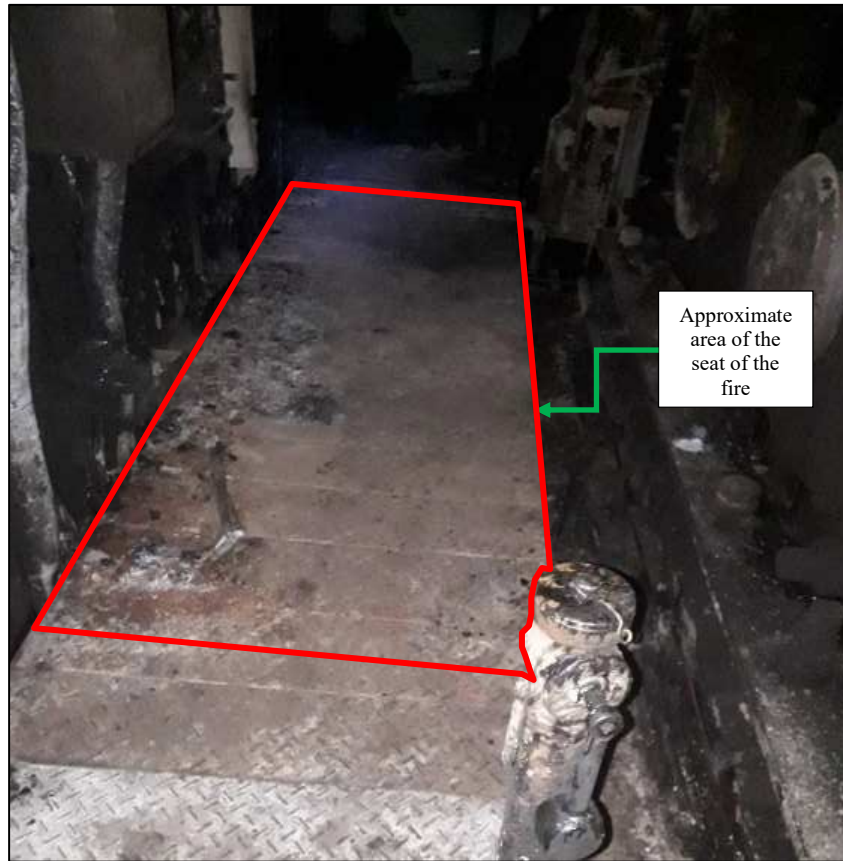
Figure 11: Seat of the fire on the main floor in the propulsion room

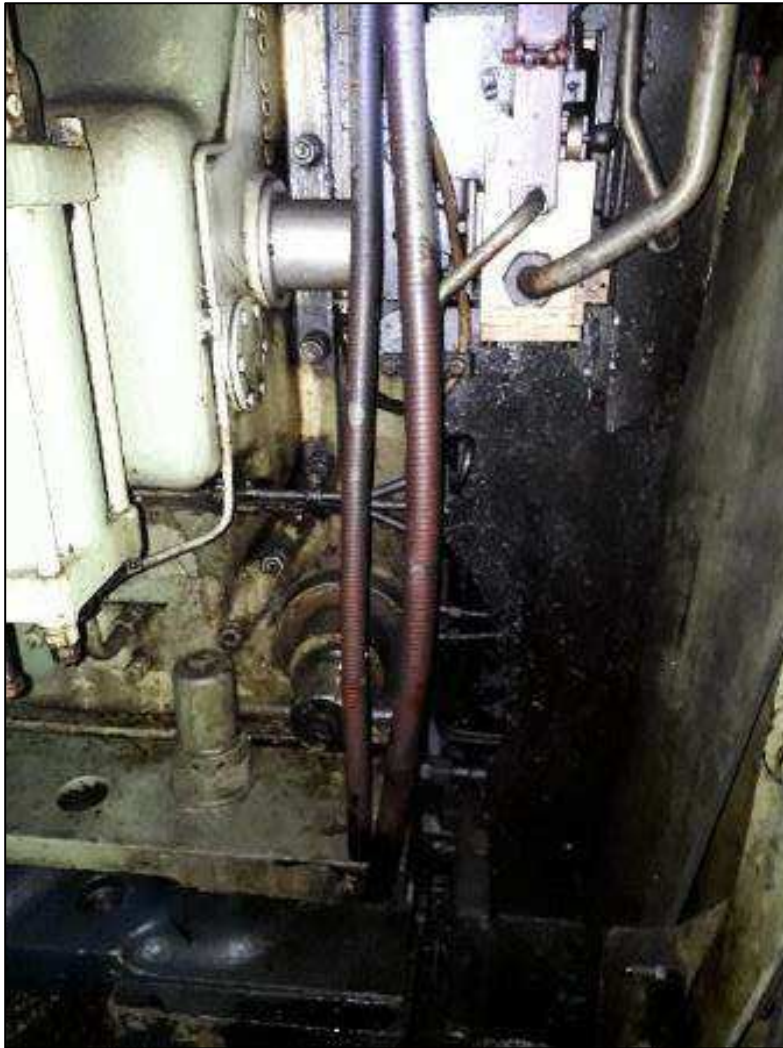
The safety investigation did not rule out that the fire spread due to the presence of combustible materials at and around the starboard propulsion engine, and in the bilges. The electrical cables at the aft of the starboard propulsion engine under the plates and in the bilges were found covered by PVC braided pipes, most probably to protect them from the oily water in the bilges. Some PVC braided pipes were used to direct leaked oil and fuel from the engine into the bilges or collection containers. A similar arrangement was used on the port side engine (Figure 12).

Figure 12: PVC braided pipes used to direct leaking oil from the port engine

- .2 Combustible materials in the form of leaked fuel, leaked oil, braided PVC pipes (to direct the leaks), plastic containers to collect drained oils, oil in the bilges and the vicinity contributed to the propagation of the fire.

21/2020_R1 Provide guidance in the vessel's SMS on good housekeeping practices with reference to monitoring of oil leaks.

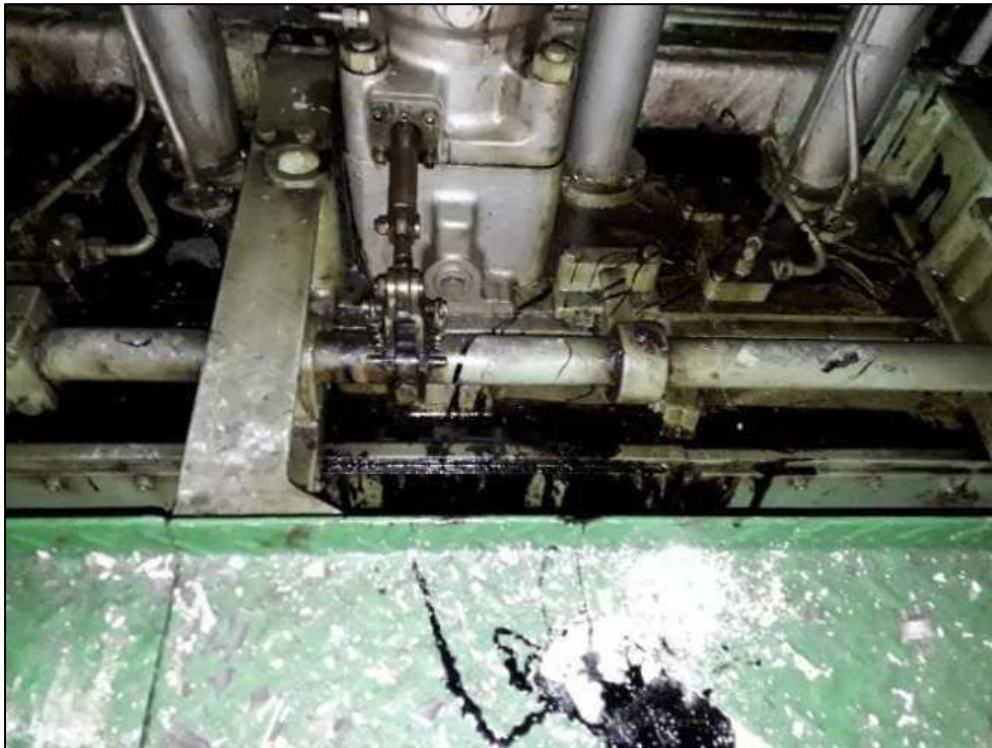
It was highly likely that the use of plastic materials, braided PVC and the leaked oil on and around the starboard propulsion engine (Figure 13) exasperated the situation and allowed the fire to develop further; in particular, a hanging plastic container which had been used on the aft/port side of the starboard engine, to collect the leaked fuel oil from the engine's fuel oil pumps.

Figure 13: Propulsion engine's fuel pumps tray showing leaked fuel

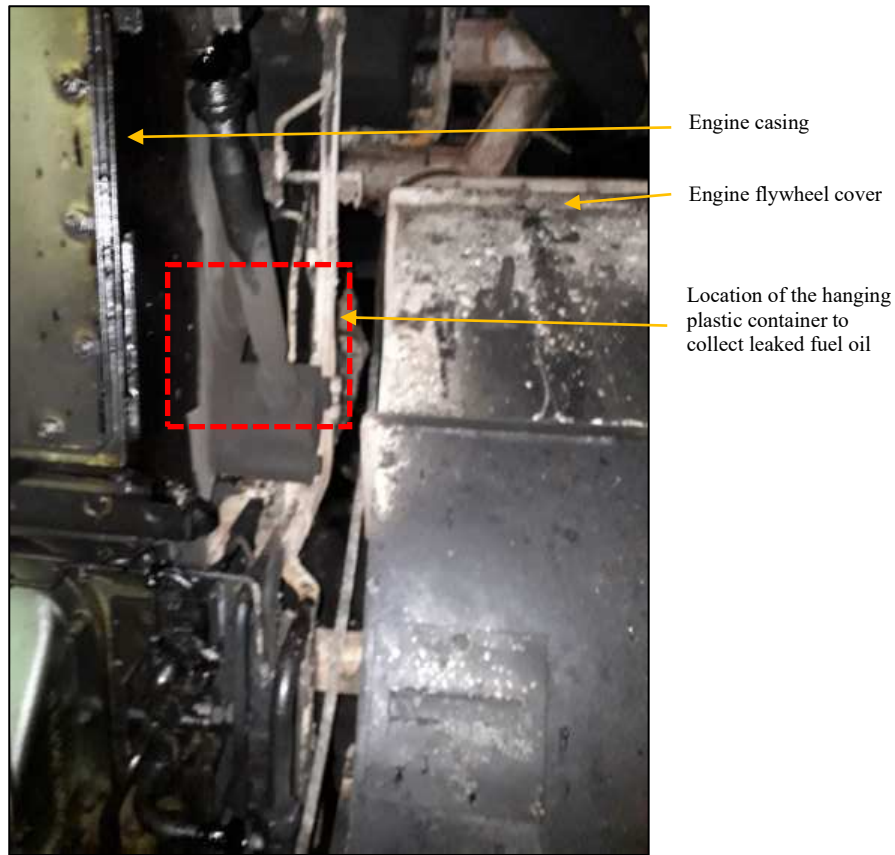
The safety investigation was also made aware of at least one plastic container, which was used to collect the starboard engine's fuel pumps' leaking fuel oil. This container, which is very common in many engine-rooms, was hanging on the aft/port side of the engine. It was clear that it had caught fire, as the bottom of the charred container was found in the bilge exactly below its original position.

The estimated position of the plastic container is shown in Figure 14 (red dotted box), while Figure 15 shows the plan view of the plastic container's position in relation to the starboard engine.

Figure 14: Position of the plastic container for collecting leaked oil

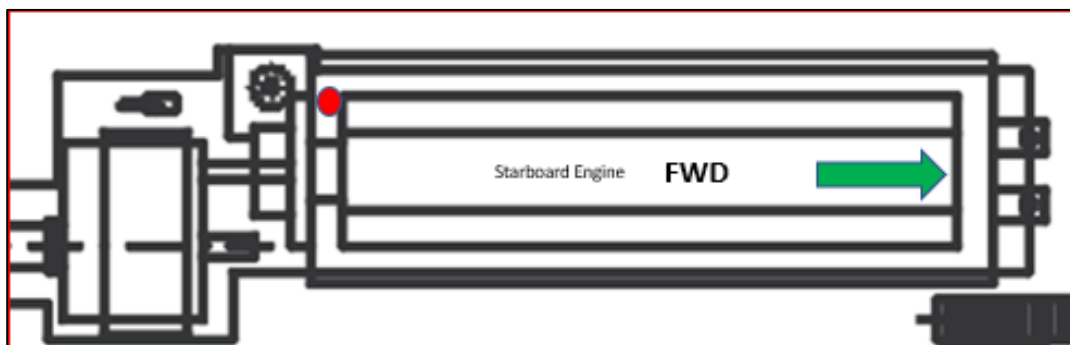
Figure 15: Red circle indicates the position of the plastic container in relation with the engine

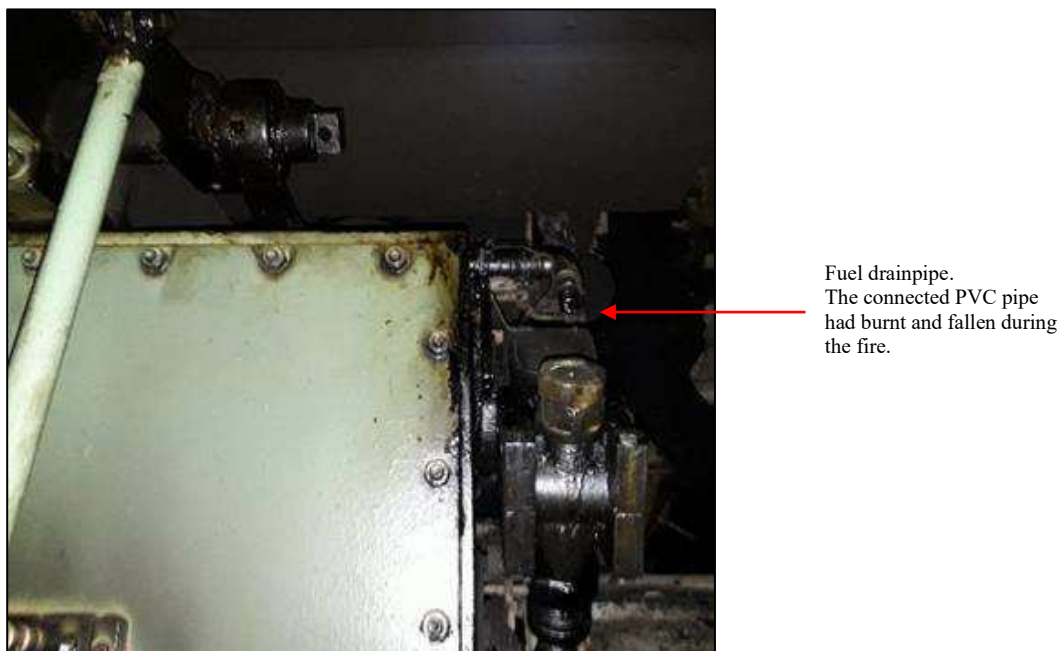
Although the seat of the fire was on the starboard side of the engine, the direction of the supply air flow (forward to aft) to the engine may have directed the flames towards the plastic container that contained the leaking oil from the main engine. The leaking oil was directed into the plastic container through a braided PVC pipe (Figure 16).

Figure 16: Starboard engine's leaked fuel drain position
