Report on the investigation of the loss of
42 containers from the container ship

Ever Smart

700 miles east of Japan, North Pacific Ocean

30 October 2017

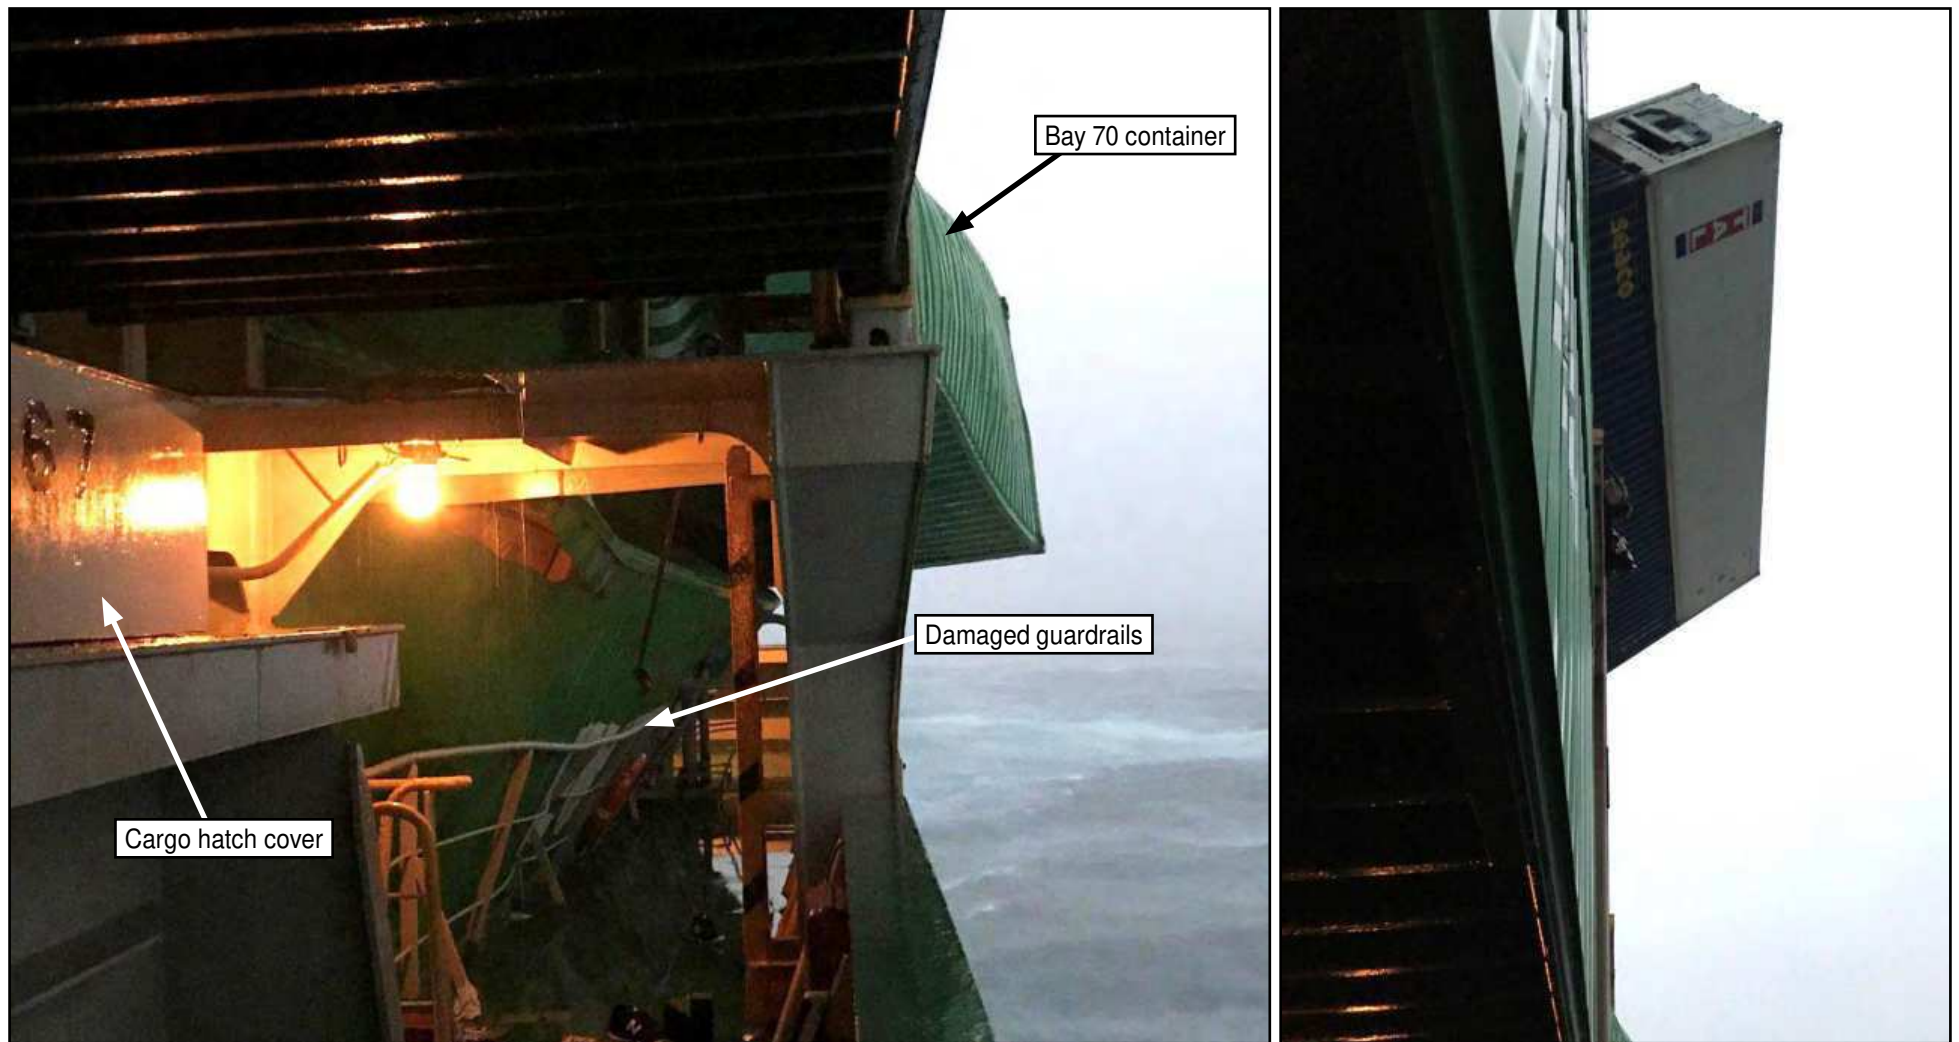
At 1648, one of the deck crew discovered that the container stacks in the ship's aftermost bay, bay 70 (**Figure 2**), had collapsed, and reported this to the C/O using a hand-held radio. The C/O called the master to the bridge and, once relieved, went aft to investigate.

Figure 2: Collapsed containers discovered in the afternoon of 30 October

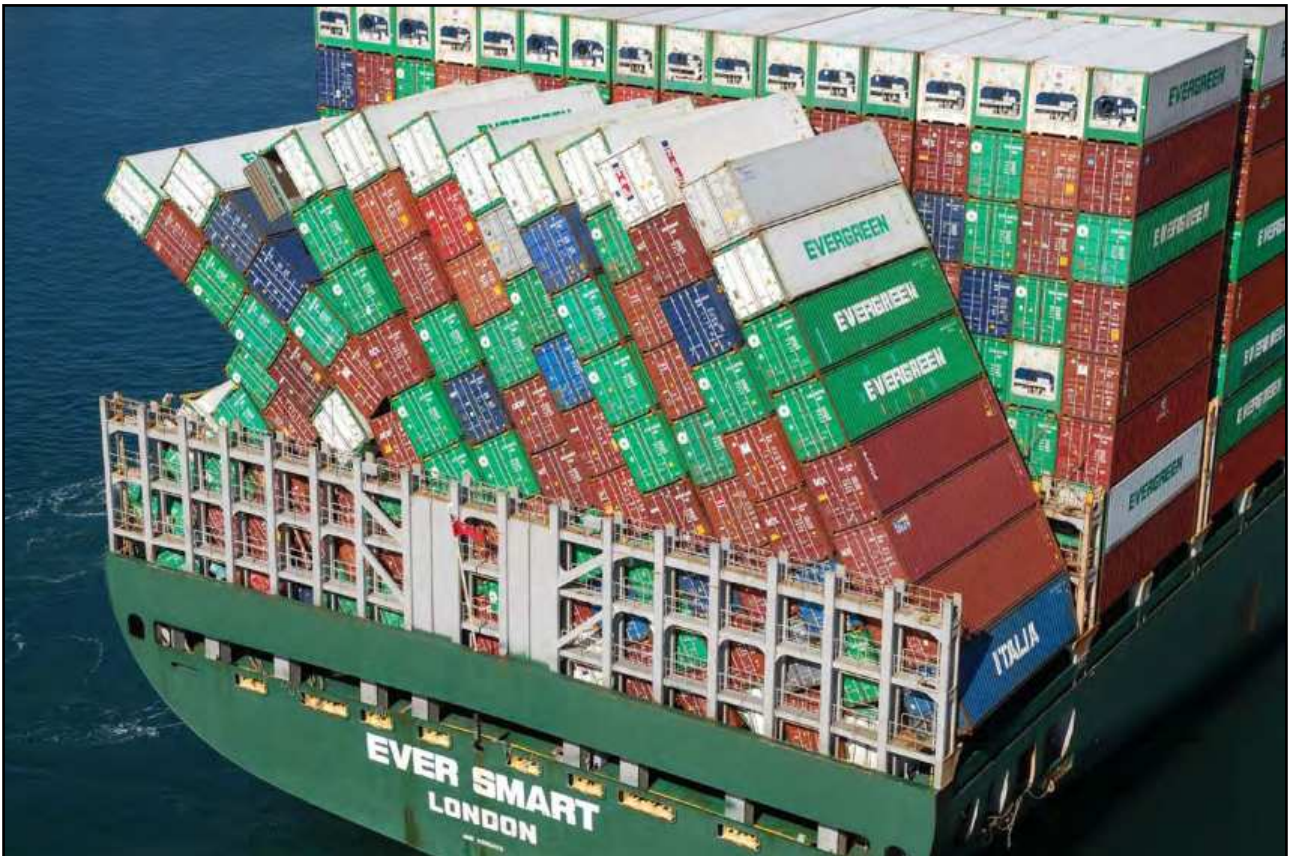
When the C/O arrived on the aft deck he discovered that all 17 of the container stacks stowed in bay 70 had toppled over to port (**Figure 3**). The two bottom tiers on the port side were crushed, three containers were hanging over the side of the ship and some were missing. The deck containers forward of bay 70 were checked and none were found to be missing or damaged.

Figure 3: Bay 70 container stow collapse to port

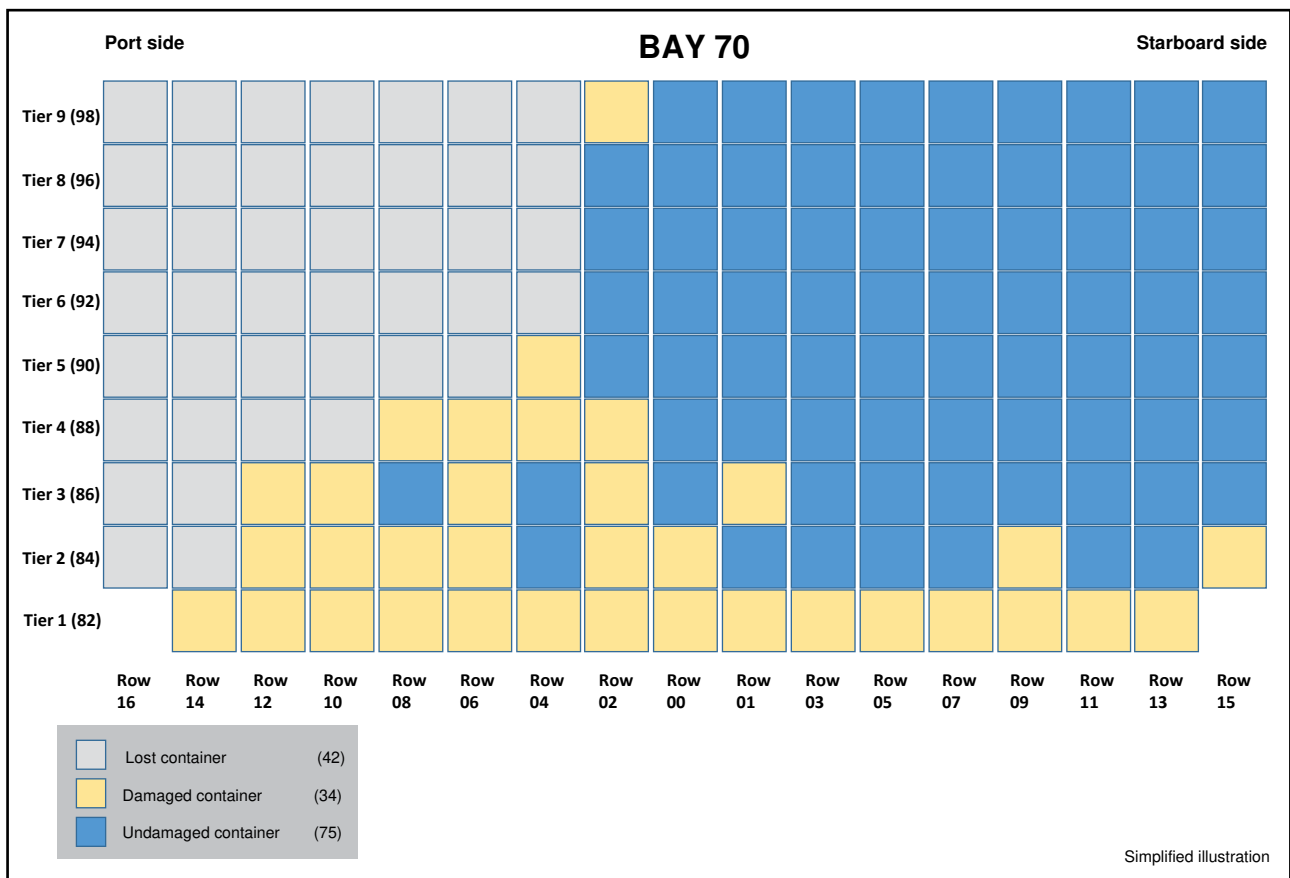
The next morning (31 October), *Ever Smart's* C/O inspected bay 70 and counted 42 containers missing (**Figure 4**); two of the containers that were previously hanging over the ship's side had disappeared overnight. The ship's aft structure was inspected, and no significant damage was found. The ship continued on passage and arrived in Los Angeles on 8 November and went to anchor for an initial damage assessment.

Figure 4: Aft end of bay 70 showing the original positions of the missing and damaged containers

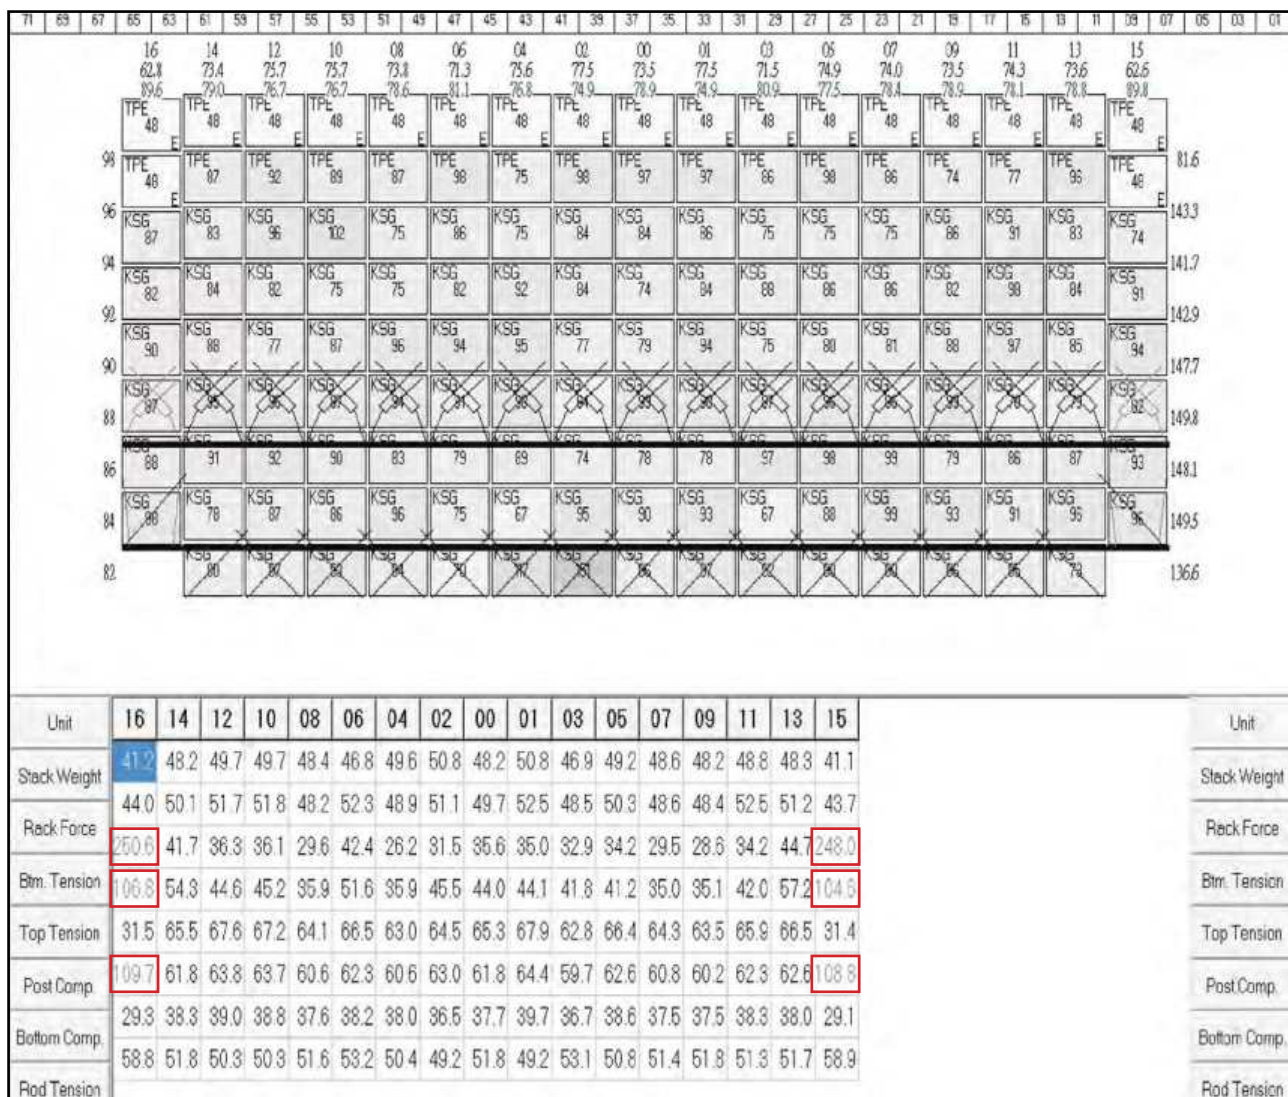
The loading computer also had a lashing calculation function that allowed the C/O to check the predicted forces acting on the containers and the lashing gear. The predicted forces for a given lashing pattern were displayed for each stack as a percentage of the prescribed limit⁷. When a force limit was exceeded, its value would turn grey. The loading computer allowed the user to adjust the lashing pattern for each bay and re-calculate the forces. The C/O used the generic lashing patterns recommended in the CSM for the bays aft of the accommodation block when the outer stacks were stacked seven containers high (**Figure 11**). The lashing calculation warned that three of the force limits could be exceeded during the passage in each of bay 70's outer stacks; one of the predicted lashing force values was 2.5 times (250%) its limit (**Figure 12**).

Figure 12: Ship's loading computer cargo lashing pattern for bay 70 and calculated lashing forces

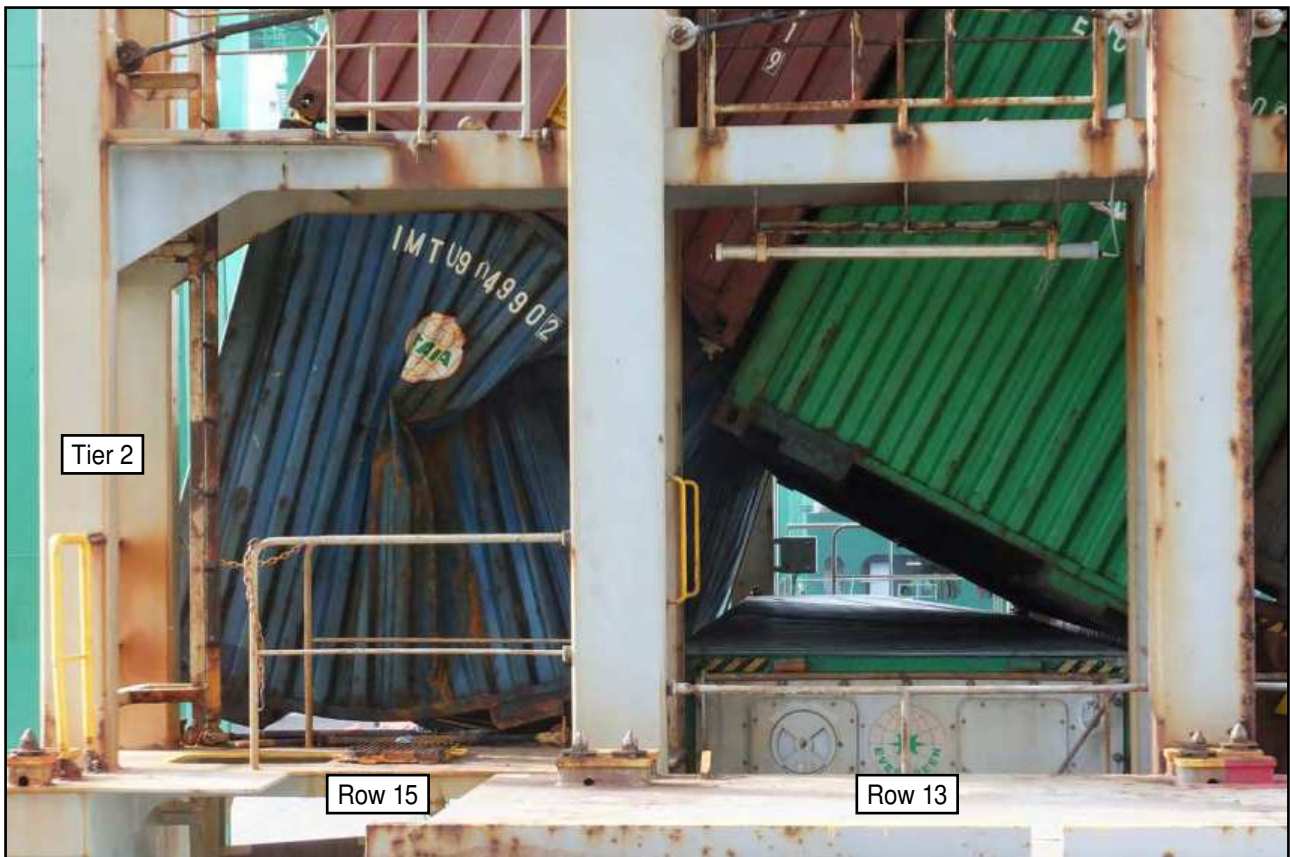
A total of 34 containers were damaged to varying degrees, and some of their doors had sprung open. The forward inboard corner post of the bottom container in bay 70's starboard outer stack (row 15, tier 2) was buckled and had collapsed (**Figure 16**). The container's aft outer corner casting had been torn away but was still attached to the deck by its twistlock (**Figure 17**). The forward outboard twistlock that had secured the container to the deck fitting, had failed. The adjacent container (row 13, tier 2) was undamaged, but the twistlocks between it and the tier 1 container below had failed and it had toppled over.

Figure 16: Bay 70: rows 15 and 13 tier 2 containers

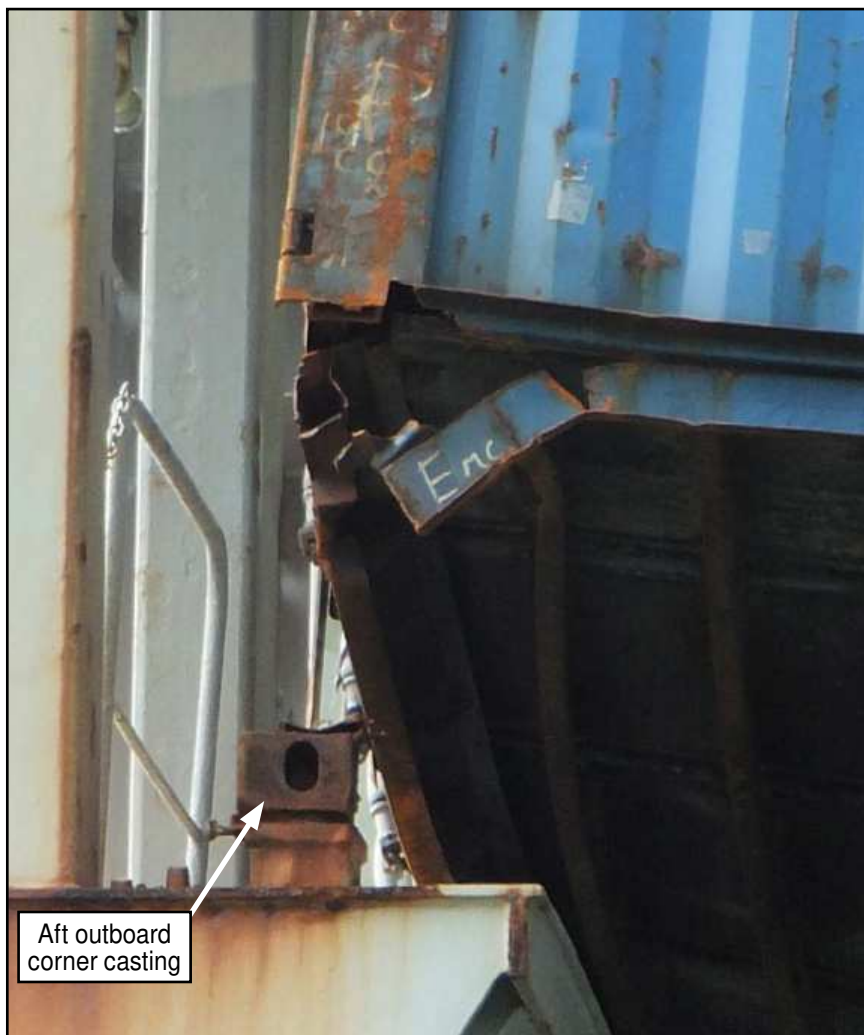
Figure 17: Aft outboard corner casting torn away from bay 70's row 15 tier 2 container

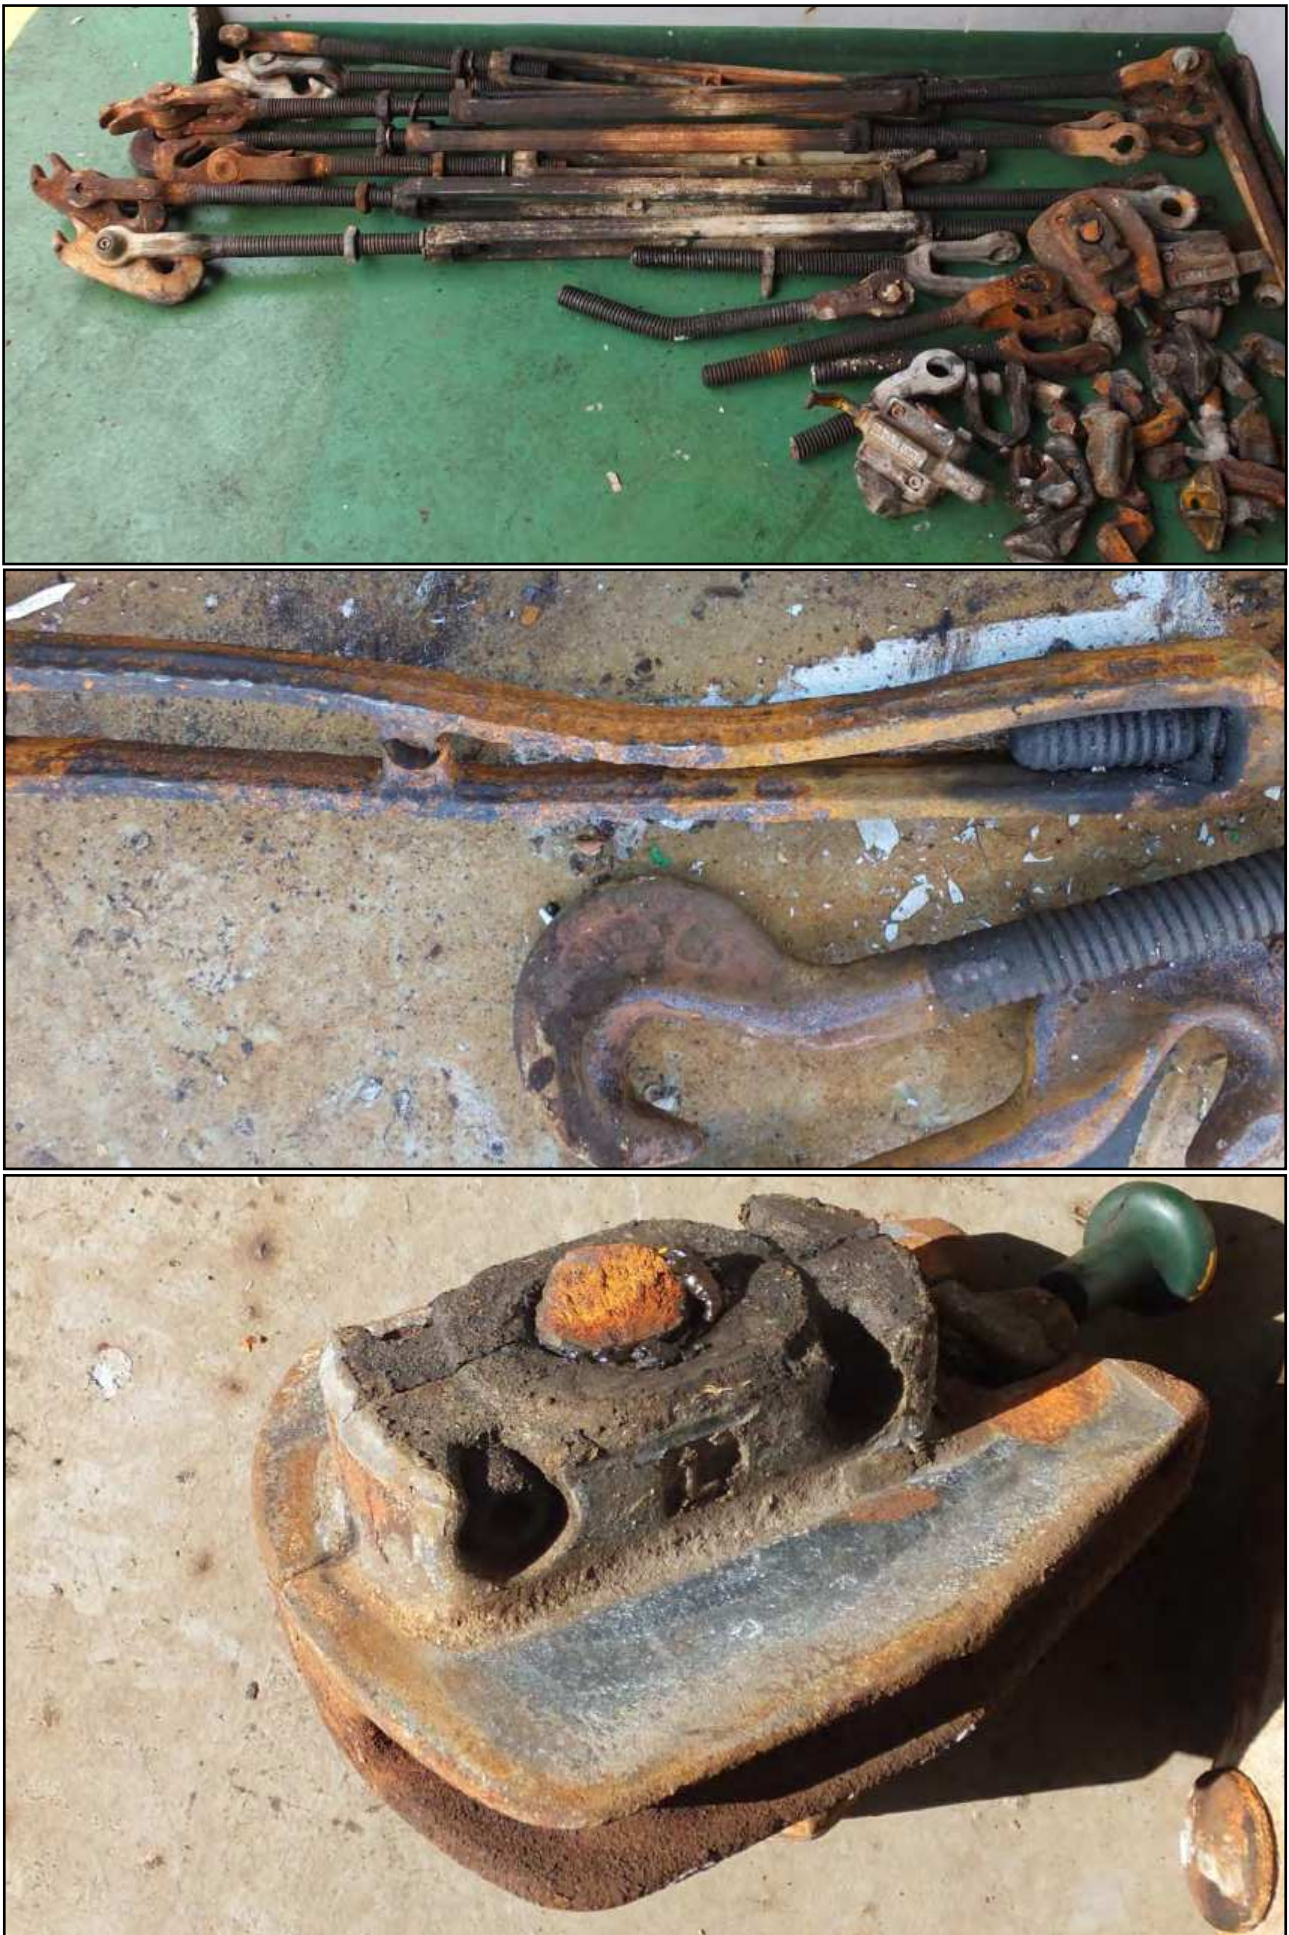
Several broken twistlocks and bent lashing rods and turnbuckles (**Figure 18**) were found close to the damaged containers. In most cases the original location of the lashing equipment could not be determined. Nevertheless, it was evident that the damage had been caused during the container stow collapse.

Figure 18: Bent and damaged turnbuckles, lashing rods and twistlocks

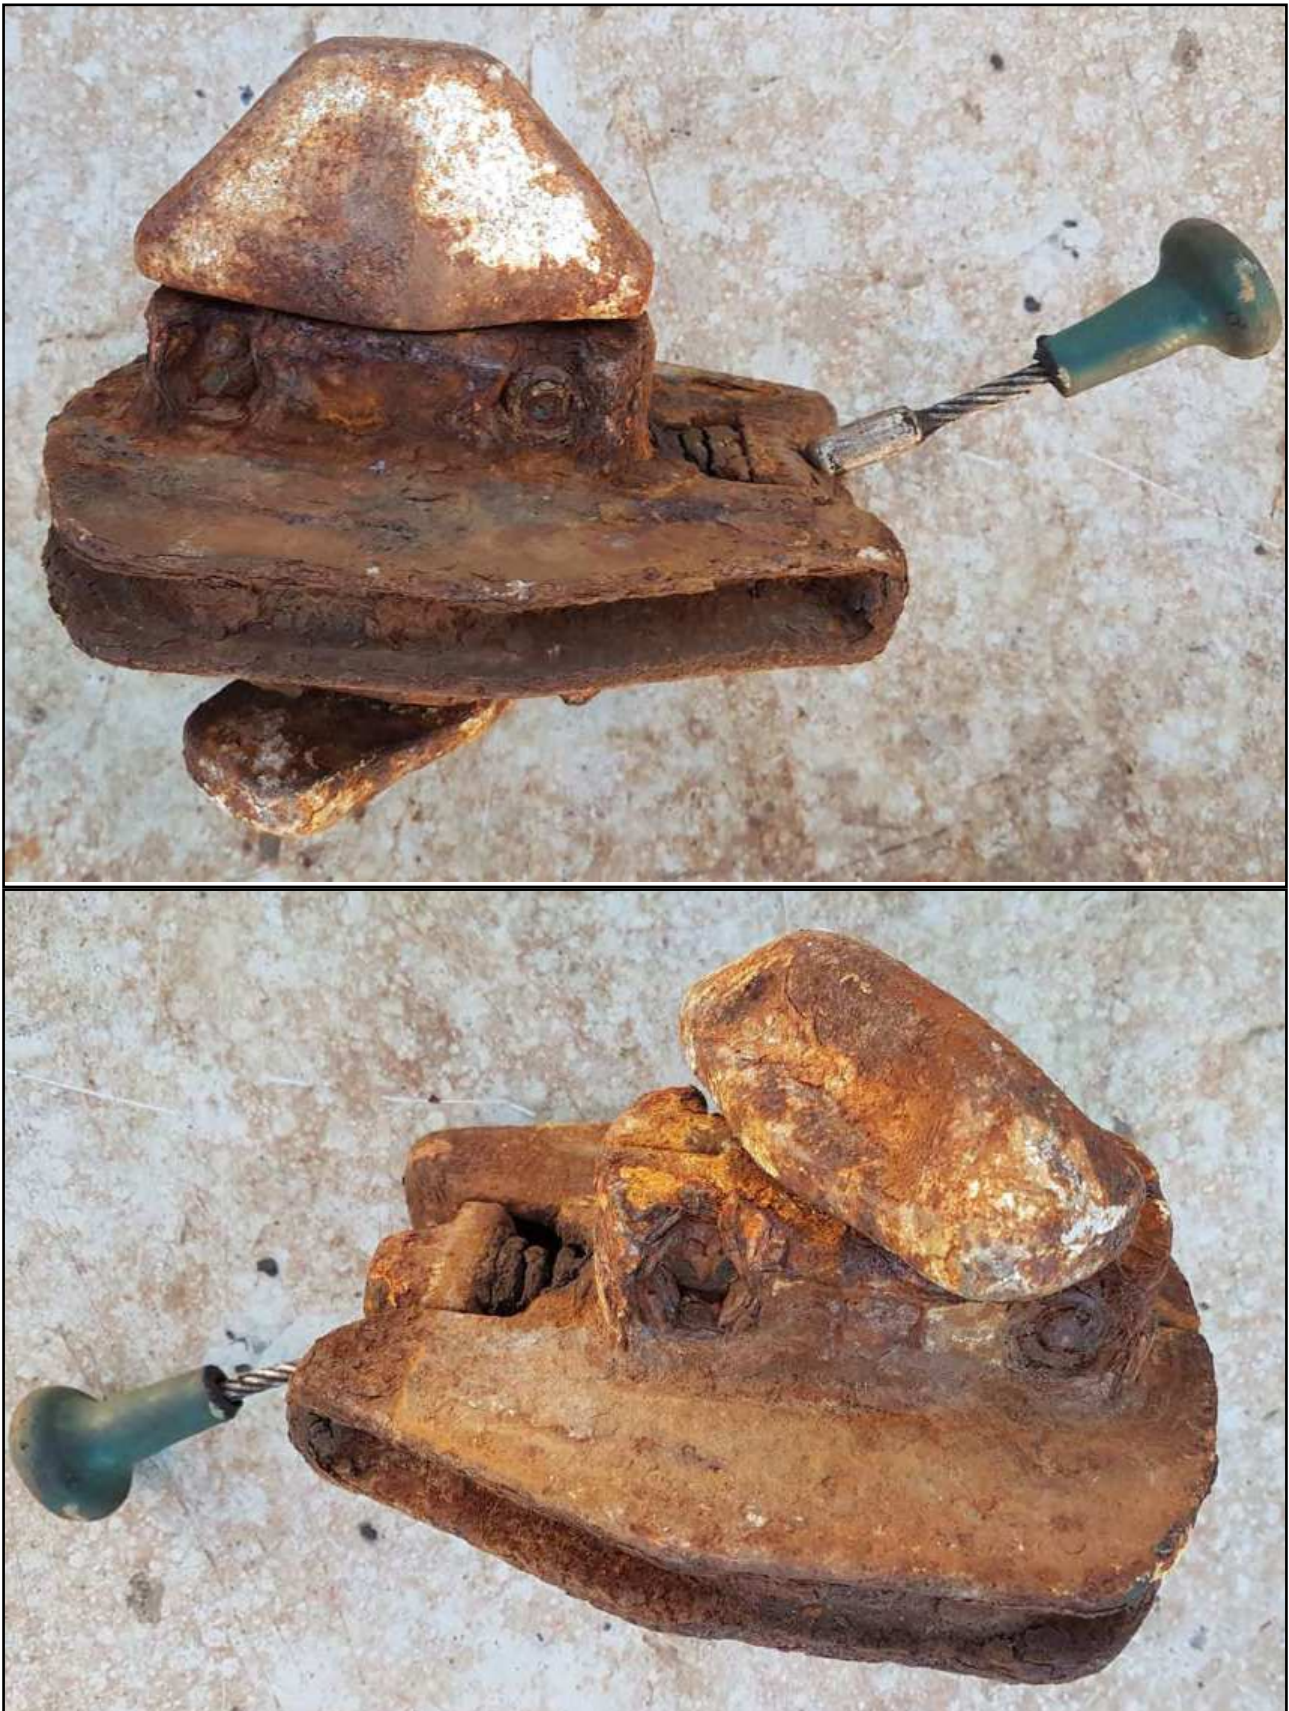
Several of the twistlocks from bay 70 were found to be corroded (**Figure 19**), but their main shafts appeared visually to be in sound condition. The ship's crew advised that twistlocks with that level of corrosion should be considered for disposal when seen.

Figure 19: Corroded twistlocks

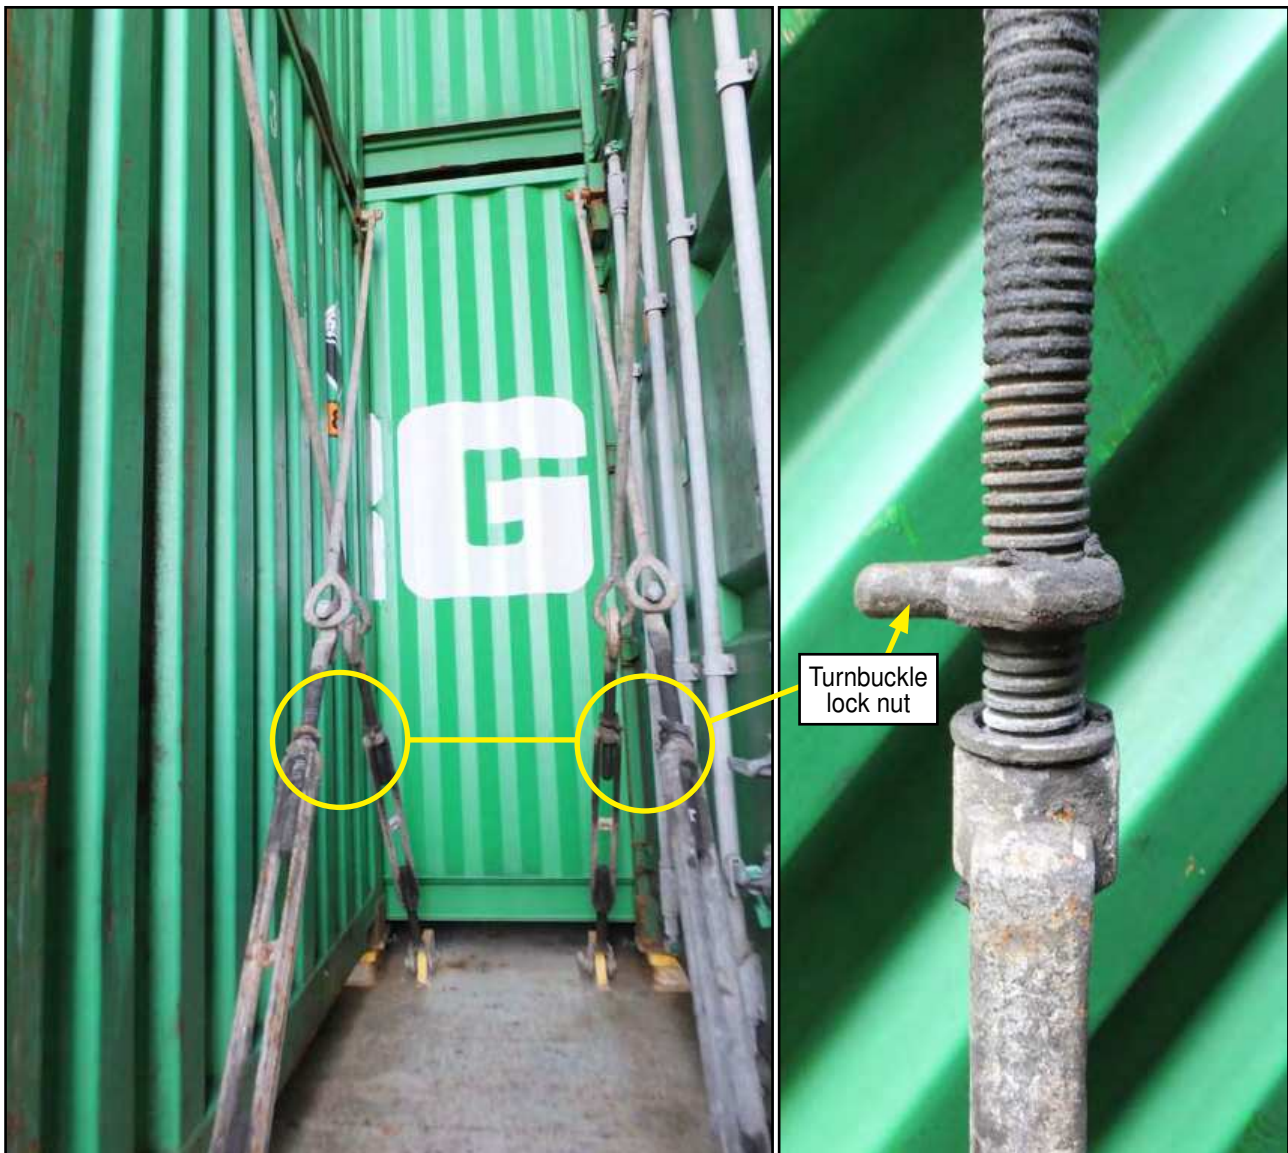
As the containers were being craned ashore, MAIB inspectors checked the lashing arrangements in bays that were not being discharged in Los Angeles. Several of the lashing rods inspected were found to be slack. It was also noted that many of the turnbuckle lock nuts had not been tightened and were loose (**Figure 20**).

Figure 20: Loose turnbuckle lock nuts

Several lashing rods and many turnbuckle lock nuts were found to be loose in unaffected bays during the MAIB's post-accident inspections. It was apparent that the turnbuckle lock nuts had not been applied, rather than vibrated loose, because most were two or three threads clear of their mating surfaces (**Figure 20**). It was therefore likely that the lock nuts had either not been tightened prior to sailing or had not been reapplied after the crew had re-tensioned the lashings during the passage. The former should have been identified and corrected during the crew's daily inspections of the lashings. Releasing and then reapplying the turnbuckle lock

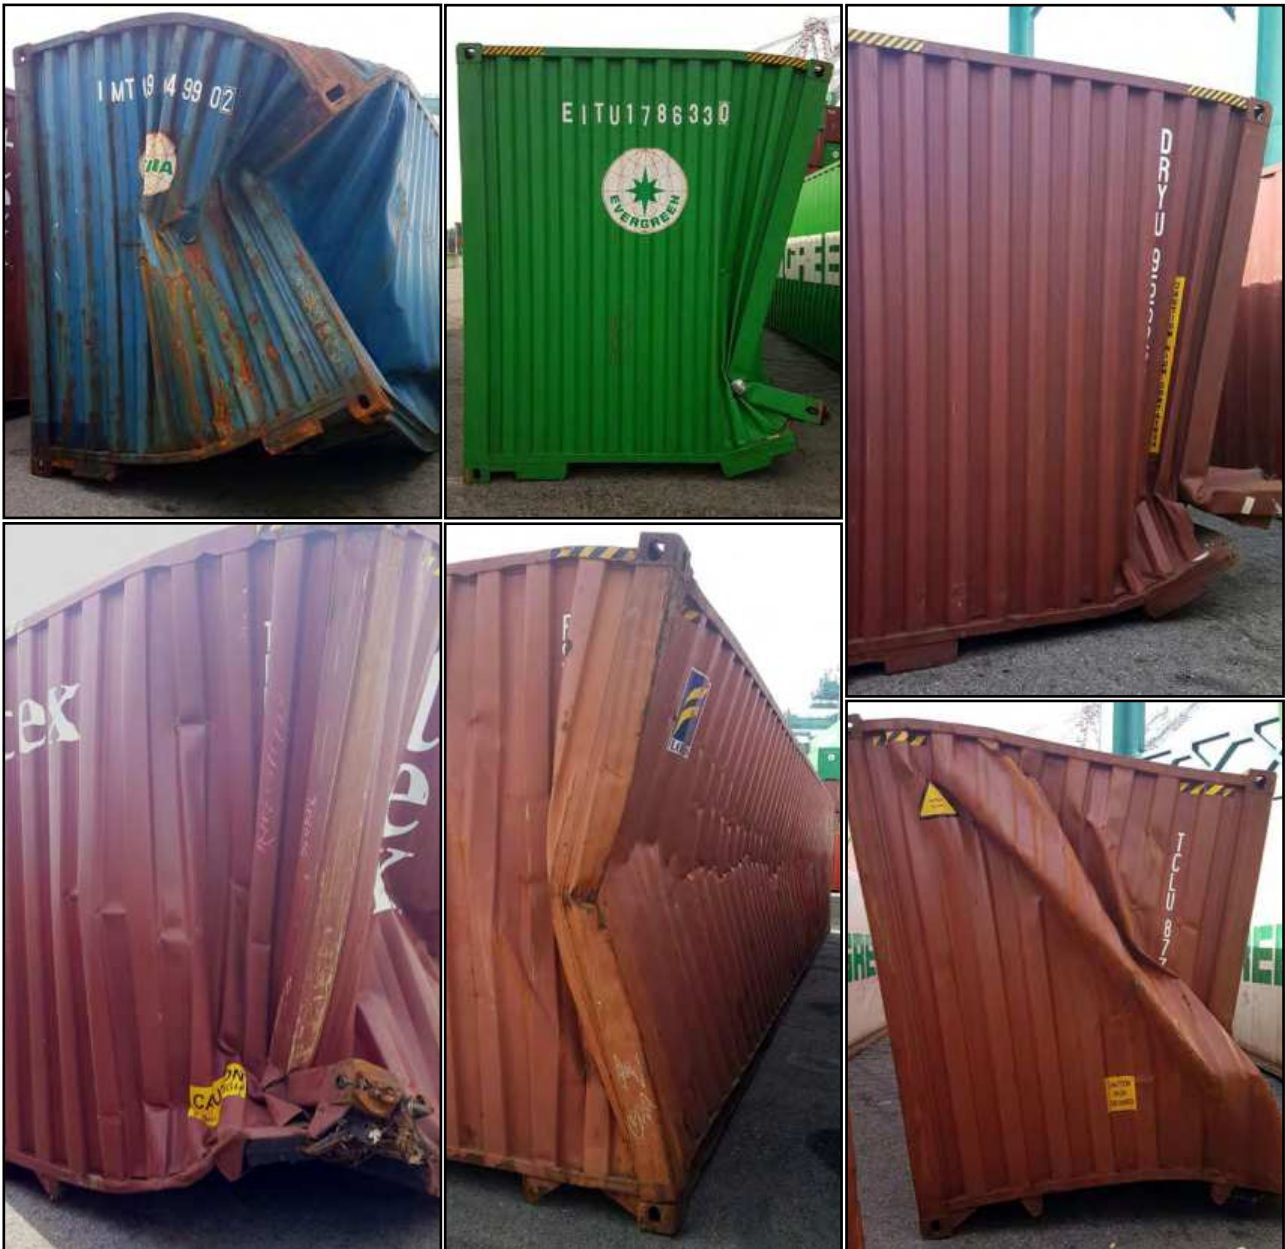
- Most of those stowed in the bottom two tiers had suffered varying degrees of buckling damage to the port forward corner posts (**Figure 21**).
- Some container side walls suffered creasing damage, mainly in line with the corner posts' buckles.

Figure 21: Damage to port forward corner posts of the containers stowed in Bay 70, tiers 1 and 2

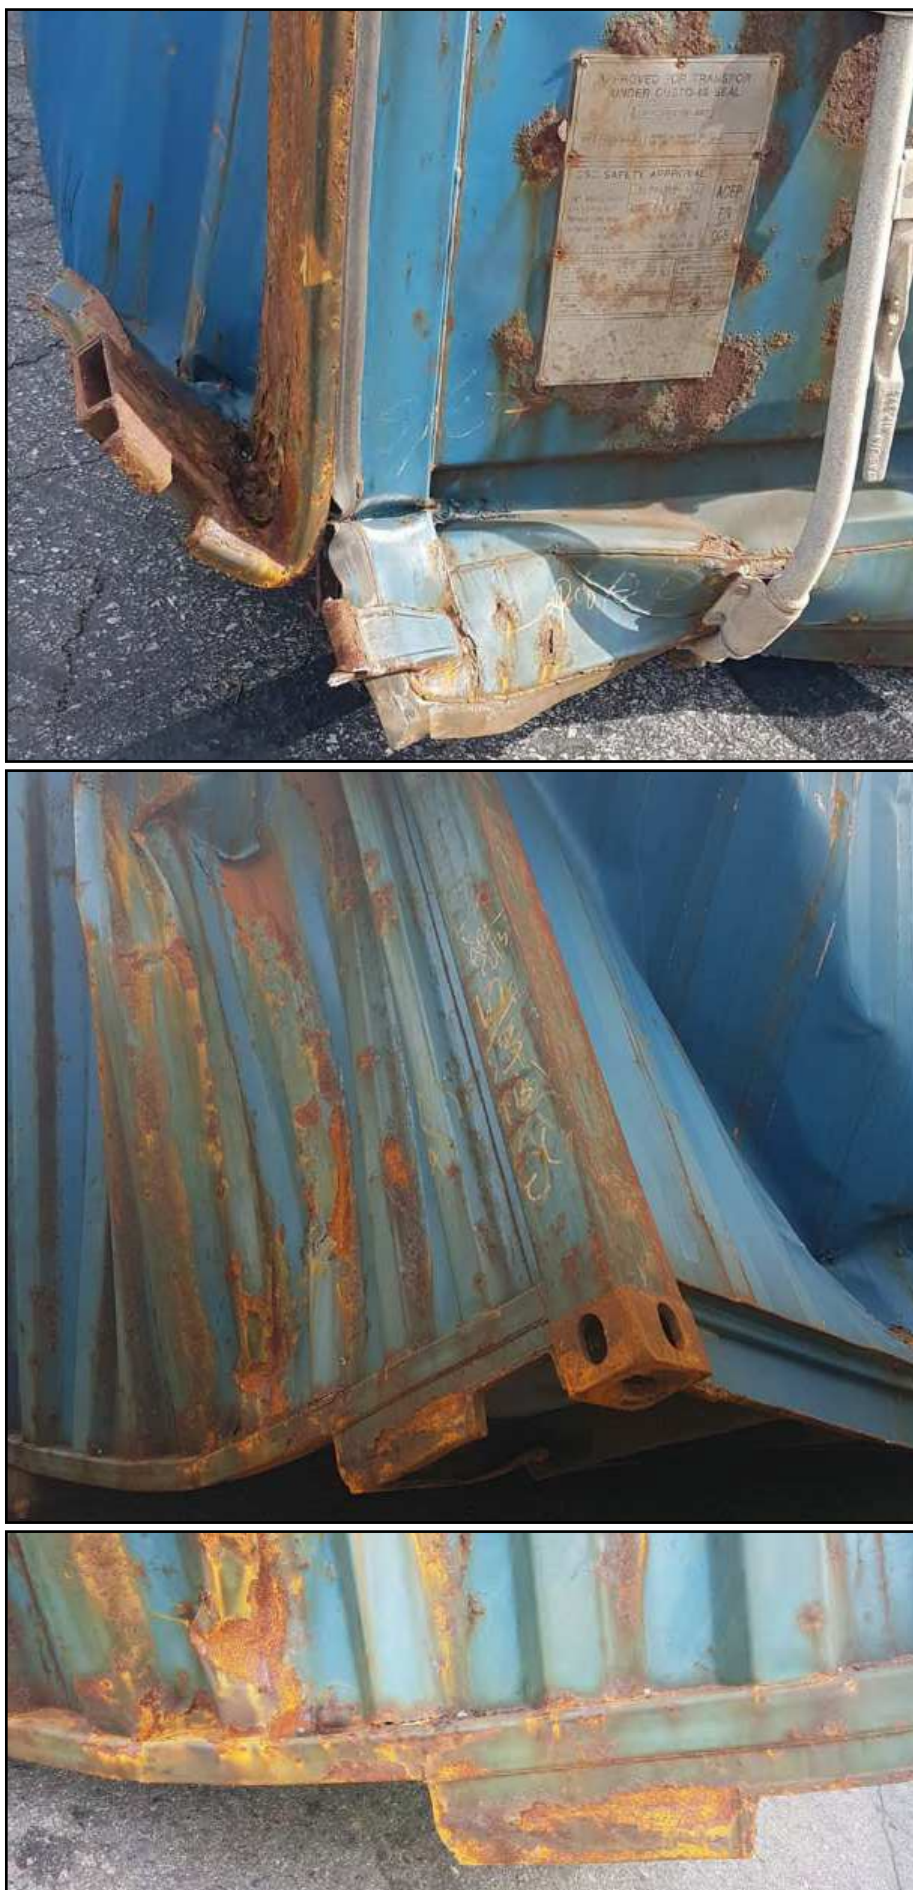
- Several corner castings had been torn from their corner posts.
- Patches of corrosion were visually apparent on the external walls of the container recovered from the bottom of the starboard outer stack (**Figure 22**).

Figure 22: Visually apparent level of corrosion to the container stowed at the bottom of Bay 70's starboard outer stack

All the containers recovered from *Ever Smart*'s bay 70 had CSC plates and documentation showing compliance with the ACEP. The bottom container in the starboard outer stack was last inspected on 20 August 2016 (**Figure 27**). It had suffered corrosion and structural damage during its working life and had weld repairs.

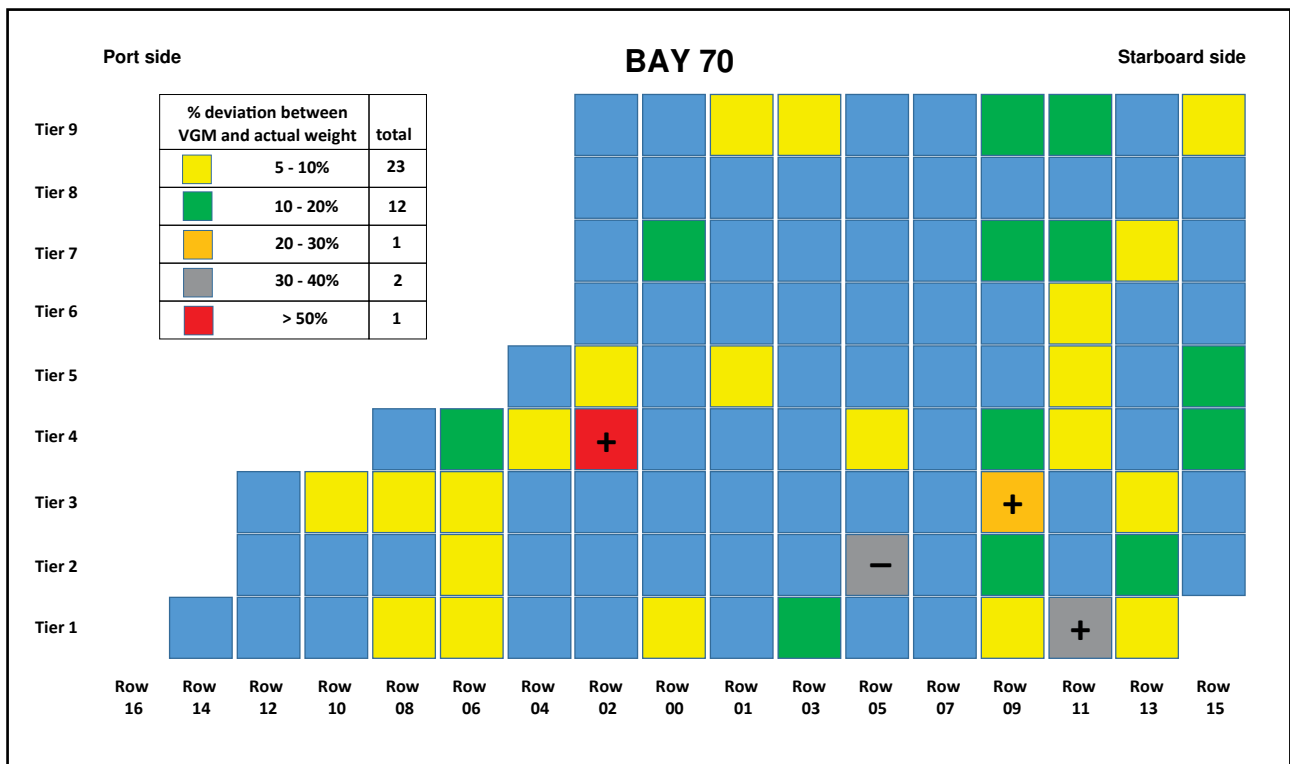
Figure 28: Locations of containers with declared and actual weight deviations greater than 5%

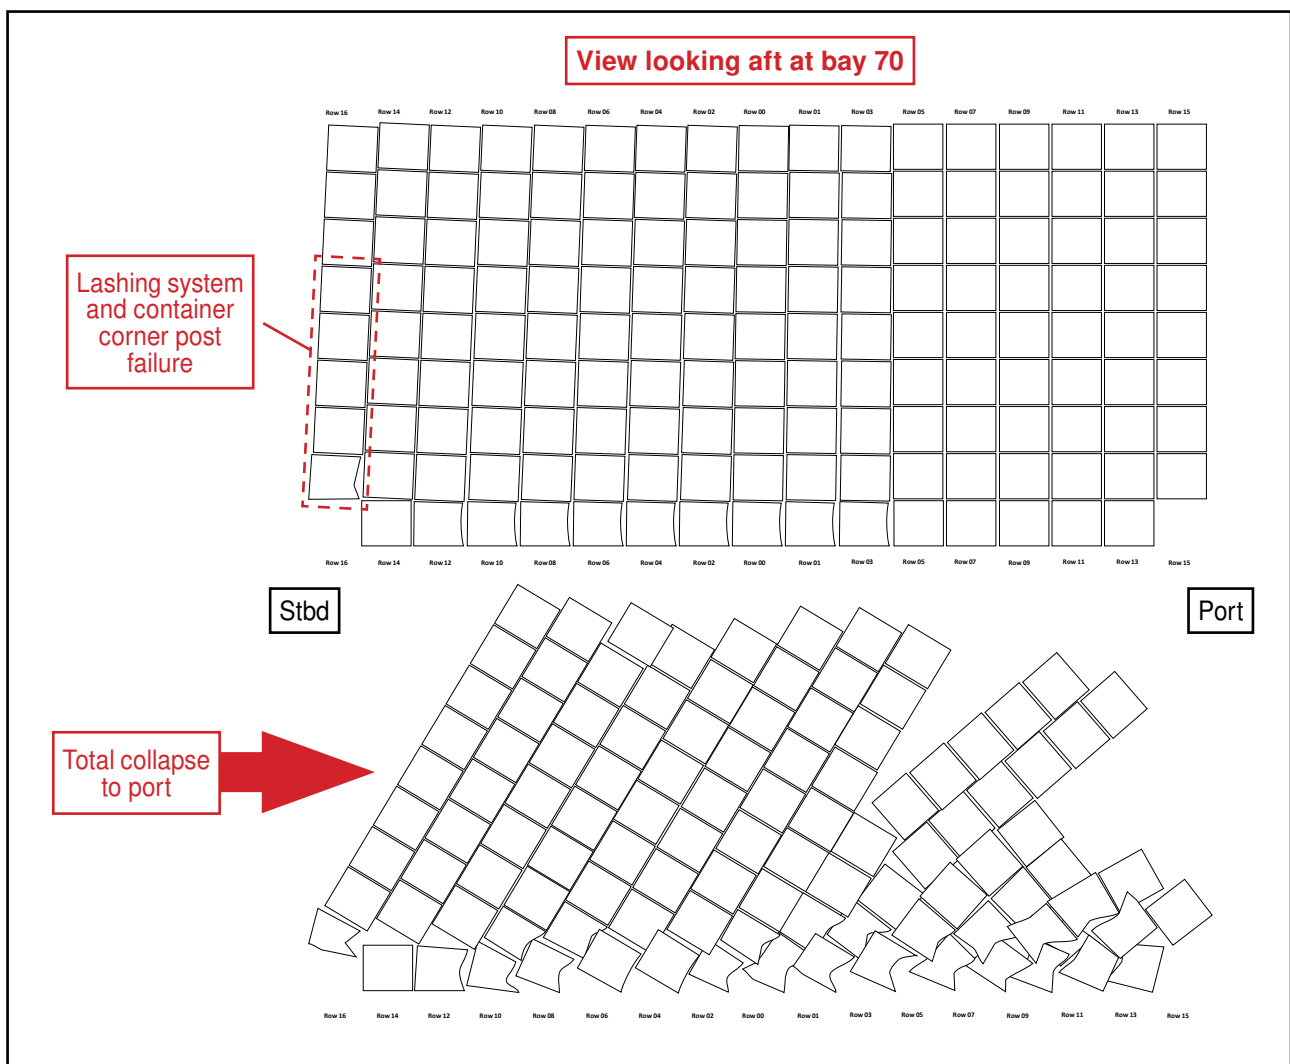
It was apparent that the collapse was initiated in bay 70's starboard outer stack (row 15) and propagated to port due to the forces created as the containers struck each other (**Figure 29**). The container at the bottom of the starboard outer stack was the only one that suffered significant structural damage. Its forward inboard corner post had buckled and its bottom aft outboard corner casting had torn free. The forward outboard twistlock had been pulled from its deck mounting. The containers in the adjacent row (row 13) suffered very little structural damage and toppled to port at tier 2 level. The port side corner posts at the forward ends of the tier 1 containers in the other stacks had all buckled and collapsed.

The evidence might suggest that the collapse was initiated by the structural failure of the bottom container in the starboard outer stack. However, rather than being the cause, the buckling of the container's corner post and the failure of its corner casting might have been the consequence of a lashing system or lashing equipment failure (**Figure 29**).

Figure 29: Likely sequence of the stowage collapse
