Report on the investigation of the loss of
42 containers from the container ship

Ever Smart

700 miles east of Japan, North Pacific Ocean

30 October 2017

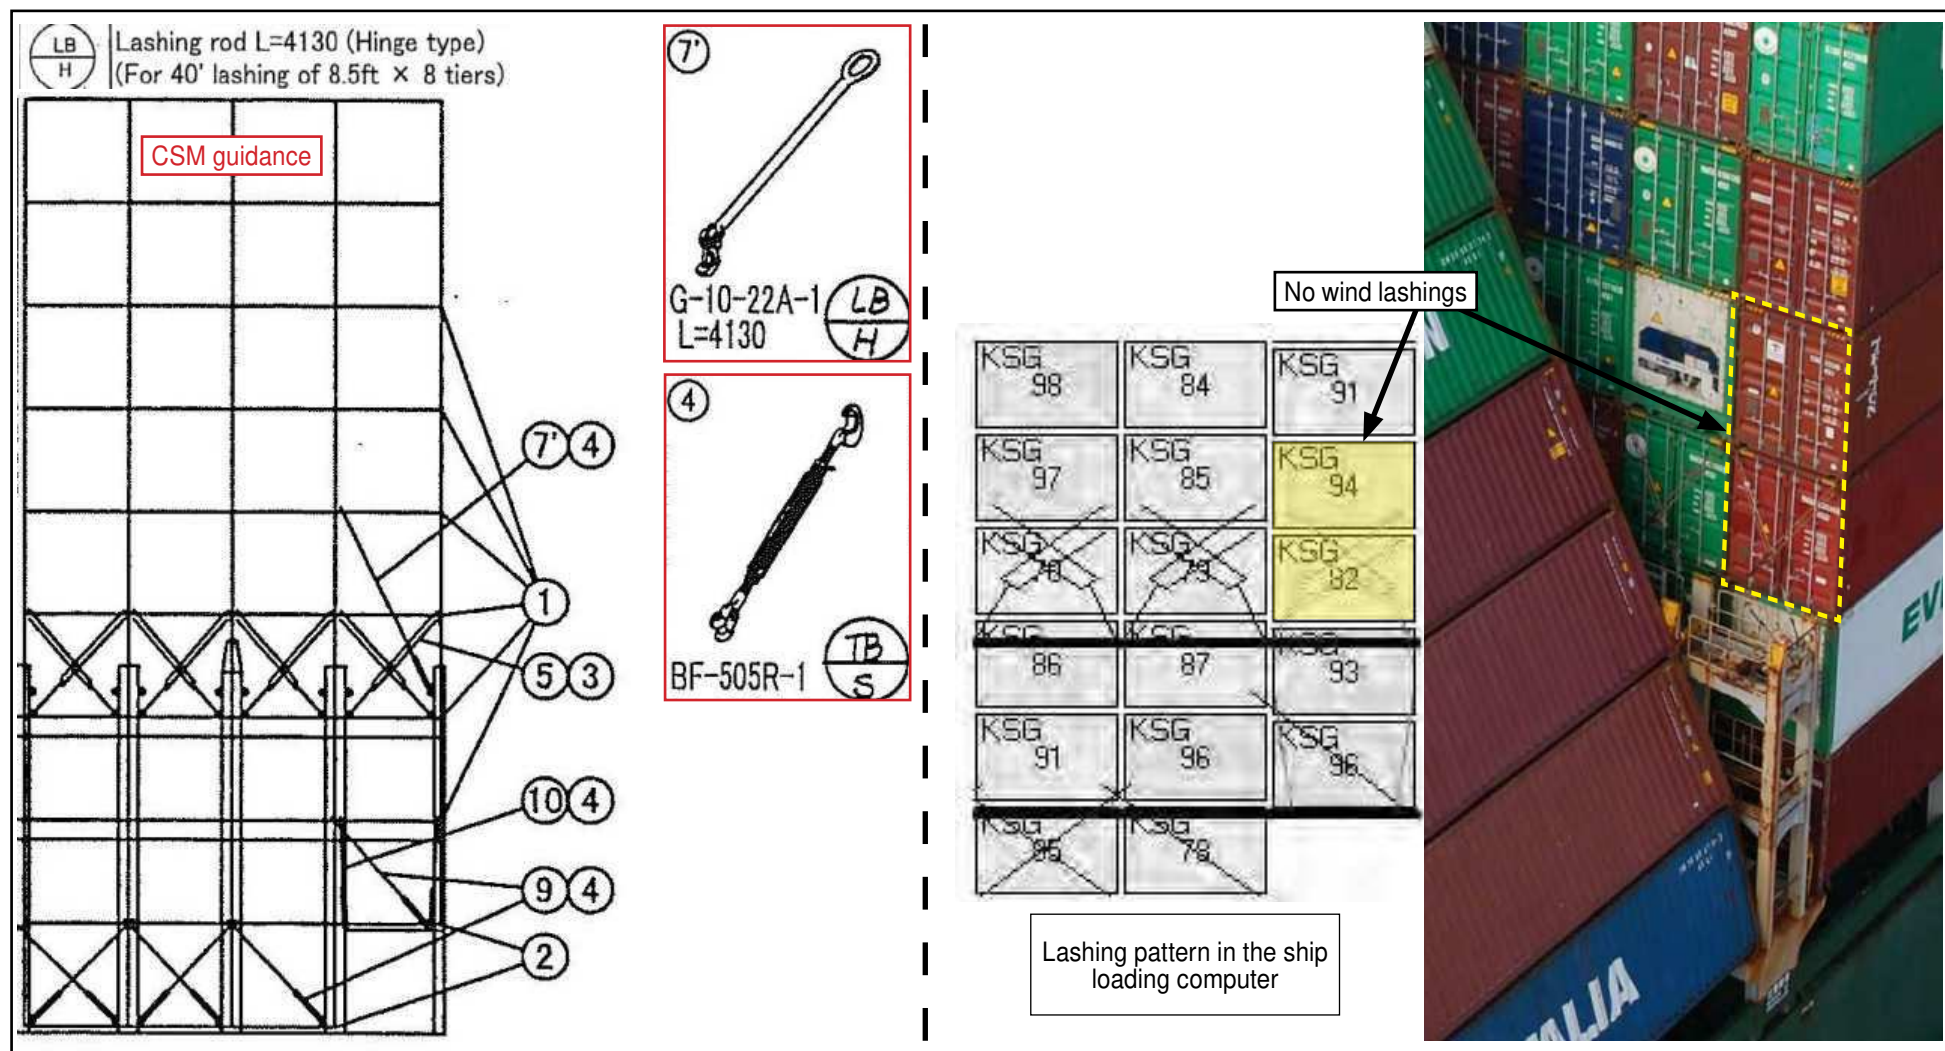
It is probable that the wind lashings had not been applied in the outer stacks of the stows aft of the accommodation block because the lashing rods were designed for standard 8'6" high containers and therefore were not long enough for a stack of hi-cube containers. This oversight would have reduced the effectiveness of the lashing system, particularly during strong winds.

Figure 31: Missing wind lashings at bay 70 and other bays aft of the accommodation block
