**Independent investigation into the grounding  
of the Chinese registered bulk carrier**

***Shen Neng 1***

**on Douglas Shoal, Queensland**

**3 April 2010**

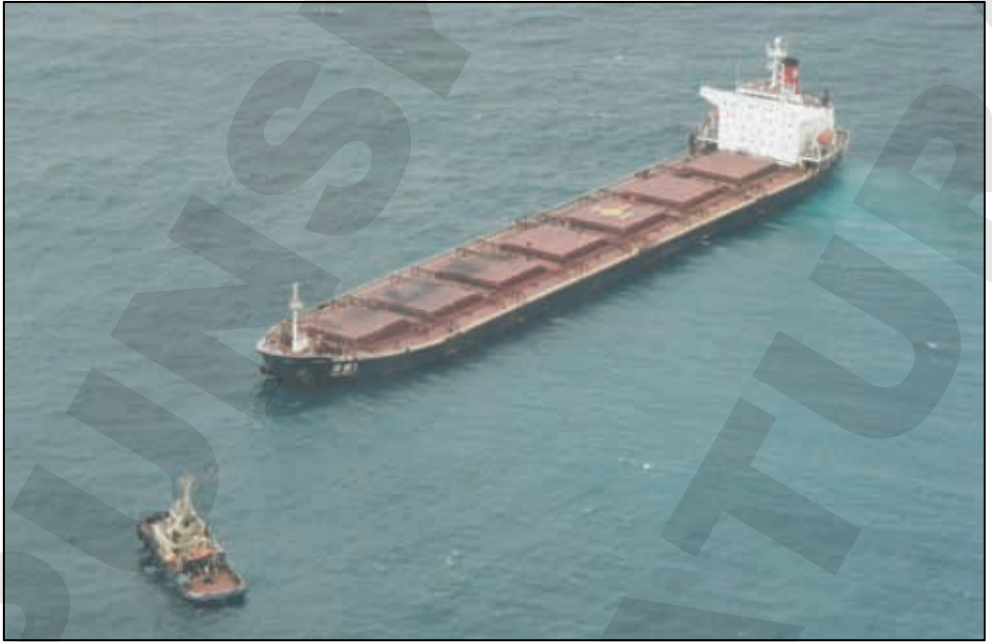
included trying to remove as much fuel oil from the ship as possible. The ship's hull was seriously damaged by the grounding, with the engine room and six water ballast and fuel oil tanks being breached, resulting in about 2½ tonnes of fuel oil being lost into the sea.

**Figure 1: *Shen Neng 1* aground on Douglas Shoal**

Between 29 April and 1 May, a more thorough underwater inspection of the damage was carried out while the ship was at anchor off Gladstone. The inspection revealed that the ship's bottom had suffered extensive plate damage. This damage comprised plate indentation, push-up, buckling and cracking. The rudder was slightly damaged but the propeller was not.

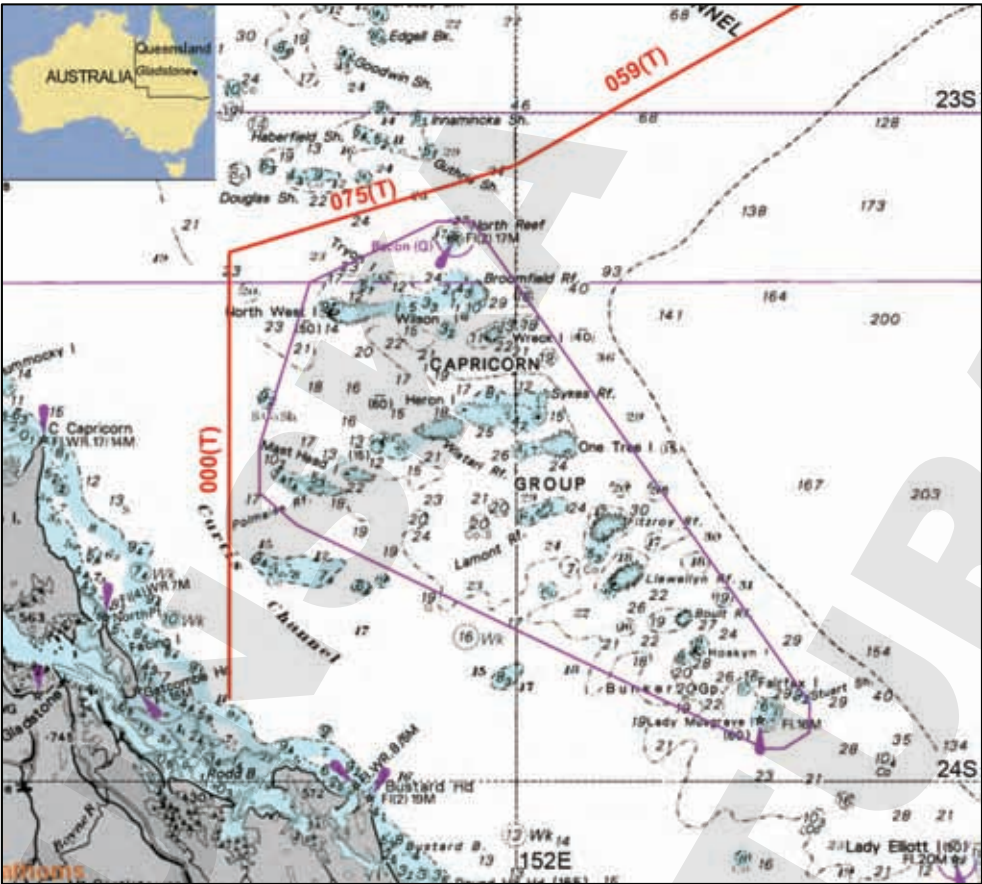
During the pilotage, the pilot noted from the chart that the master intended to steam north from the pilot boarding ground and exit the GBR area via the passage to the north of North West Island and North Reef (Figure 4).

**Figure 4: Shen Neng 1's intended passage from Gladstone**

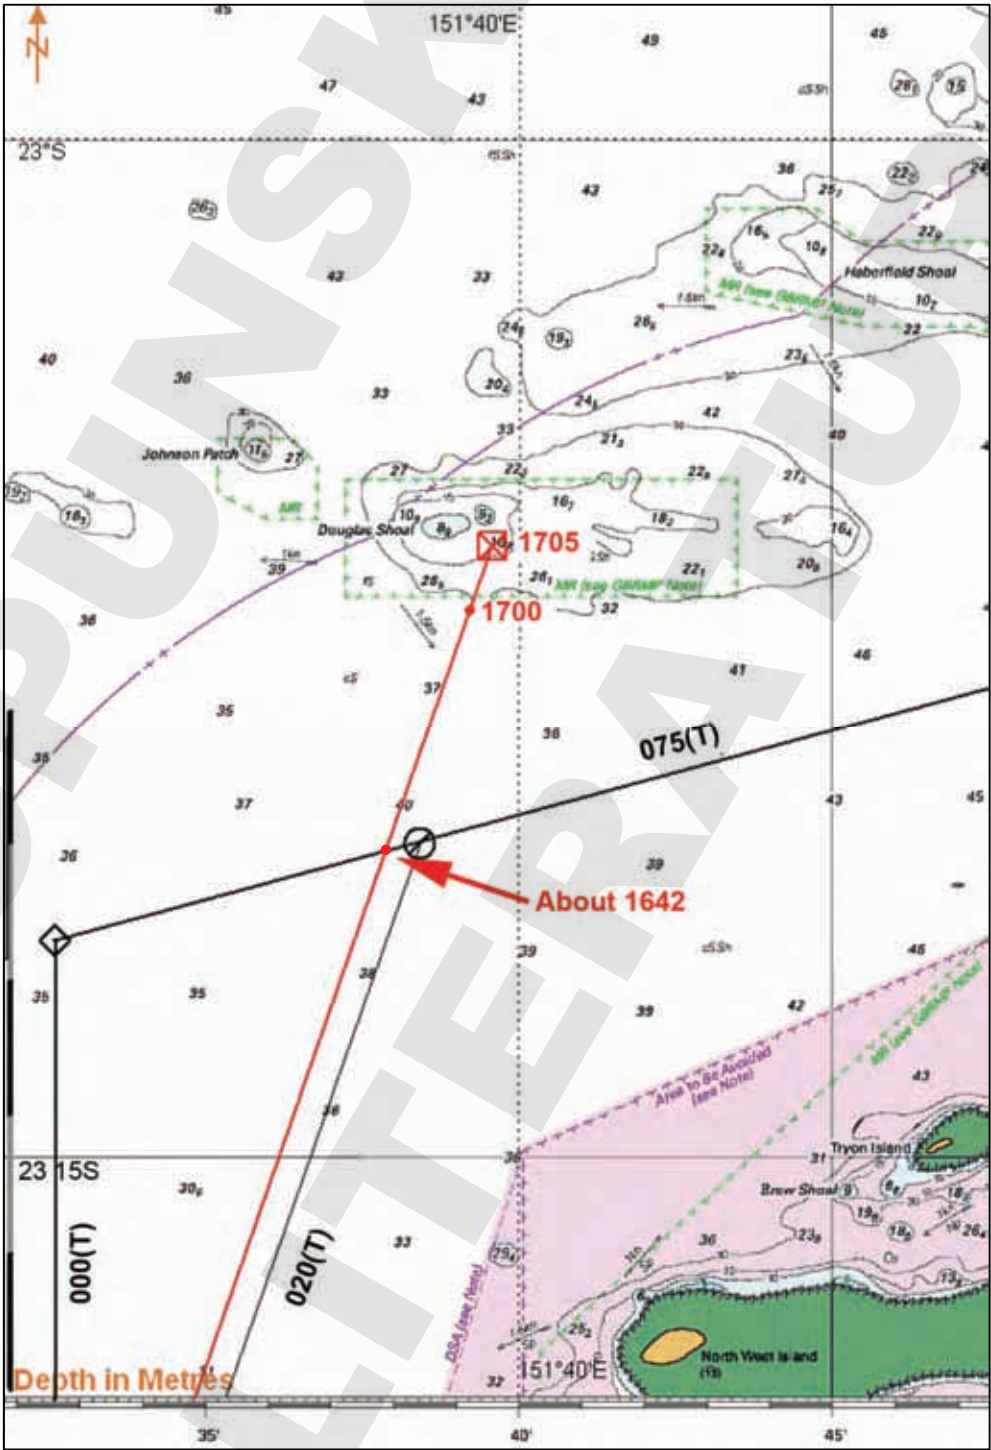
**Figure 6: Annotated section of navigational chart Aus 820 showing the original and amended route, and the ship's grounding position**

At about 1642, *Shen Neng 1* crossed the 075° (T) course line in the vicinity of the amended waypoint (Figure 6). On the ship's heading of 020° (T), Douglas Shoal was less than 5 miles ahead. The shoal, with a least depth of 8.9 m, gave no indication of its presence in the prevailing sea conditions.

By 1705, *Shen Neng 1* had come to a shuddering stop and grounded on a heading of 020° (T). The GPS unit indicated the position 23° 06.0'S 151° 39.6'E, close to a charted depth of 10.7 m on Douglas Shoal where the seabed is composed of coarse sand, shells and coral. It was almost low tide at Douglas Shoal.

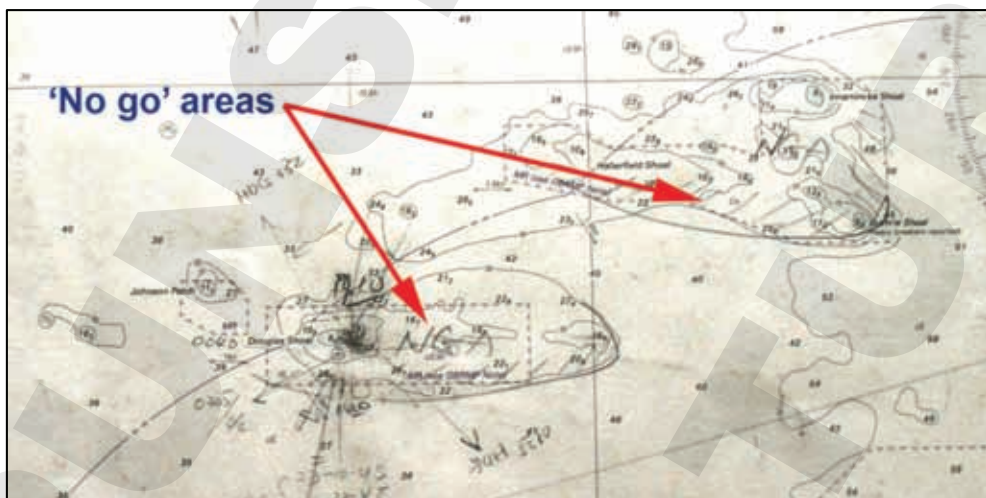
At about 1700, the chief mate recorded the GPS coordinates 23°07.0'S 151°39.2'E in the GPS log book. This position was not on chart Aus 819 and he took out chart Aus 820 from the chart table drawer so that he could plot the position. As he placed the chart on the chart table, he noticed the ship's speed had decreased to about 8 knots. He then saw the 'no go area' marked on the chart near the Marine Park boundary around Douglas Shoal and realised the ship was entering the boundary area and closing on the shoal (Figure 7).

**Figure 7: *Shen Neng 1*'s navigational chart Aus 820 showing the 'no go areas' marked around Douglas and Guthrie/Haberfield Shoals**

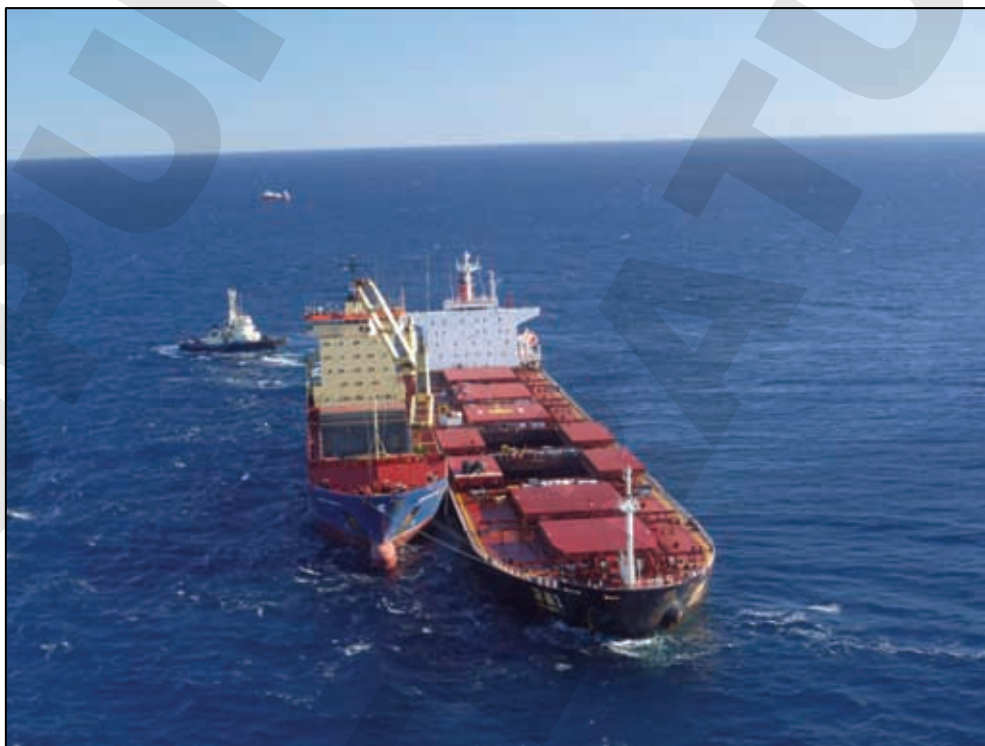
Between 9 and 12 May, *Shen Neng 1* was towed to Hervey Bay. Over the next 7 days, 19,000 tonnes of coal was offloaded into smaller ships (Figure 8). The salvors determined that, with the cargo removed, the ship could be safely towed to an overseas port for repairs.

**Figure 8: Coal offloading operations being conducted in Hervey Bay**

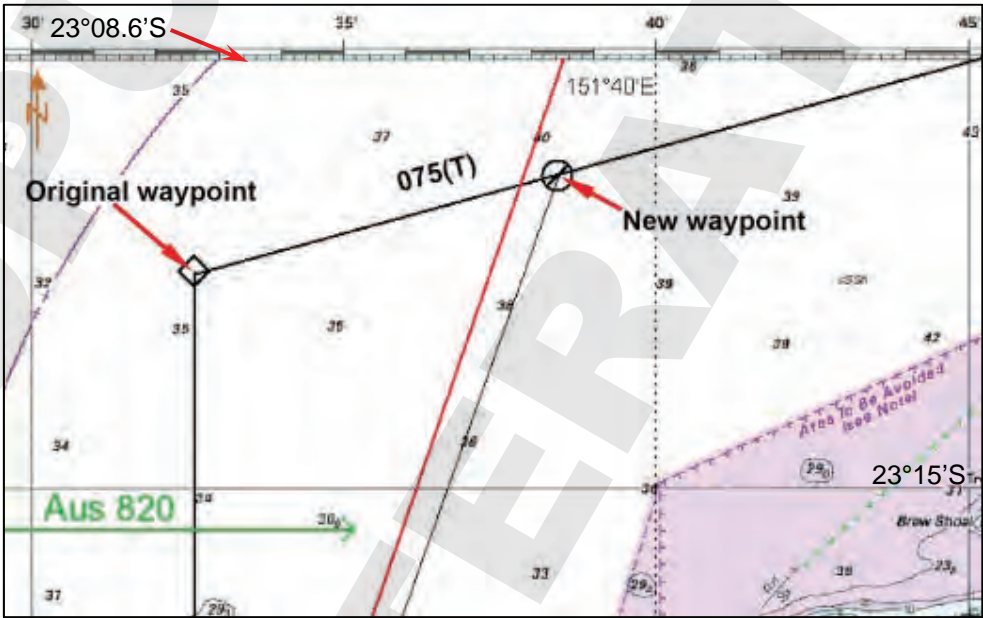
The northern limit of Aus 819 was  $23^{\circ} 08.6'S$ , about 2 miles north of North Reef. This latitude runs through the middle of the passage and does not show the sea area to the north (Figure 11). It is in this sea area that unmarked underwater navigation hazards exist. Consequently, officers who are unfamiliar with transiting the passage may not be aware of the shallow water that exists to the north of the chart's northerly limit.

**Figure 11: Annotated section of navigational chart Aus 819 showing the northern limit of the chart**

However, when *Shen Neng 1*'s chief mate took over the watch on 3 April, Aus 819 was on the chart table. While that chart was on the chart table, he could not identify the underwater dangers directly ahead of the ship as it followed the 020° (T) course.

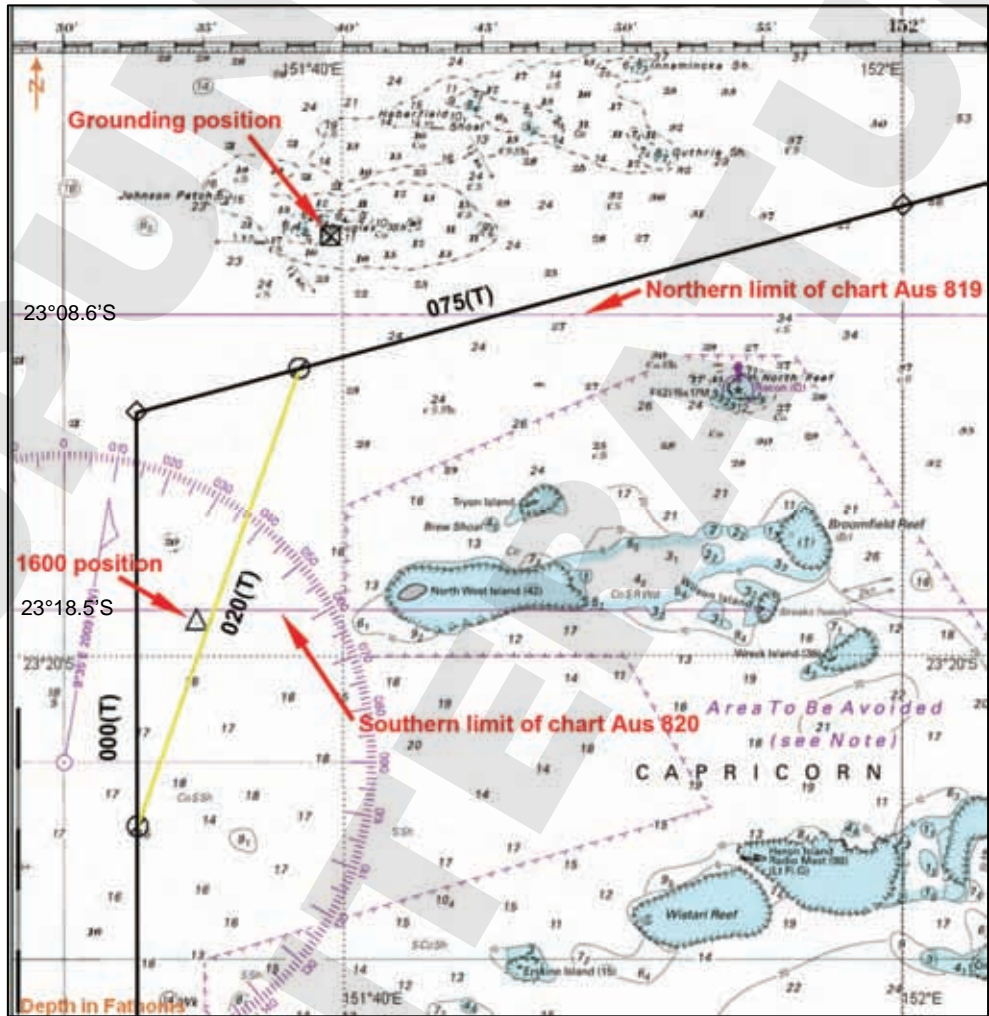
**Figure 12: Section of navigational chart Aus 366 showing the limit of charts Aus 819 and Aus 820**

By 1630, the ship would have travelled to a position where the most appropriate chart to use was Aus 820. However, no 1630 position was taken and so chart Aus 819 remained on the chart table until 1700. It was only then that the chief mate changed charts and saw the dangers ahead of the ship.

With respect to avoiding a recurrence of this failure to change to the appropriate chart, it should be noted that the only way this can be avoided from a systematic perspective is through use of the seamless coverage available when using Electronic Navigation Charts. Additionally, it is also worth noting that if the ship had been using an ECDIS and its safety depth/look-ahead function, alarms would have been raised well ahead of any grounding, even if the new course had not been entered into their navigation system.

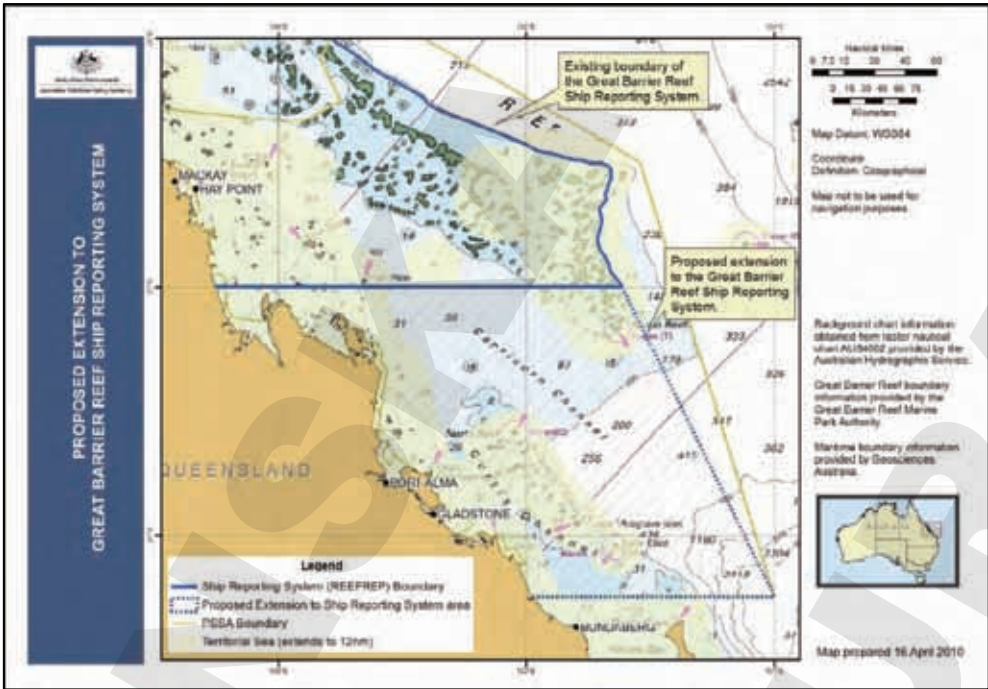
**Figure 13: Extension of REEFVTS coverage to the southern boundary of the PSSA**

In November 2010, the IMO agreed to AMSA's proposed extension of REEFVTS coverage to in the southern boundary of the PSSA.
