SAFETY INVESTIGATION REPORT

REPORT NO.: 01/2021

MV STARA PLANINA
Two manoverboards
in position 66° 05.0' N 005° 26.3' E,
02 January 2020

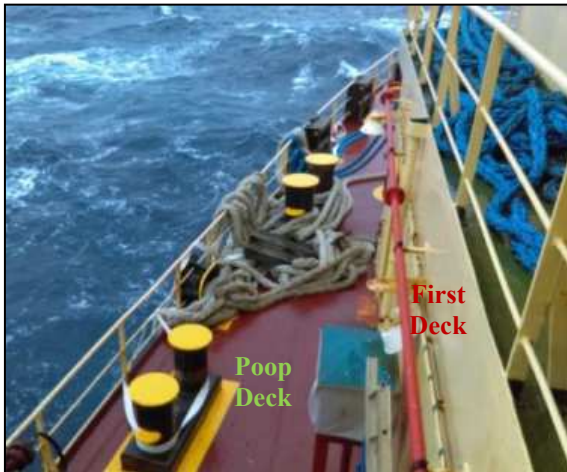
At around 1100, two ABs and the deck trainee arrived on the first deck to assist. The operation moved to the starboard side and, at one point, the deck trainee was seen on the poop deck assisting the chief officer. As the crew could not untangle two of the mooring ropes on the starboard side, the crew members secured them to the guard rails of the poop and first decks (Figure 4).

Figure 4: Situation on starboard side, two ropes secured to the railings of the poop deck, while the end of one of the ropes was hauled onto the first deck

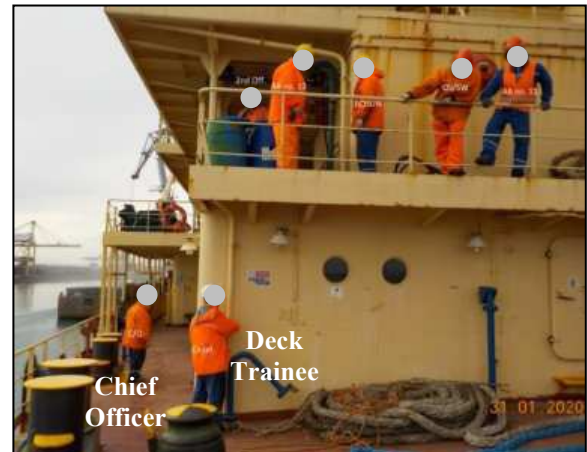
The crew reported that at this moment, a large wave suddenly washed over the poop deck from starboard to port sides. Unexpectedly, a second larger wave washed on board from the same direction and within seconds of the first one. Both the chief officer and the deck trainee were swept overboard. Figure 5 shows the position of the crew members at the time of the accident.

Figure 5: Simulation of the crew's location when the waves washed over the poop deck

Reports from various witnesses indicated that when the first wave struck on board, the deck trainee had proceeded to hold onto a drainpipe, while the chief officer had already made his way to the port side towards the ladder. However, soon after the second wave struck, several crew members noticed orange, winter jackets floating in the water. It soon became clear that both the chief officer and the deck trainee had been washed overboard.

Two consecutive, unexpected large waves (the second one reportedly larger than the first), washed over the poop deck where the chief officer and the deck trainee were located. Reportedly, both crew members were not secured to the vessel, given that the securing operation of the mooring ropes had been completed.

The safety investigation hypothesized that a sudden roll of the vessel was possibly induced by the waves. Furthermore, the force of the wave itself may have been too strong for the chief officer and the deck trainee to react, leading to their fall overboard.

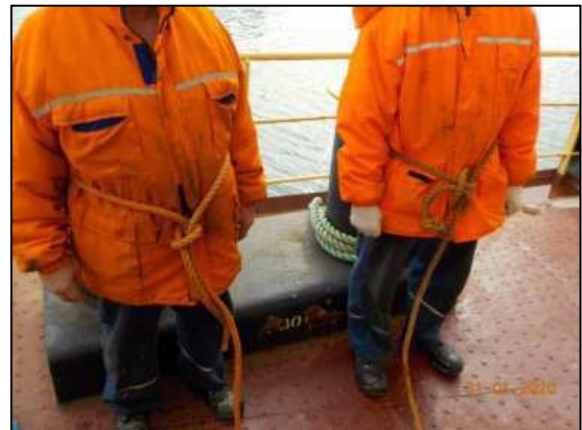
and the deck trainee had ropes tied around their waists (Figure 6). Most of the crew members could not confirm whether the other end of their rope was secured to the vessel during the recovery of the mooring ropes. One of the crew members stated that the rope was not secured to any part of the vessel, as the other end was noticed lying free on deck. Another crew member stated that the chief officer and the deck trainee were tied together with the same rope.

However, all crew members confirmed that when the two large waves washed over the poop deck, both the chief officer and the deck trainee were not secured to any part of the vessel⁶

Figure 6: Simulation of how the rope was tied around the chief officer's and deck trainee's waists

The crew used ropes around their waists. Although the plan to secure oneself had been put in practice, this did not provide the necessary protection to the two crew members. A fall of a crew member from a height, while being secured with a rope, would result in internal/external injuries in the abdominal region and back. A safety harness is designed to prevent such injuries¹³.
