# National Transportation Safety Board

## Marine Accident Brief

### Collision between Bulk Carrier *Century Queen* and Towing Vessel *Kaytlin Marie*

<b>Accident type</b>	Collision	<b>No.</b> DCA19FM038
<b>Vessel names</b>	<i>Century Queen</i> and <i>Kaytlin Marie</i>	
<b>Location</b>	Lower Mississippi River, mile 126, near Hahnville, Louisiana <sup>1</sup> 29°59.47'N, 090°25.17'W	
<b>Date</b>	June 8, 2019	
<b>Time</b>	1215 central daylight-saving time (coordinated universal time – 5 hours)	
<b>Injuries</b>	Two minor, one serious	
<b>Property damage</b>	\$1,375,198	
<b>Environmental damage</b>	About 8,954 gallons of diesel fuel released	
<b>Weather</b>	Visibility 10 miles, winds north-northwest 4 mph, air temperature 88°F	
<b>Waterway information</b>	The Mississippi River at the accident site is approximately half a mile wide. The nearest river gage (mile 126.9) was 20.95 feet and rising.

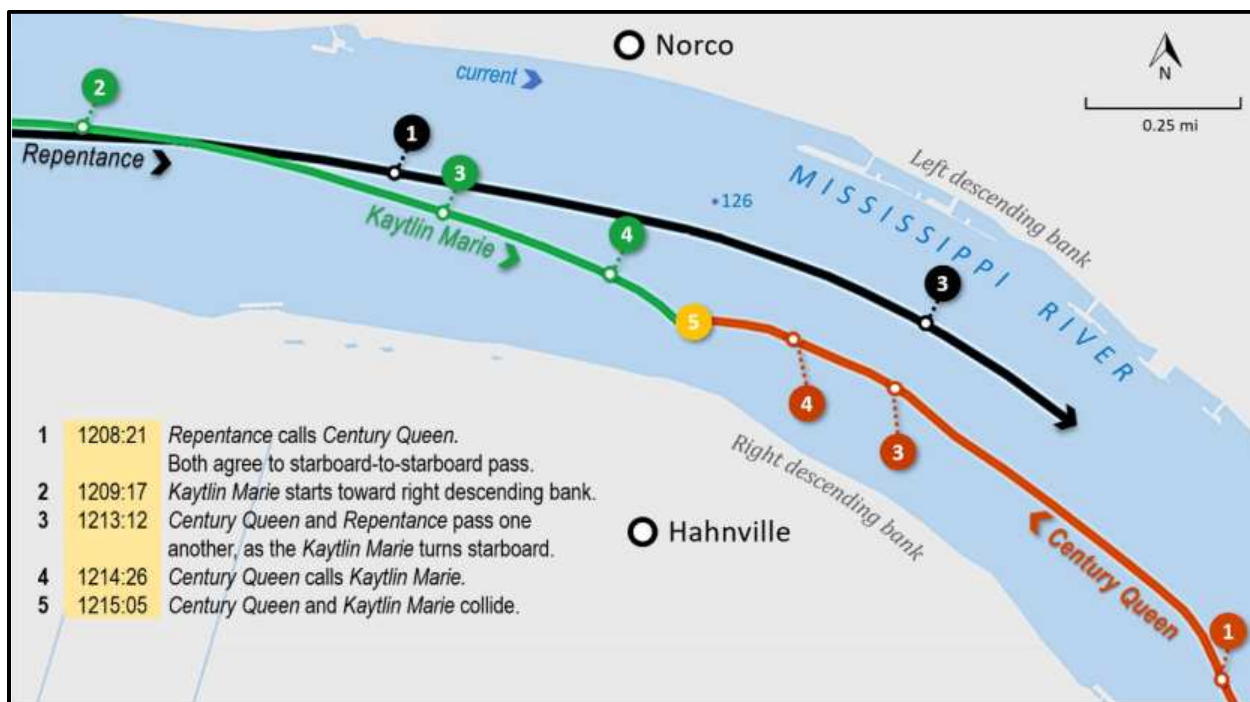
Tracklines of the vessels during the last 7 minutes prior to the collision. The *Century Queen* is represented in red, the *Kaytlin Marie* in green, and the *Repentance* in black. (Background source: Google Maps)

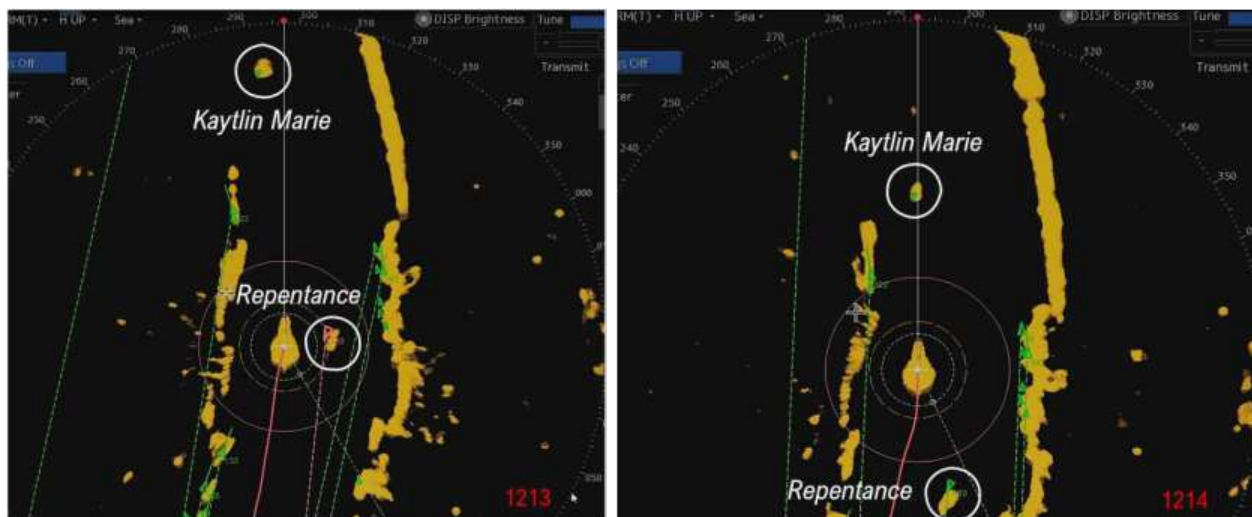
After passing the *Repentance*, the bulk carrier continued to make incremental course changes to port. At 1213:40, the pilot on the *Century Queen* ordered the rudder to port 5°. The *Kaytlin Marie* had altered course to starboard another 10° in the previous minute, toward the right descending bank, as the towboat and bulk carrier headed almost directly toward each other.

Screenshots of the *Century Queen*'s radar on a 0.75 nautical mile scale on a head-up display. The *Kaytlin Marie* is shown fine-to-port at 1213 (left) and dead ahead with a port bow aspect at 1214 (right). The *Repentance*'s position is also identified.

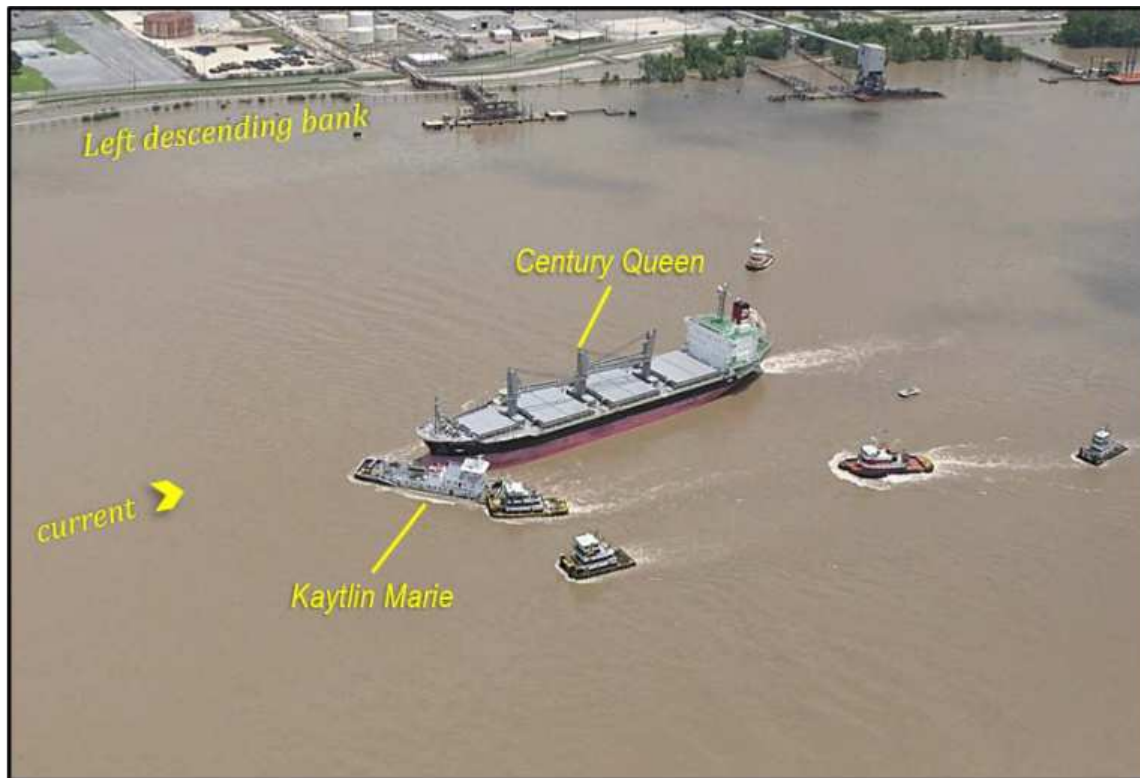
At 1215:08, the *Century Queen*'s bulbous bow struck the *Kaytlin Marie* amidships at about a 90° angle. The towboat's number 4 and 5 port fuel tanks outboard of the engine room were holed. Eventually, an estimated 8,954 gallons of marine diesel oil were released into the river. The cover to the port aft slop tank was dislodged; an unknown amount of waste oil was released as well. The engine room, whose windows were shattered, was at risk of flooding through an open starboard (up-current) door. A cleat on the port side that had caught on the damaged bow of the bulk carrier prevented the towboat from capsizing, as the *Kaytlin Marie* was pushed sideways up-current until both vessels came to a stop. The *Century Queen*'s bulbous bow was torn open for approximately 6 feet, and the void space was filled with river water and the released diesel fuel.

**Both vessels shortly after the collision (Source: US Coast Guard)**

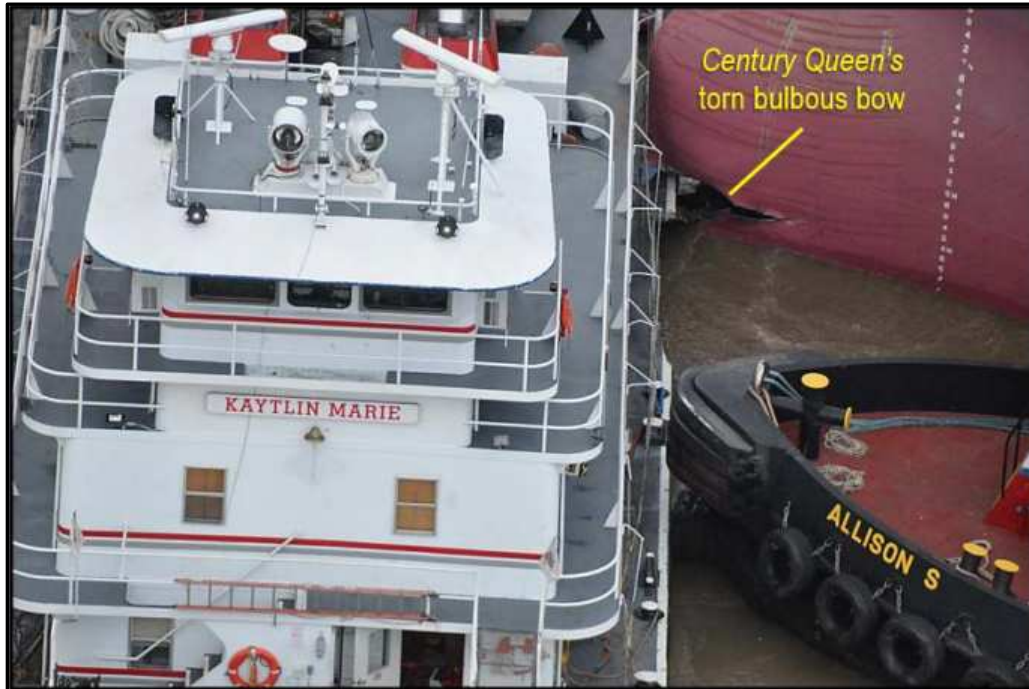
*Kaytlin Marie* embedded in the *Century Queen*'s bulbous bow. (Source: Coast Guard)

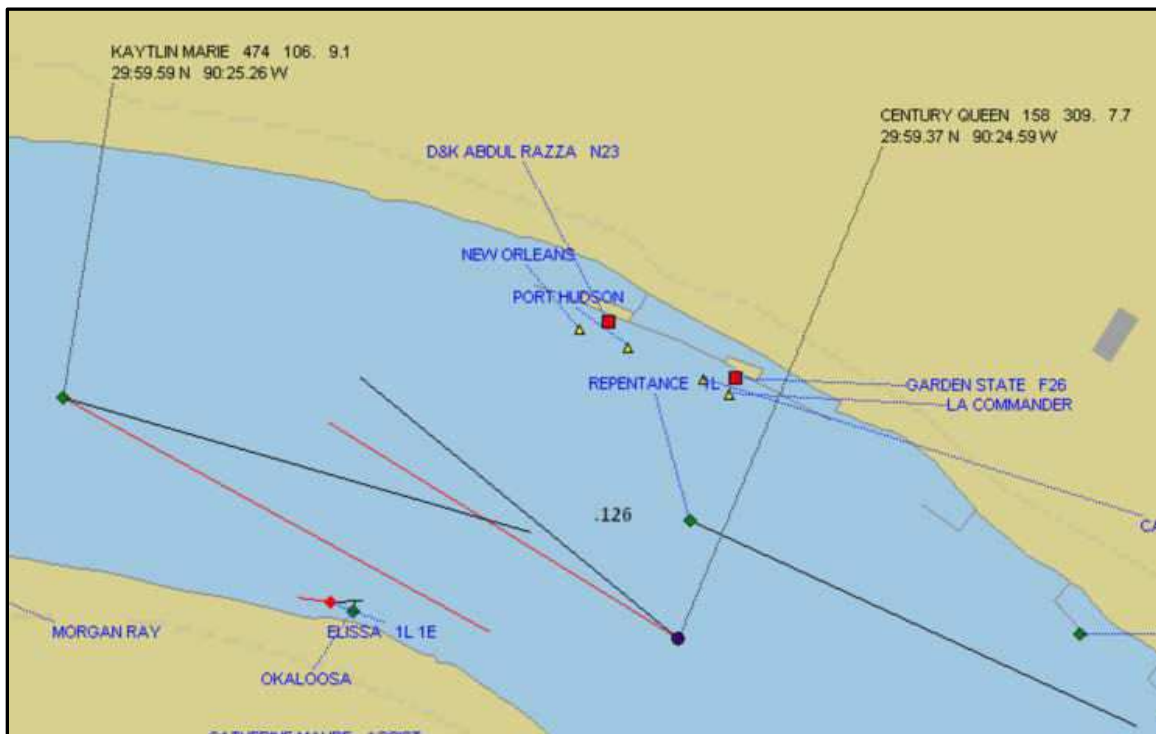
Screenshot of the VTS Ports and Waterways Safety System (PAWSS) tracking the *Century Queen* and *Kaytlin Marie* at 1213. Red vectors indicate the vessels' heading, and black vectors indicate their course over ground.

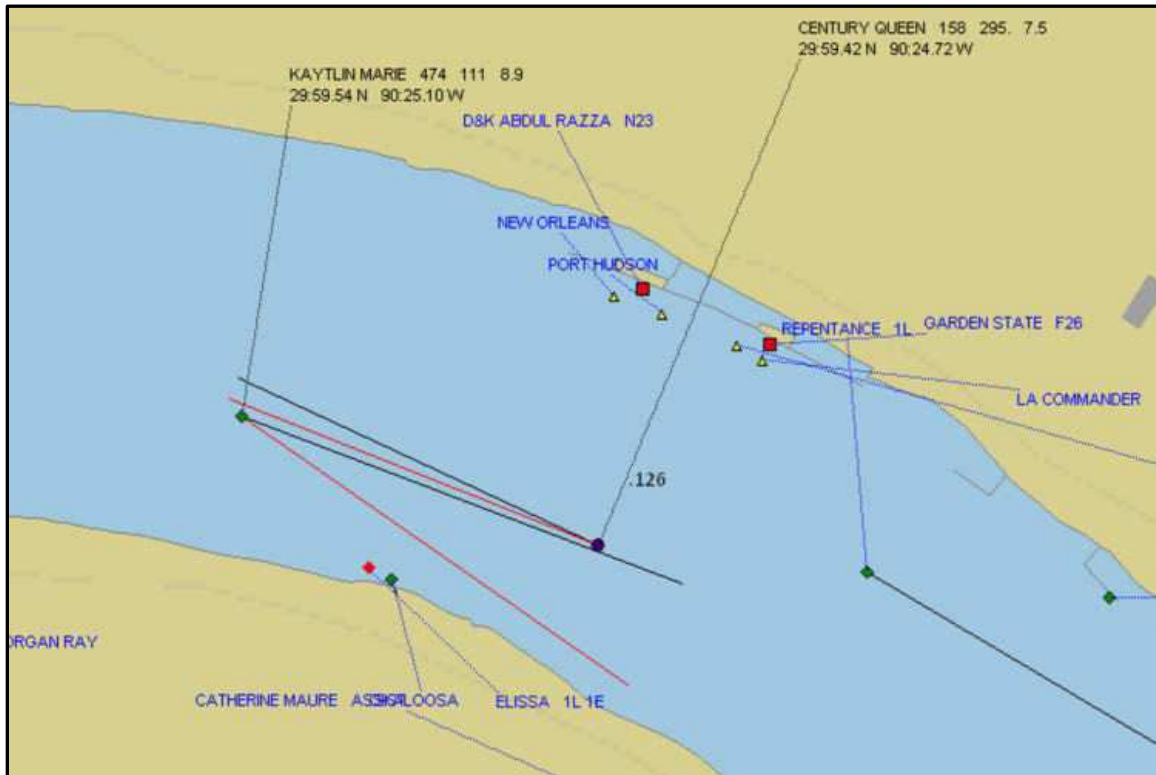
Screenshot of VTS' PAWSS at 1214. The *Century Queen* had altered course 14° towards to port in the previous minute.
