Report on the investigation of  
the death of a third officer struck by a freight vehicle  
on the stern ramp of the ro-ro freight ferry

## ***Seatruck Progress***

Brocklebank Dock, Liverpool

15 May 2019

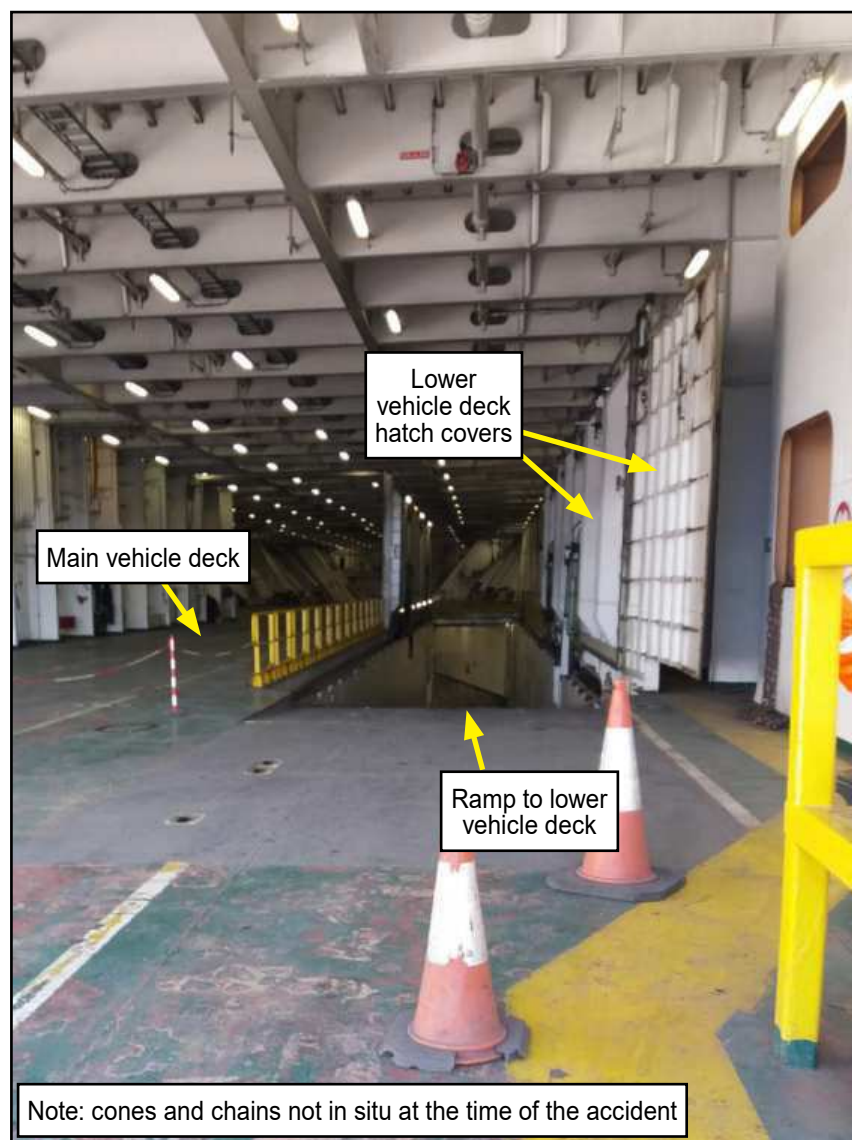
**Figure 3:** Ramp from main to lower vehicle deck post-accident (hatch covers open)

The 3/O returned to the CCR and left the outgoing master's car keys on the desk. He then chatted briefly with both chief officers and was asked by the relieving chief officer to oversee cargo operations while he went to his cabin and changed into working clothes. The 3/O also collected the key to the relieving master's car, which required moving on board from the quayside. By about 1900, the main vehicle deck was almost clear of cargo and the 3/O opened the hatch covers over the lower vehicle deck ramp on the main vehicle deck's starboard side (**Figure 3**).

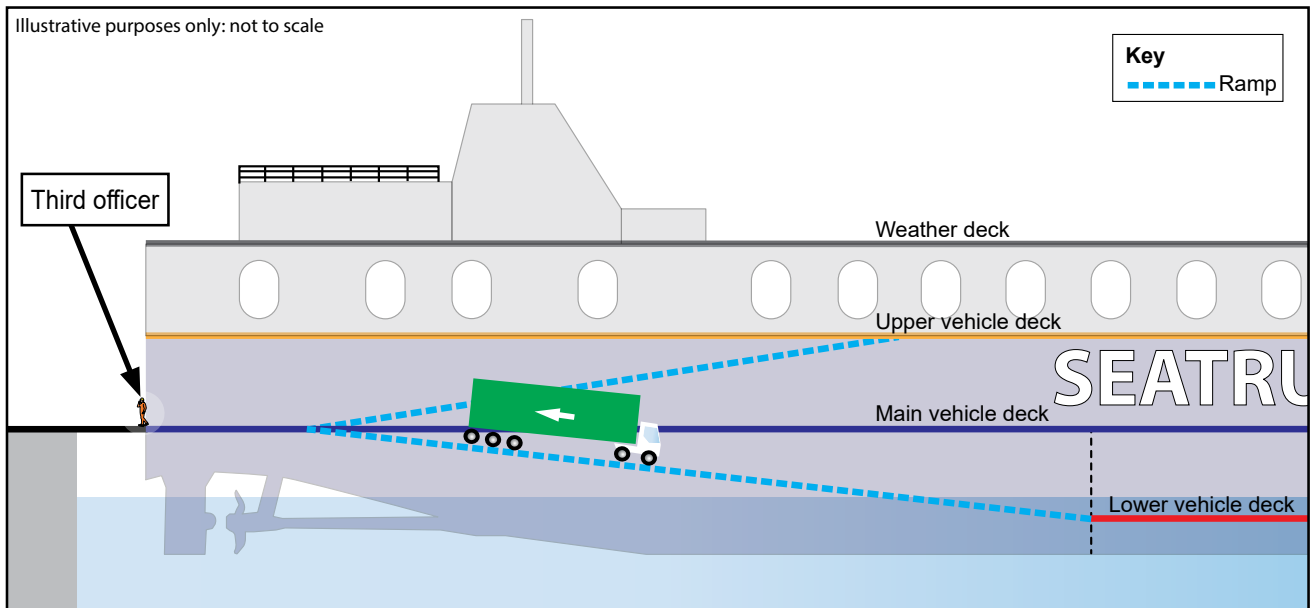
**Figure 4a:** Route from lower vehicle deck to stern ramp – semi-trailer and tractor unit on lower vehicle deck ramp

When pushing the semi-trailer from the lower to the main vehicle deck (**Figures 4a and 4b**), the tractor driver had to keep the semi-trailer in a straight line between the sides of the lower deck ramp. A slight alteration to the right was made towards the top of the ramp to avoid hitting a protective barrier around the stern ramp's starboard hydraulic ram. It was also noted that when transiting down the stern ramp, the semi-trailer was kept parallel and close to the starboard side (**Figure 9**).

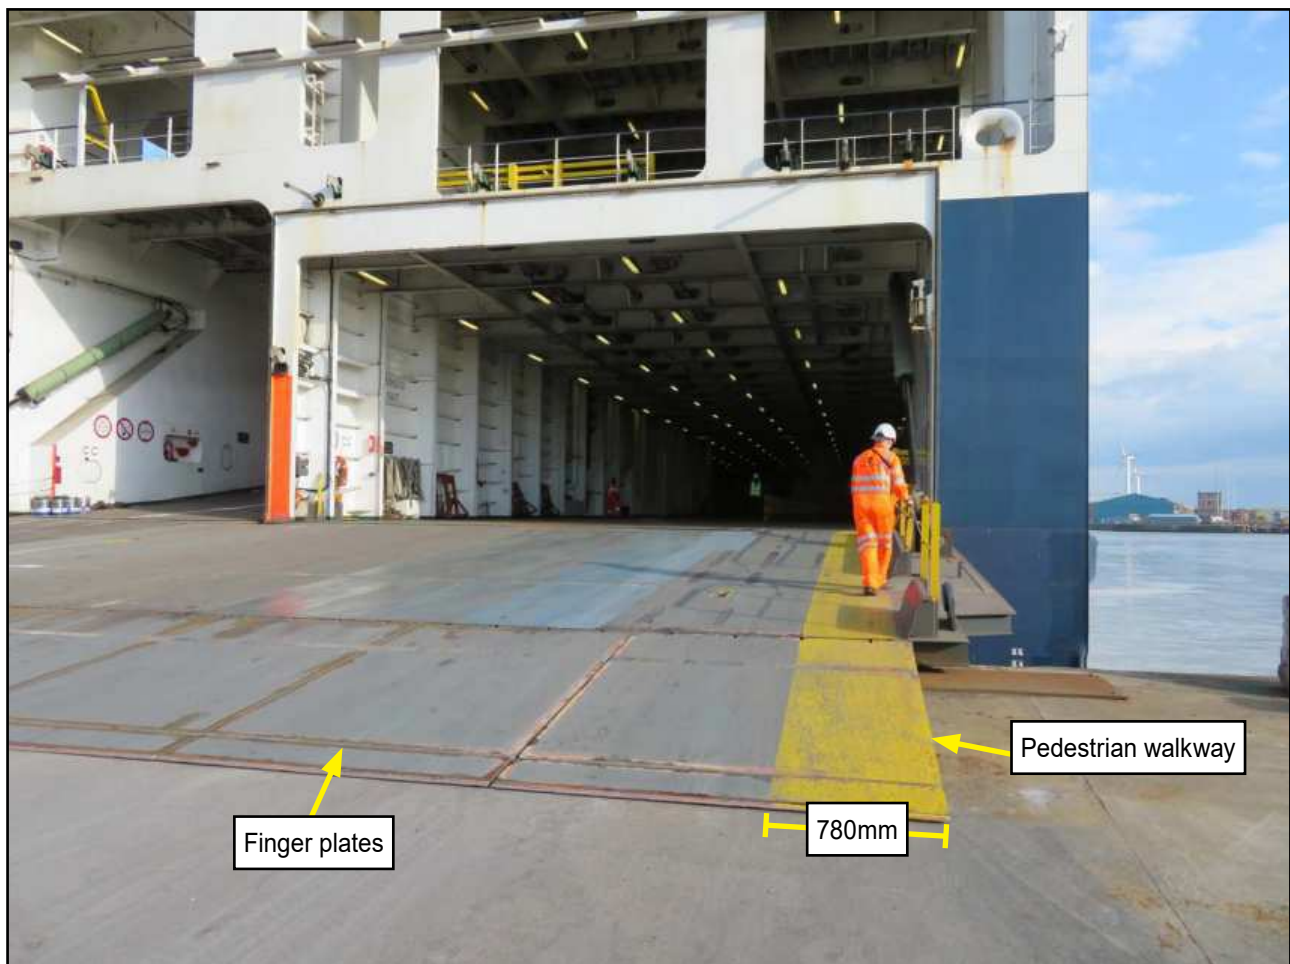
**Figure 7:** The stern ramp and painted pedestrian walkway

There were no locally produced onboard instructions concerning safe access to the ship. There were no signs, instructions or out of bounds areas for pedestrians marked near the ship's stern ramp, but a 780mm wide yellow line from the finger plates to the main vehicle deck was painted on the starboard edge (Figure 7). The line was an extension of an escape route marked on the main vehicle deck and indicated a walkway on the stern ramp. It was also intended to assist drivers in keeping vehicles clear of the stern ramp's starboard hydraulic ram. There was no corresponding line marked on the port side of the stern ramp. Markings on the starboard edge of the stern ramps on sister vessels managed by Seatruck varied between similar solid lines and painted footprints.

- Painted walkways on vehicle ramps and decks that are not protected are liable to be encroached upon by vehicles and are not safe unless other measures to control pedestrian access and vehicular traffic are also implemented. They are even less safe if they are not used.

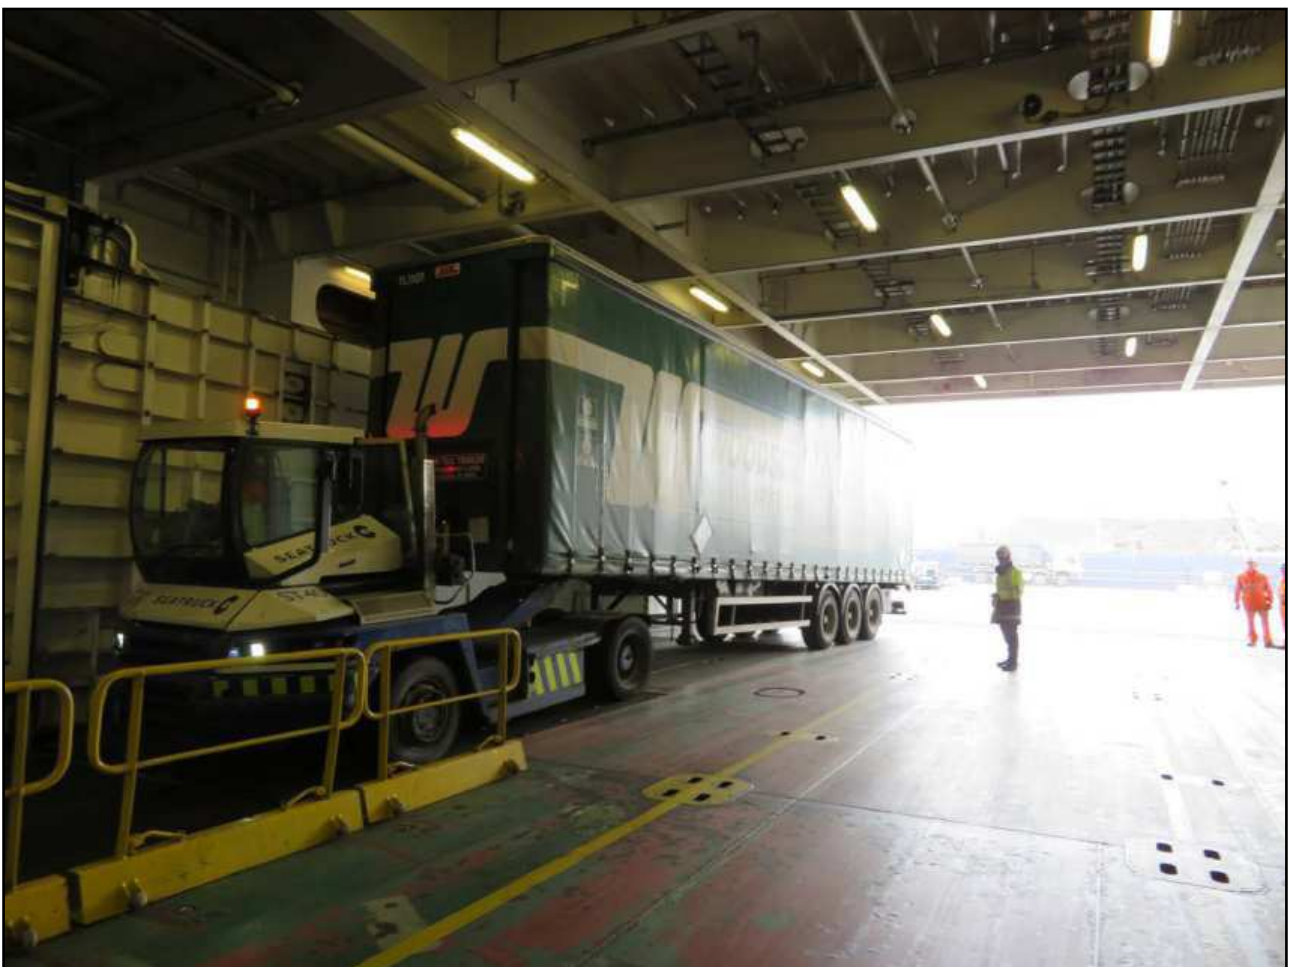
**Figure 8:** Vehicle handling reconstruction on board *Seatruck Power*

On 18 May 2019, MAIB inspectors observed a semi-trailer being pushed ashore from the lower vehicle deck of a sister vessel, *Seatruck Power* (**Figure 8**). The purpose of the reconstruction was to gain a clear understanding of the driving method, observe the path of the semi-trailer and tractor, and to gauge the effectiveness of the tractor's visual and audible warning devices. Earlier examination had already confirmed that the audible and visual warning devices fitted to the tractor involved in the accident on 15 May had been operating correctly.

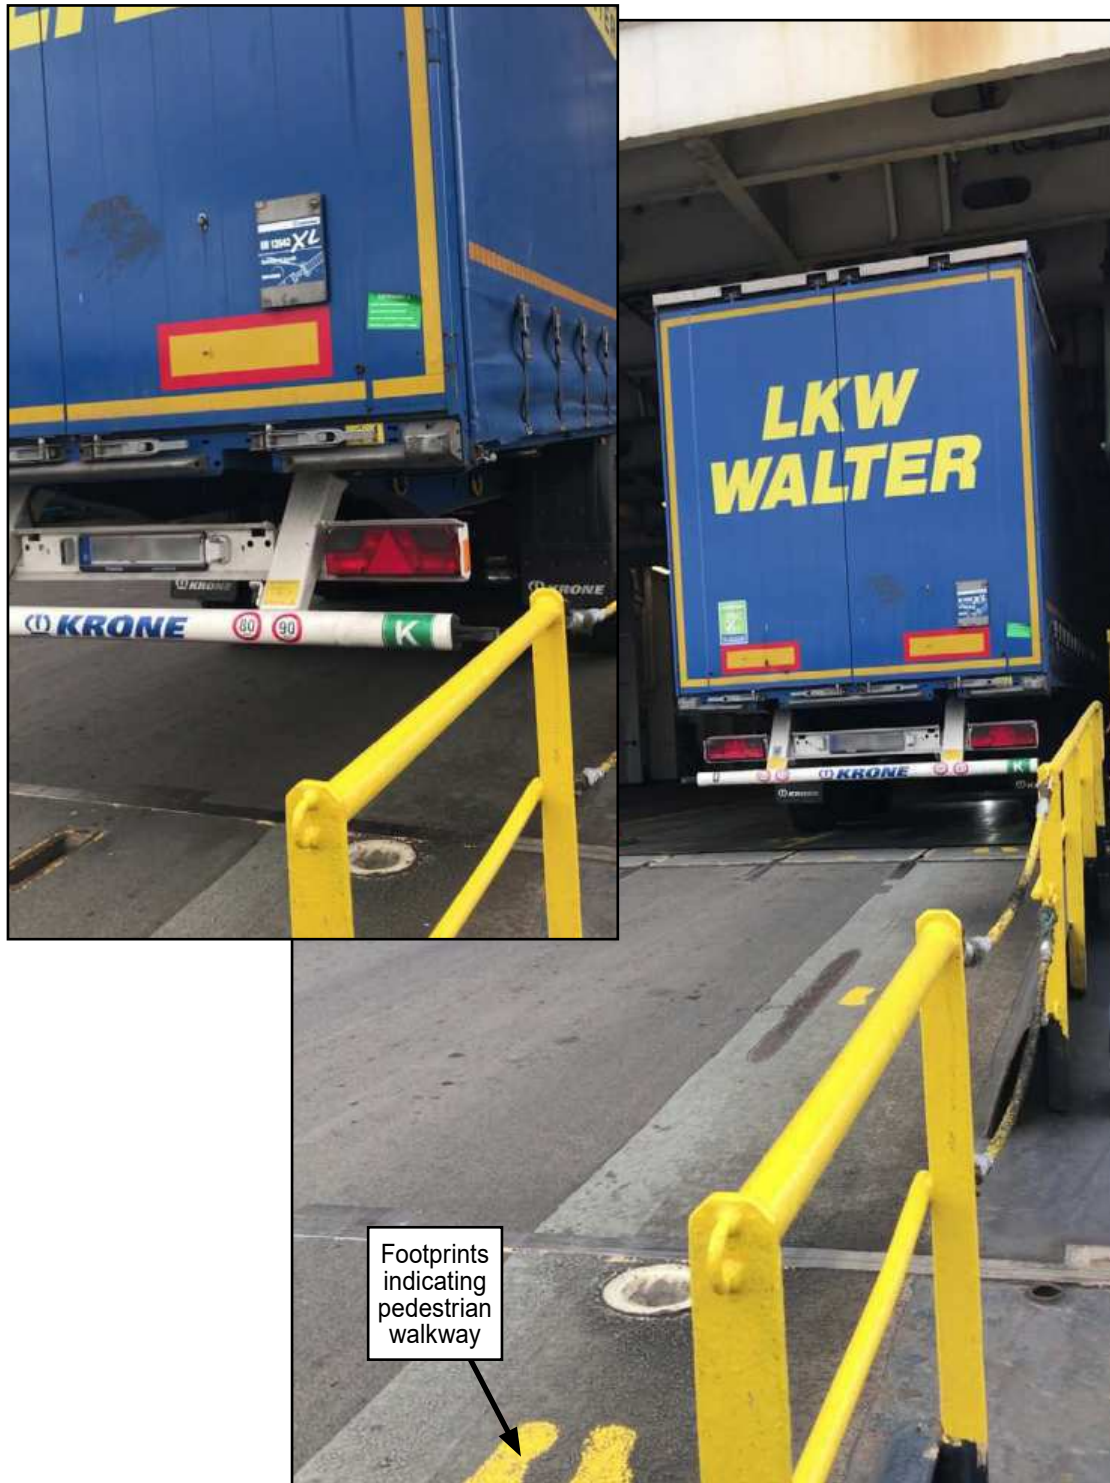
**Figure 9:** Semi-trailer being pushed down stern ramp during reconstruction (18 May 2019) on board *Seatruck Power*

The noise from the tractor's engine as the semi-trailer approached was difficult to distinguish when standing at the bottom of the stern ramp. The tractor's audible reversing and pushing alarm could not be heard until the back end (free end) of the semi-trailer drew level with the observer's position. The tractor's orange flashing warning beacon was obscured by the semi-trailer and could not be seen.

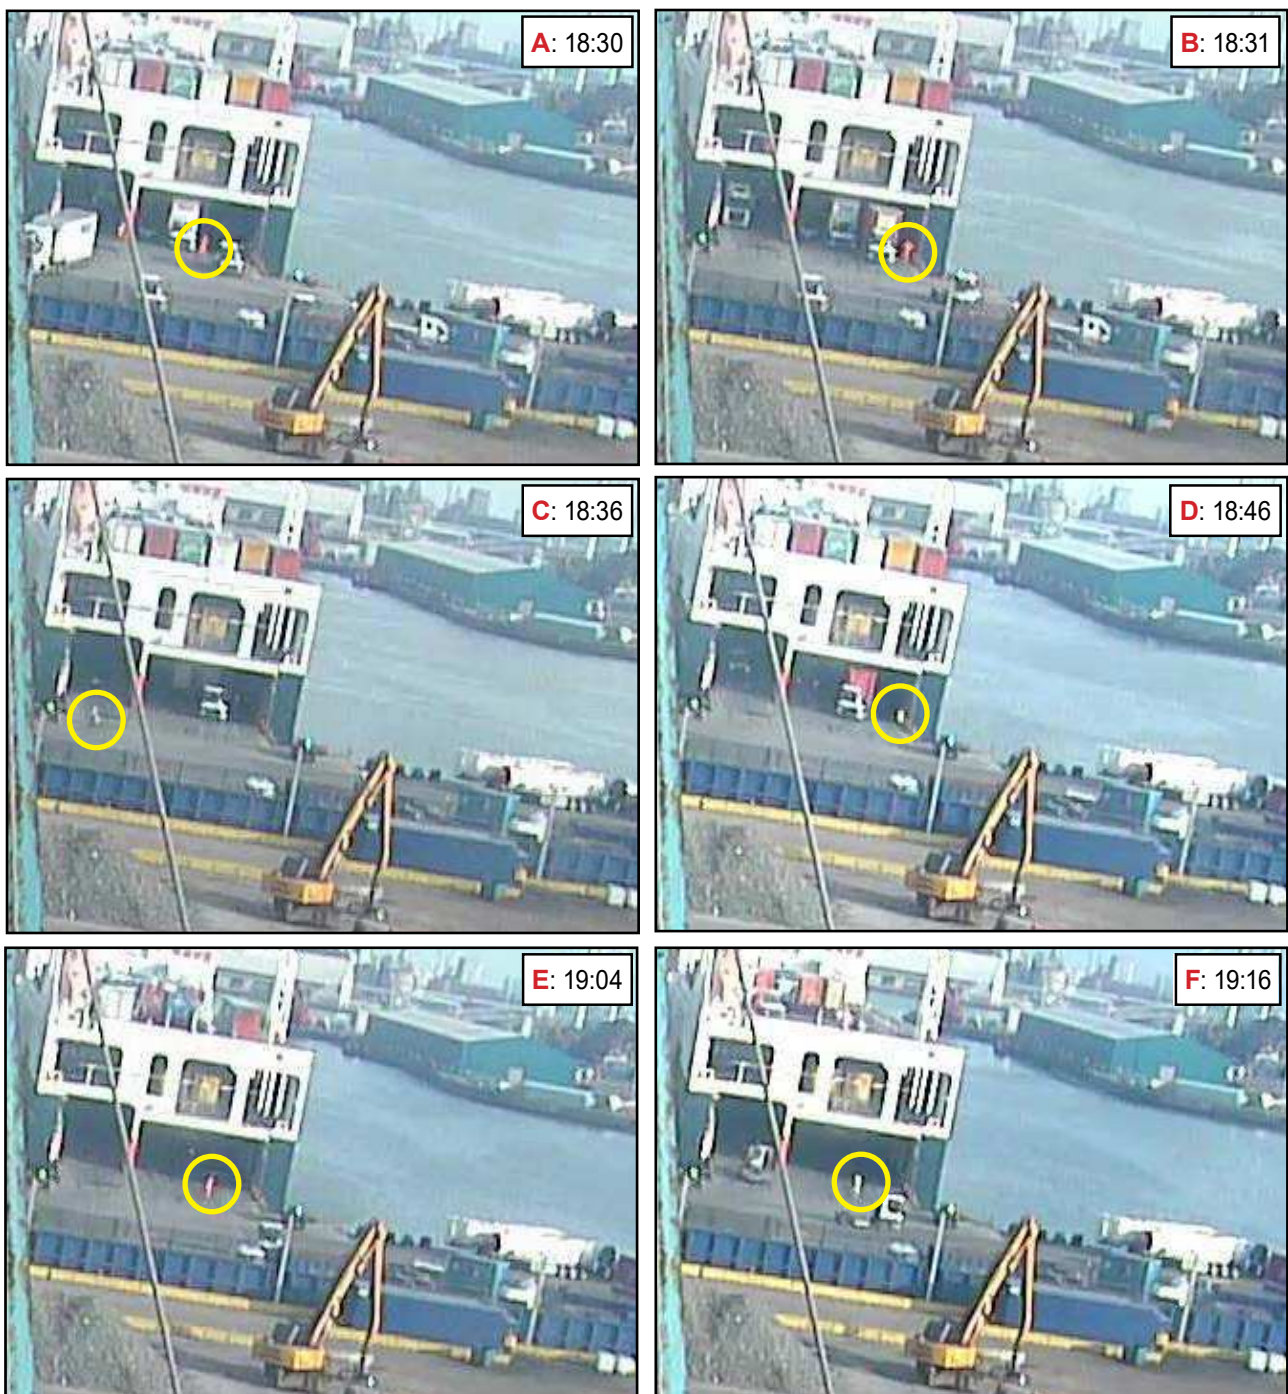
**Figure 10:** Examples of movements across the stern ramp

- When the 3/O was struck by the semi-trailer, he was close to the bottom of the ramp, approximately 0.7m inboard of the yellow line delineating the ramp's starboard walkway (**Figure 5**).
- In the hour leading up to the accident the ferry's crew and shore workers used the stern ramp on 14 occasions to board or leave the ferry by foot. Numerous movements of pedestrians were also seen across the main vehicle deck near the top of the ramp leading down to the lower hold.
- Pedestrians were on the stern ramp at the same time as moving vehicles.
- Pedestrians crossing the stern ramp did so at varying angles (**Figure 10**) with only one keeping to the painted walkway.
- Pedestrians used the internal ramps to move between vehicle decks.

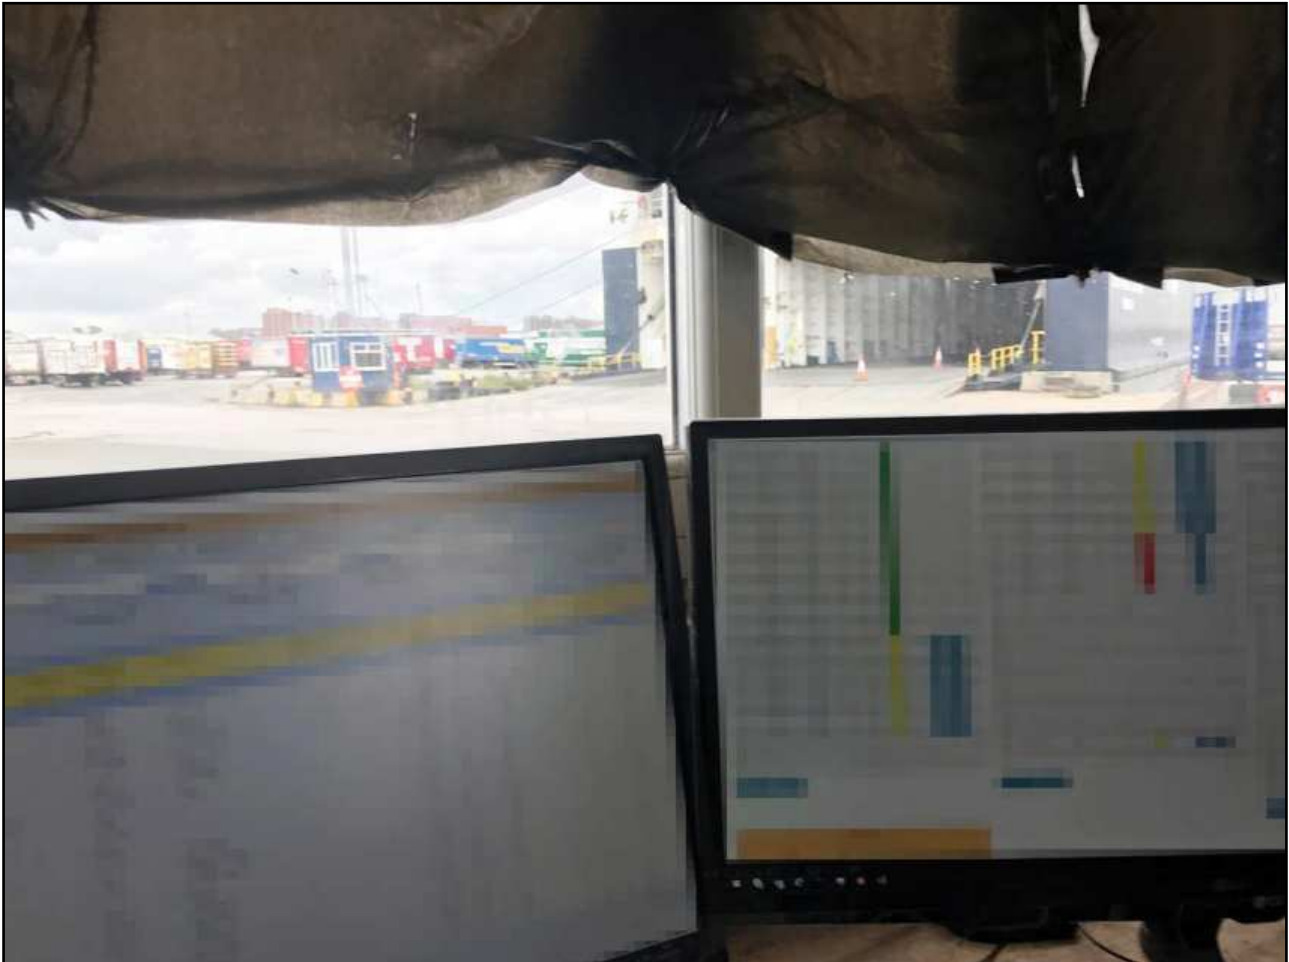
**Figure 13:** View from shore controller's portacabin

The movement and storage of semi-trailers inside the Brocklebank terminal were overseen by a Docklands shore controller from a portacabin on the quay opposite the ferry berth. The portacabin windows were partially covered by plastic bags to eliminate glare of the sun on the display screens inside. Despite this, the shore controller had a good view of the vehicle turning area at the bottom of the ferry's stern ramp and of the stern ramp itself (**Figure 13**).

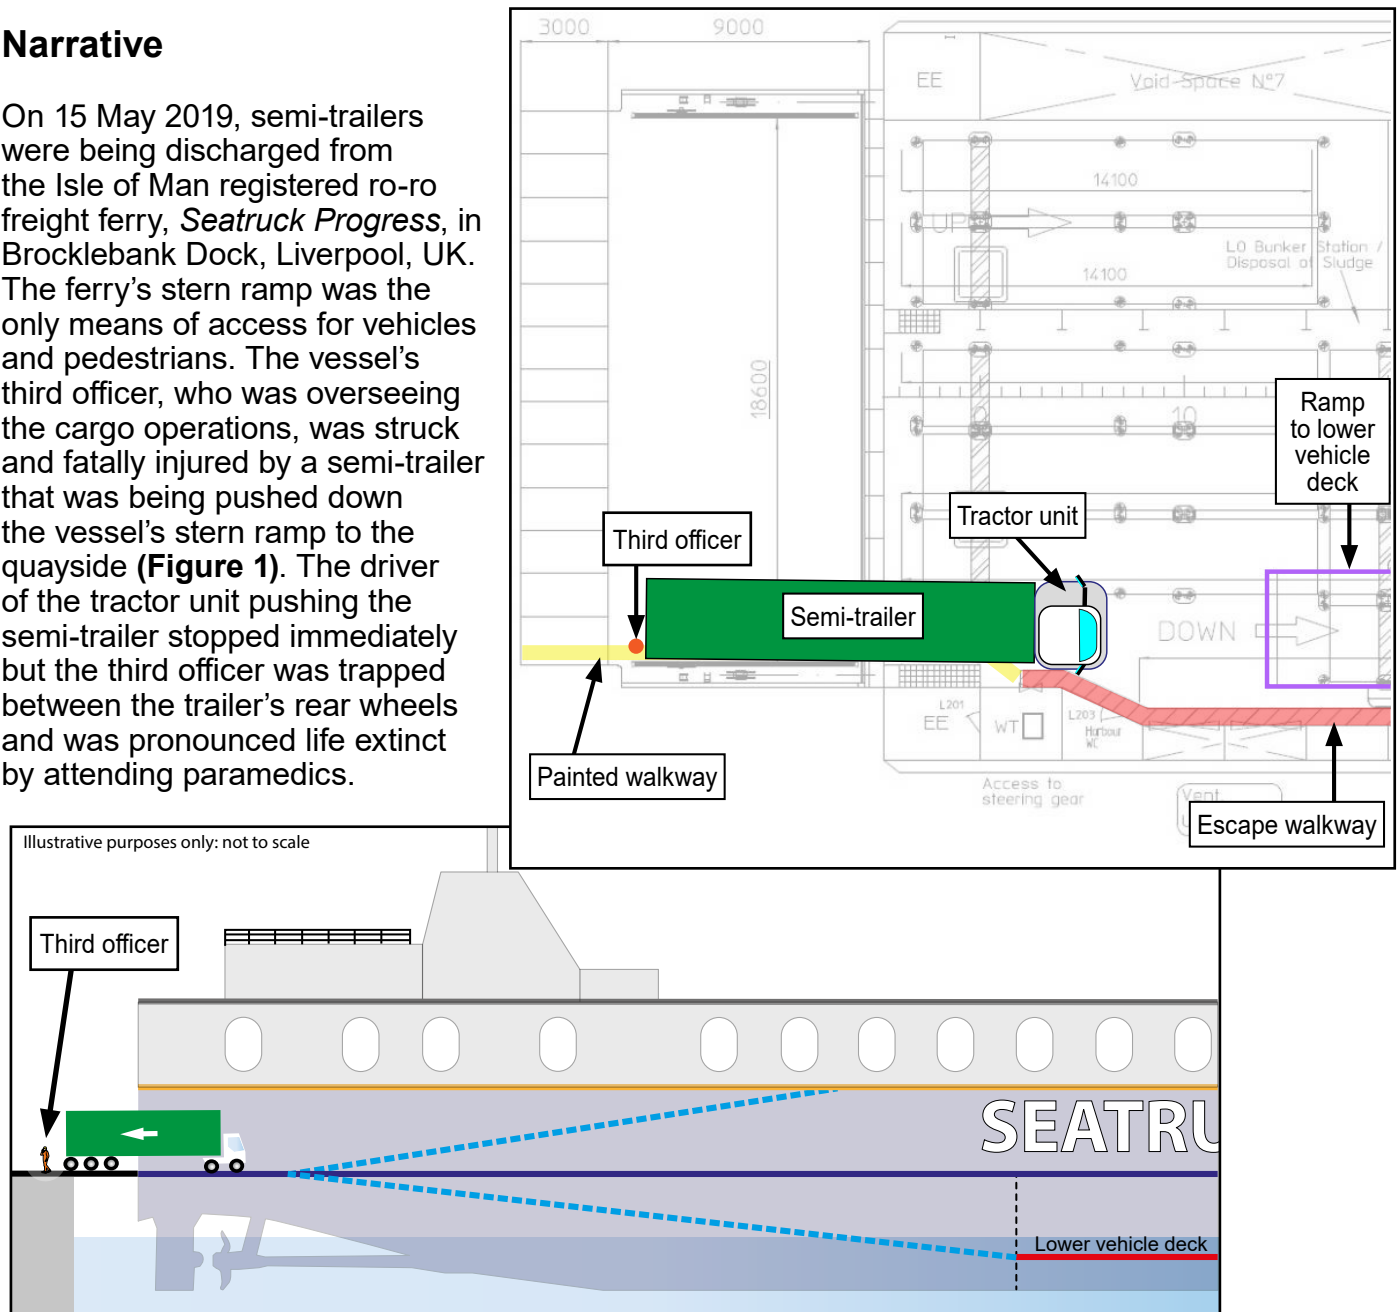
**Figure 1:** *Seatruck Progress* with the semi-trailer and the third officer on the stern ramp

The third officer was talking on his mobile telephone and was facing down the ramp, away from the direction of the semi-trailer's approach, when he was struck. He probably did not hear the trailer approaching amongst the noise from cargo operations on other decks, and he was standing away from a pedestrian walkway that was painted along the starboard edge of the ramp.
