# National Transportation Safety Board

## Marine Accident Brief

### Contact of Tanker *Dank Silver* with Sunshine Bridge

<b>Accident type</b>	Contact	<b>No.</b> DCA19FM040
<b>Vessel name</b>	<i>Dank Silver</i>	
<b>Location</b>	Lower Mississippi River, mile 167.4, St. James Parish, Louisiana <sup>1</sup> 30°05.88' N, 090°54.75' W	
<b>Date</b>	June 16, 2019	
<b>Time</b>	1322 central daylight time (coordinated universal time – 5 hours)	
<b>Injuries</b>	None	
<b>Property damage</b>	\$4.55 million est.	
<b>Environmental damage</b>	None reported	
<b>Weather</b>	Visibility 10 miles, sunny, winds south-southwest 10 knots, slight chop, air temperature 92°F, water temperature 78°F	
<b>Waterway information</b>	The Mississippi River at the Sunshine Bridge is about 2,550 feet wide, bank to bank. At the time of the accident, the river gage at Donaldsonville was 31.33 feet, and the current near the accident site was 5–6 knots. (Flood state was in effect at 27 feet.) <sup>2</sup>

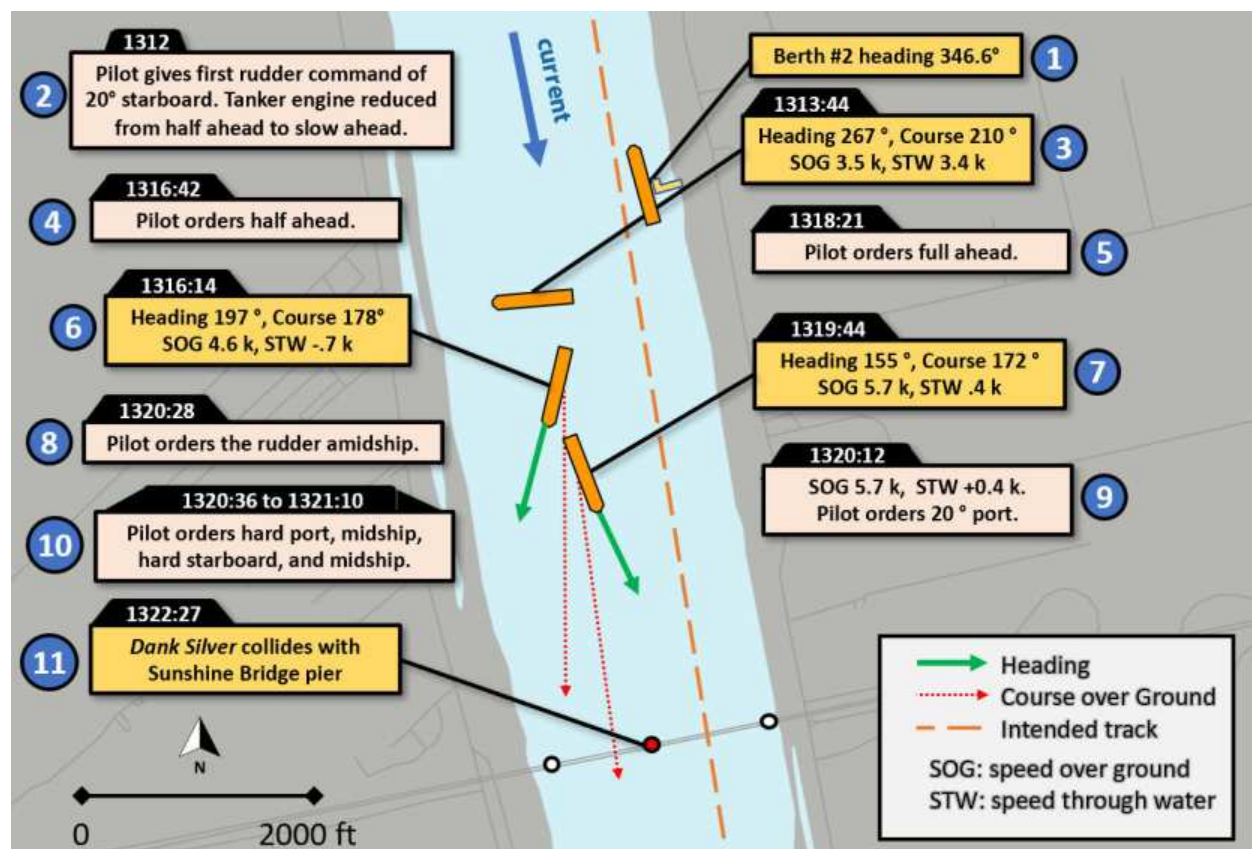
Course of the *Dank Silver* from ECDIS data. (Background source: Google Maps)

At 1314:12, ECDIS showed the *Dank Silver* turning to port, on a heading of 267.4°, making a course of 210°, and at a speed over the ground of 3.5 knots. The ship's rudder was hard to port, and propulsion was stopped. As the tanker continued to turn counterclockwise, at about 1316:08,

At 1316:42, about 6 minutes before the collision, the tanker was about 0.7 miles from the bridge, and the pilot ordered half ahead on the ship's engine. ECDIS showed *Dank Silver* heading 197°.4, making a course of 178°.9, with a speed over the ground of 4.6 knots and a speed through the water of -0.7 knots. At 1318:21, the pilot ordered full ahead, and at 1319:37, the ship's speed through the water was a positive 0.1 knots.

At 1320:12, about 2-1/2 minutes before the collision, the *Dank Silver* was about a quarter mile from the bridge. The ship's speed over the ground had increased to 5.7 knots, and the speed through the water was +0.4 knots. About this same time, the pilot ordered 20 degrees port rudder.

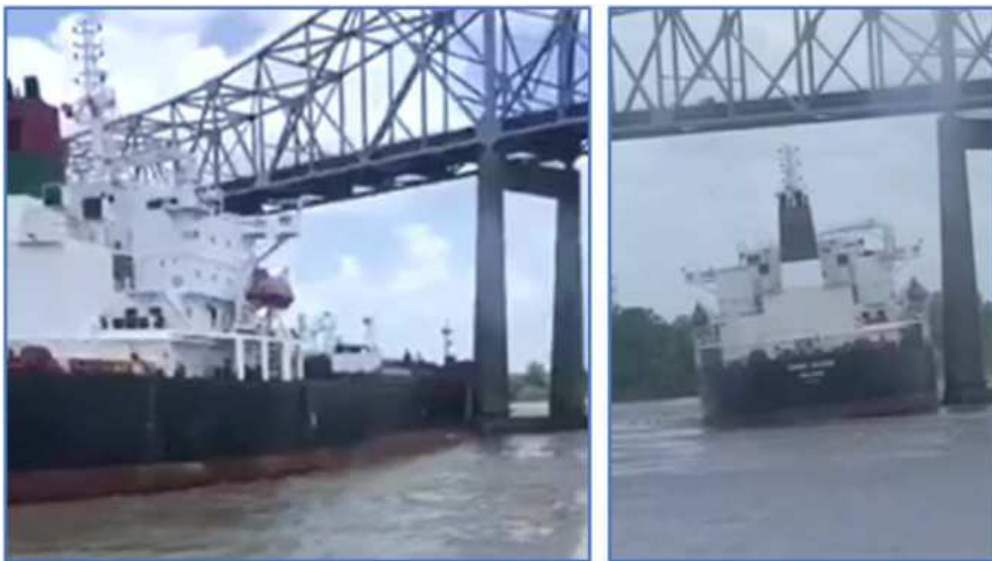
At 1322:27, the forward part of *Dank Silver*'s starboard side struck the western pier to the channel span of the Sunshine Bridge. The strike caused about \$3.5 million in damage to the bridge fendering system. Four of the tanker's water ballast tanks sustained deformation damages to the hull plating and internals, but damage did not reach the cargo tanks. Additionally, the hull plating comprising one of the ballast tanks was breached.

Photos showing the *Dank Silver* striking the Sunshine Bridge. (Source: Crescent Towing)

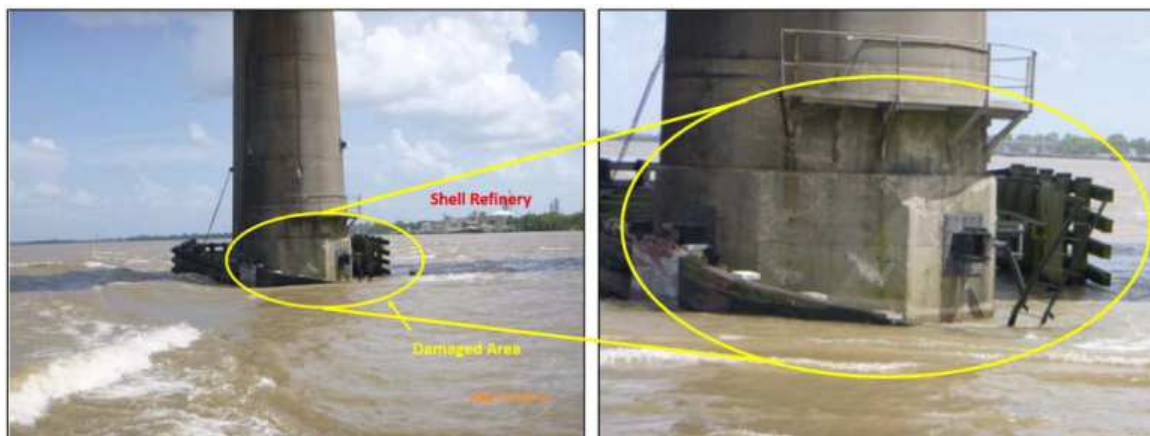
Damage to the fendering system for the western pier of the Sunshine Bridge, from the north. (Source: Louisiana Department of Transportation and Development)
