SAFETY INVESTIGATION REPORT

REPORT NO.: 13/2020

May 2020

MV RIGA
Fatality following entry into cargo hold
in position 42° 09.6' N 016° 24.6' E
27 May 2019

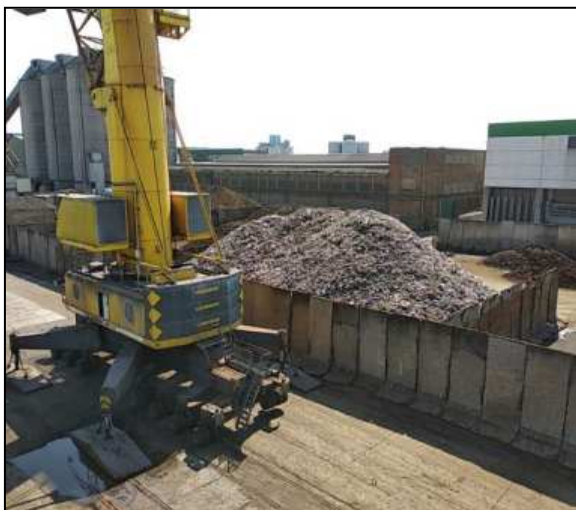
At the time of the accident, the vessel was loaded with 3,926 mt of ‘packaging waste glass cullet’, which was loaded from an unsheltered location on the quay (Figure 2), at Porto Marghera, Italy. It was reported that the cargo, when loaded, was partly wet, as it was raining a couple of days prior to loading.

Figure 2: Area on the quay from where cargo was loaded

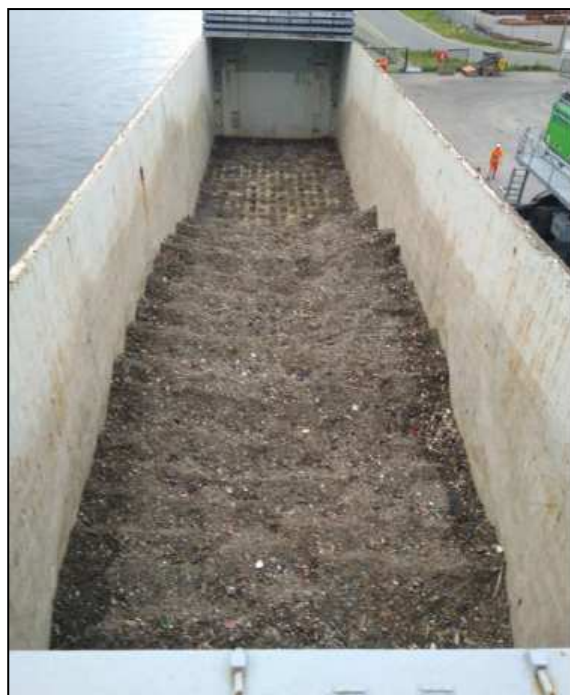
Figure 3: Cargo hold, as seen from forward

Riga was fitted with a single cargo hold (Figure 3) having a capacity of 5713 m³. The cargo hold had a length of 62.4 m, a breadth of 11.0 m and a depth of 8.43 m.

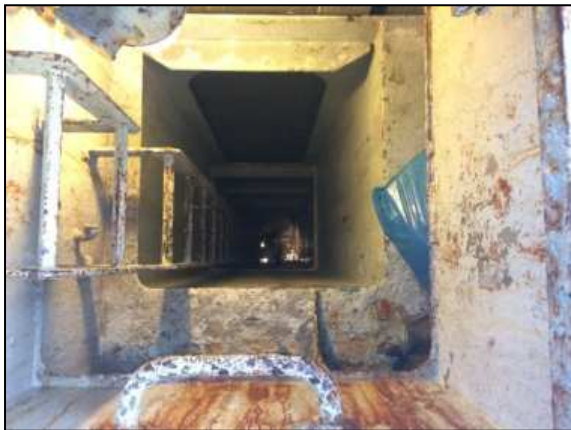
Figure 6: Cargo hold access ladder – aft

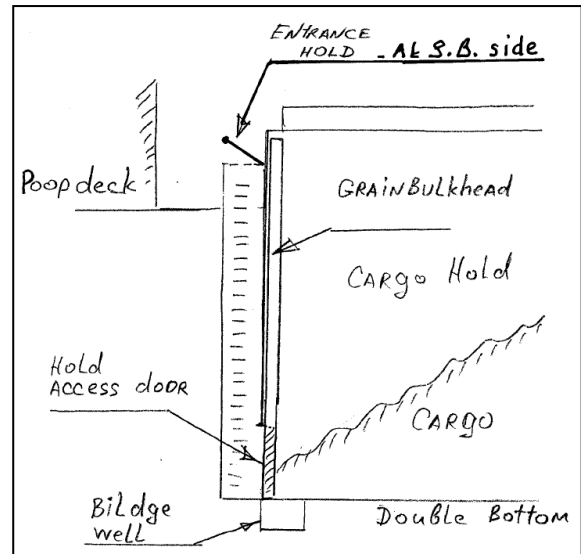
The cargo hold was fitted with two bilge wells – one on the port side and another on the starboard side, both of which were located at the aft of the cargo hold (Figure 7). The bilge wells were fitted with suction pipes to pump out water from them via an ejector. The bilge wells were also fitted with sensors (Figure 9) which triggered an alarm if the level of any liquid inside the wells reached these sensors.

Figure 7: Rough profile sketch of the cargo hold (aft)

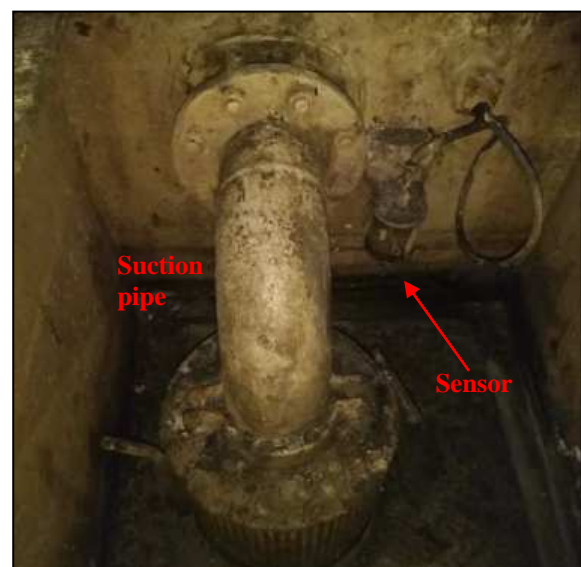
Figure 9: Cargo hold bilge well

Alarm panels were fitted in the engine-room, the mess room, the chief and second engineers' cabins, and on the bridge. The safety investigation tested the bilge well alarm and found the bridge alarm panel operational.

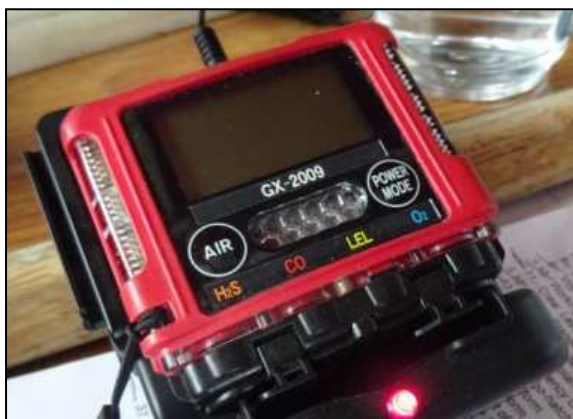
Riga was provided with a portable gas detector (Figure 10) for the measurement of Oxygen, Hydrogen Sulphide, Carbon Monoxide and combustible gases in the lower explosive limit (LEL) range.

Figure 10: Portable gas detector on board *Riga*

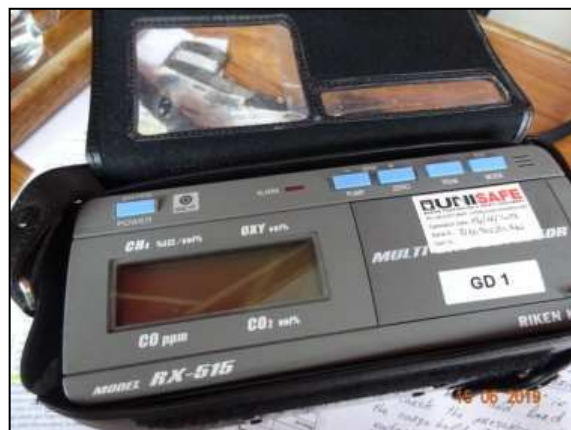
The additionally supplied gas detector was capable of measuring Oxygen, Carbon Monoxide, Carbon Dioxide and hydrocarbons (combustible gases). Unlike the previously mentioned gas detector, this one was capable of measuring the volume

Figure 11: Additional portable gas detector supplied on board *Riga*, after the accident
