SAFETY INVESTIGATION REPORT

REPORT NO.: 11/2020

MT ALYARMOUK

**Damage to equipment, leading to a fall from a height on deck,
in position 06° 20' N 079° 34' W
10 May 2019**

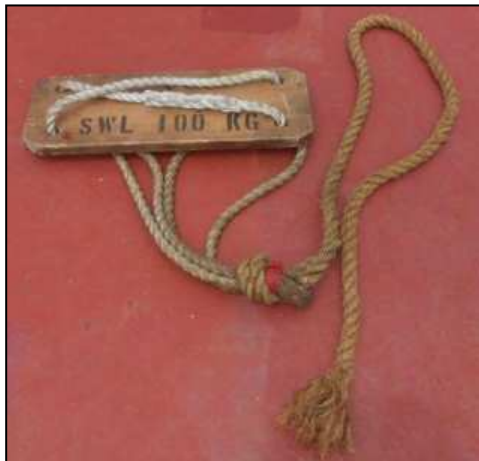
Figure 2: The bosun's chair

The bosun's chair was marked with a safe working load (SWL) of 100 kg (Figure 2); however, there was no evidence available to the safety investigation which could help indicate how this SWL had been determined.

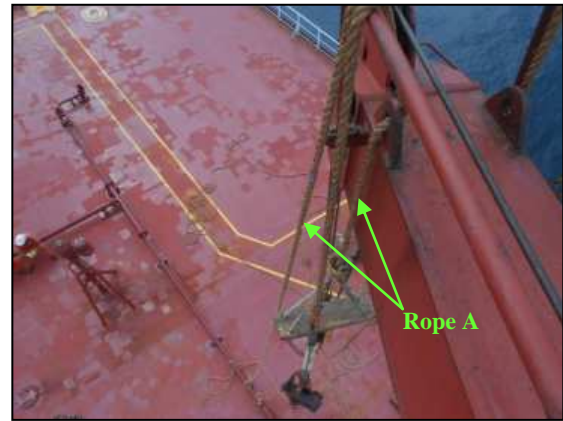
Figure 4: Simulation of rigging arrangement for the bosun's chair

The ropes used were manila (natural fibre). The equipment was rigged by passing rope 'A' over the lower course of the guard rails, which were fixed to the jib of the crane, through a pad eye on the jib and tied to the bosun's chair (Figure 4).

The point of failure of the rope was found to lie in the vicinity of the pad eye of crane jib through which the rope was passed to carry out the task (Figure 4).

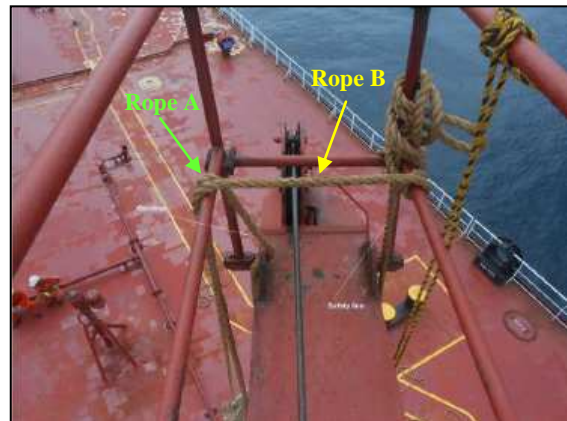
Figure 5: Simulation of rigging arrangement for the safety harness (the yellow-black line was used to hoist/lower tools for the task).

For the safety harness, rope 'B' was passed over the opposite guard rails and then over the same lower course of the guard rails as rope 'A'. As an additional precaution, rope 'B' was secured onto the opposite guard rail (Figure 5).

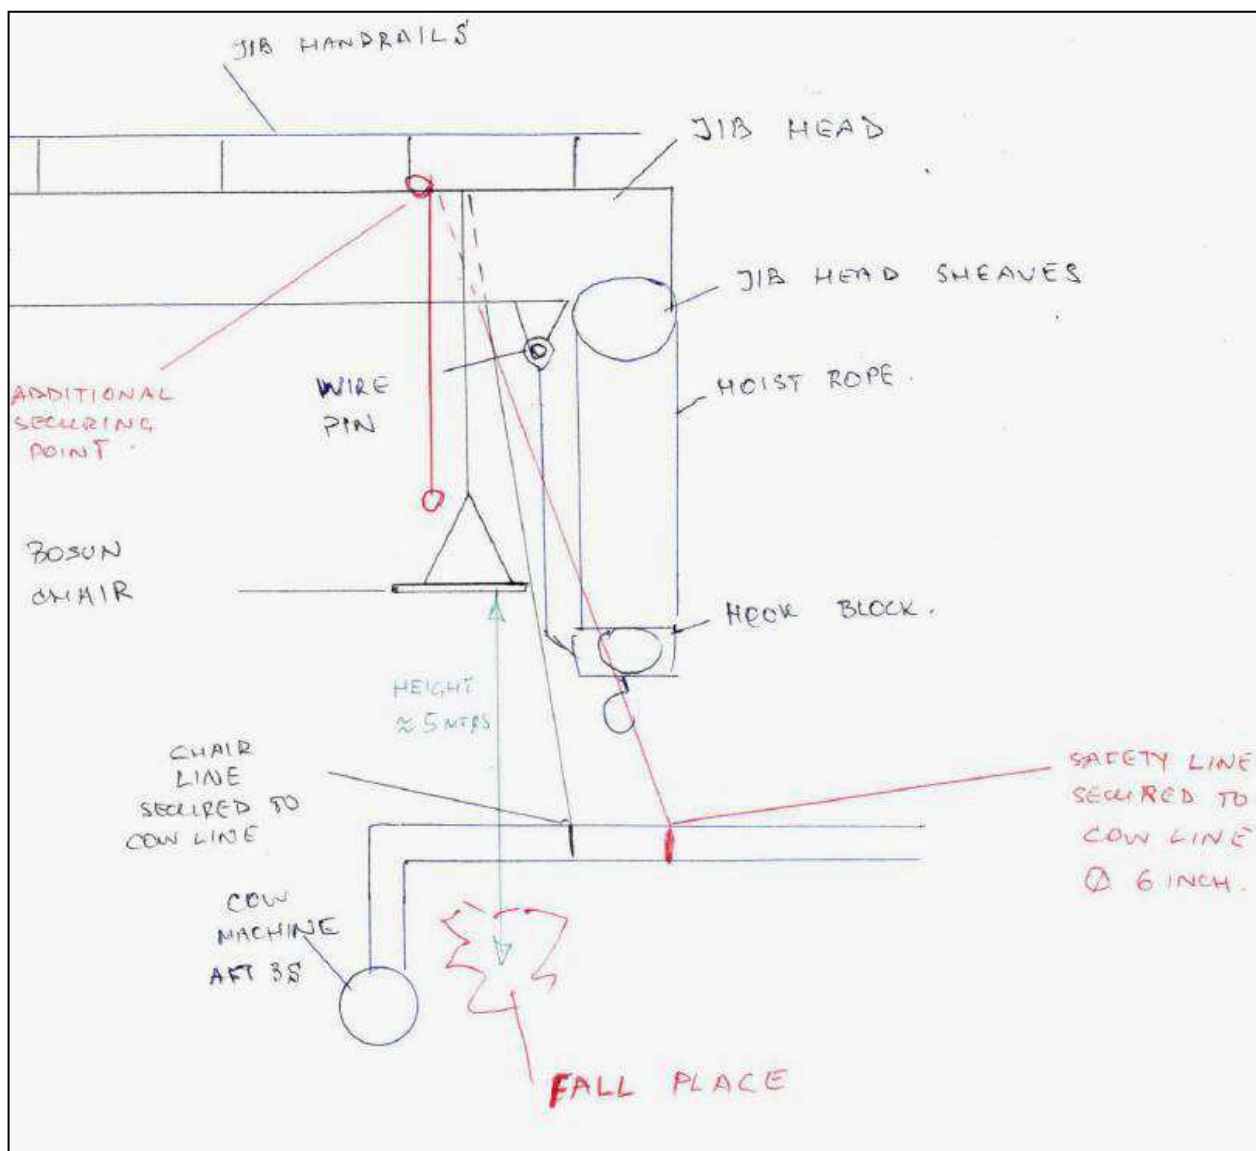
Figure 6: Rough sketch, showing the entire bosun chair's arrangement

The free ends of ropes A and B were secured to a crude oil washing (COW) branch line of the vessel, which ran on the main deck, as seen in Figure 6.

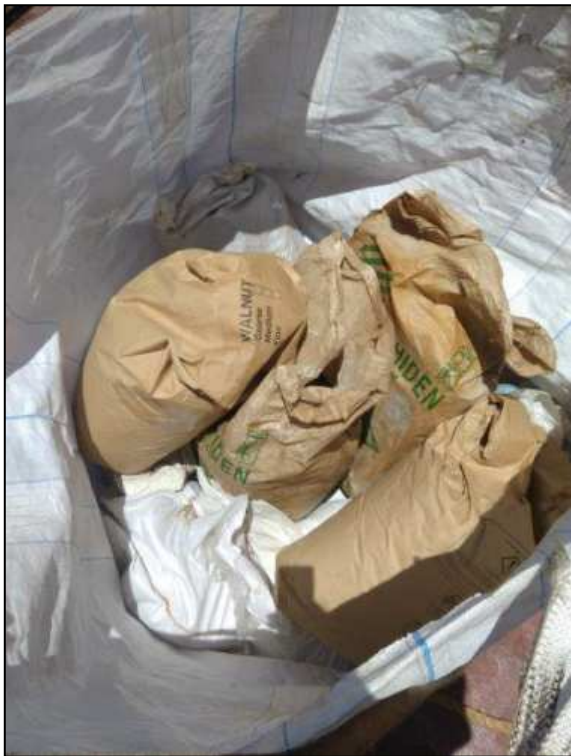
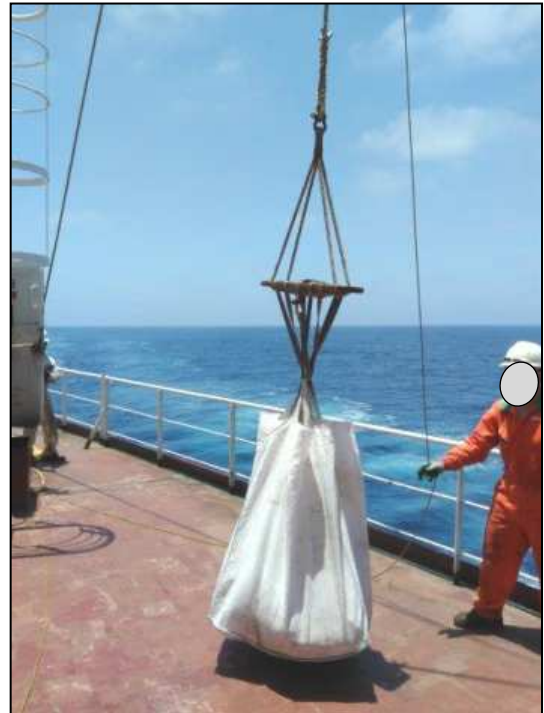
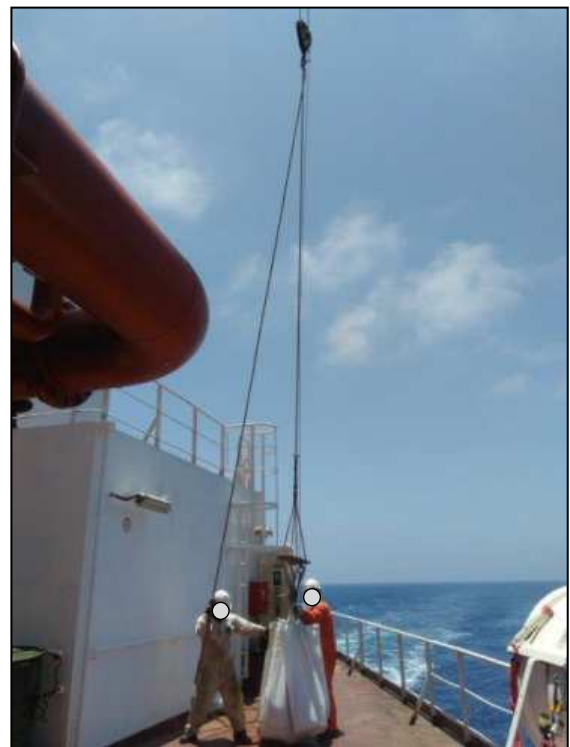
Prior to being used for the task, on the same day, the bosun's chair and ropes 'A' and 'B' were reportedly tested by suspending a load of 250 kg from the rigging equipment, for a period of 10 minutes. Bags of cement, weighing 50 kg each, were used as the load (Figures 7, 8 and 9).

Figure 7: Cement bags used for the test

Figure 8: Simulation of the test

Figure 9: Simulation of the test arrangement

The rope and the bosun's chair were subjected to a load test of 250 kg, although the certified strength of the rope was not known and the SWL of the bosun's chair was identified at 100 kg. Although this test (250%) had no direct bearing on this accident, the safety investigation believes that unless the minimum breaking strength and the safe working load of the rope and the bosun's chair are known, overloading during such tests may occur, potentially weakening and damaging the equipment.

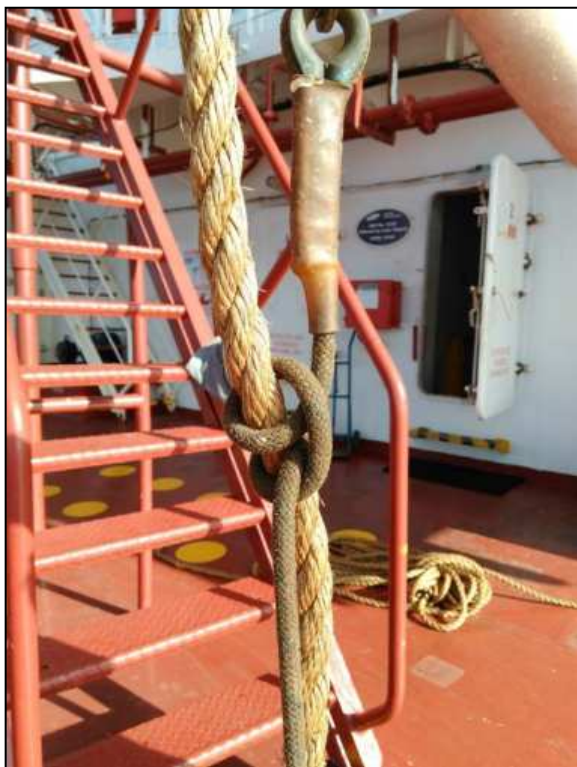
Figure 13: Simulation of safety harness secured to rope B during lowering.

The bosun released the safety harness from rope 'B', following which, the end of rope 'B' was lowered to the main deck. The bosun tied a clove hitch around a point along the length of rope 'B' (Figure 13), and the able seafarer and the ordinary seamen, who were positioned on the main deck, then started to slowly lower the bosun's chair.

Furthermore, the bosun had re-secured the safety harness to rope B using a clove hitch, before the bosun's chair was lowered. The securing knot slid along the length of rope B and did not arrest his fall.

A clove hitch is a common, easy-to-tie (and untie) knot used to secure a rope to a horizontal pole or a ring. However, as it would tend to slip, especially when repeatedly subjected to varying levels of load, this knot is not recommended to be used on its own. Moreover, when secured to a vertical pole or along a freely hanging rope, it will have a tendency to slide down the surface in the absence of any tension on it.

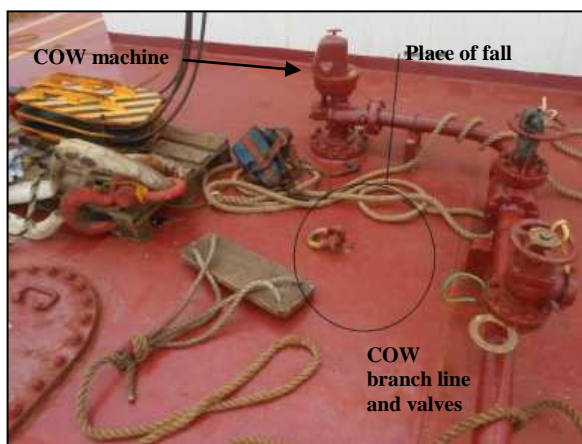
Figure 14: Location where the bosun fell

The fractured ribs were most probably caused by the various fittings, such as the COW machine, branch line, valves, manhole cover, *etc.*, which were in the proximity of his fall (Figure 14).

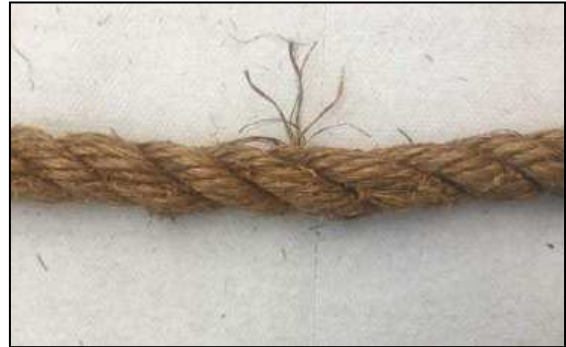
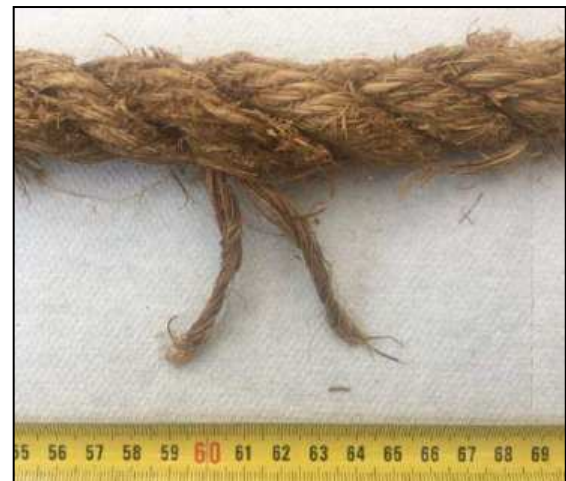
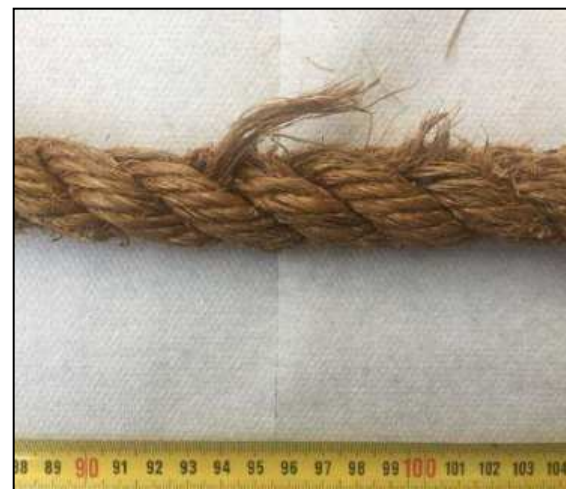
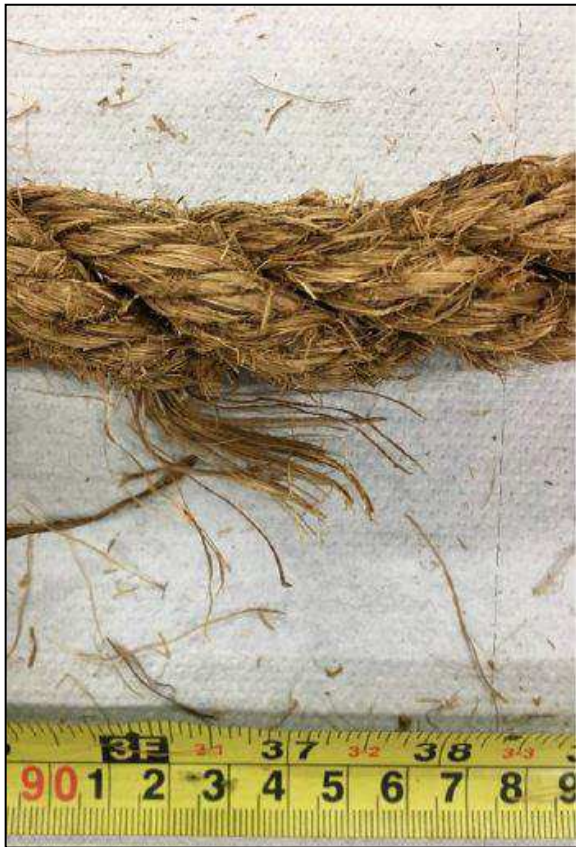
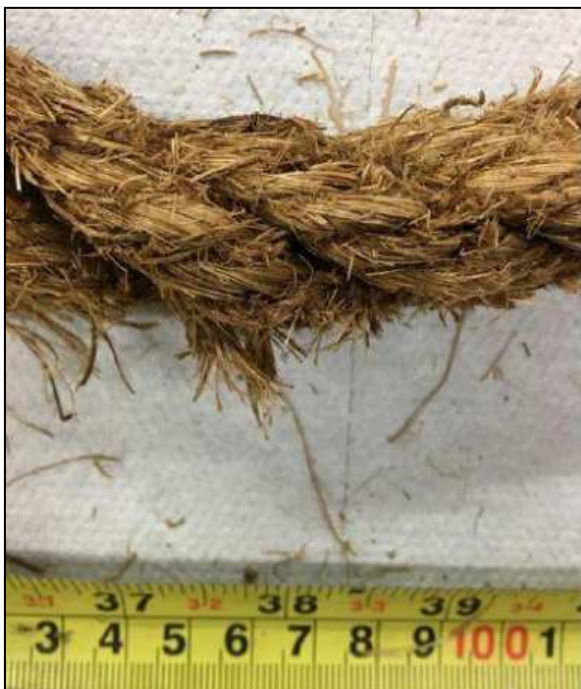
Visual inspection of the rope sections showed signs of fraying, weathering and the presence of some damages, in the form of worn down or cut fibres and strands, along their lengths (Figures 16 to 20).

Figure 16: Failed fibres

Figure 17: Failed strands

Figure 18: Failed strands

Figure 19: Failed and worn down fibres and strands

Figure 20: Failed and worn down fibres and strands

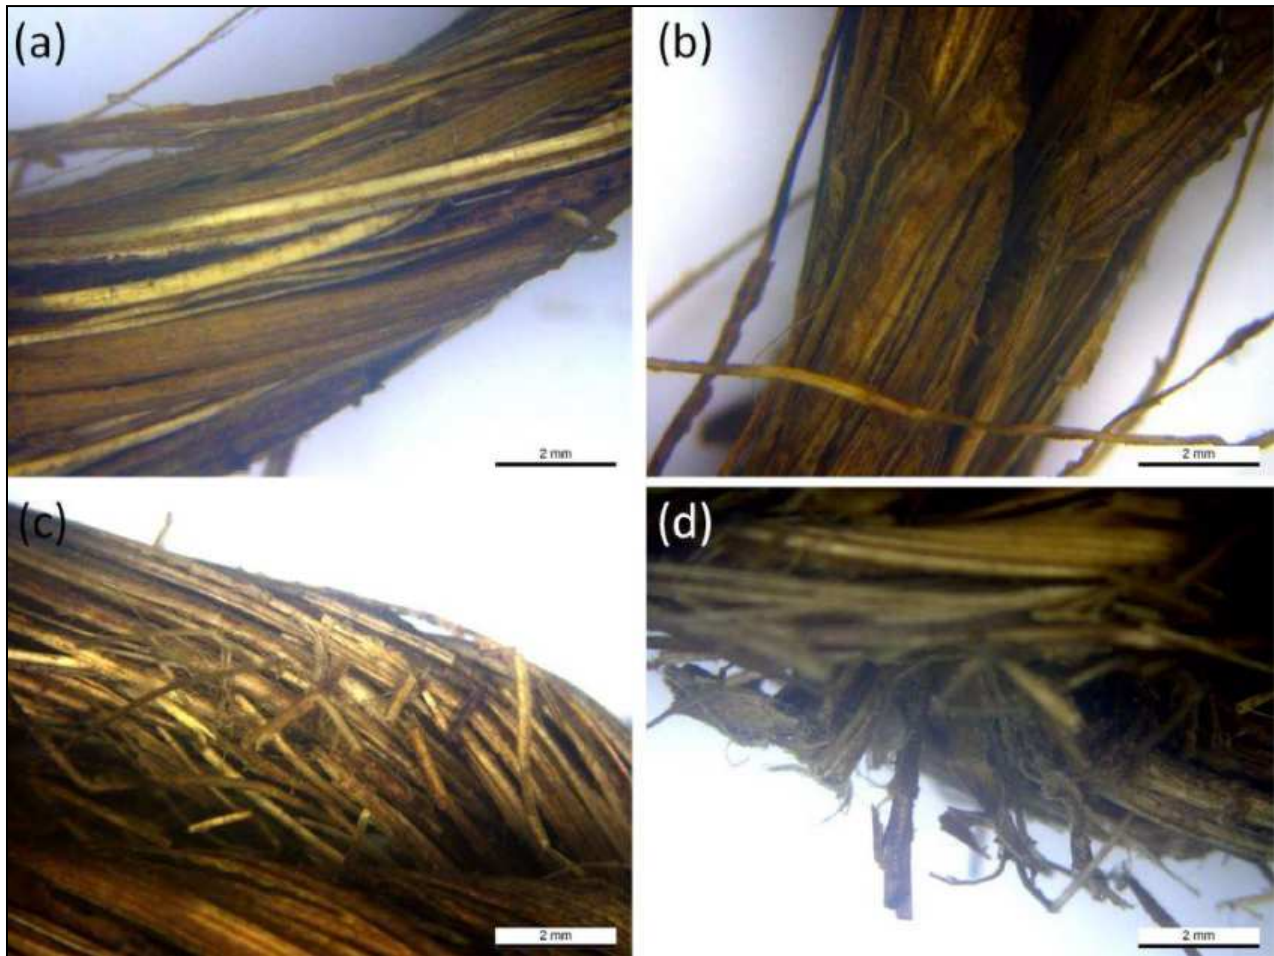
Low-magnification stereomicroscopy of the rope filaments revealed extensive damages in the vicinity of the point of failure. Individual filaments of the rope sections were either broken or had a furry appearance, both of which are common signs of abrasion (Figure 21). No signs of extensive weathering or rotting were observed, which suggested that the rope had experienced damage primarily in and around the ultimate point of failure.

The laboratory analysis concluded that the failure of the rope was caused by localised abrasive damage.

While some signs of fraying and overall signs of wear were noticed along the entire lengths of the two rope sections, fragmentation of fibres was observed close to the point of failure. This fragmentation of fibres and the texture of the rope indicated localised contact with a hard surface, which caused severe abrasive damage and led to failure of the rope.

Figure 21: (a) Undamaged internal strands; (b, c and d) abraded fibres near the point of failure

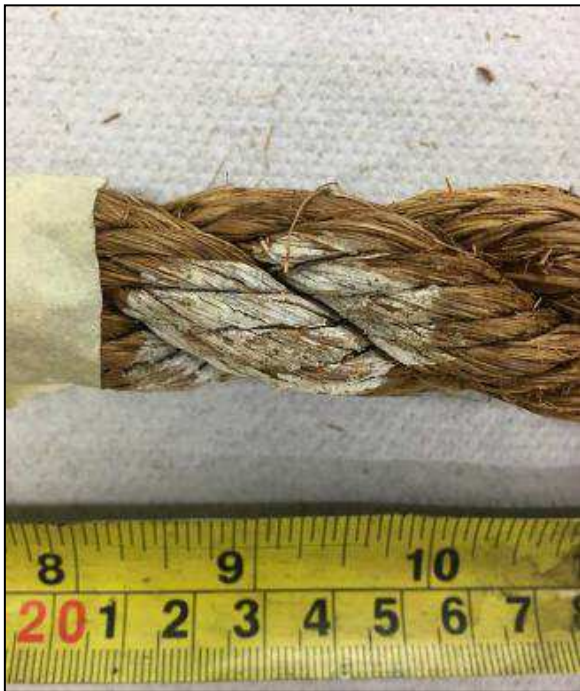
Figure 22: Paint residue on rope sample

Paint residue was noticed on the sample of the rope received by the MSIU – at a distance of about 0.8 m from the point of failure (Figure 22). This indicated that the ropes were not free of paint, as was indicated in the inspection records and the risk assessment, raising doubts on the thoroughness of the on board inspections.
