Report on the investigation of
the fire on the main vehicle deck of

Commodore Clipper

while on passage to Portsmouth

16 June 2010

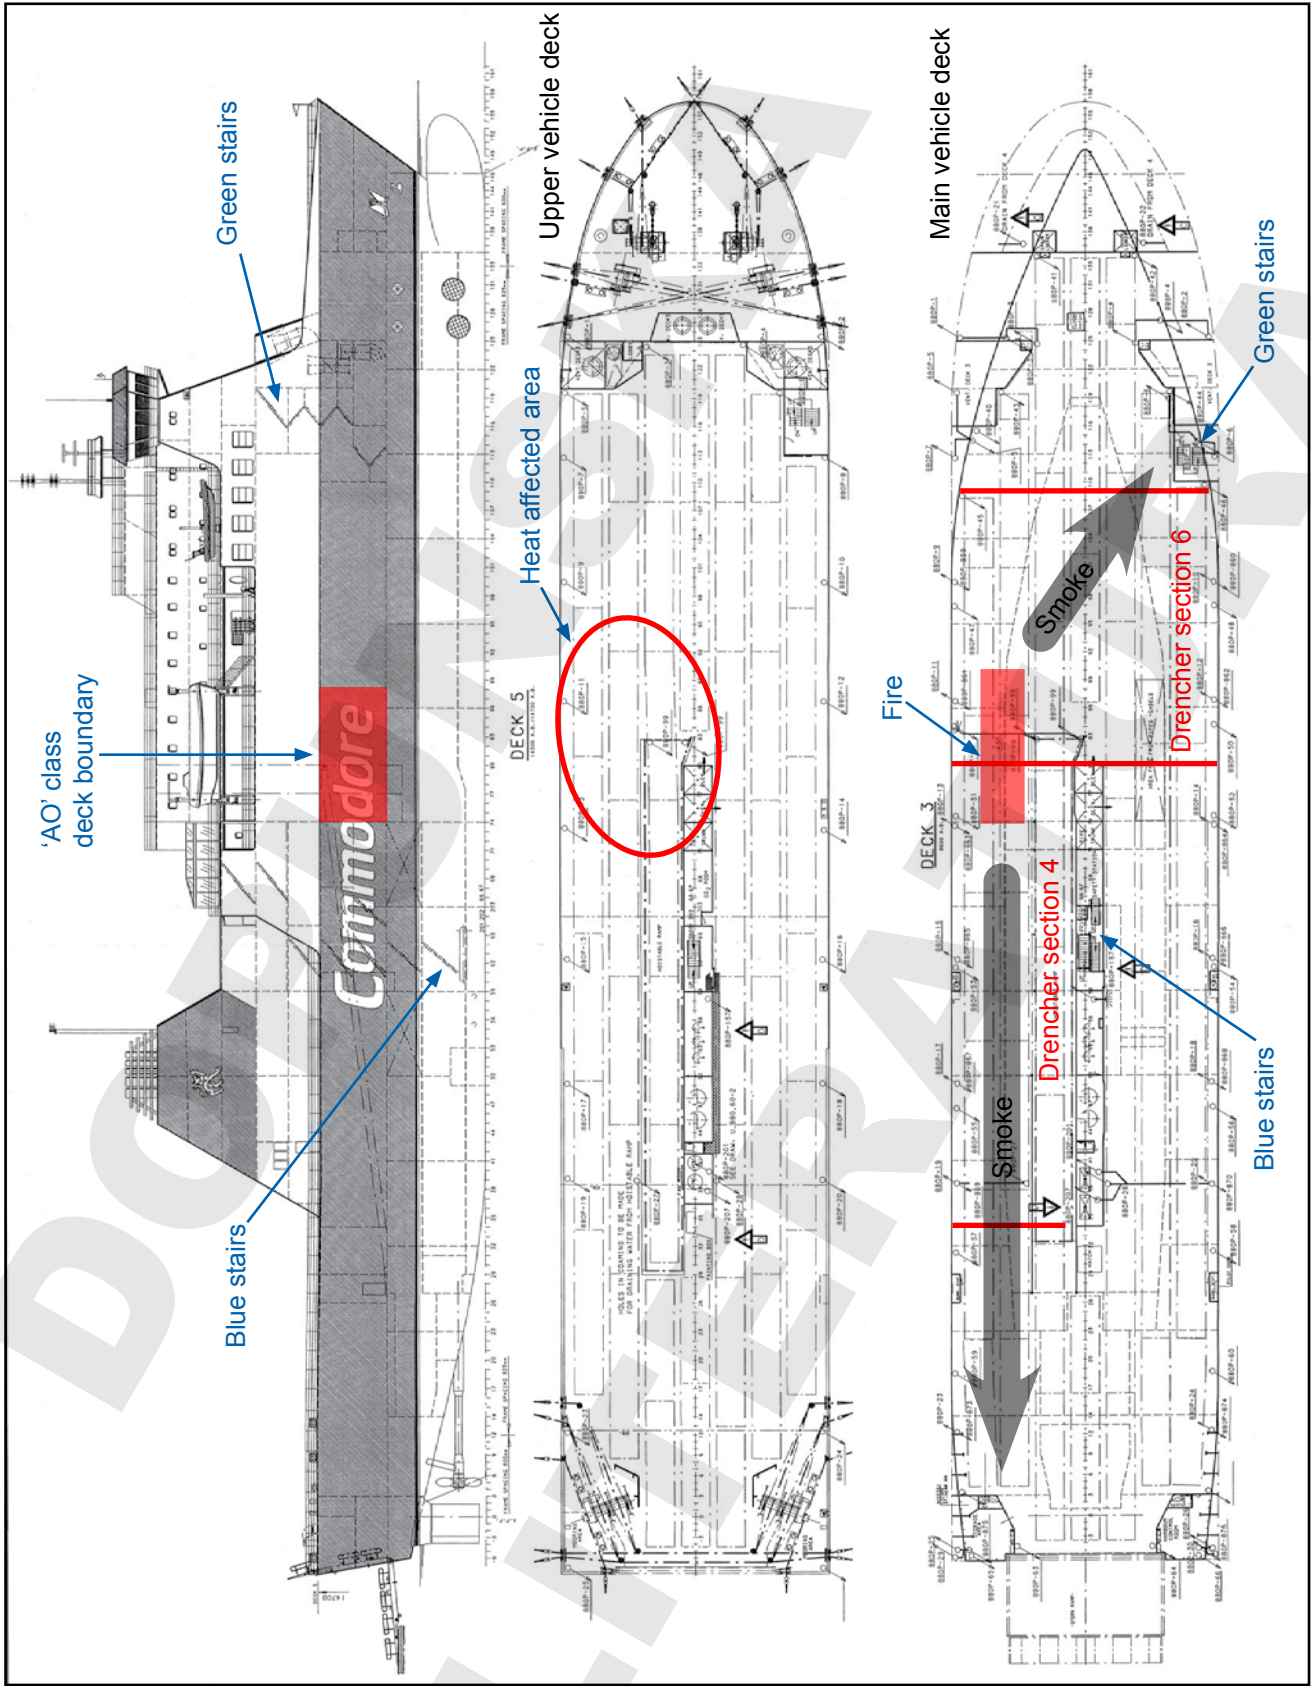
Figure 4

The chief engineer turned the switch on the bridge to ensure that the vehicle deck ventilation fans had been shut down. He then started the vehicle deck drenching system¹ in section 4, the immediate location of the fire (**Figure 4**). At about 0306, main vehicle deck water leakage alarms were triggered, indicating that water from the drenchers had started to drain overboard from the compartment.

General arrangement of Commodore Clipper and location of the fire

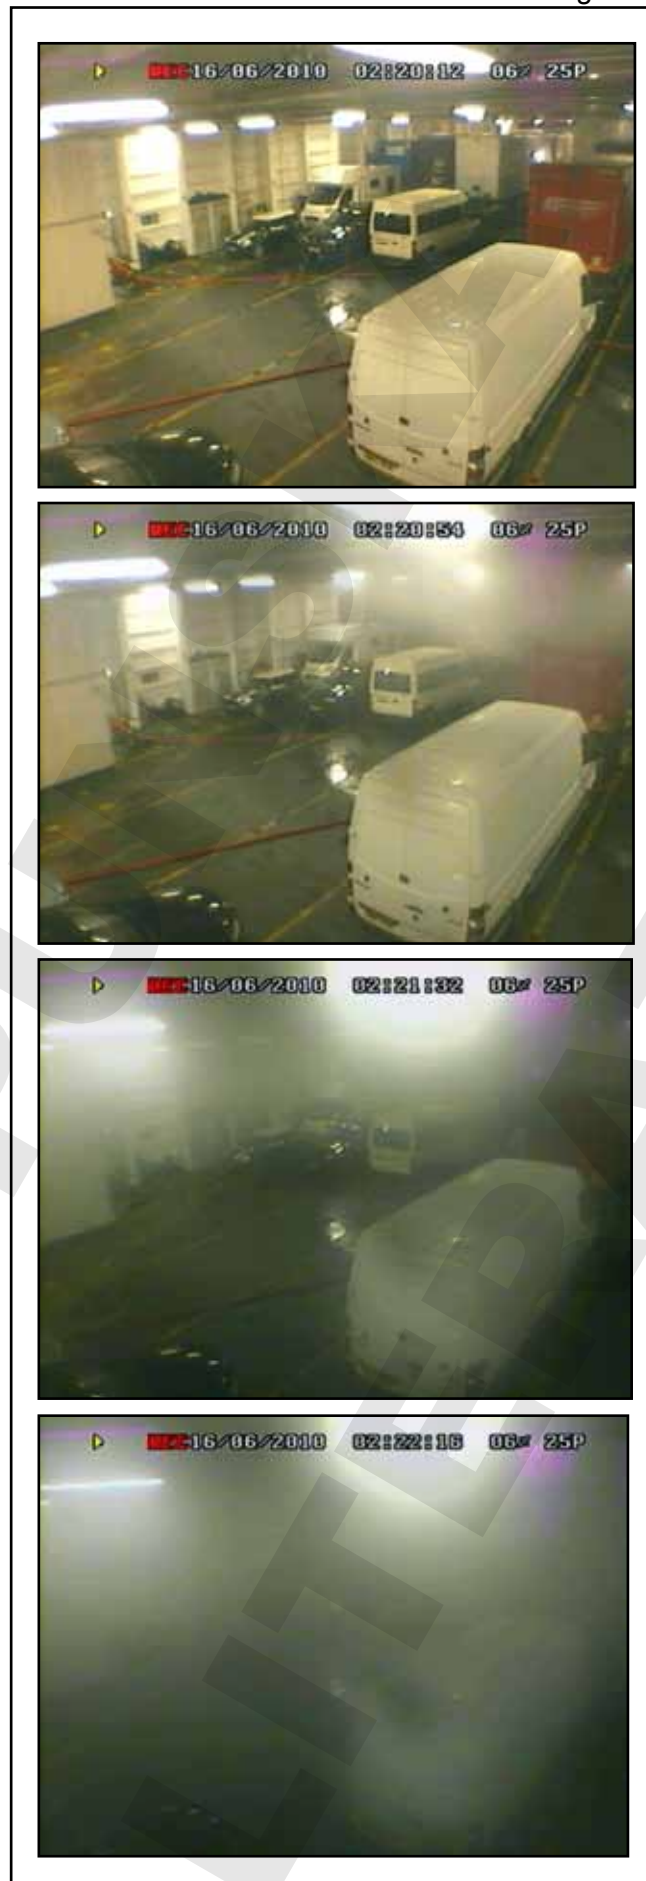
Figure 5

Cloud of steam from the upper vehicle deck as boundary cooling was started (CCTV timings are in UTC)

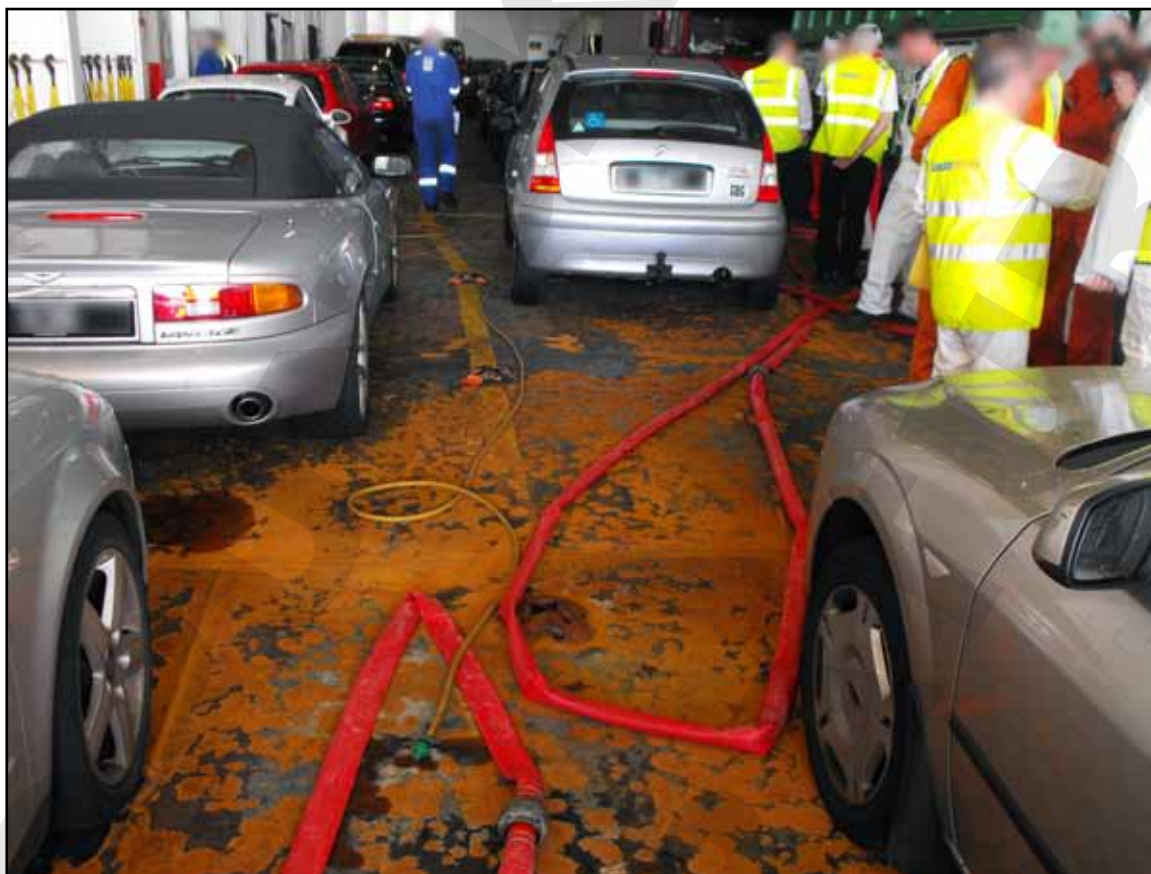
Figure 6

After about 30 minutes of drenching and boundary cooling, the chief and third engineers measured the temperature of the upper vehicle deck using a portable infra-red thermometer. They recorded average deck temperatures above the fire of 180°C, and noted that the steel plating had buckled and the paint coating had gone. The heat did not cause any of the cars parked in the immediate area above the fire to ignite (**Figure 6**).

Heat damage to the upper vehicle deck

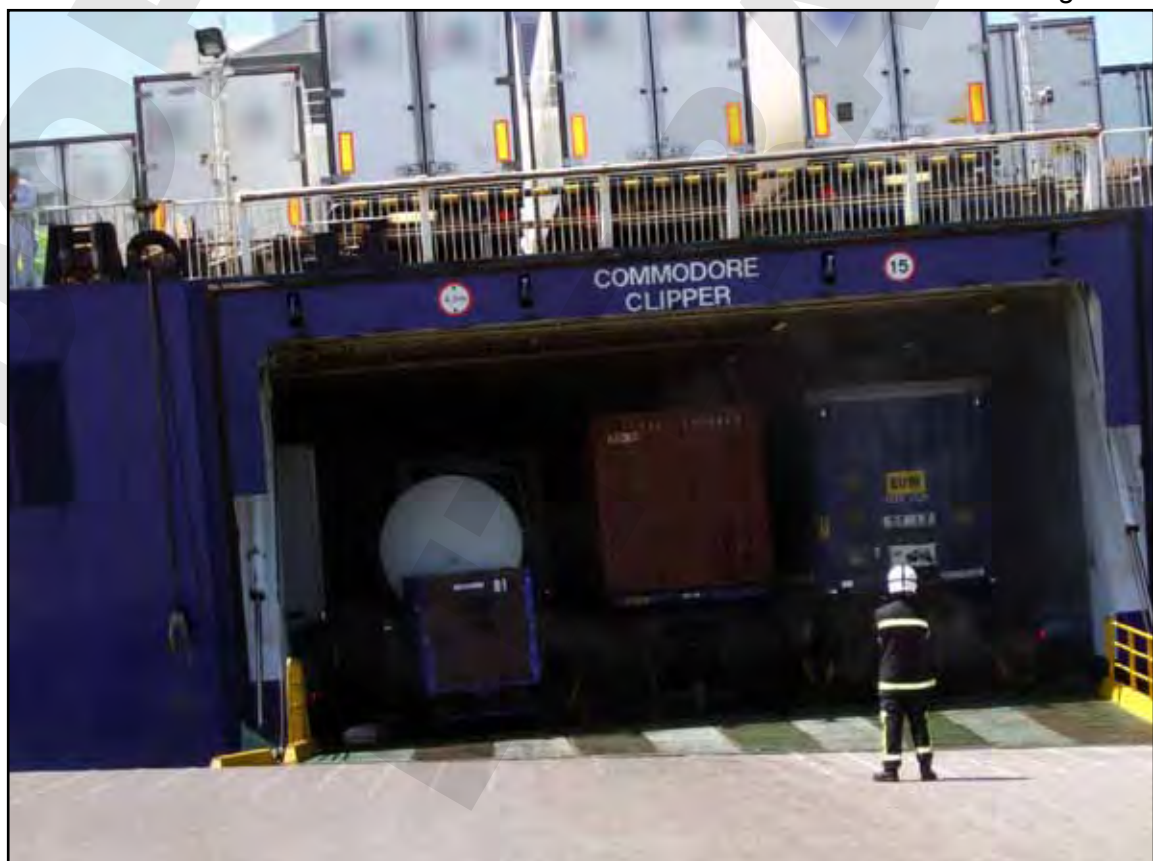
Figure 11

View of the main vehicle deck after the stern ramp was opened

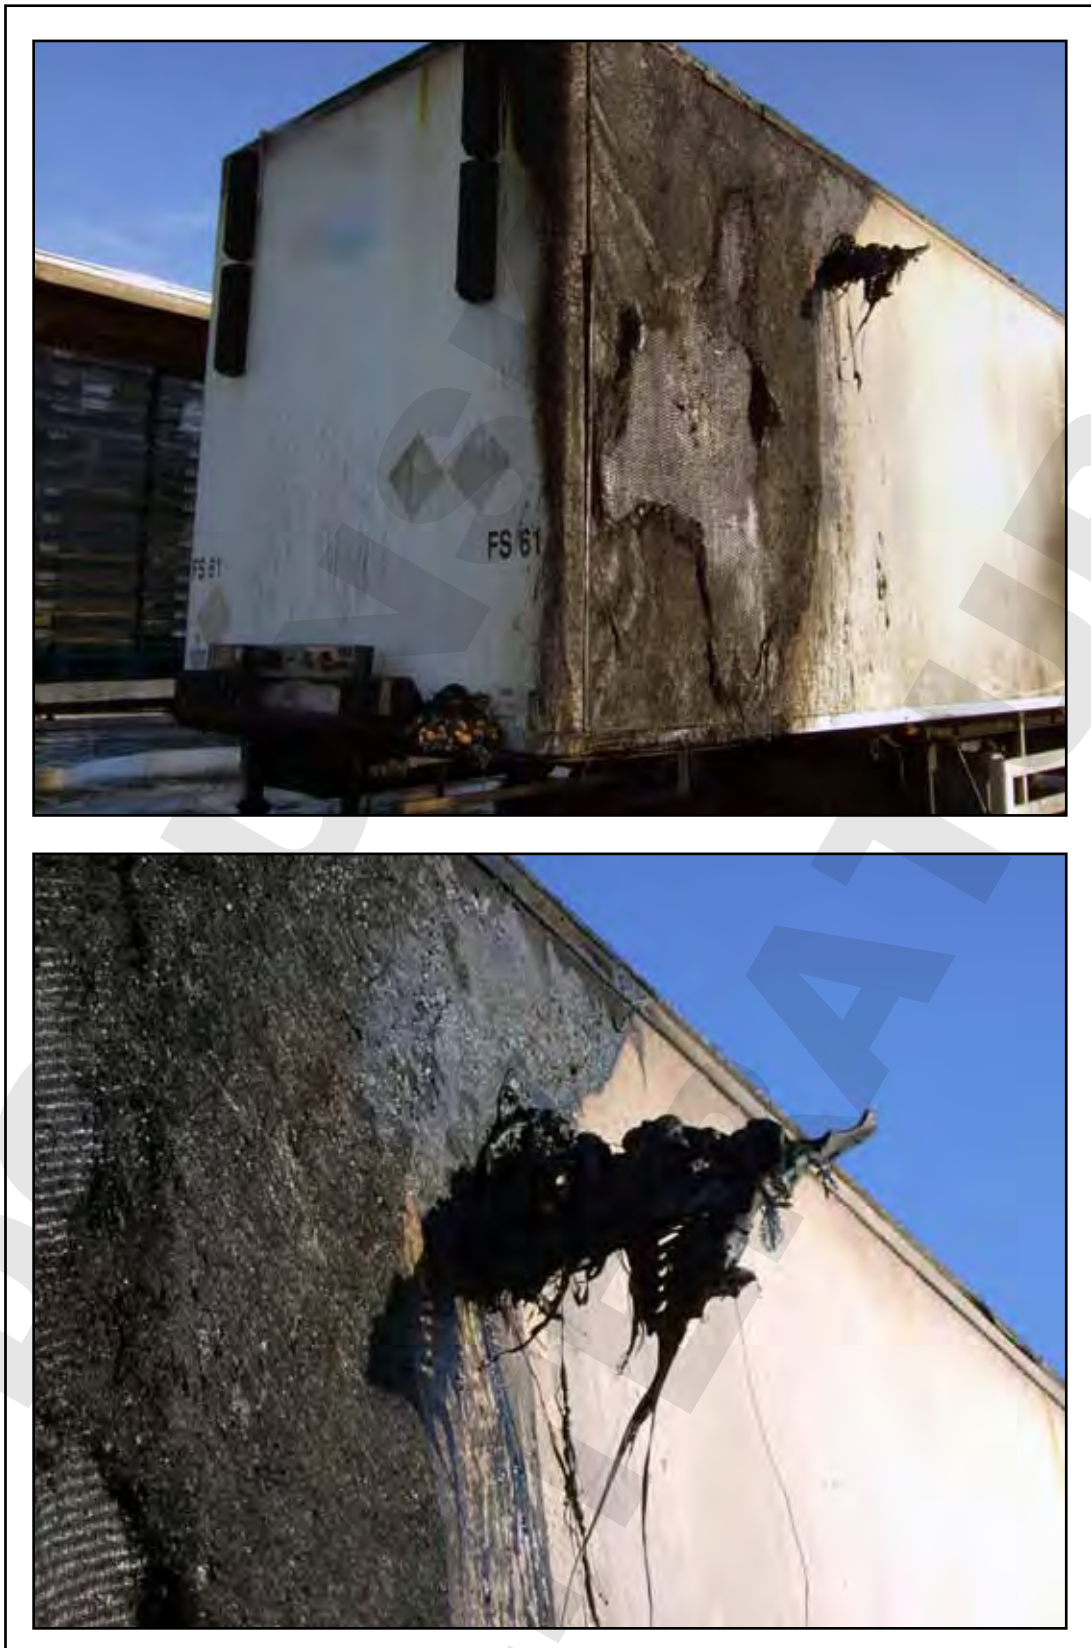
Figure 12

Partially burnt debris on trailer FS61

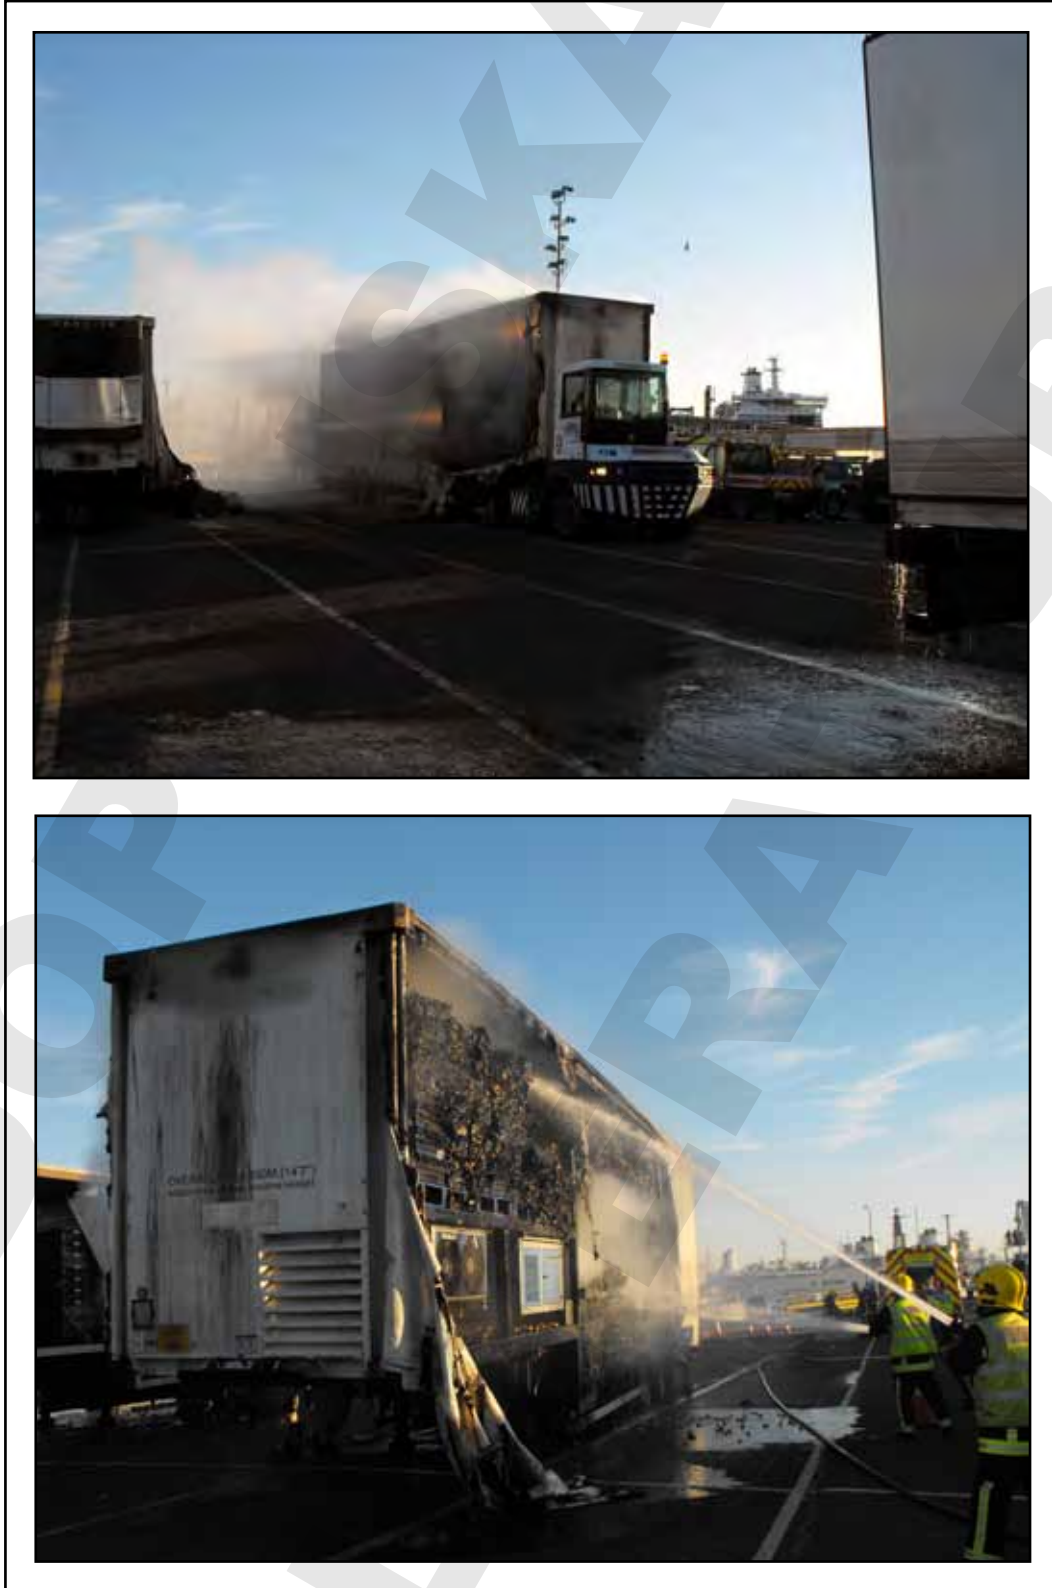
Figure 14

Trailer CRF461 continuing to burn after being removed from the main vehicle deck

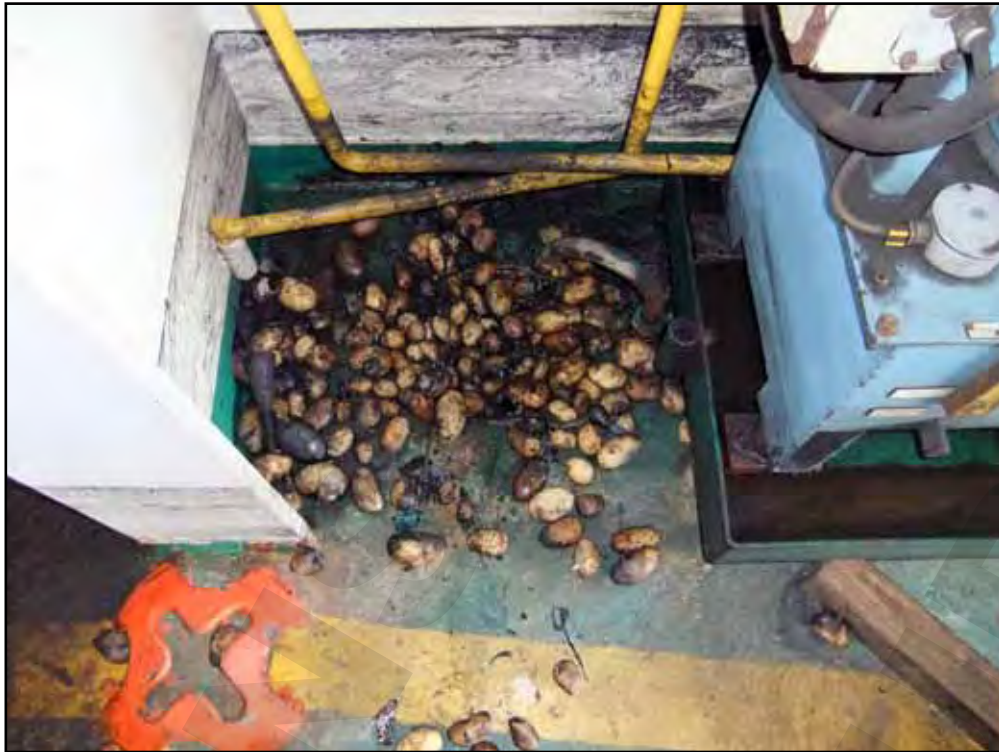
Deck drain blocked by potatoes

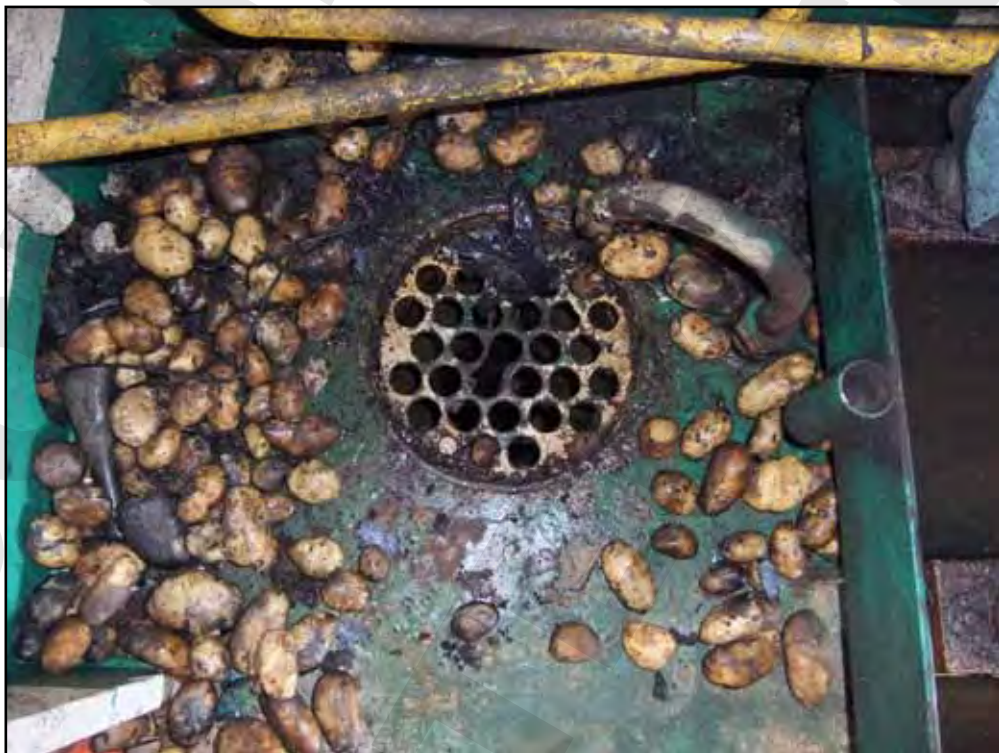
Deck drain cover with potatoes removed

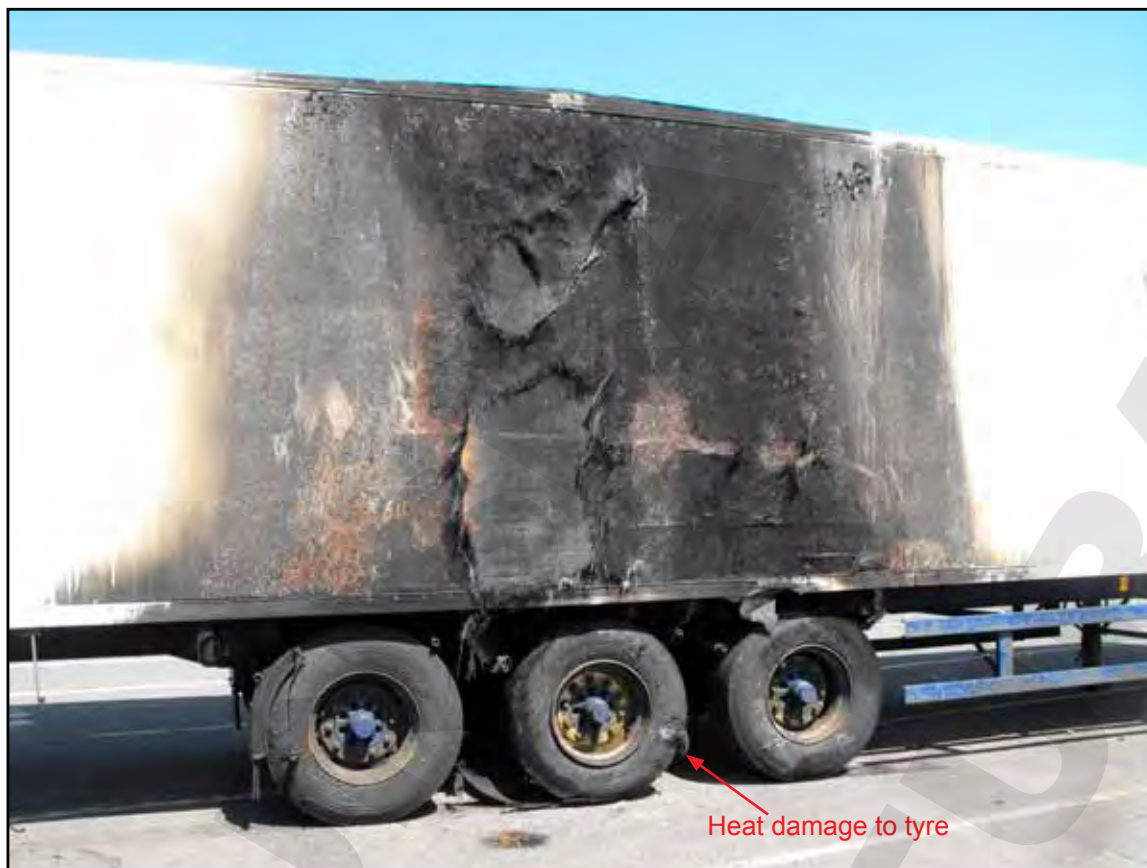
Charred and delaminated tyres on trailer GC13-1

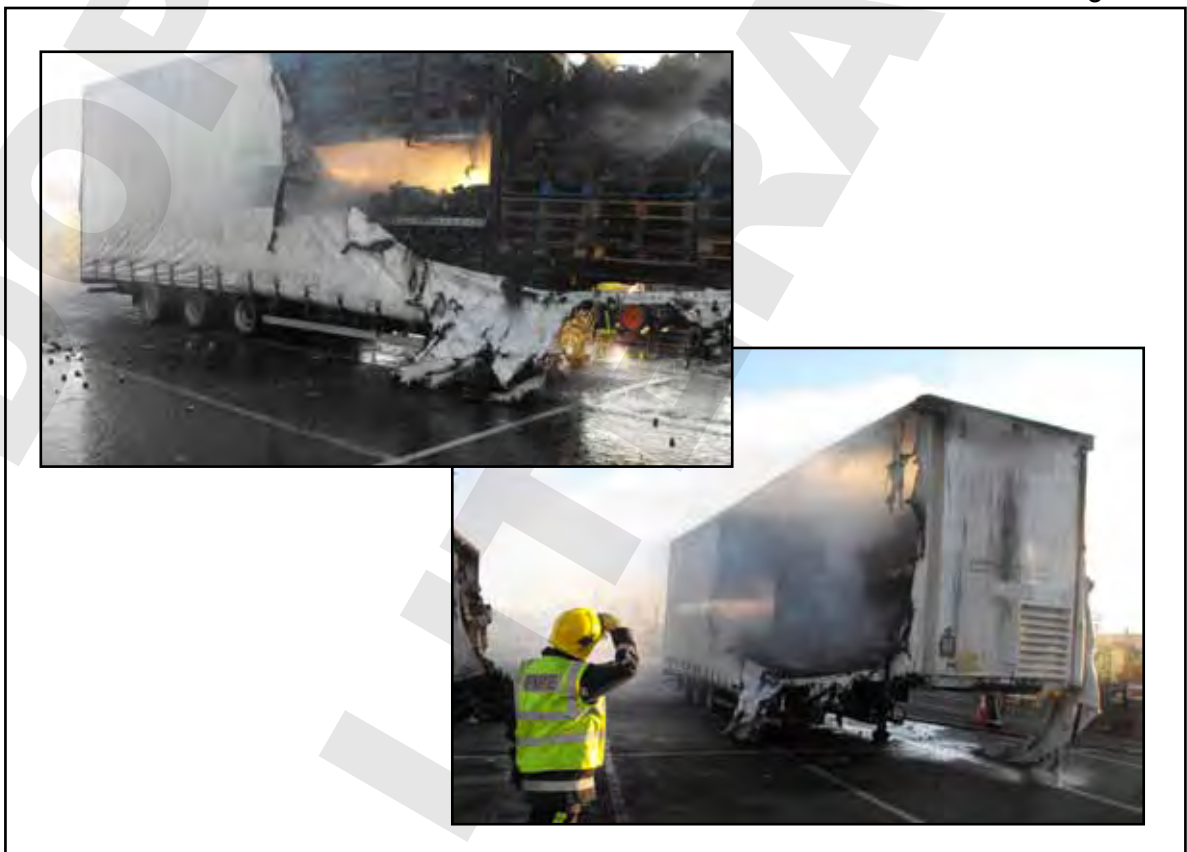
Figure 18

Trailer CRF461

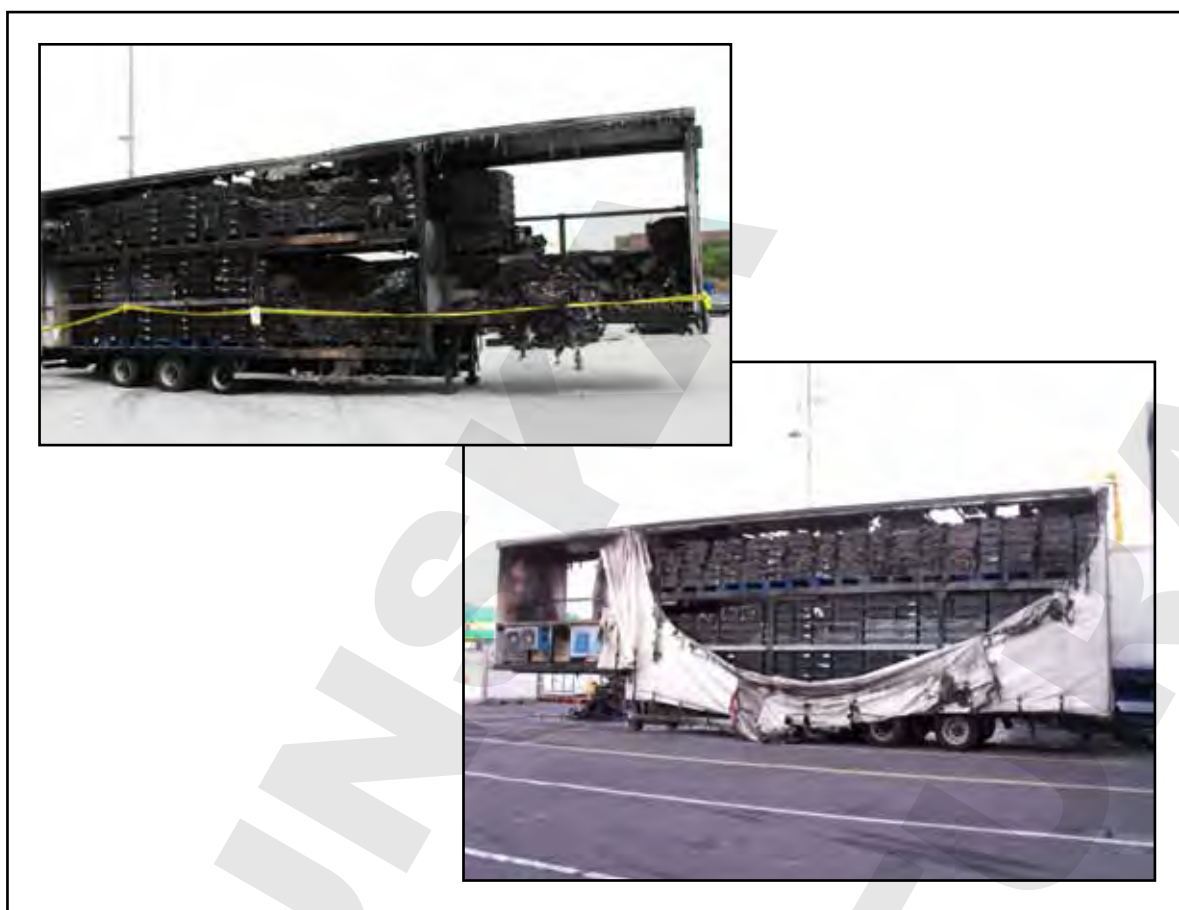
Trailer CRF459

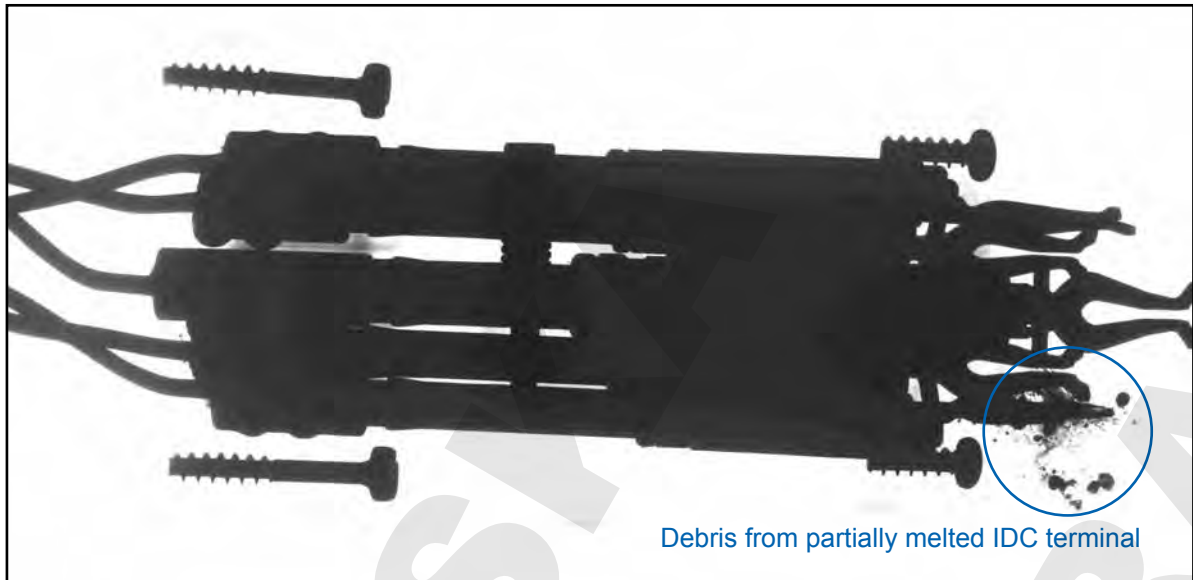
Figure 26

X-ray of the external power supply connection on trailer CRF459

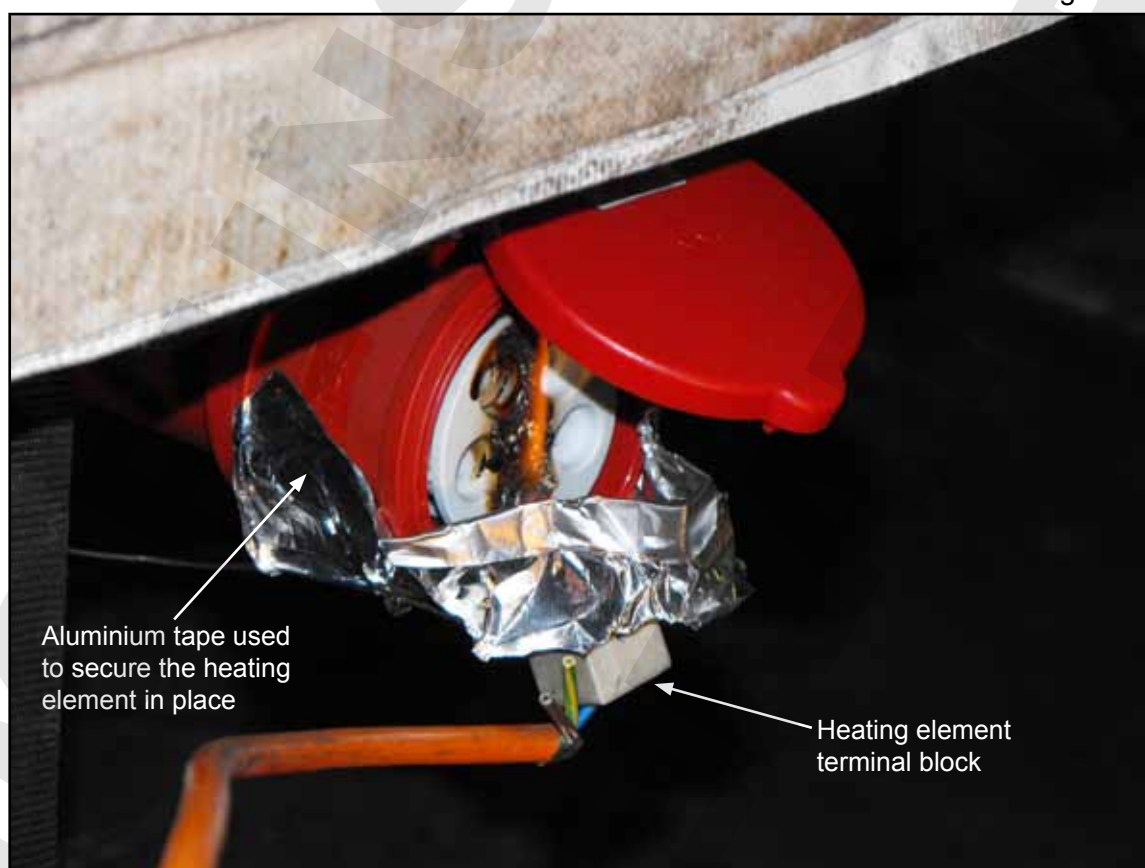
Figure 30

Ignition of the StarTop plug after sustained internal heating

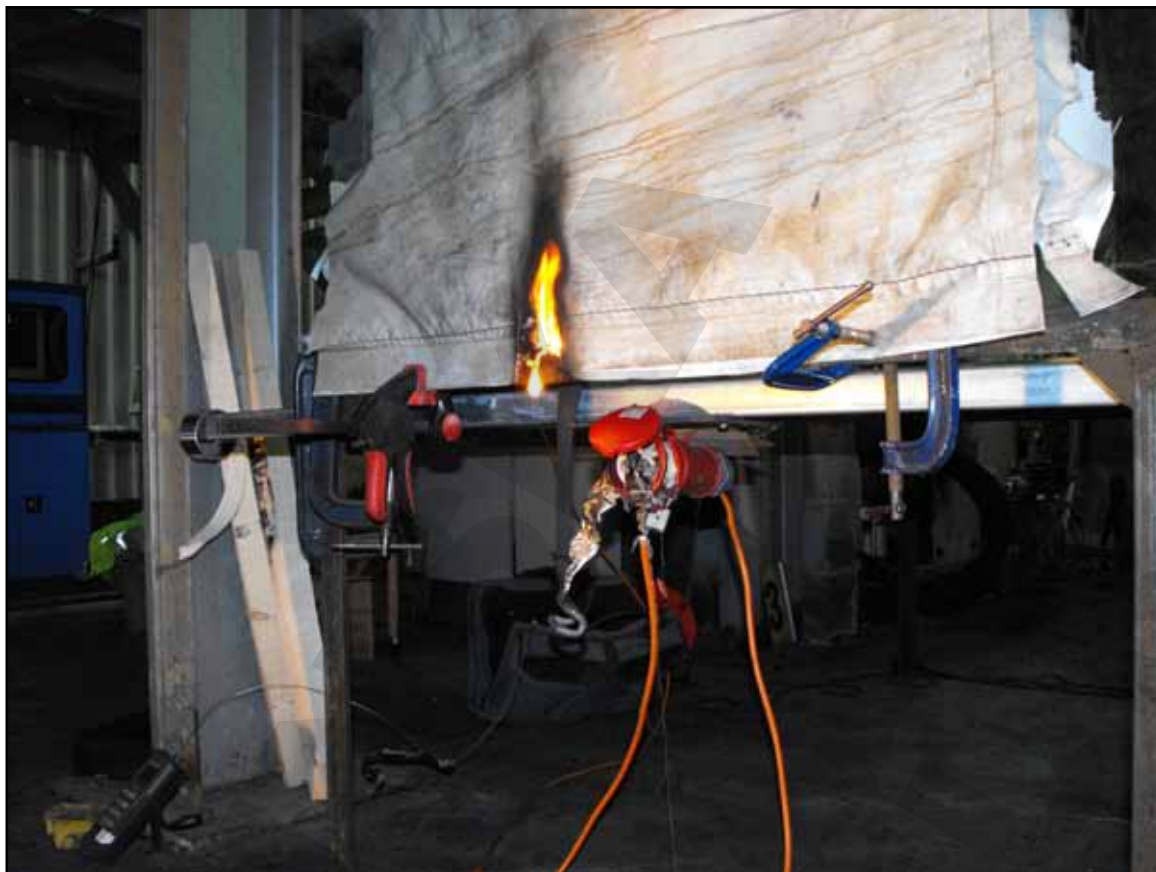
Ignition of the curtain-side material

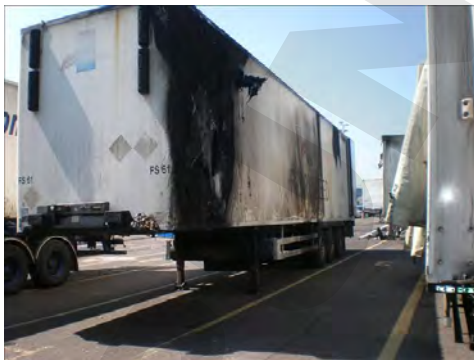
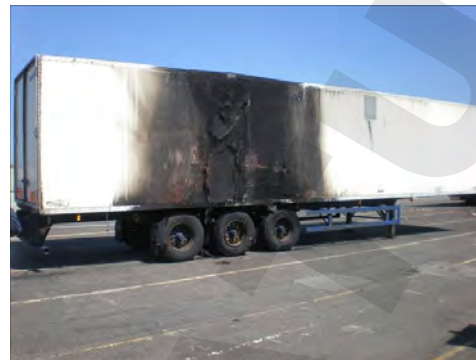
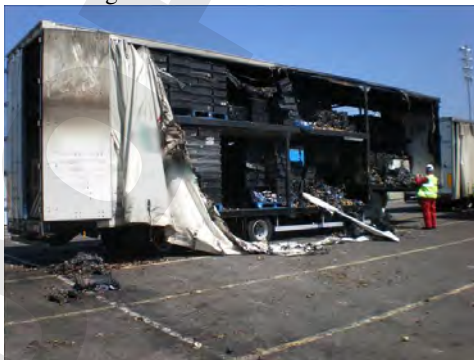
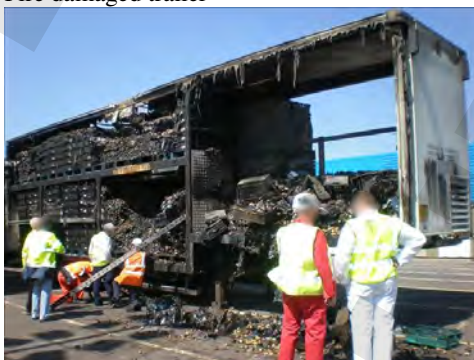
Fire damaged trailer

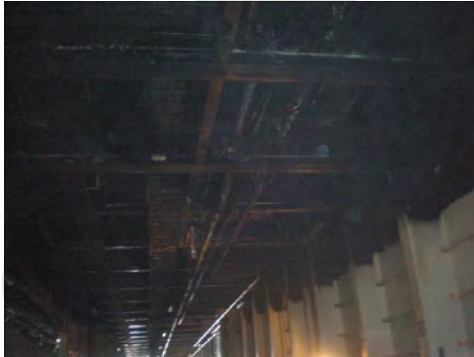
After fire

Repaired: Fire damage was repaired, as necessary, as detailed in the following report. Smoke affected zones were washed down with fresh water.

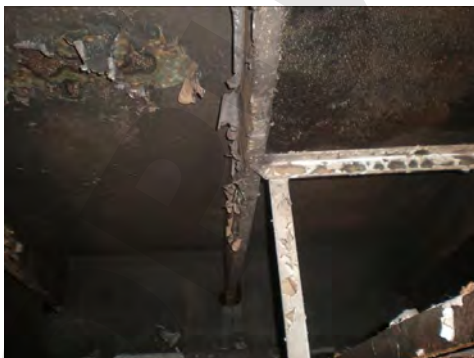
- Between frames 71 and 74 - 3 longitudinals buckled.
- Between frames 74 and 77 - 6 longitudinals and 1 deep longitudinal buckled.
- Frame 77, web and lower flange buckled.
- Between frames 77 and 80 - 6 longitudinals and 1 deep longitudinal buckled.
- Between frames 80 and 83 - 6 longitudinals buckled.
- Between frames 83 and 86 - 4 longitudinals and 1 deep longitudinal buckled.
- Between frames 83 and 86 - 1 deep longitudinal buckled, just forward of ramp.
- Between frames 86 and 89 - 2 longitudinals buckled.

Longitudinal buckled

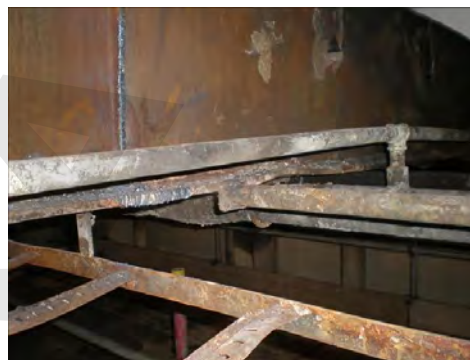
Frame 77, web and lower flange buckled (buckled longitudinal deep frame already removed)

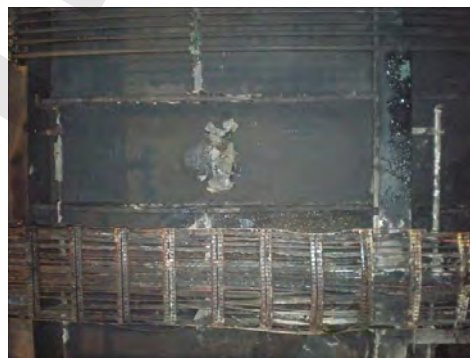
- Main Vehicle Deck (deck3), port side main cable tray buckled and cable insulation destroyed, between frames 74 and 77.
- Forward switchboard, both power supplies fire damaged.
- Reefer socket, fuse boxes and breaker cabinets water damaged.

Fire damaged cable tray

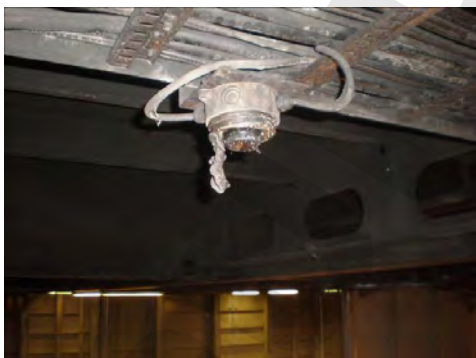
One section of the motherboard, in the control unit was also found burnt out.

Fire damaged, fire detector head

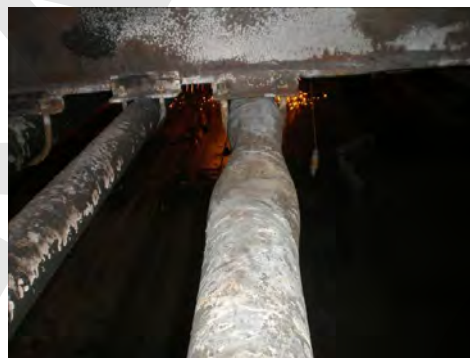
Buckled drencher main aft of frame 77

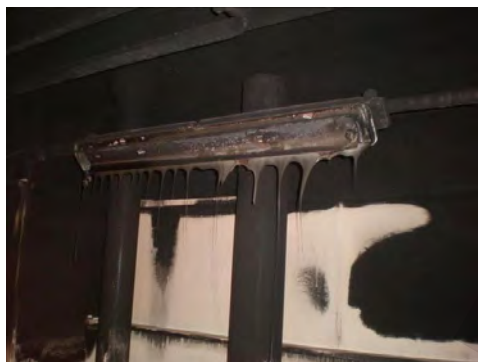
Fire damaged light

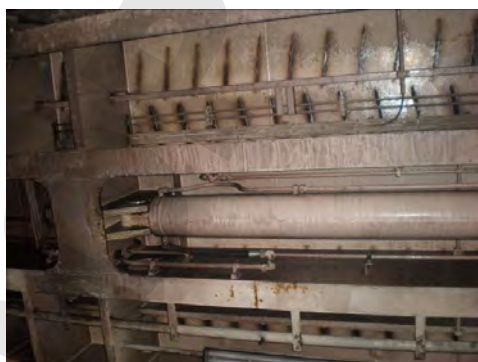
Internal ramp

The internal ramp was recommissioned, by the manufacturer's representative and then overload tested in operation, with 85 tonnes (10%+ in excess of the safe working load of 75 tonnes).

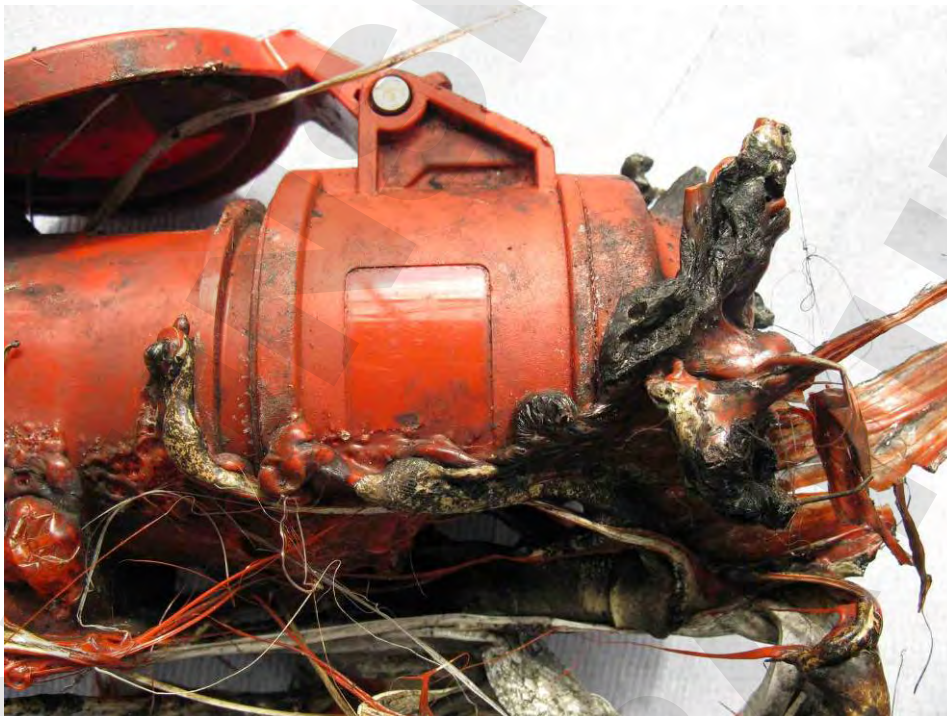
Figure 3 Supply socket

The plug and socket arrangement at the power intake to the trailer was badly melted and was heavily carbonised at the free socket end, Fig. 3. The free socket had been on the end of the cable from the ship's power supply.

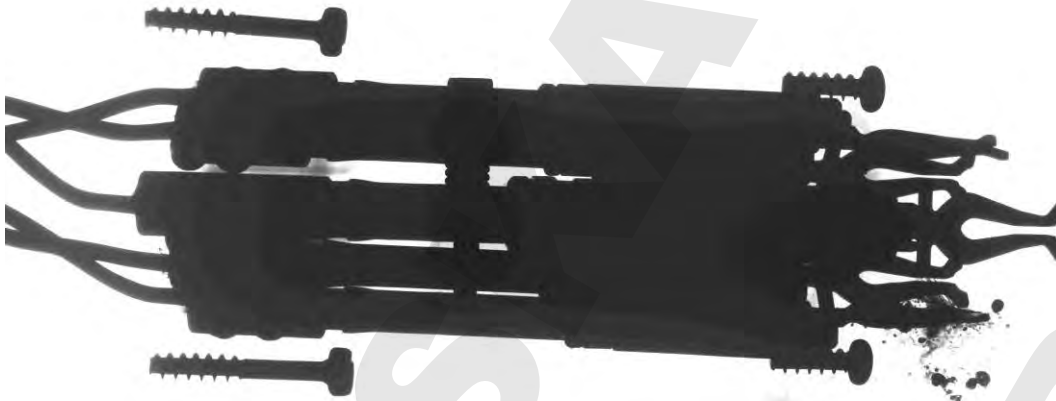
Figure 7 X-ray of plug and socket

The X-rays of the plug and socket revealed that the free socket had insulation displacement connectors, IDC, at the cable terminals whereas the fixed plug on the trailer had screw terminals, Fig. 7.

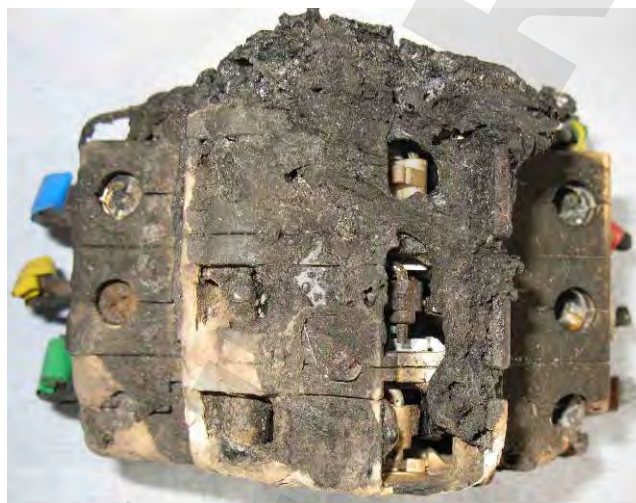
Figure 10 Trailer MCB

An examination of the MCB in the trailer control box showed that there was no evidence of arcing at its terminations and the condition of the MCB confirmed that the fire had not started at the MCB, Fig. 10.

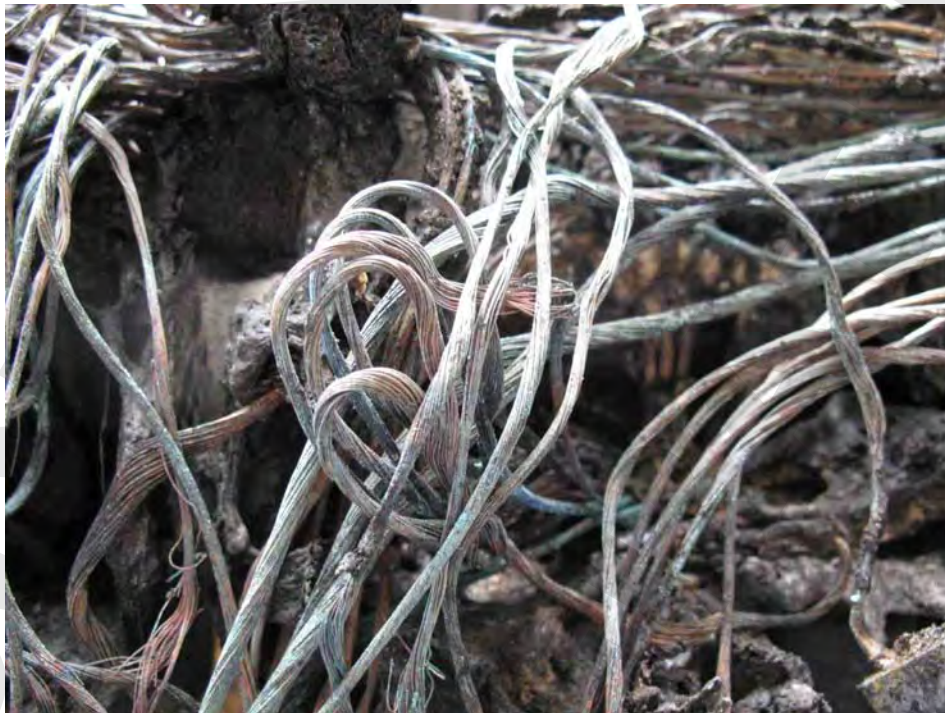
Figure 11 **Fire damaged wiring**

No evidence of arcing or other features that could have been the cause of the fire were found.

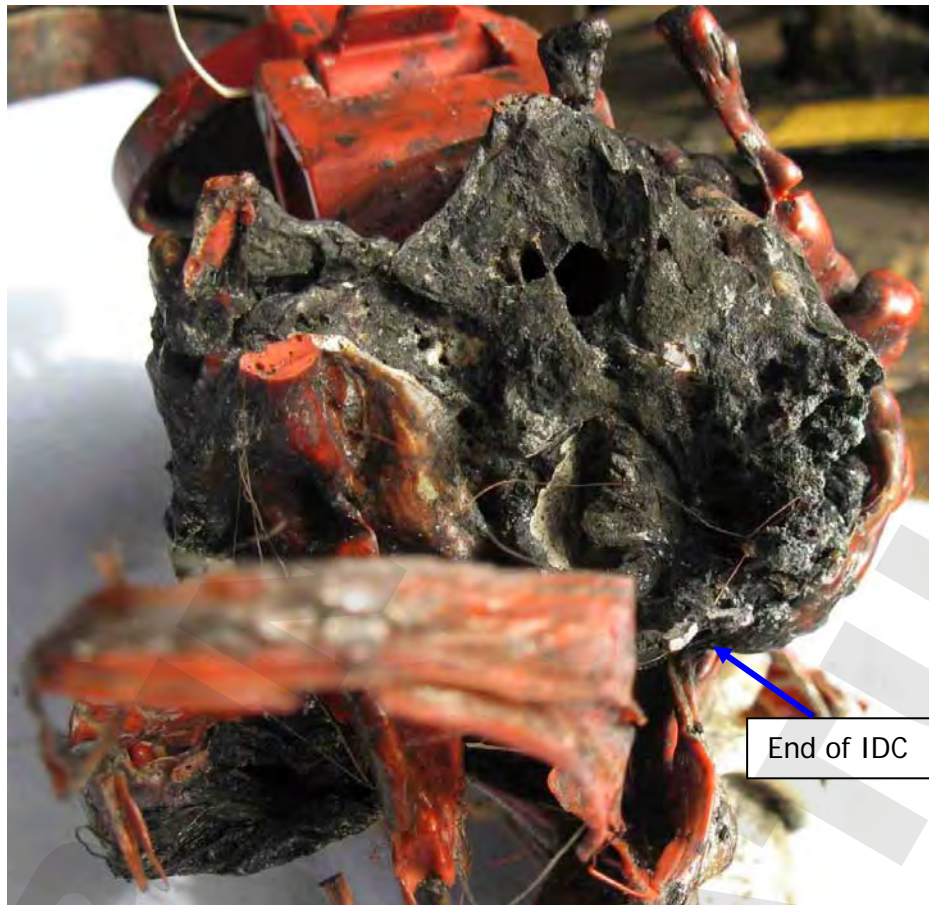
Figure 16 Charred free socket

The free socket at the trailer end of the cable from the ship's supply was a five-pin, 32 A, Mennekes 'Startop' socket. The trailer mounted plug and the socket were fused together by molten plastic. At the plug end the terminals were visible and did not show any evidence of arcing or severe overheating, Fig. 14. A large portion of the free socket had burned away, Fig. 15. The ends of one of the IDC connectors could be seen emerging from the charred plastic, Fig. 16.

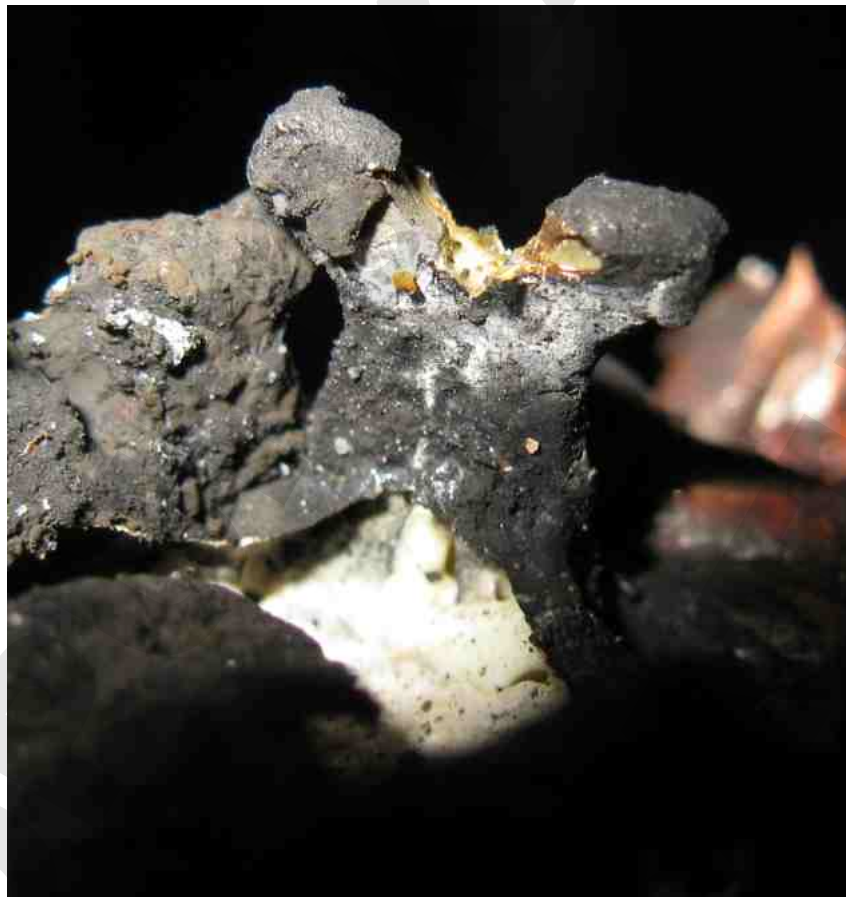
Figure 19 Blue phase IDC

The carbonised plastic around the IDC terminals was carefully removed so that the condition of the five connectors could be examined. What appeared to be slight arcing damage was seen at the end of the Blue phase terminal, Fig. 19. Later examination showed this to be melted plastic.
