Report on the investigation of
the fire on the main vehicle deck of

Commodore Clipper

while on passage to Portsmouth

16 June 2010

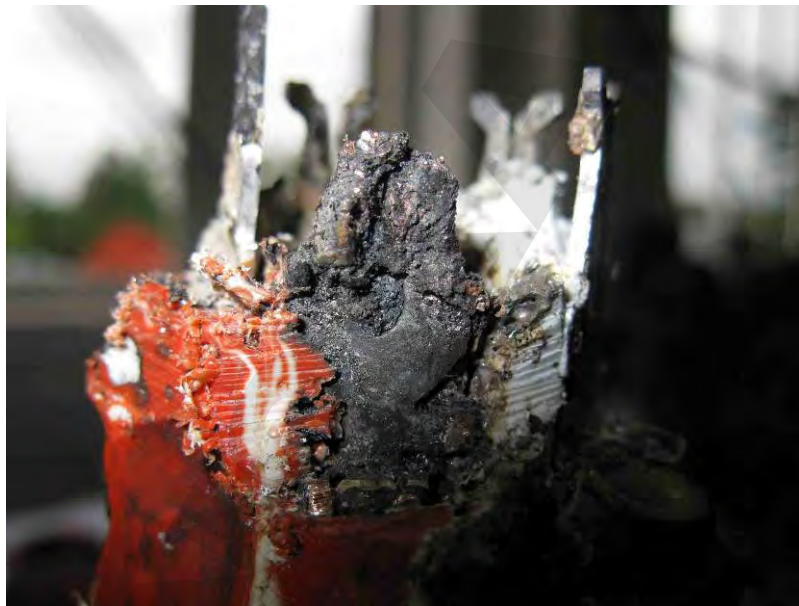
Figure 20 Brown phase IDC

The brown phase terminal had severe arcing damage and the remains of some conductor strands were adhered to the back of the terminal, Figs 20 & 21.

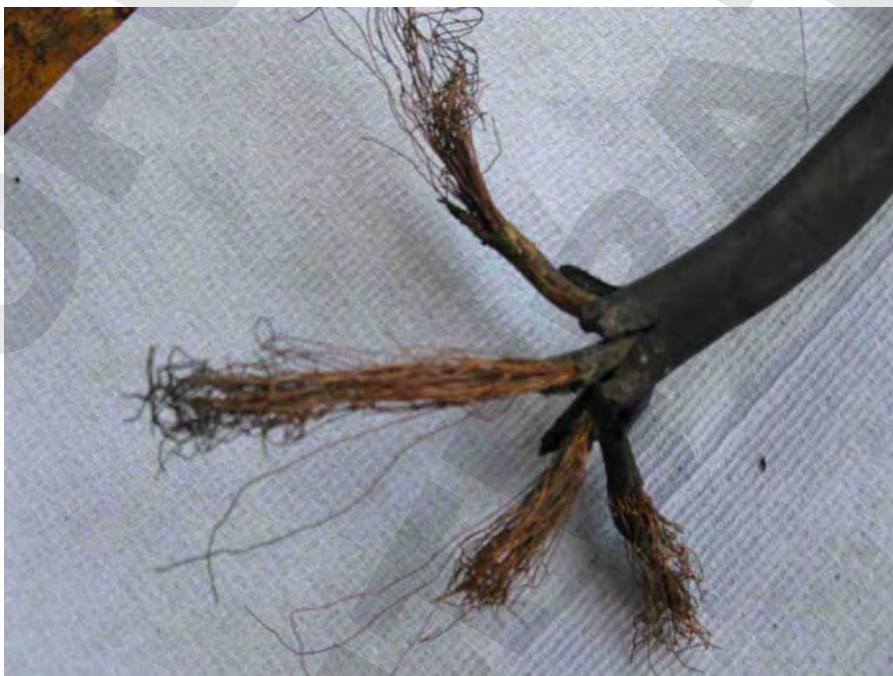
Figure 27 Cable cores

The ends of the cable that had been fitted to the free socket were examined. The exposed conductors on two of the cores were the same length; the third core had some strands broken off shorter than the rest and on the fourth core all of the strands were shorter. The fourth core was the brown phase, Fig. 27. It was reported to Cobham that the cable had been pulled out of the connector during the fire fighting operation.

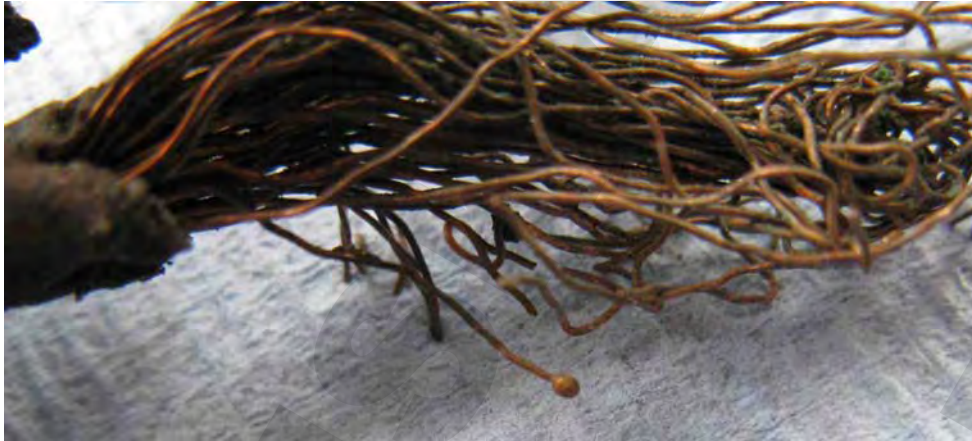
Figure 28 Copper globule

Close examination of the conductor strands of the brown core revealed several small globules of melted copper, Fig. 28.
