Was the 2014 Oso Landslide Predictable?

Michael Raiwet

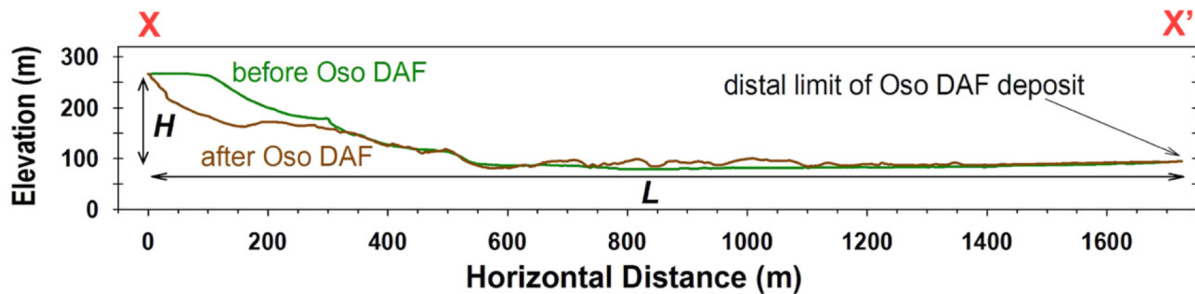
Figure 1 – Longitudinal topographic profiles from before and after the Oso debris avalanche flow (DAF); H = maximum height; L = length (Iverson *et al.*, 2015)

The landslide was initiated from a 190 m hill slope with an average slope less than 20° that was composed of unconsolidated glacial till and outwash (Henn *et al.*, 2015). Based on seismic data, detectable landslide motion began at 10:36:33 AM local time (Iverson *et al.*, 2015). The initial slide is believed to involve remobilization of remnants of the 2006 Hazel landslide. Movement was moderate and is believed to have come to a rest before reaching the river (Iverson *et al.*, 2015). However, as this initial movement decelerated, retrogressive collapse of the upslope bluff took place at approximately 50 seconds after the event initiated. From here, the slope quickly accelerated, due to a number of factors but likely the most significant being liquefaction of water-saturated sediment at its base (Iverson *et al.*, 2015). Seismic data indicates another prominent seismic event 310 seconds after the initial detection (Iverson *et al.*, 2015). This is believed to be caused by secondary debris fall (Iverson *et al.*, 2015). An estimated volume of 7.6 cubic metres flowed for about 1.13 km in the brief time that elapsed during the 2014 Oso landslide.

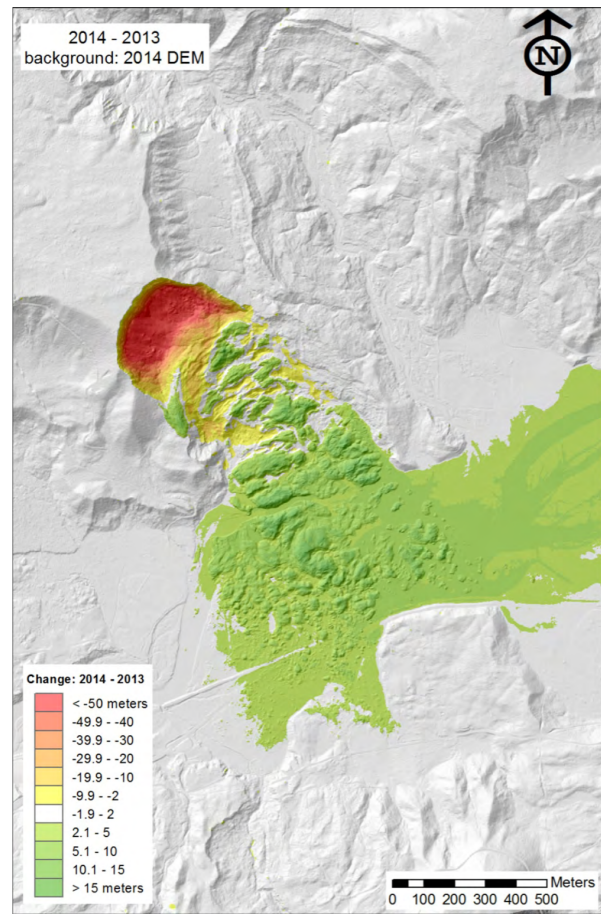
Figure 2 – Differences in elevation between 2013 and 2014 using lidar data (Wartman *et al.*, 2014).

Destabilization caused by the Stillaguamish River cutting into the toe of the hill slope's debris pile may have also reduced slope stability (Wayman, 2014). Figure 2 shows evidence of river movement towards the base of the hill slope in the bottom left portion of the image.
