# Final Report - PC Rate Degradation Analysis of the Longview LoRaWAN System

## Executive Summary

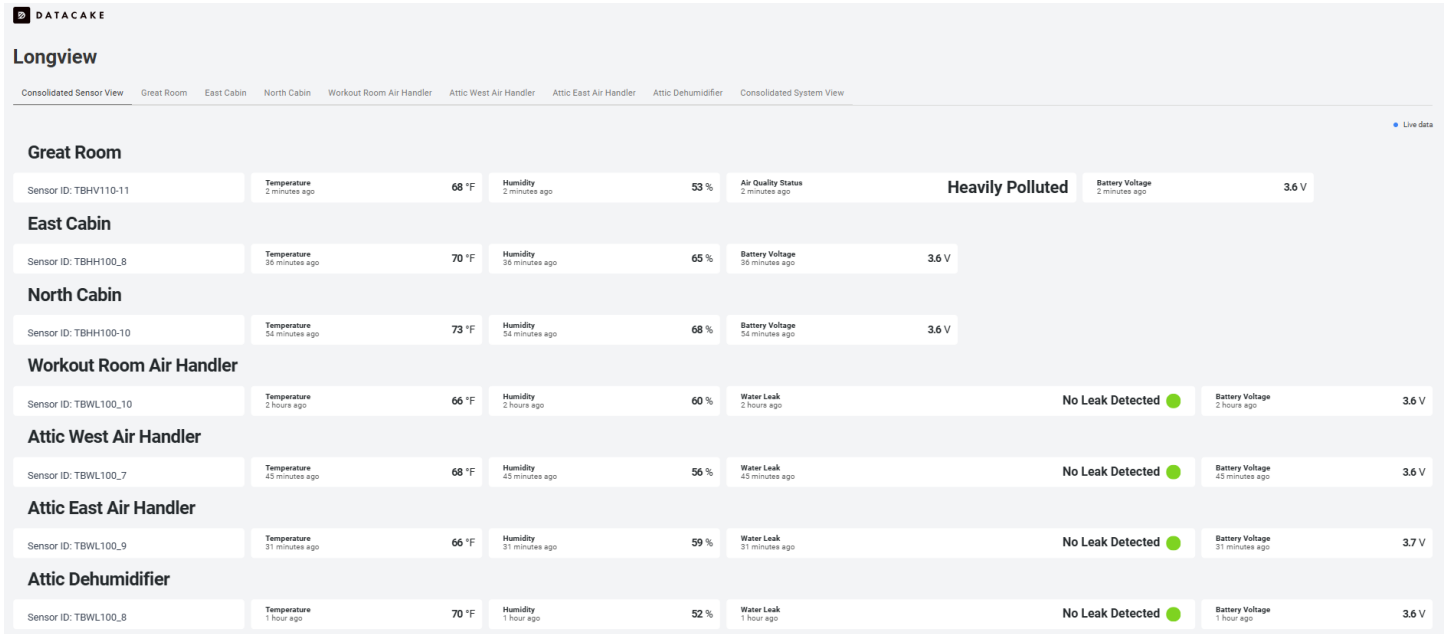
Above - Longview System Dashboard

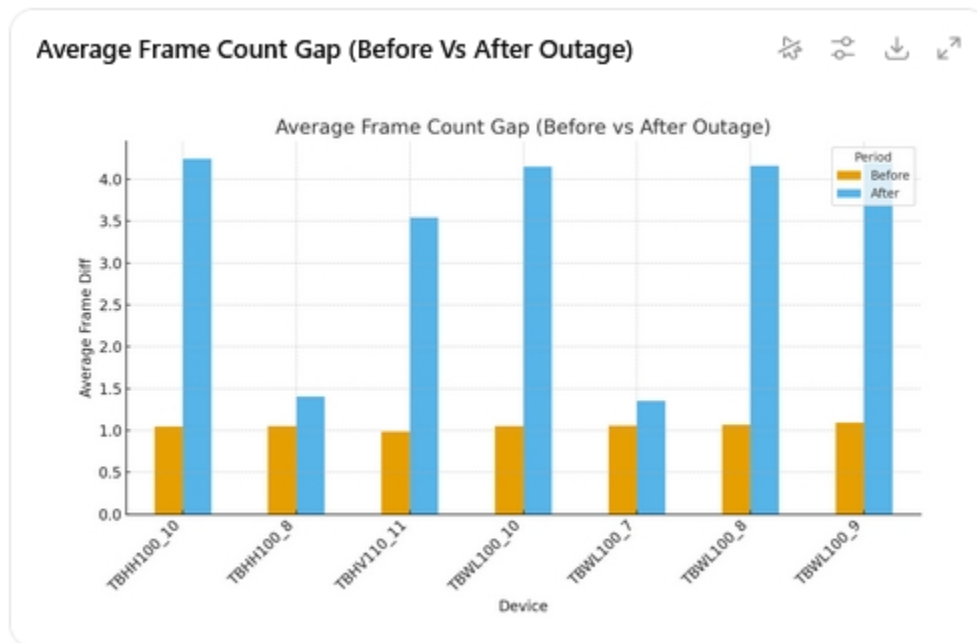
- **Observation:** Devices continued transmitting at the expected cadence; frame counters incremented normally.
- **Finding:** The network server only received ~1/3 of the expected uplinks from affected devices.
- **Analysis:**
  - This pattern is consistent with a **channel mask desynchronization** rather than a total sub-band mismatch.
  - Likely scenario: affected devices began transmitting across **24 channels (3 sub-bands)** instead of the gateway's **8-channel block**.
  - The gateway hears only 8 of those 24 → **8/24 ≈ 33%**, matching the observed ~34% PC Rate.
  - Downlink testing confirmed another issue: the gateway transmits downlinks with **RX1 Delay = 5s**, but devices likely still expect **RX1 = 1s**. Result: devices miss downlinks, never ACK, and cannot receive corrective MAC commands.

Above – Using Gaps in Framecount to Illustrate Performance Degradation in the Longview System

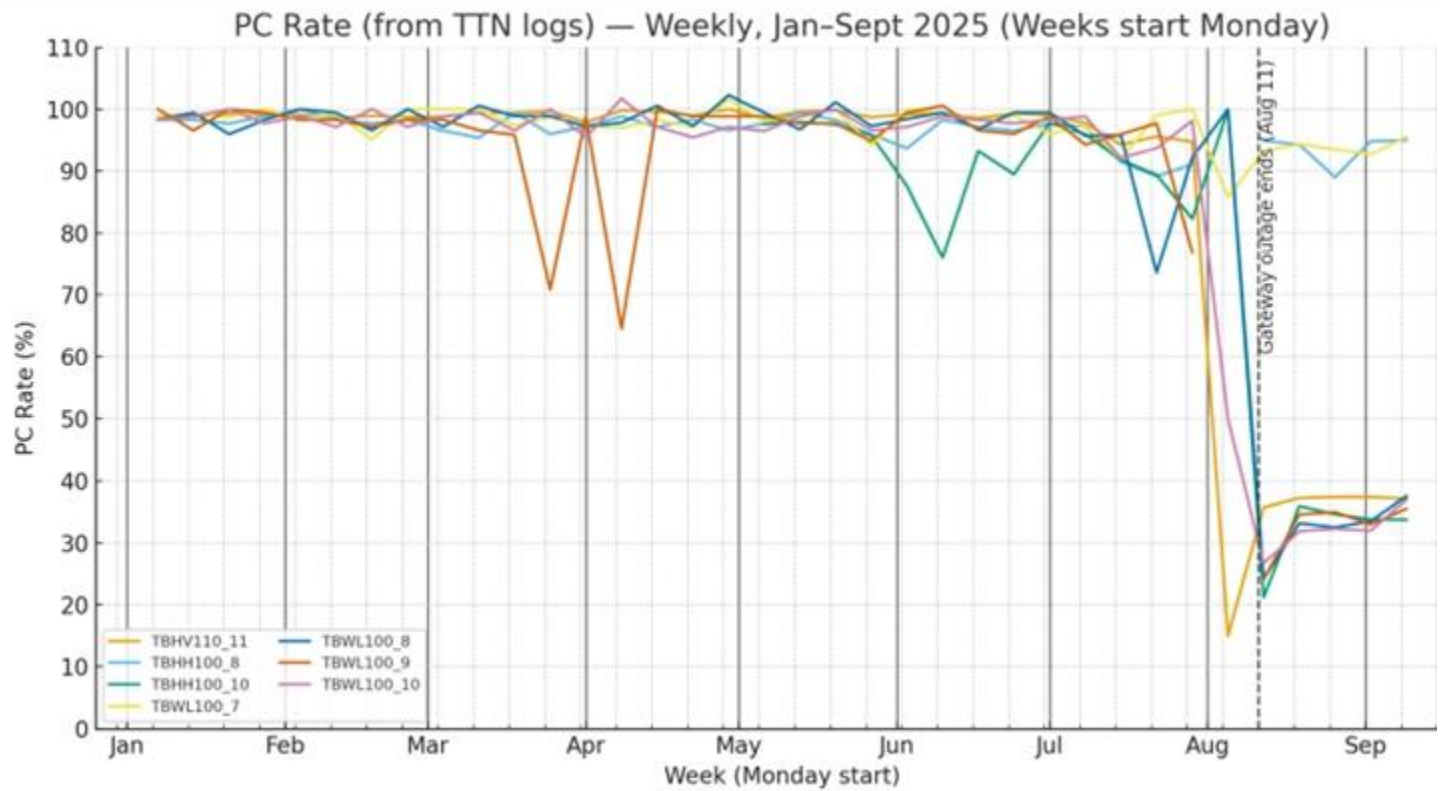
- After gateway recovery, **2 devices returned to ~94% PC Rate** but **5 devices dropped to ~34%**.
- The poor PC Rate of the 5 devices is caused by a combination of an RX timing mismatch and expanded channel masks.

As a result, the 5 poor performing devices continue to have a PC Rate of ~34%.

Above – Using Gaps in PC Rate to Illustrate Performance Degradation in the Longview System
